**Feasibility Study**  
for the  
**REHABILITATION AND ADAPTIVE REUSE**  
of the  
**GARVER FEED MILL**  
Madison, Wisconsin

April 21, 2005

## STRUCTURAL CONDITION ASSESSMENT

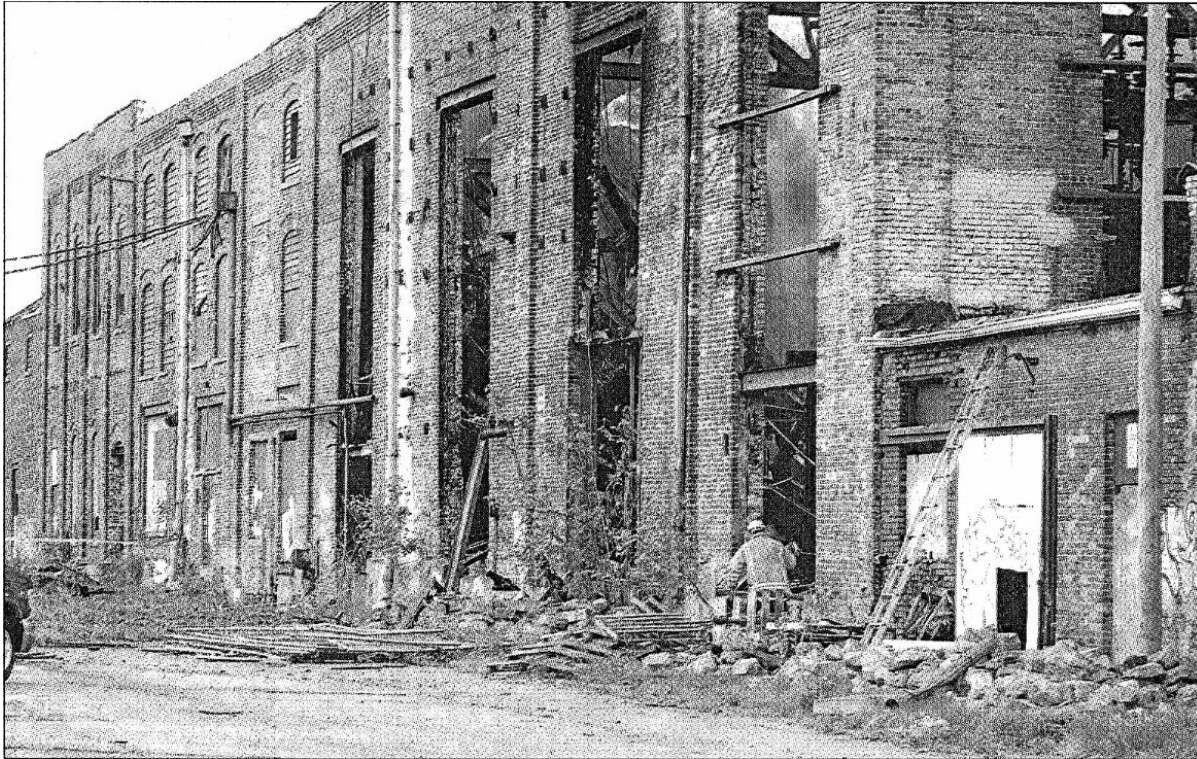
In May, 2001, fire broke out in the Garver Feed Mill Building.<sup>22</sup> As a result of the damage from that fire, portions of Building 2a, the infill building between Building 2a and Building 5, and Building 5 have been demolished. The building is presently being utilized by the Botanical Gardens for storage while plans for adaptive reuse are developed.

*Figure 29, May, 2001 Photograph of the fire-damaged rear elevation of the main building. Note the uniform cornice line despite very different fenestration patterns at each section of the building. Photo credit: John Maniaci/Wisconsin State Journal.*

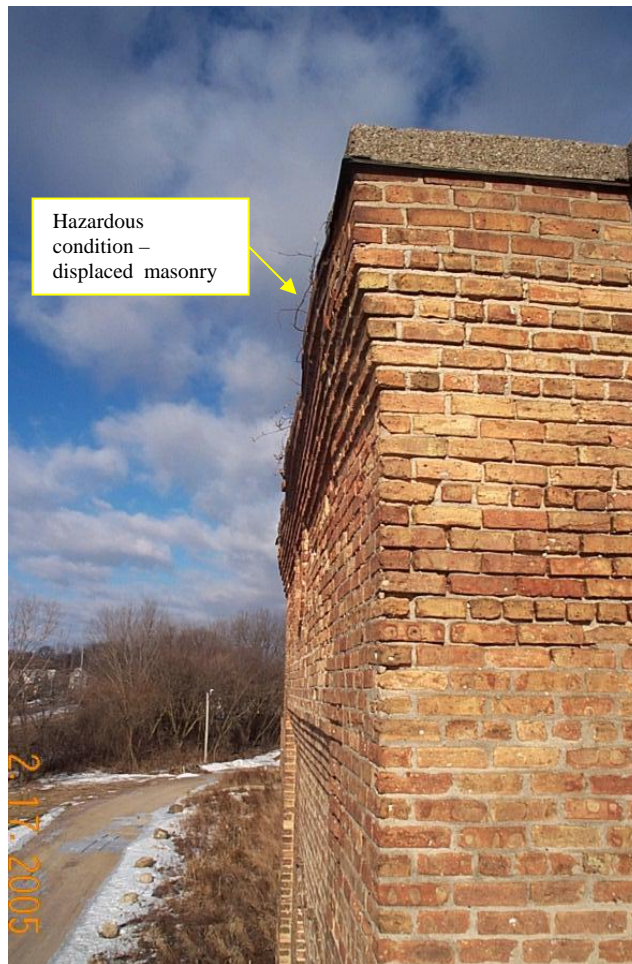
Notwithstanding their significant width, the masonry parapets are in uniformly poor and potentially unstable condition. Moisture has penetrated deep into the assembly from both sides through open mortar joints and openings in the clay tile coping joints. The subsequent freeze/thaw cycles have compromised the bond between the mortar and the brick. Evidence of related brick movement that has led to an imminently hazardous condition was observed over the main entry and was brought to the attention of Ron Linsicum. [See Figure 31] This condition was subsequently mitigated; however, other areas of brick movement were observed, particularly at the top of the north wall of the boiler building. [See Figure 32]

Figure 31, displaced masonry at parapet.

1. **ROOF REPLACEMENT AND PARAPET RECONSTRUCTION**
  - a) Remove 100% of the existing roofing and related insulation materials.
  - b) Remove 100% of the existing roof deck material.
  - c) Repair and replace existing or missing roof framing members as required. (Our preliminary evaluation indicates that this work is limited to rafters, and that the principal beams and purlins are structurally sound.)

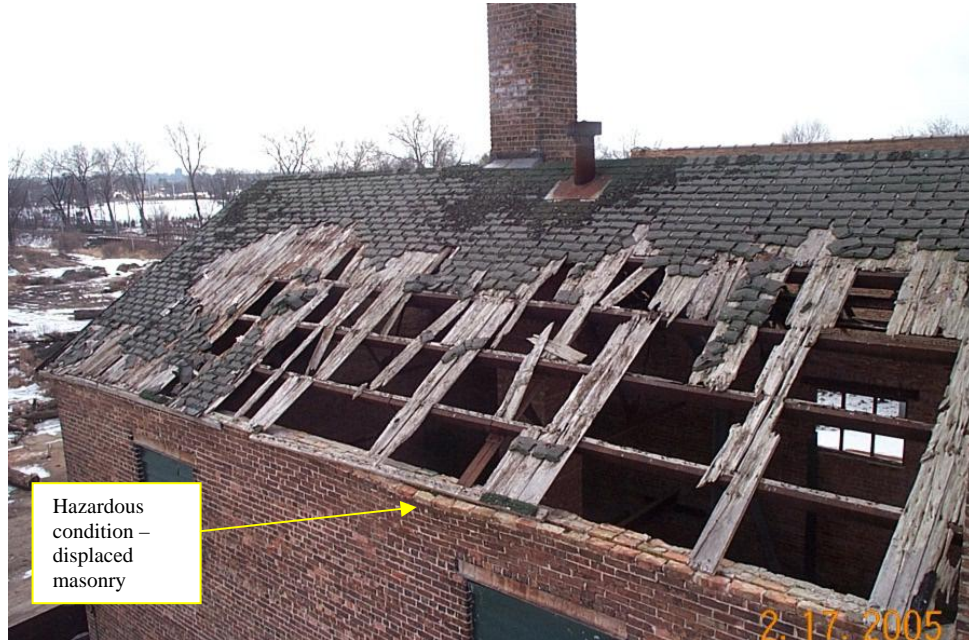
Figure 32, displaced masonry at boiler building

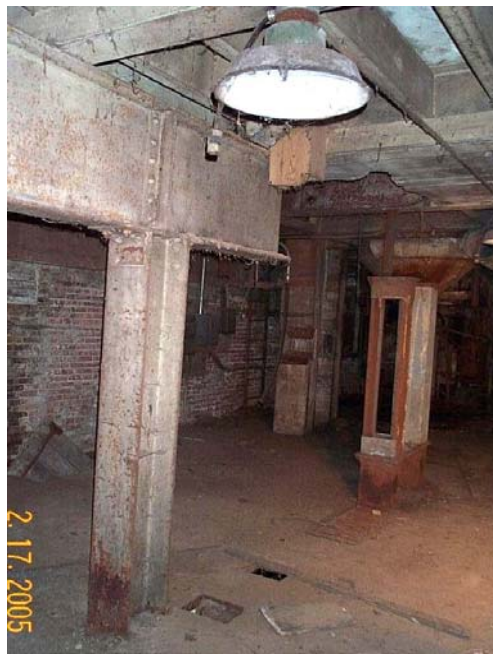
Very little equipment remains in the building. The elevator that was located at the east end of the space (#3) has been removed. It is interesting to note that the grain bins, hopper and cup conveyor are still reasonably intact in Space #6, [See Figure 33] and an interesting barrel or cylinder conveying system remains in Space #24.

Figure 33, original cup conveyor equipment
