MASTER PLAN REPORT

MADISON METRO TRANSIT FACILITY STUDY MADISON, WISCONSIN

MARCH 9, 2018

Madison Metro Transit Building Master Plan Report

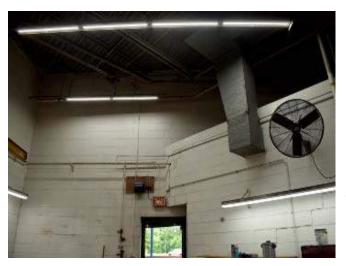
The current exhaust fans are operating beyond their life expectancies, with some having significant amount of rust. The missing damper in EF-34 is causing air to leak through that inlet when that fan is turned off, which could have unnecessary efficiency losses. The blocked roof intake could cause the generator to overheat due to a lack of air flow. The damaged and missing wire-frame netting on the vacuum-system exhaust ports could clog the vacuum pipes and cause debris to enter the intake of HV-12. As part of the ventilation and make-up air systems discussed above, it is recommended that all exhaust fans be replaced as part of a balanced and integrated ventilation system.
