OLBRICH BOTANICAL GARDENS ROYAL THAI PAVILION CONDITION ASSESSMENT REPORT

AUGUST 30, 2022

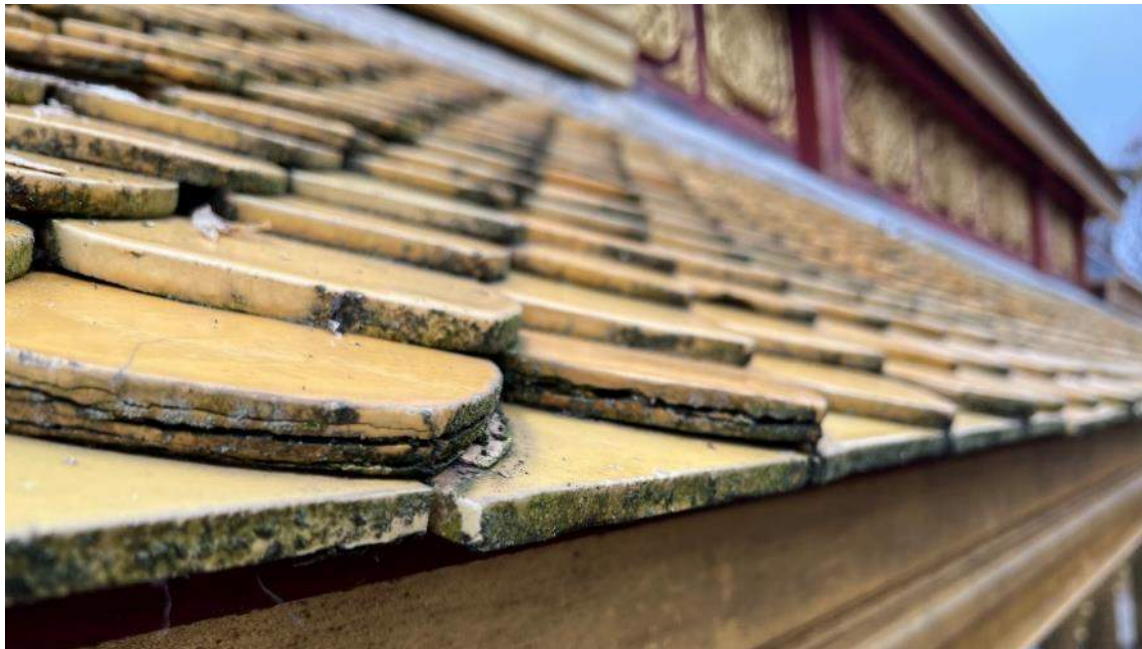
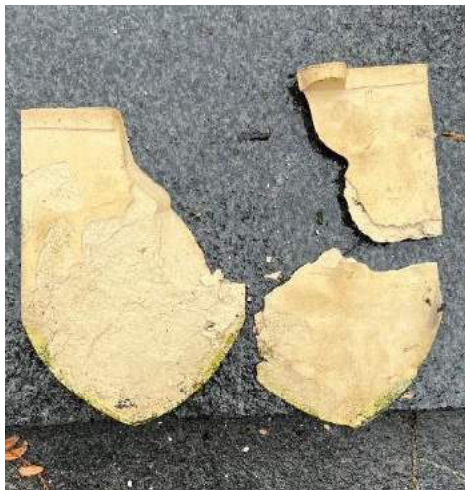
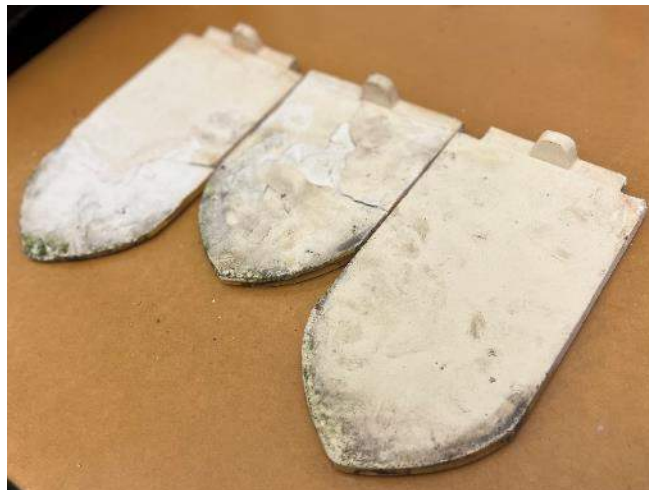
The condition of the roofing tiles is **CRITICAL**. The tiles are failing through splitting or shaling due to continued water exposure, and further deteriorating

through our Wisconsin climate's freeze-thaw cycle. It is assumed that more than 40% of the tiles are currently damaged. While testing has not been conducted on the existing tile nor the attic stock on hand, it is generally assumed that it is the Thai buff clay substrate that is not well-acclimated to withstand the typical weather patterns of our northern climate, regardless of enhanced treatments.

This damage classification is evaluated as the most extreme condition since the tiles were observed and have an extreme likelihood of falling off the roof, which could cause harm to the public below. It is recommended that, in the short term, barricades or netting be put into place to prevent any possible injury. Upon review of the fall zone with a structural engineer, a barricade should be placed a minimum of eight feet from the structure to isolate the fall zone for the tiles.

A full replacement of the roofing tiles is recommended. The replacement tiles themselves should be recreated in shape, size, and glazed color, yet be made of an alternate clay material that is compatible with the Wisconsin climate. The tile should be convex to match the existing tiles for aesthetic and technical reasons. The overall surface of the tile will look much more uniform if the tiles are manufactured in this way. The tile should be laid in the same pattern and method, utilizing the tabs as originally designed. Modern substrate materials and roofing methods should be incorporated to prevent further water infiltration to the remaining structure. These will include contemporary synthetic underlayments, sub-tile membrane, and flashing systems. These systems must be carefully engineered to allow for the freest possible flow of water vapor and resist bulk water from above being introduced to the interior portions of the pavilion.

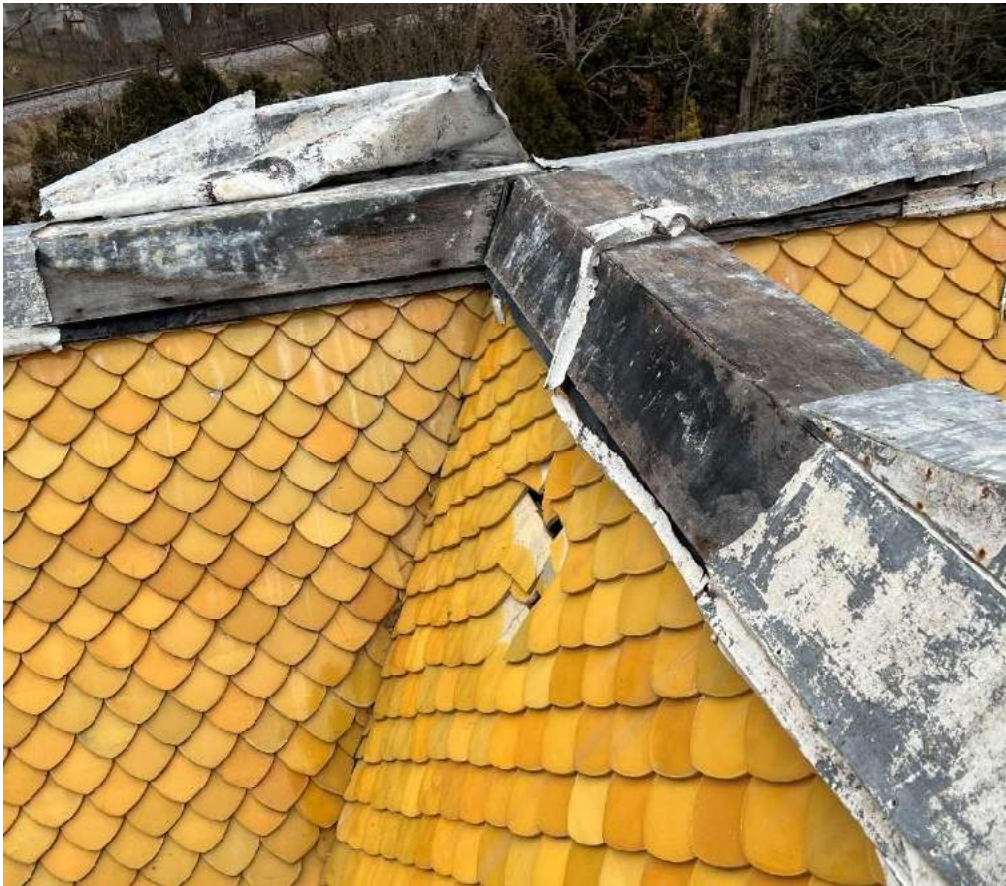
The existing lead flashings were observed to be under designed; a heavier grade of lead would have resisted some of the damage that has obviously been done to the flashings. Further exacerbating the issue is the lead flashing attachment material and method. Carbon steel fasteners were used in the installation which have caused a cascade of issues that include the degradation and failure of both the fasteners and the lead due to galvanic cell action. Cyclic fatigue brought about by a loosely attached flashing (due to the galvanic degradation noted above) has opened significant voids in the flashings

which has allowed water infiltration at the fastener locations as well as at the areas that have pulled apart from the wood substructure. The lead flashings are entirely missing or severely deformed in several locations, again, due to the lack of adequate material, attachment and the cyclic fatigue brought about by the constant effect of wind and the occasional high wind event. The use of standard steel fasteners and nails has also caused rust and enlarged holes in the lead loosening their fastening ability. This open condition is also now subsequently exposing the formerly concealed untreated wood components below these areas also causing premature decay and deterioration. For this reason, we classify these areas as **CRITICAL** conditions.

A secondary challenge to the structure is the lack of adequate flashing systems at the valleys and wall to roof junctures (wall and apron flashings). These conditions are contributing to the premature failure of some finish materials, and degradation of some of the teak structural elements. Proper flashing design and installation will help to prevent wind-driven rainwater from entering the structure and contributing to further wood decay of the roof substructure and associated finishes. These areas are also considered **SEVERE** conditions.

It is recommended that all flashings be replaced in kind with new materials that match the existing in all ways except in their overall grade, or weight. Replacement materials should be fastened minimally with double hot-dipped galvanized nails that have been confirmed to be compatible with new flashings. Additionally, the **MINIMAL** use of some Ice & Water Shield would also assist in the proper drainage of the roof areas. This material may be used very sparingly and must not be considered as a final, primary roofing substrate.

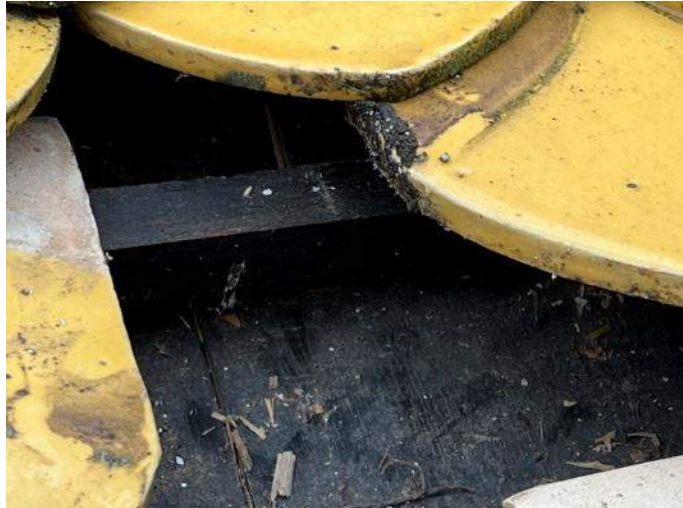
The wood roof substructure is in **GOOD** overall condition; no significant work should be anticipated for this building component.

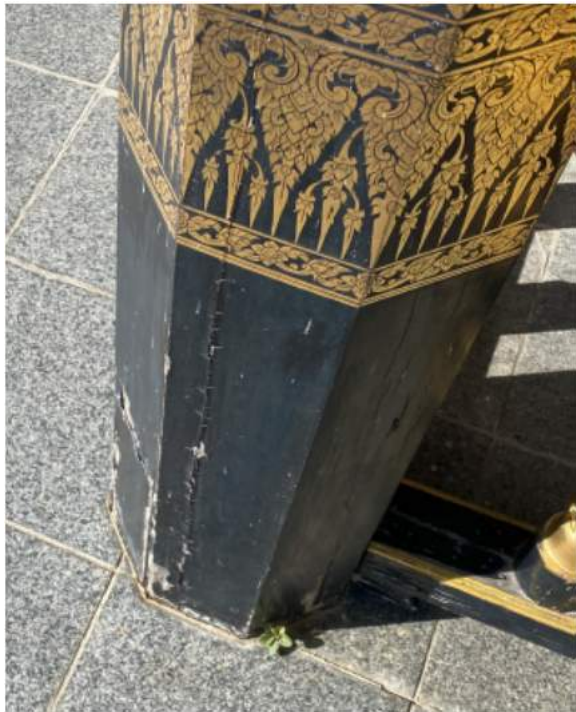
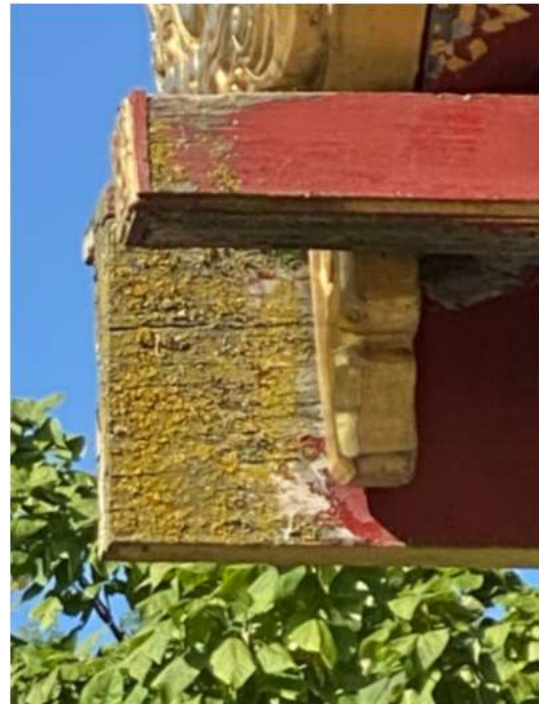
These elements are in **FAIR to POOR** overall condition. Water damage to these elements is causing some collateral deterioration. The wood columns reveal water damage at the bases. The rafter ends are becoming dry rotted and require repair. The painted wood ceiling and soffit panels show signs of buckling seams and popping paint.

It is recommended that the repair of these elements commence after the water issues (especially those that are reaching the interior components) are completed. Wood consolidation repairs will be employed in areas where differential weathering will not be an issue. Partial replacement dutchman repairs can be used in very limited locations depending on the skill of the carpenters and craftspeople working on the project. Full replacement of any wood element will only be completed as a last-resort response to an area that will not be able to repaired to the point where other less invasive repairs will provide a long-term/permanent solution. New paint/lacquer coatings should be applied to consolidate the exposed areas.

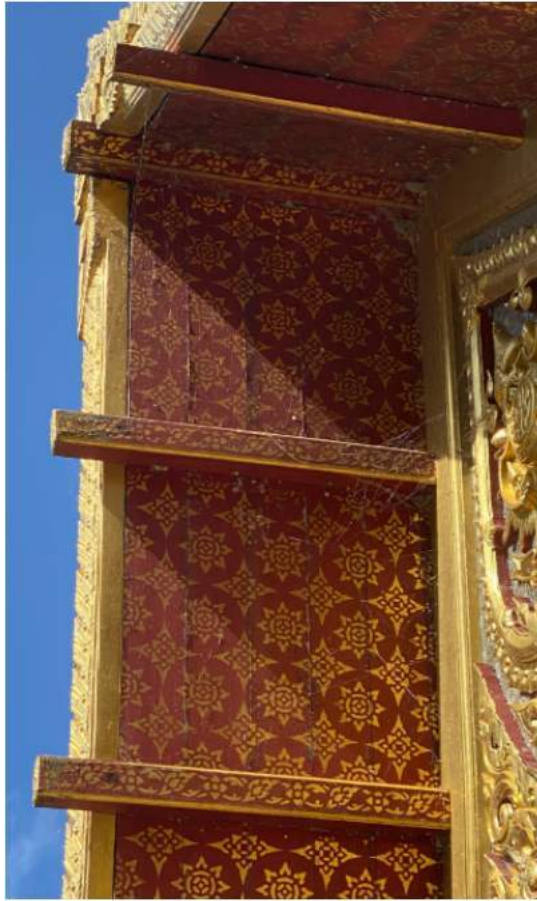
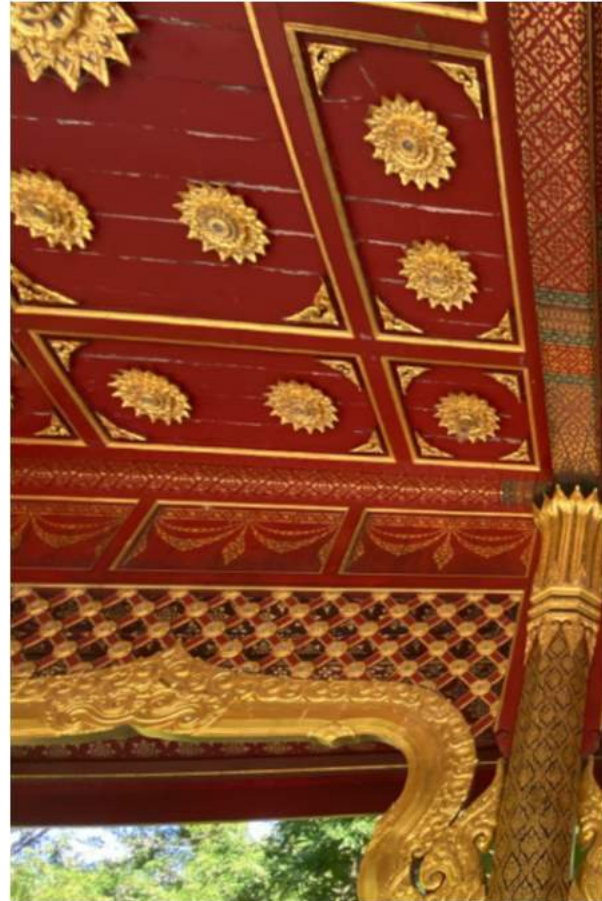
The conditions of the decorative finishes are in generally **FAIR** overall condition, yet **CRITICAL** in some locations. The existing finishes exceed their standard life period and the relatively harsh Wisconsin winters have taken their toll. Areas at extreme water exposure have seen their finishes completely washed away – most notably at rafter ends, ceiling boards, and column bases. Ongoing gold leaf maintenance is required, and could be as often as every few years when exposed to the elements.

The structure is in need of new coats of lacquer and gold leaf. These remedial finishes should be done under the instruction of Thai artists to ensure the proper techniques are used to refresh the building.

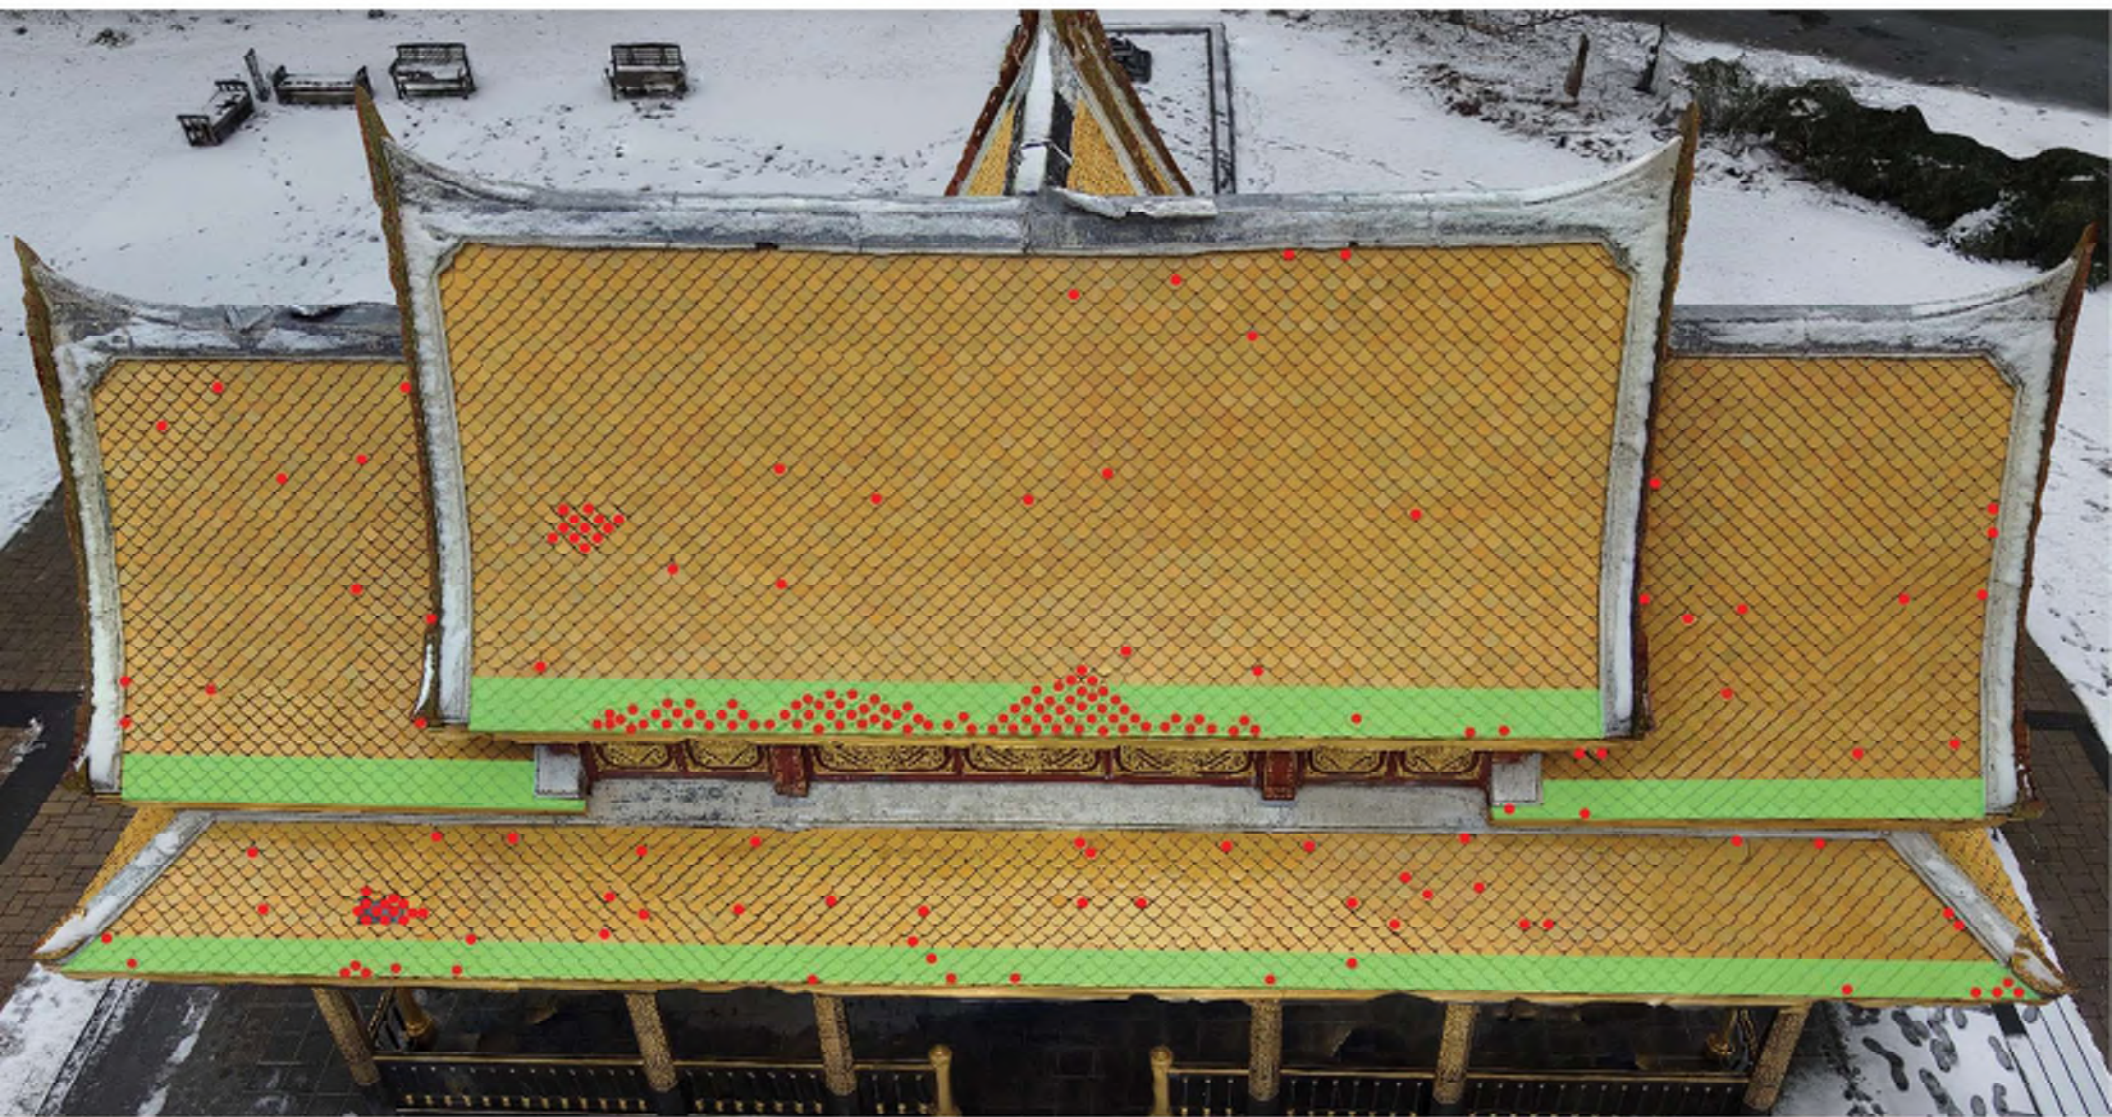
1. East Roof - Initial observed damaged tiles from aerial view (not accounting for shear cracking) - Priority 1

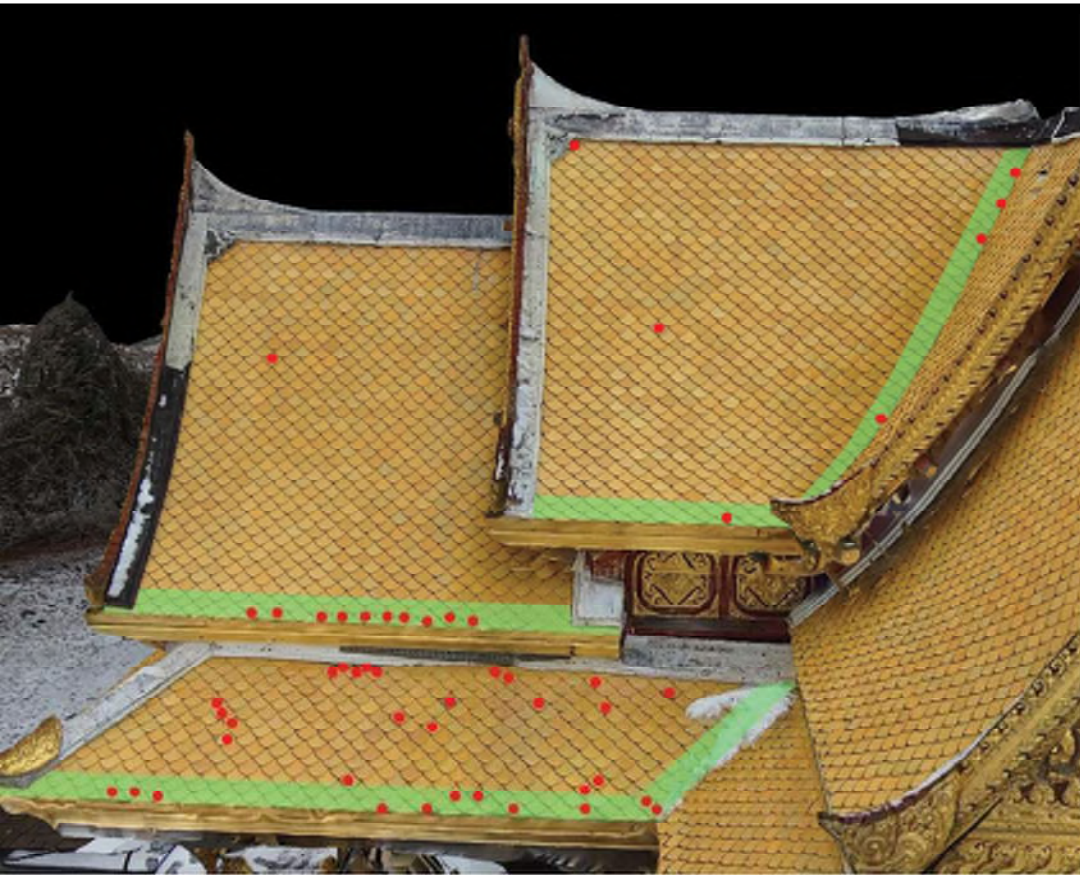
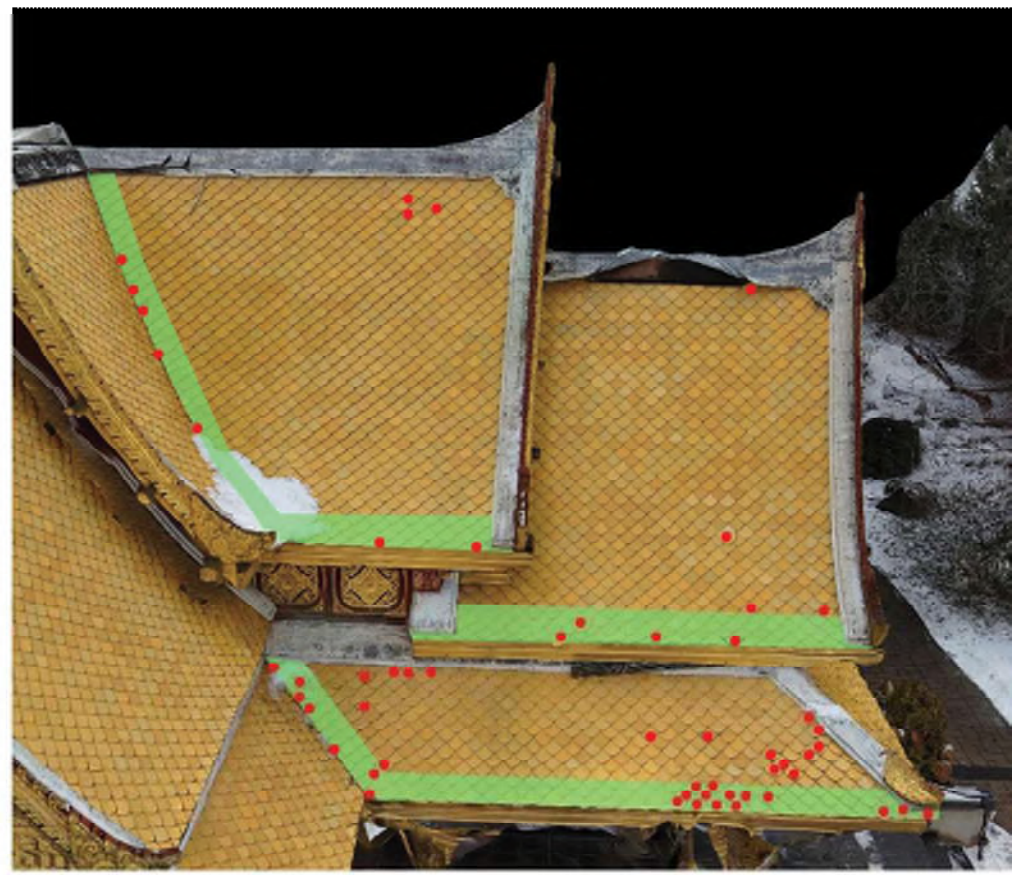
2. West Roofs - Initial observed damaged tiles from aerial view (not accounting for shear cracking) - Priority 1

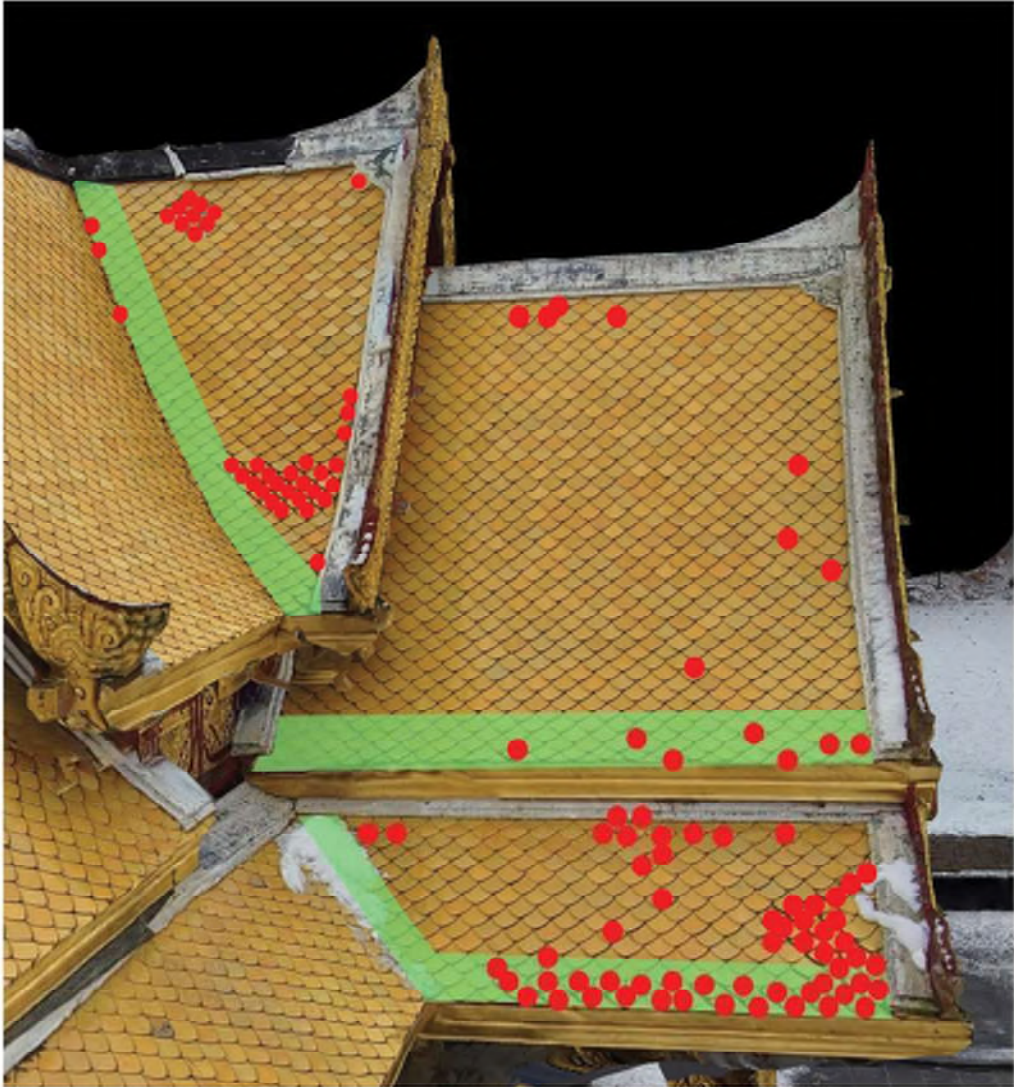
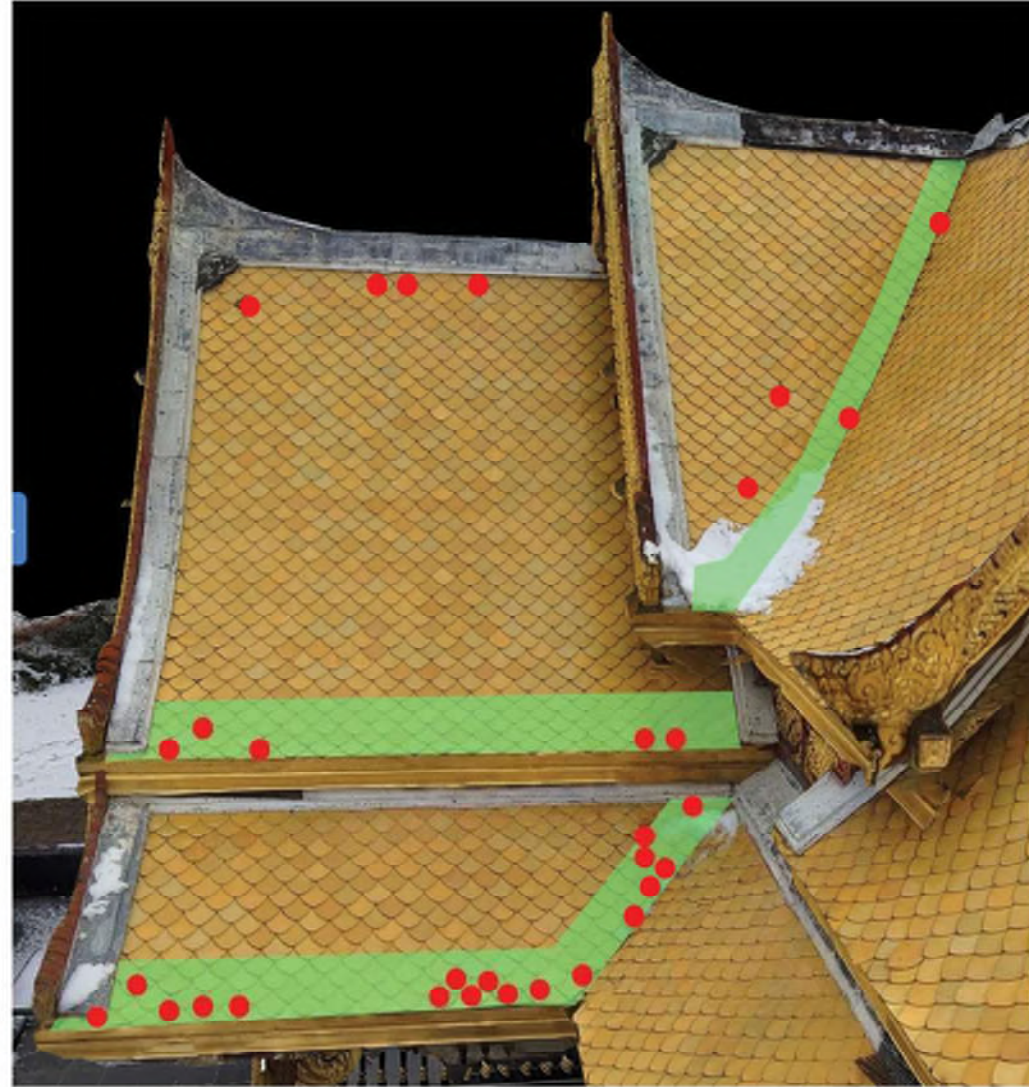
3. North & South Roofs of West Gable - Initial observed damaged tiles from aerial view (not accounting for shear cracking) - Priority 1

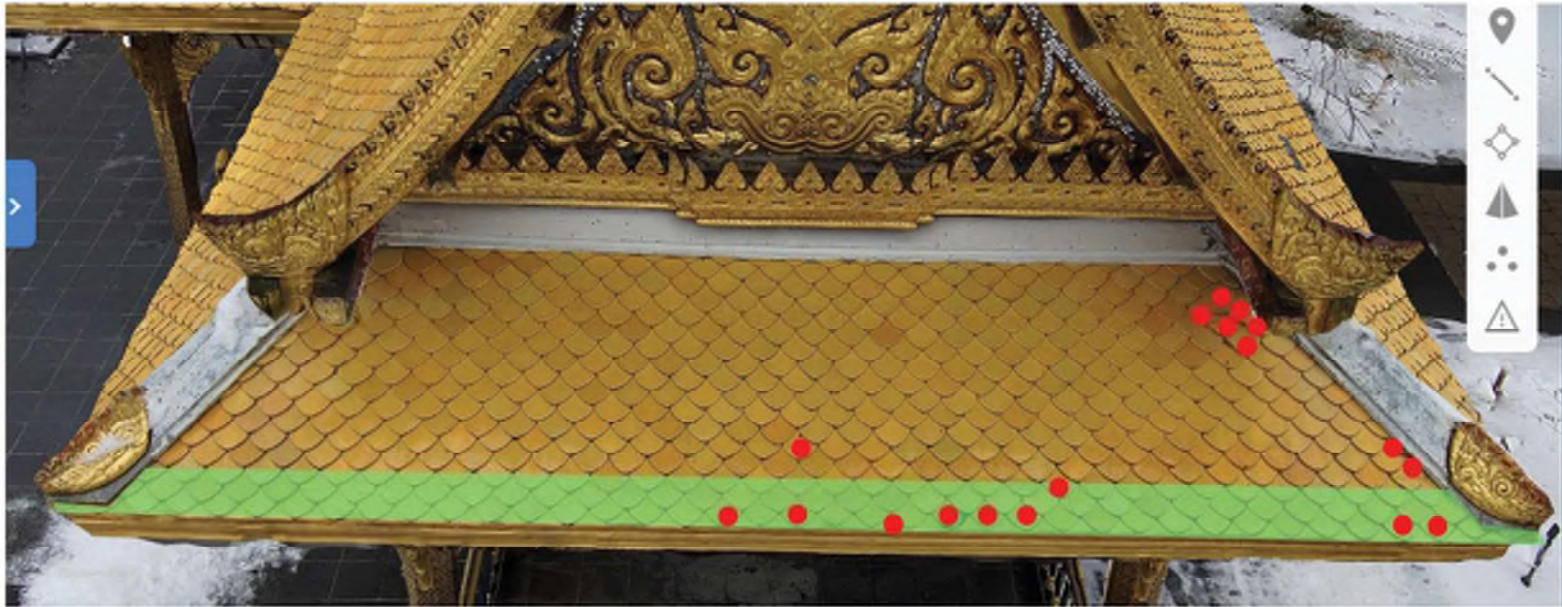
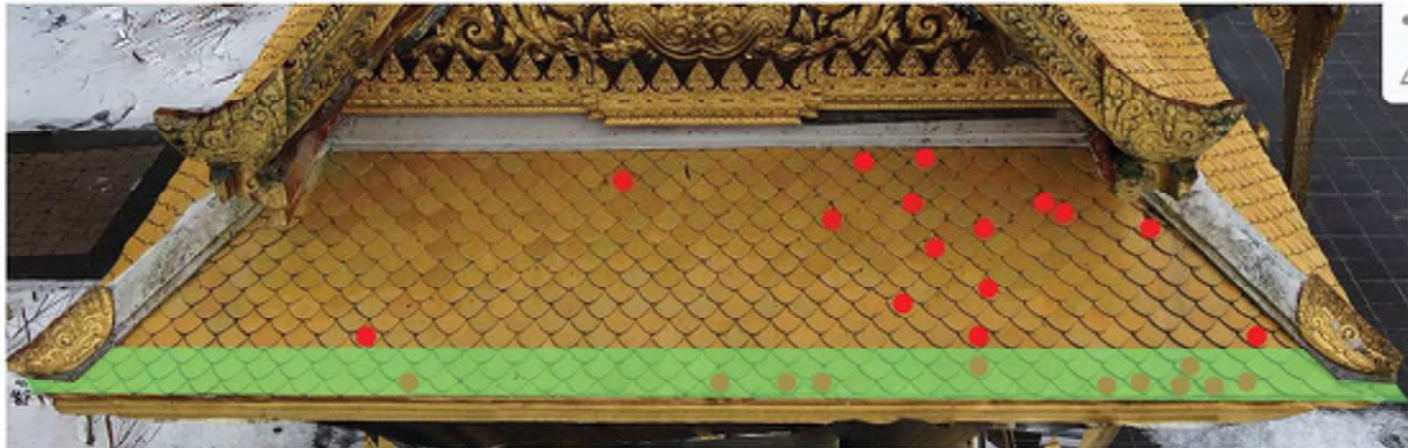
4. North & South Main Gable End Roofs - Initial observed damaged tiles from aerial view (not accounting for shear cracking) - Priority 1

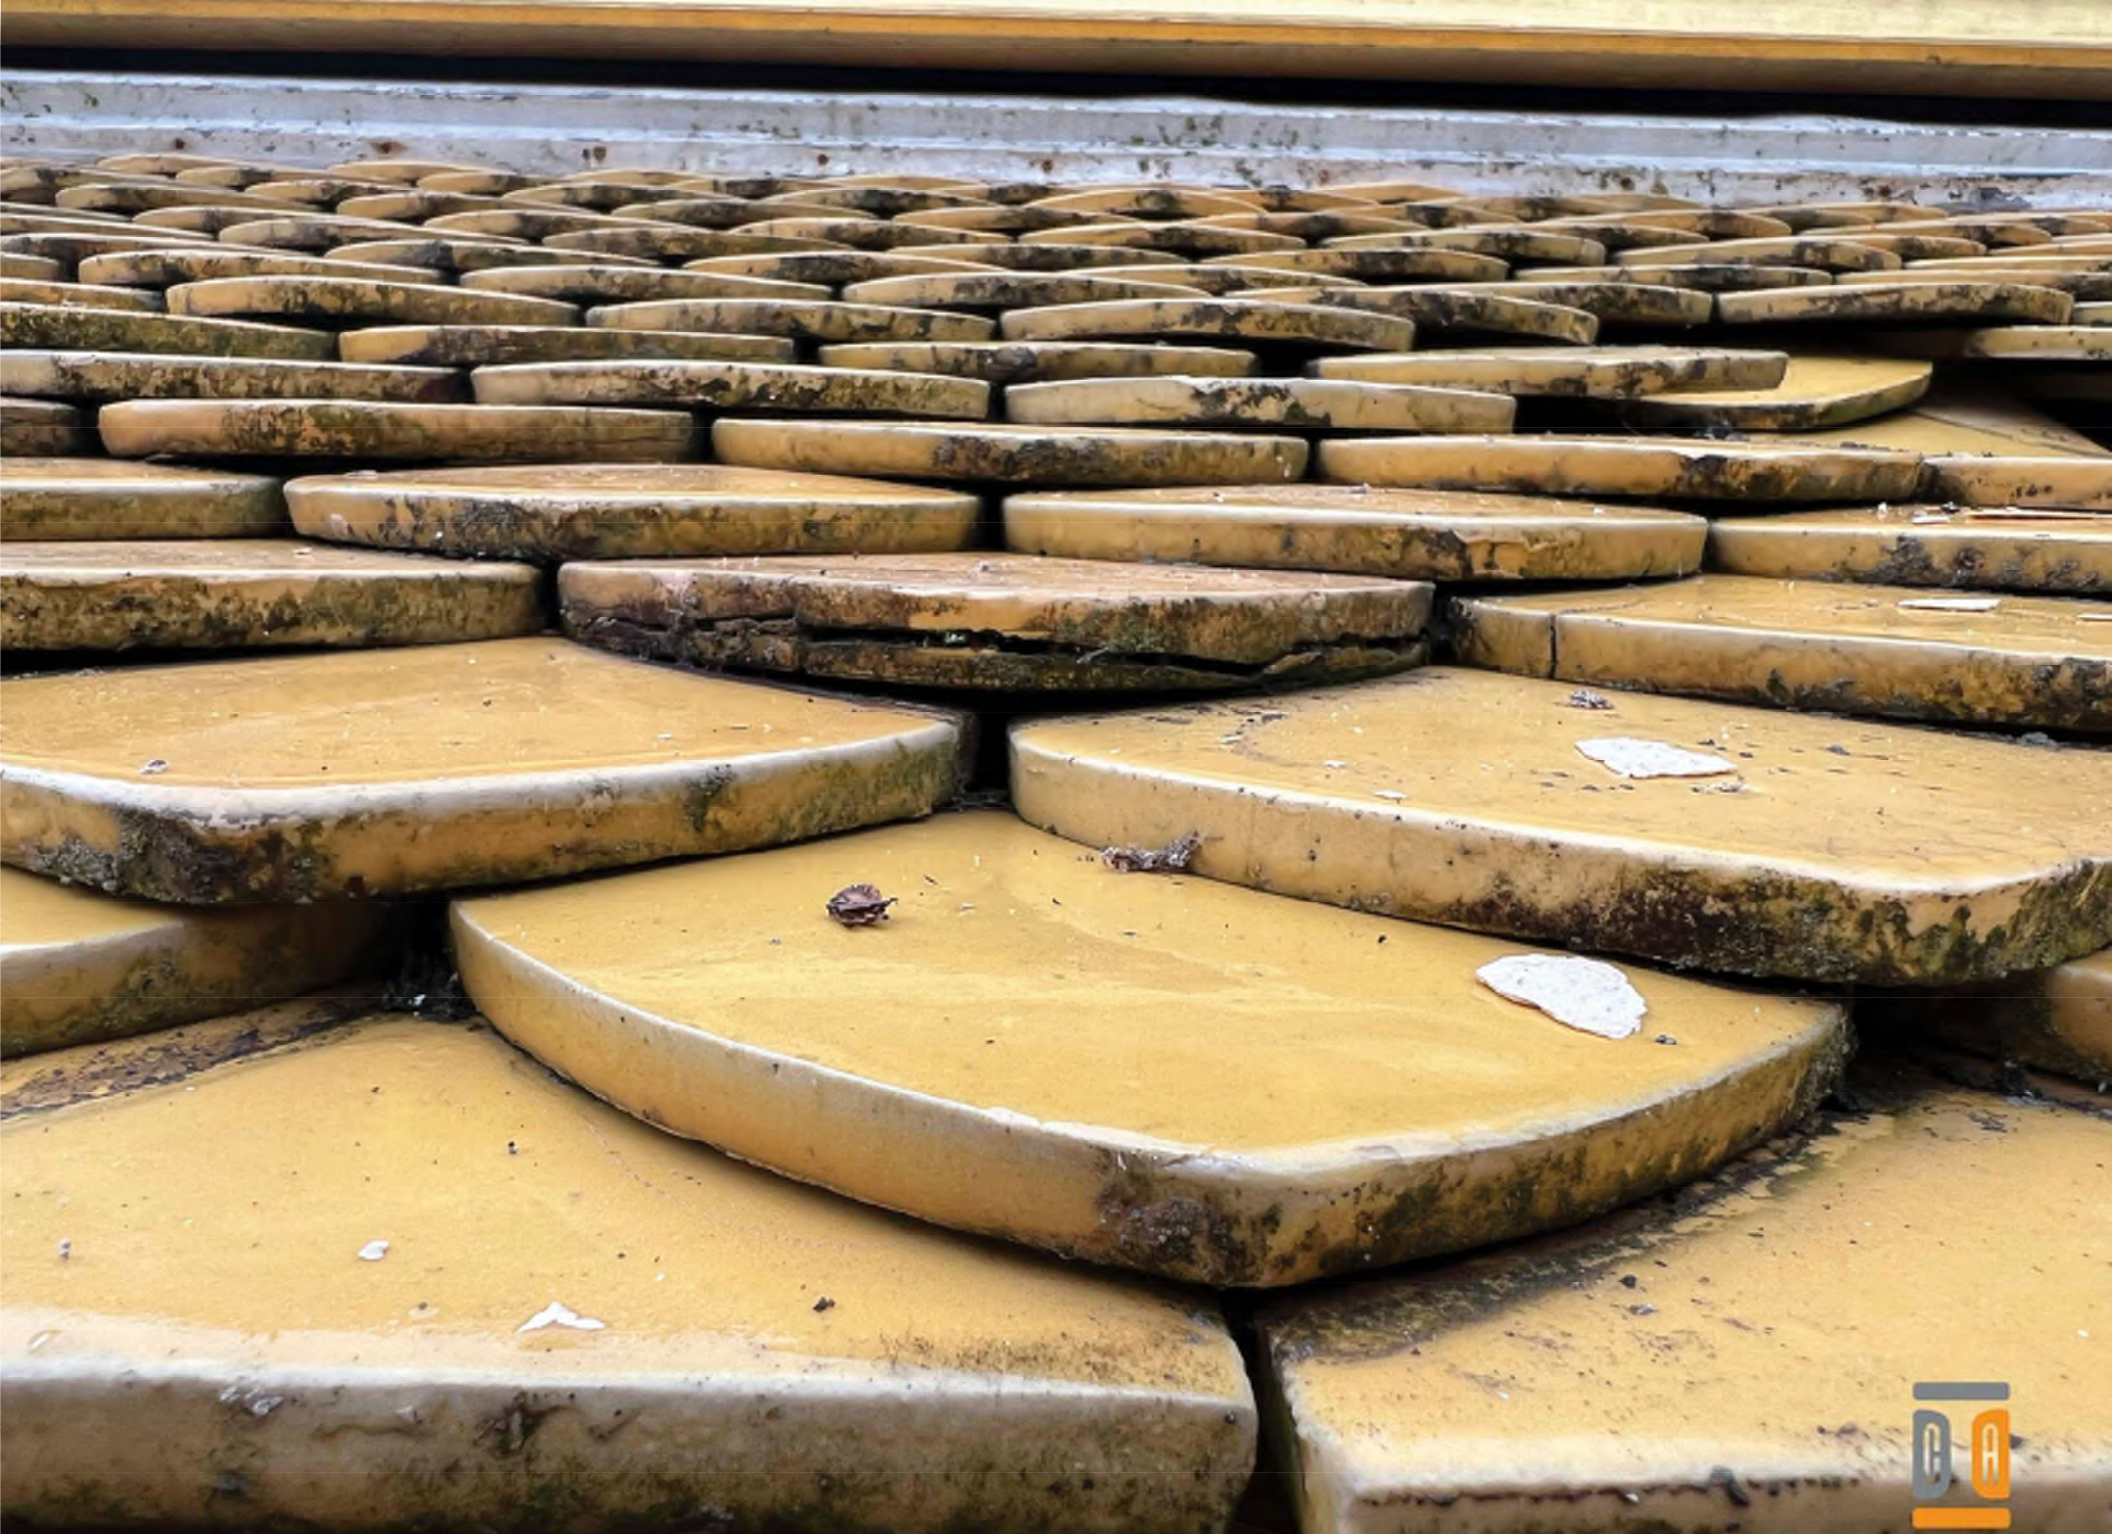
5. Tile debris at top of down-slope - Priority 1

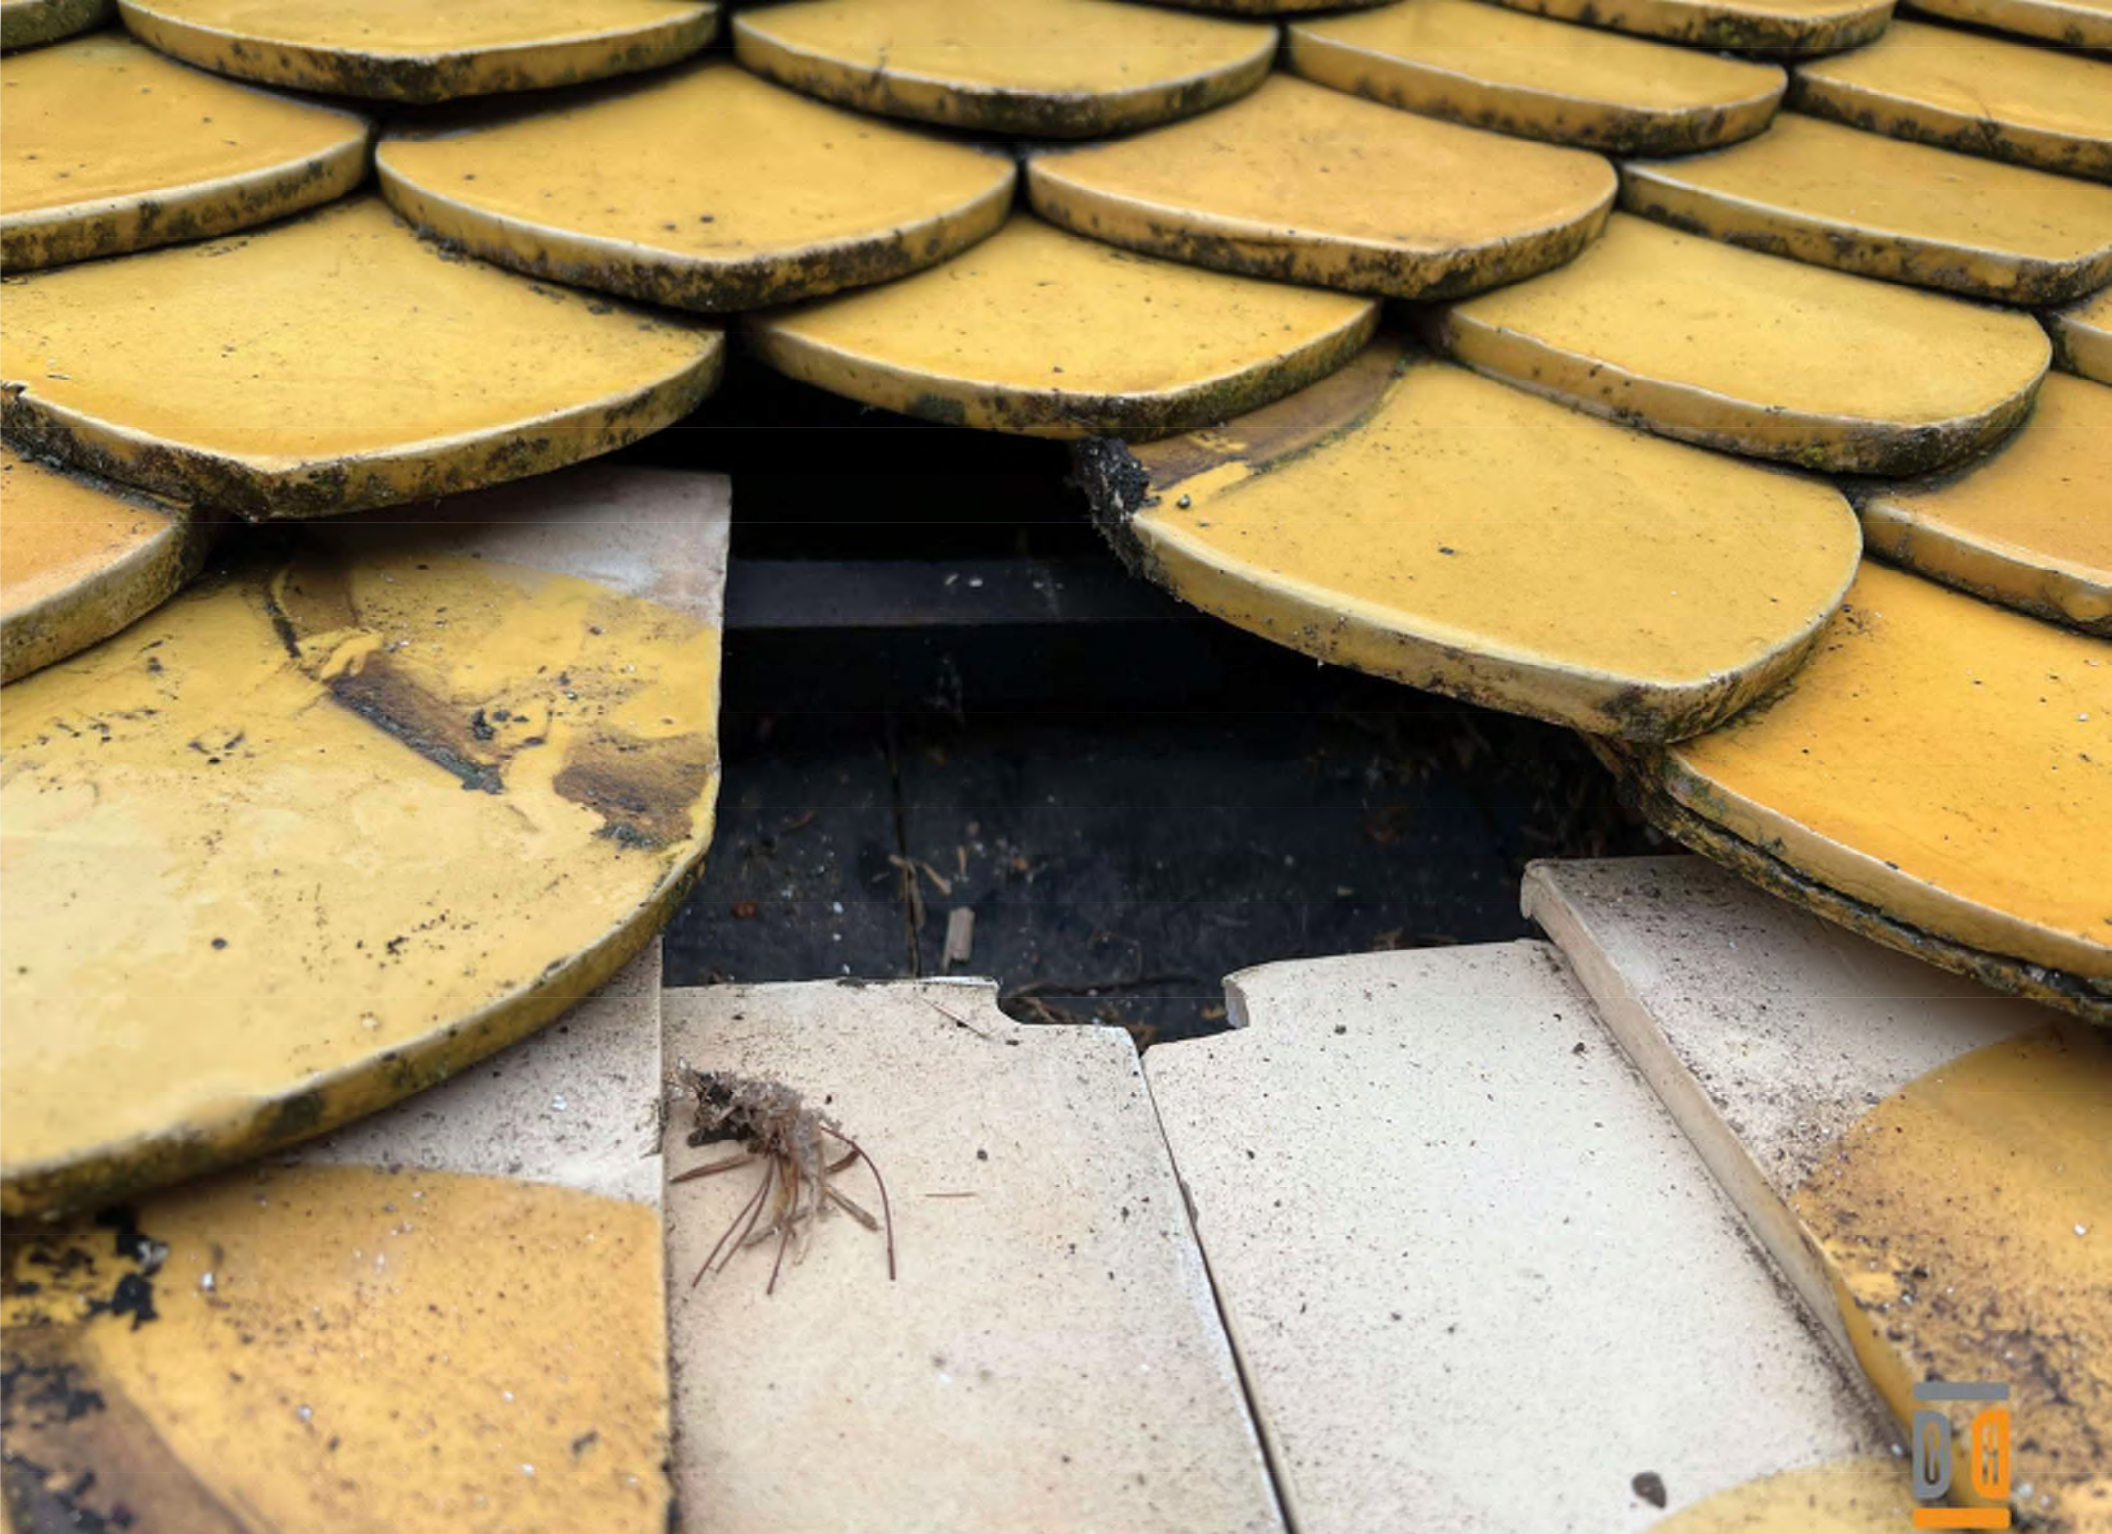
6. Failure mode, laminar failure, expansive clay soluble salt capillary action water crystallization/expansion - Priority 1
