OLBRICH BOTANICAL GARDENS ROYAL THAI PAVILION CONDITION ASSESSMENT REPORT

AUGUST 30, 2022

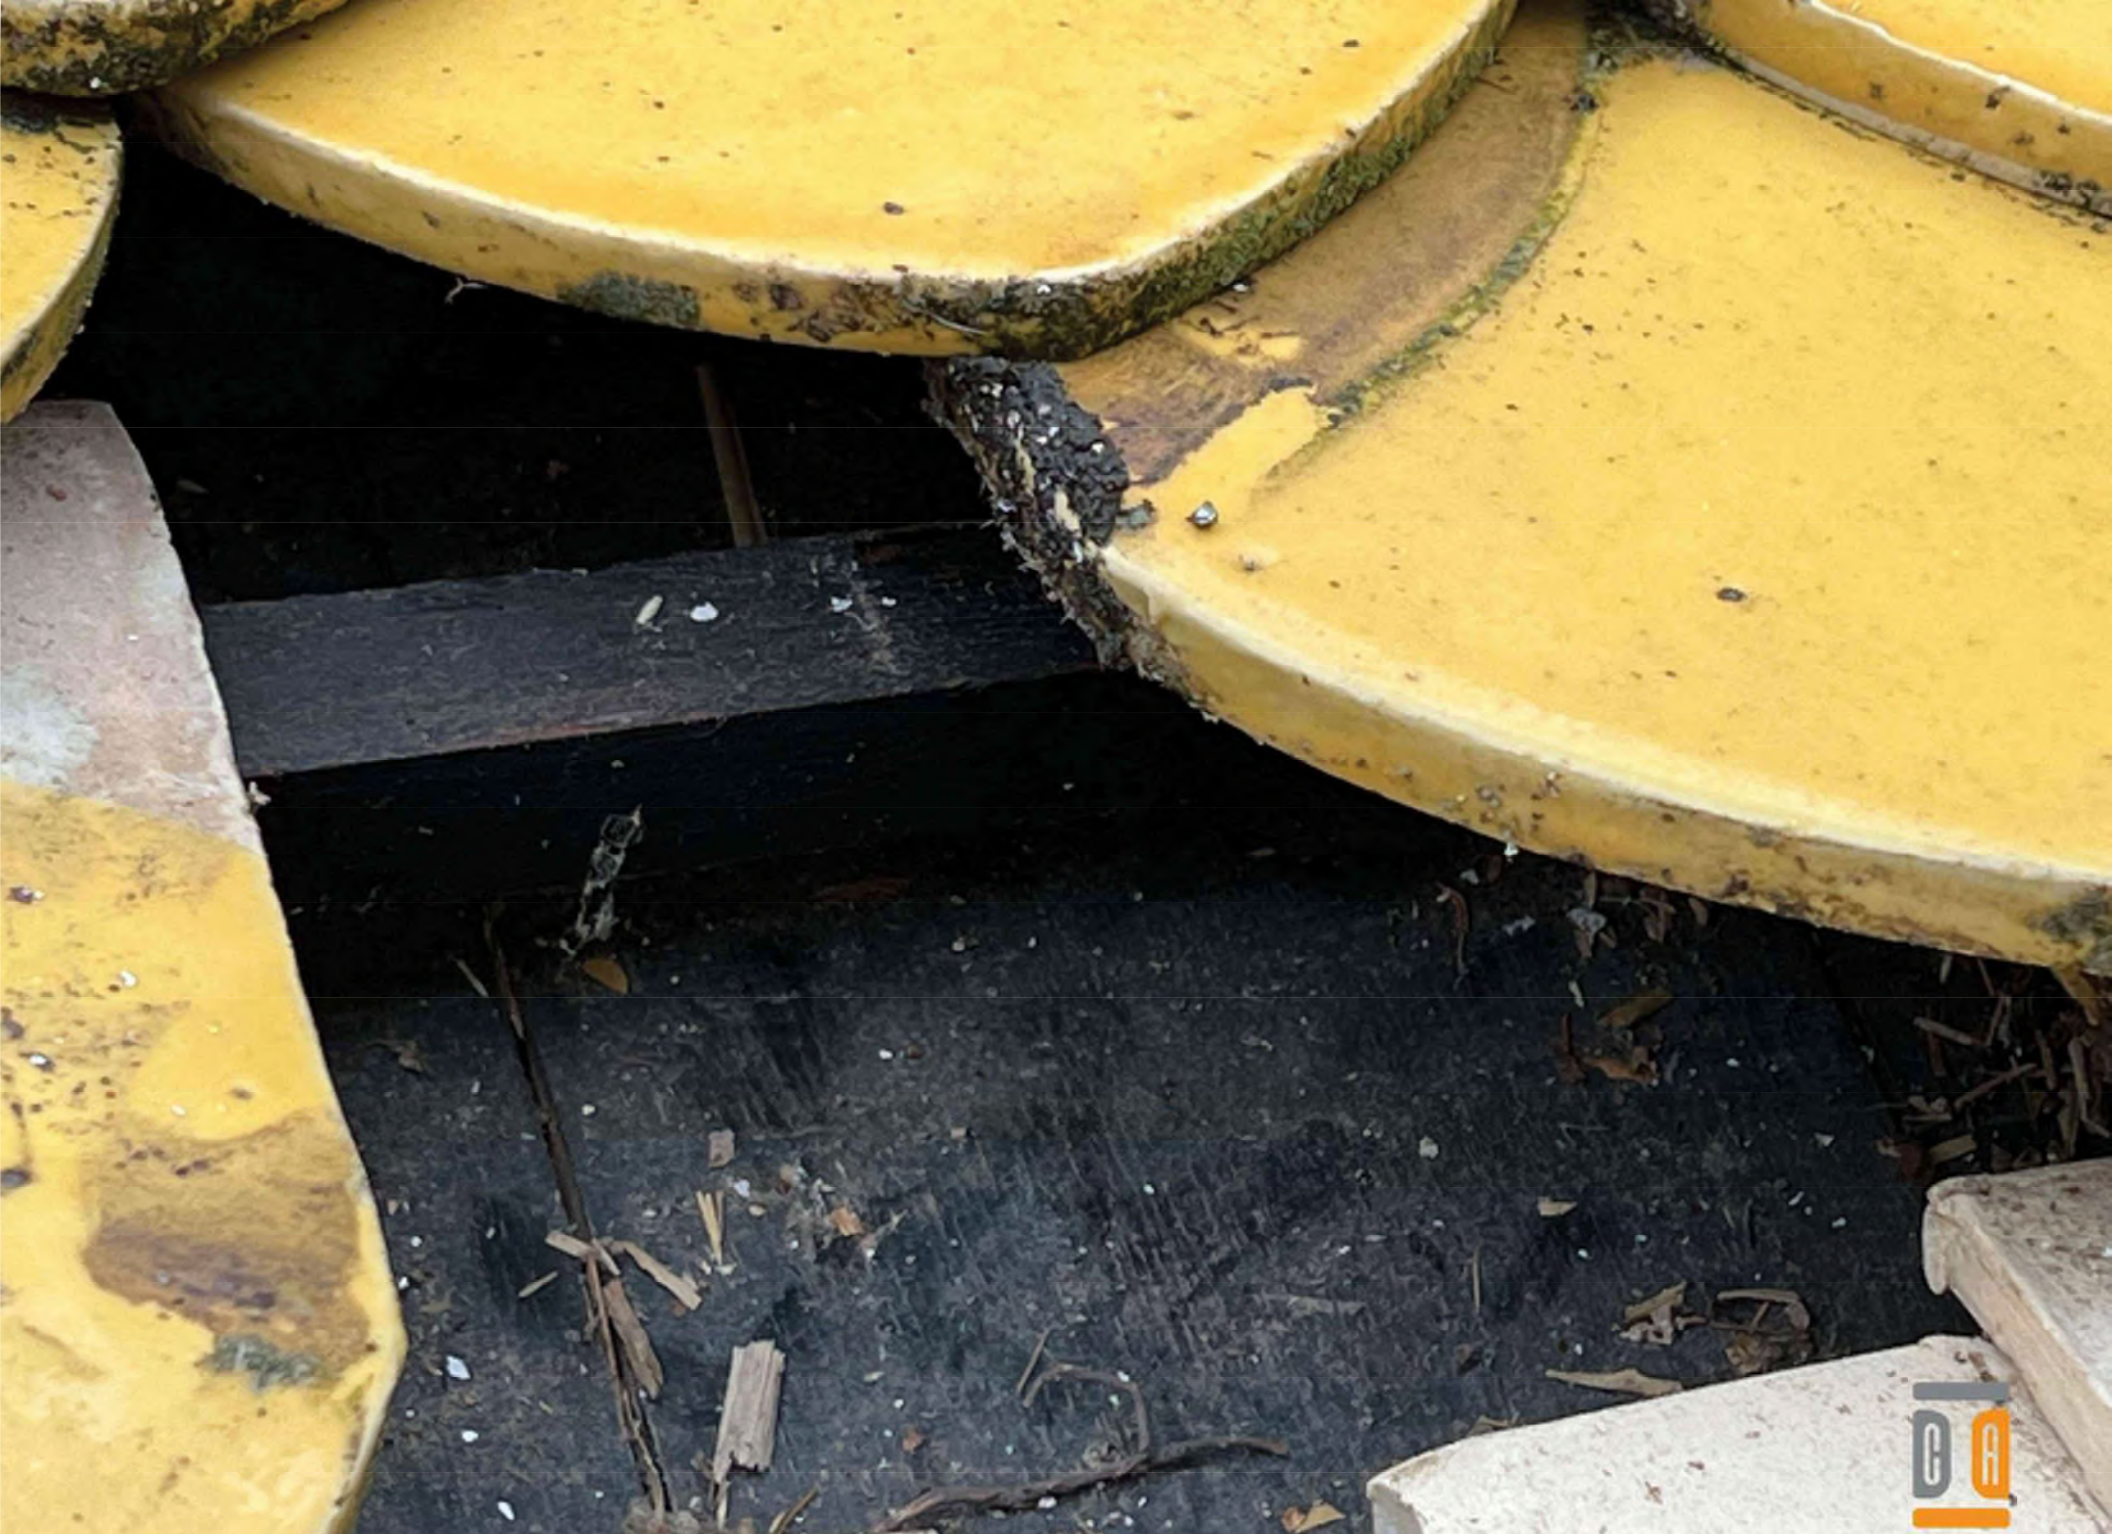
7. Roof Substructure without underlayment. Asphaltic (bituminous) coating on wood - Priority 2

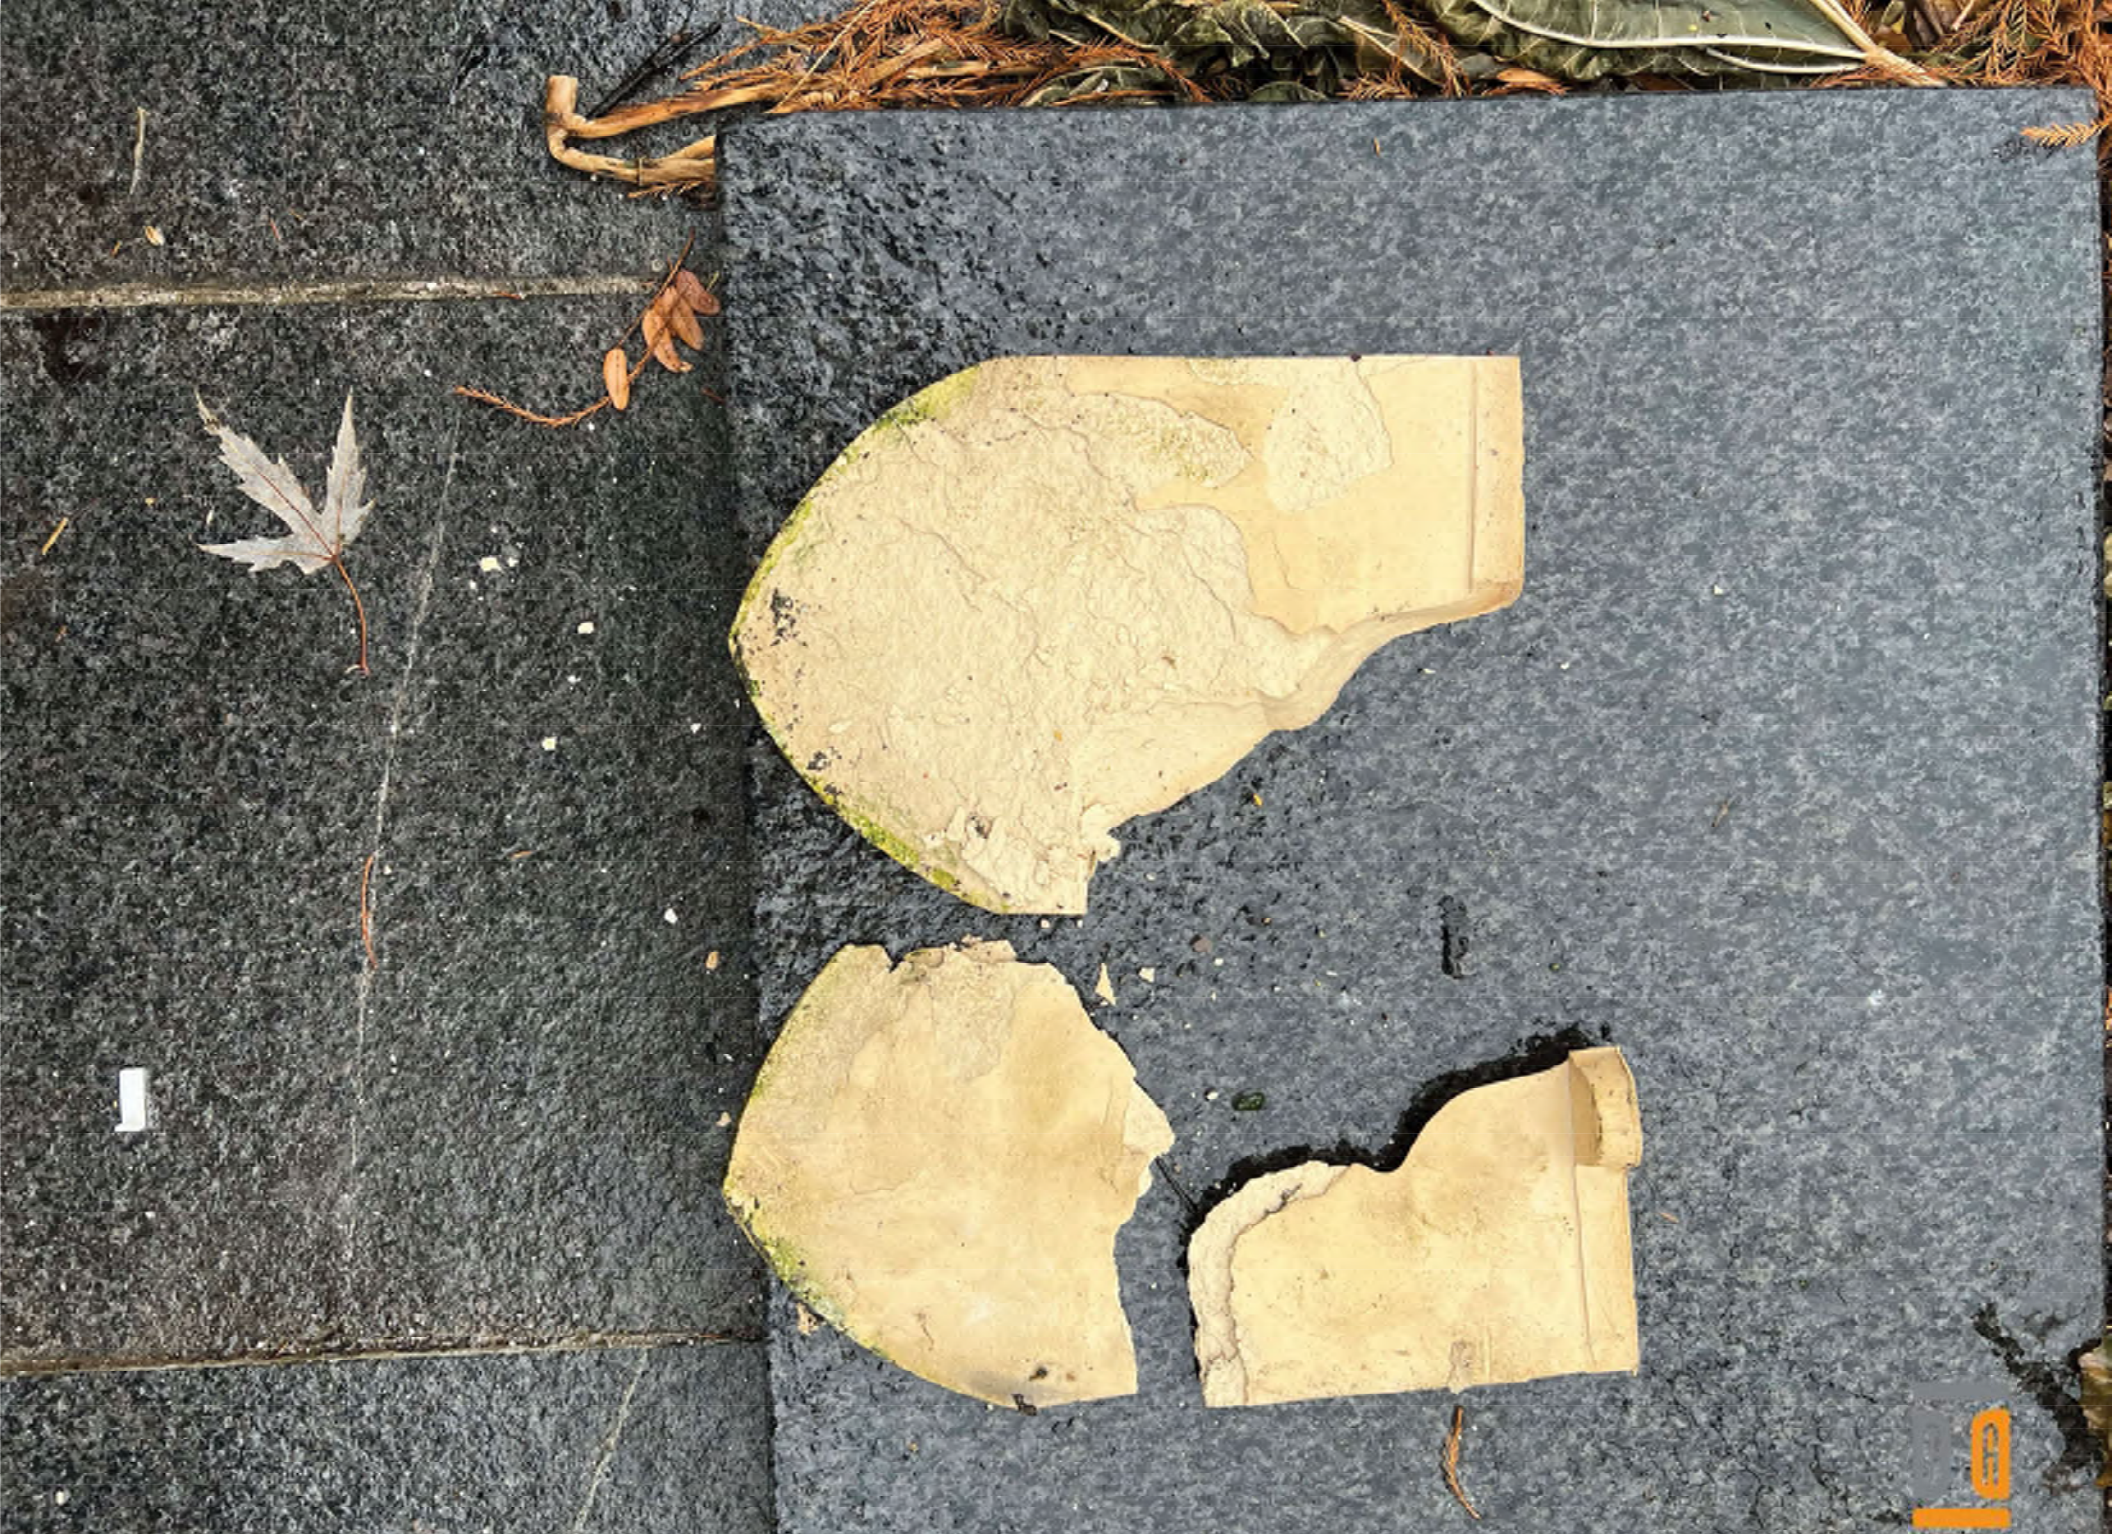
8. Exploded tile - Typical condition of water-infiltration damage - Priority 1

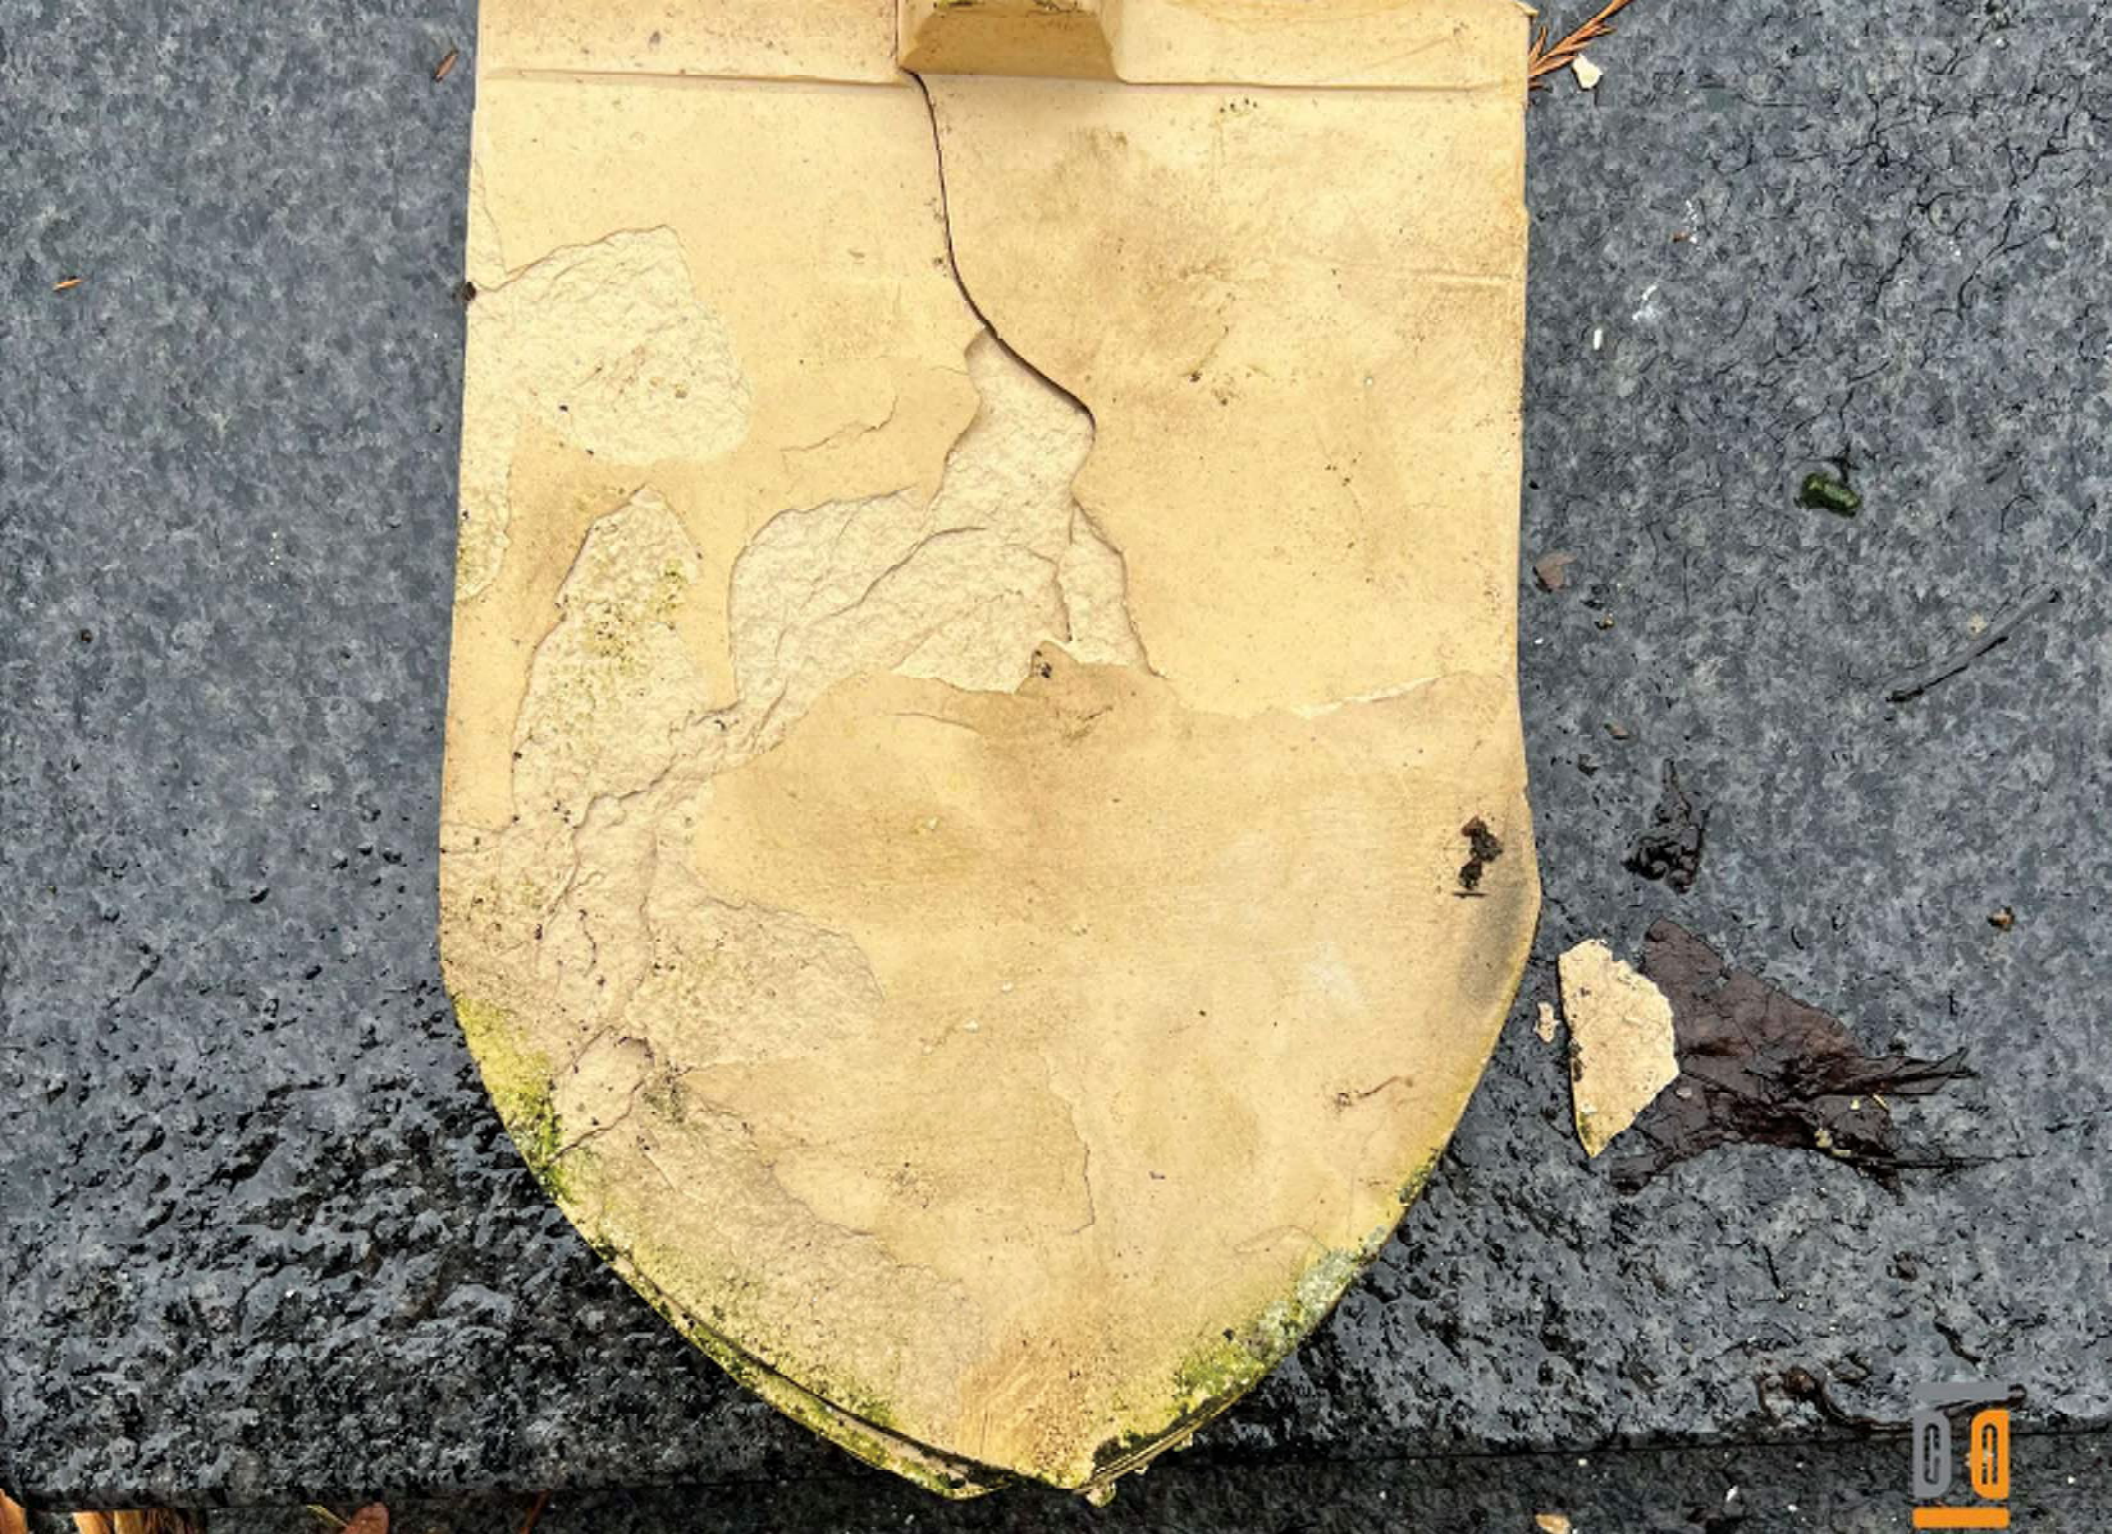
9. Reconstructed tile - Typical condition of water-infiltration damage - Priority 1

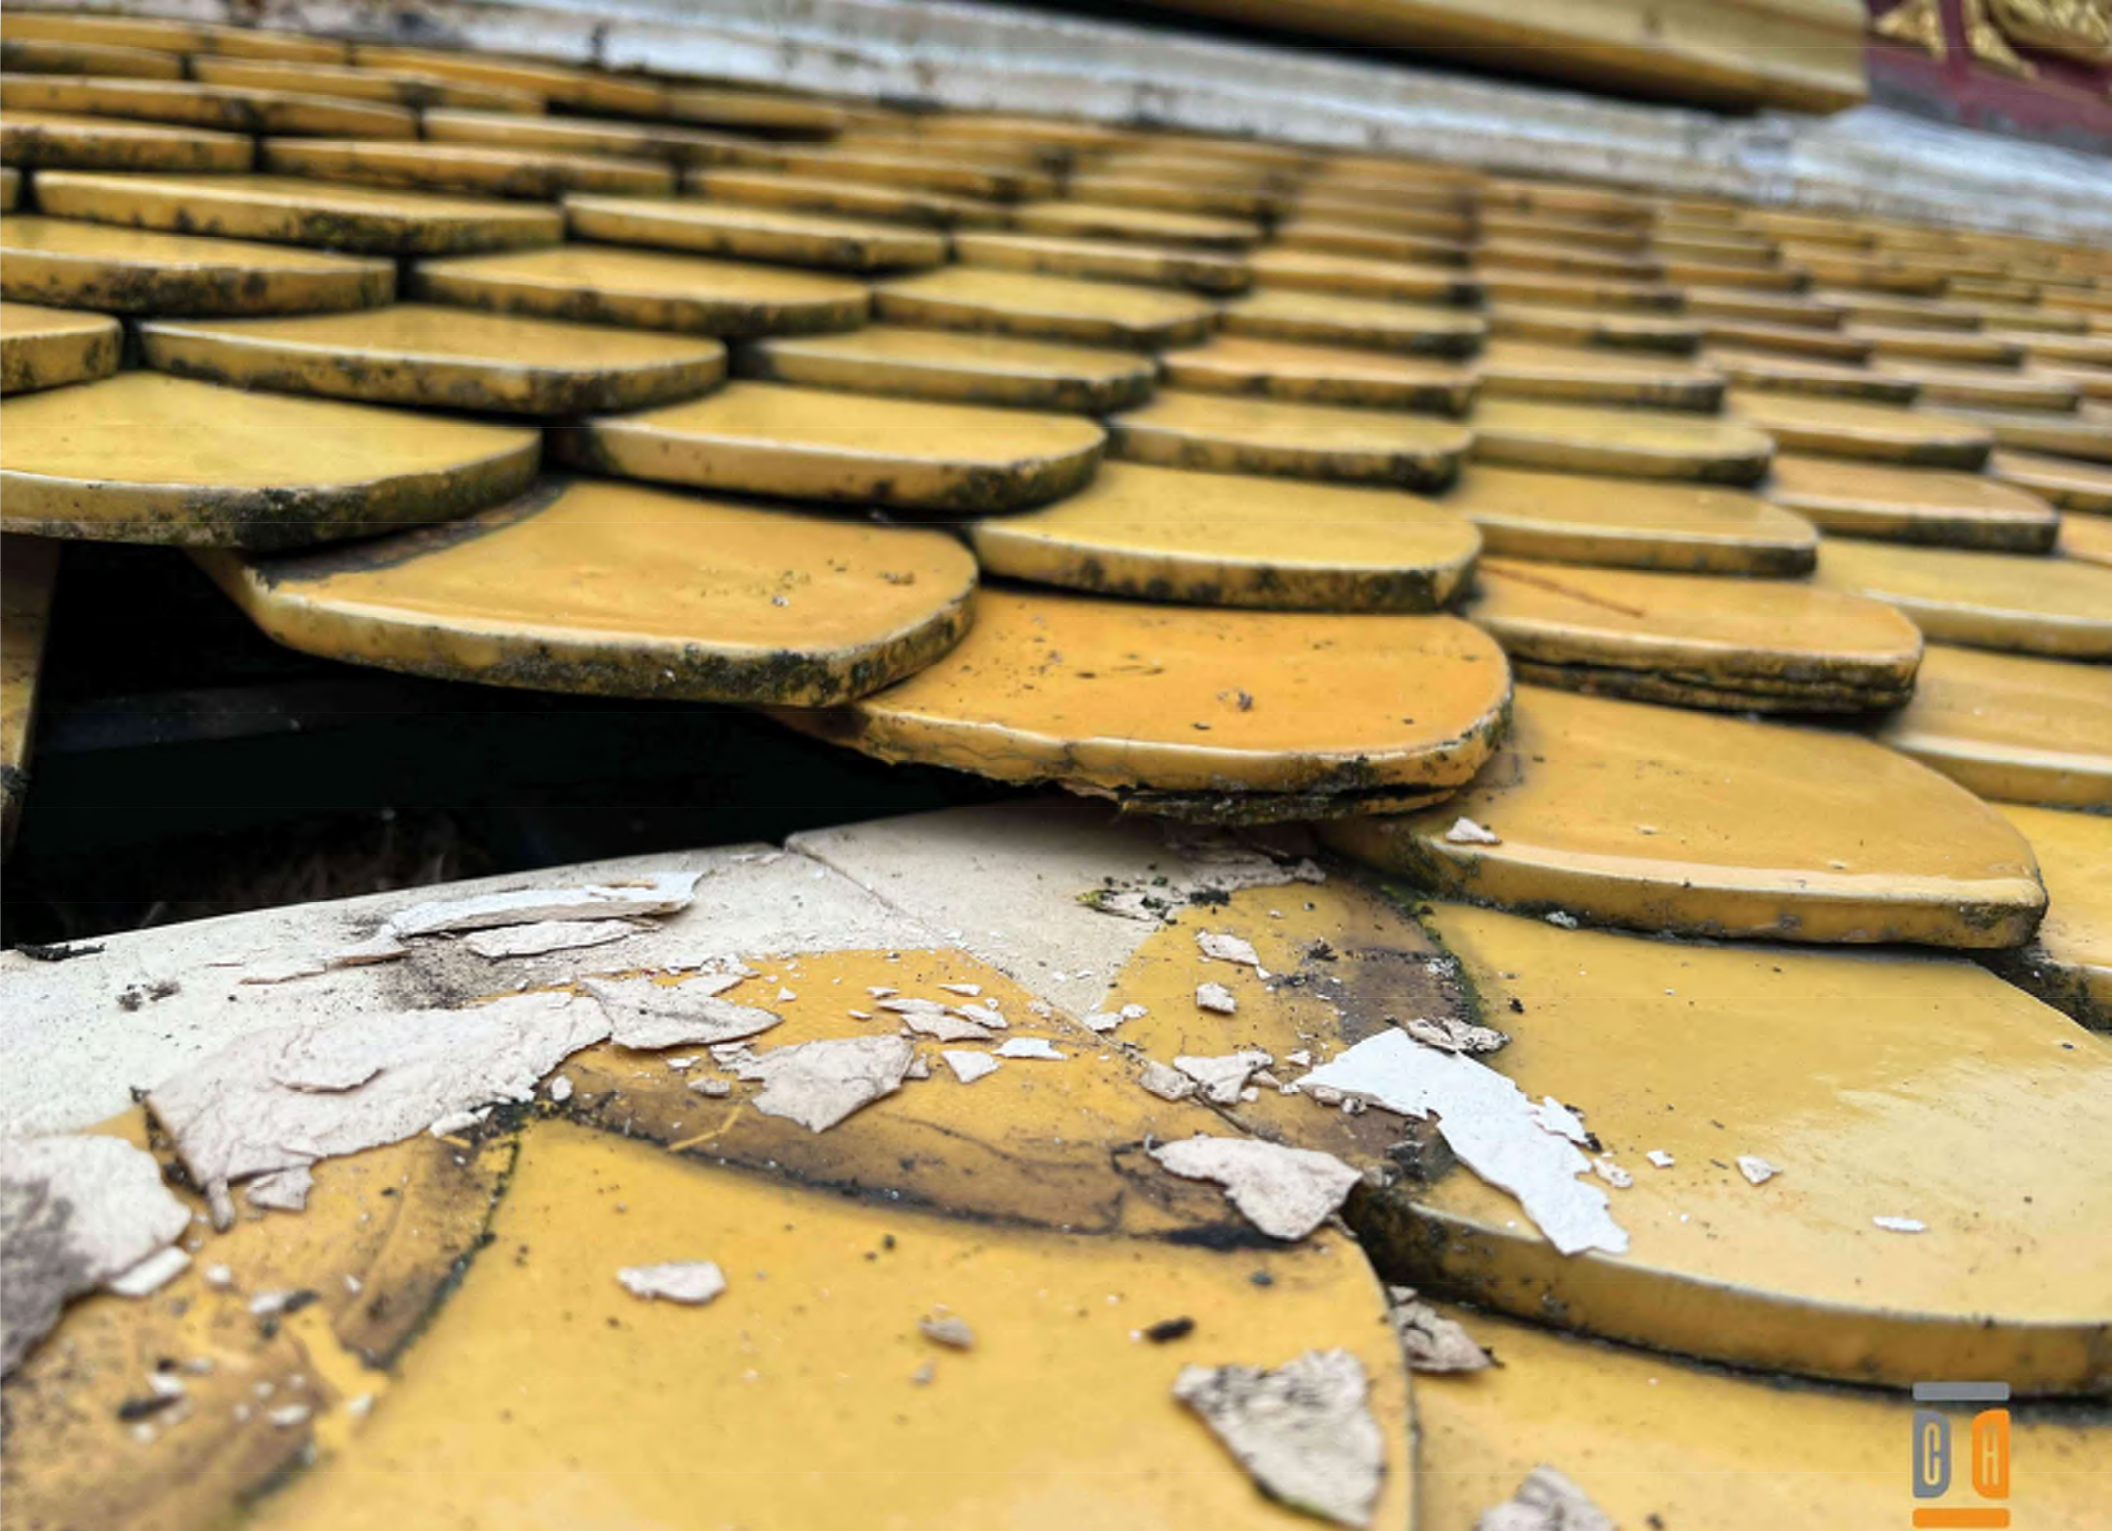
10. Removed tile location relating to #8 (above) - Priority 1

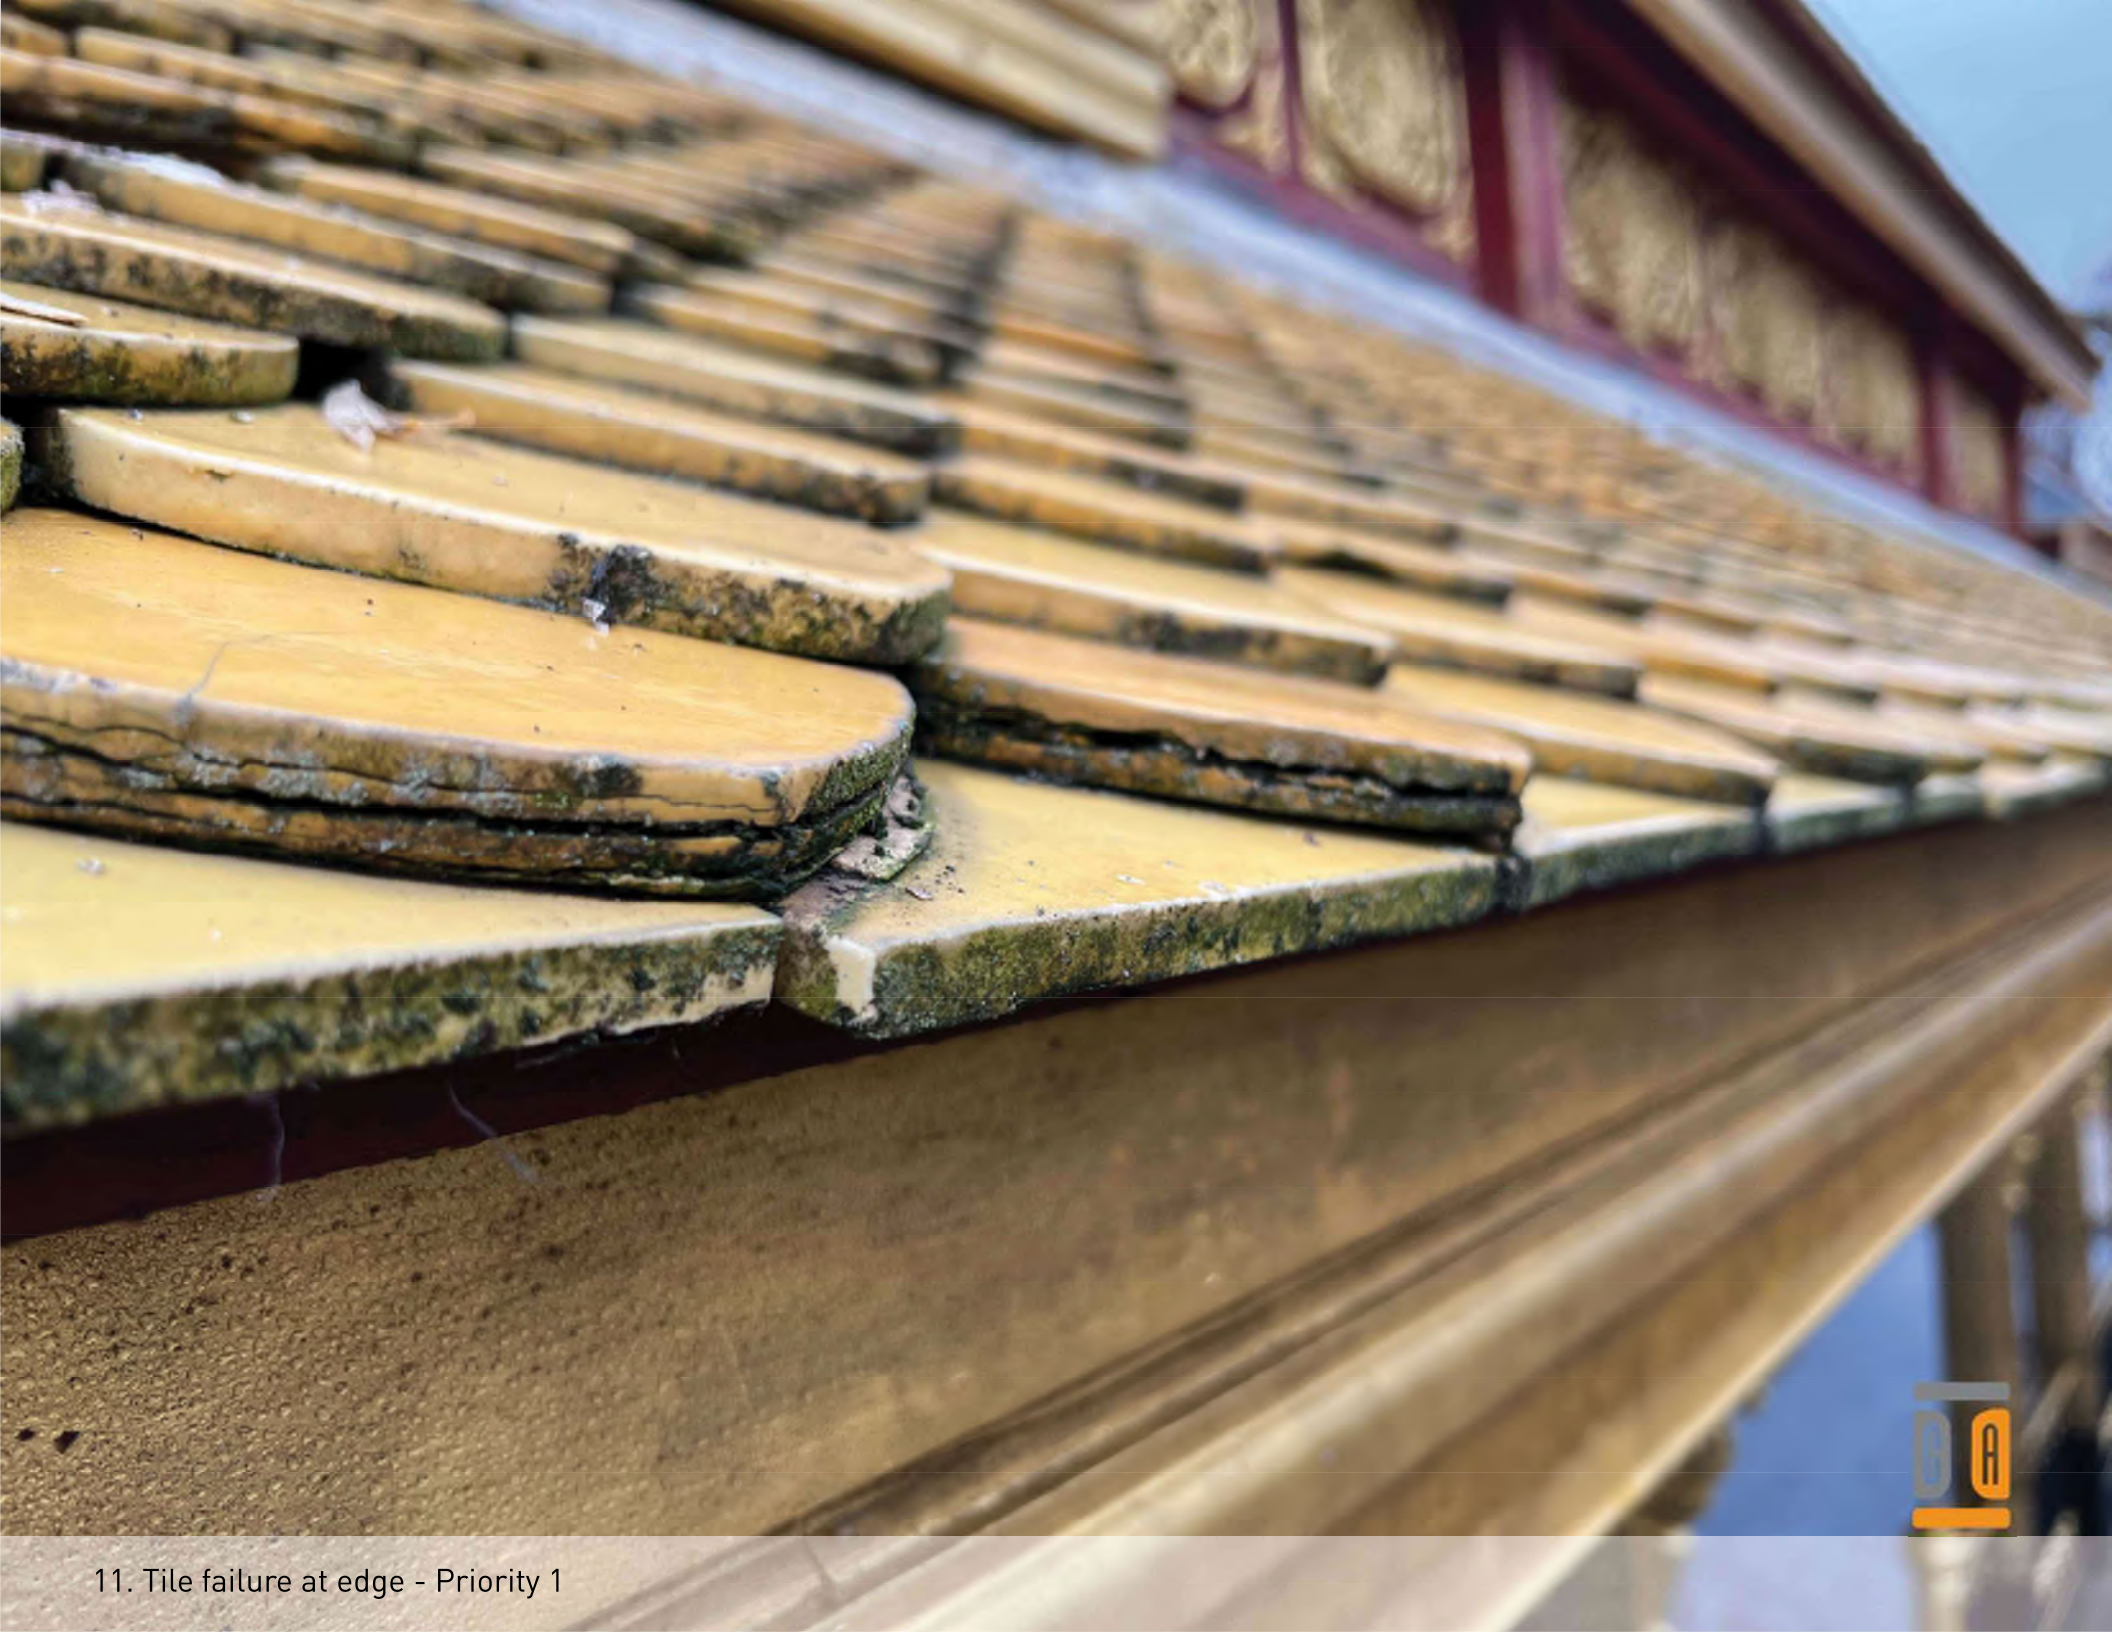
11. Tile failure at edge - Priority 1

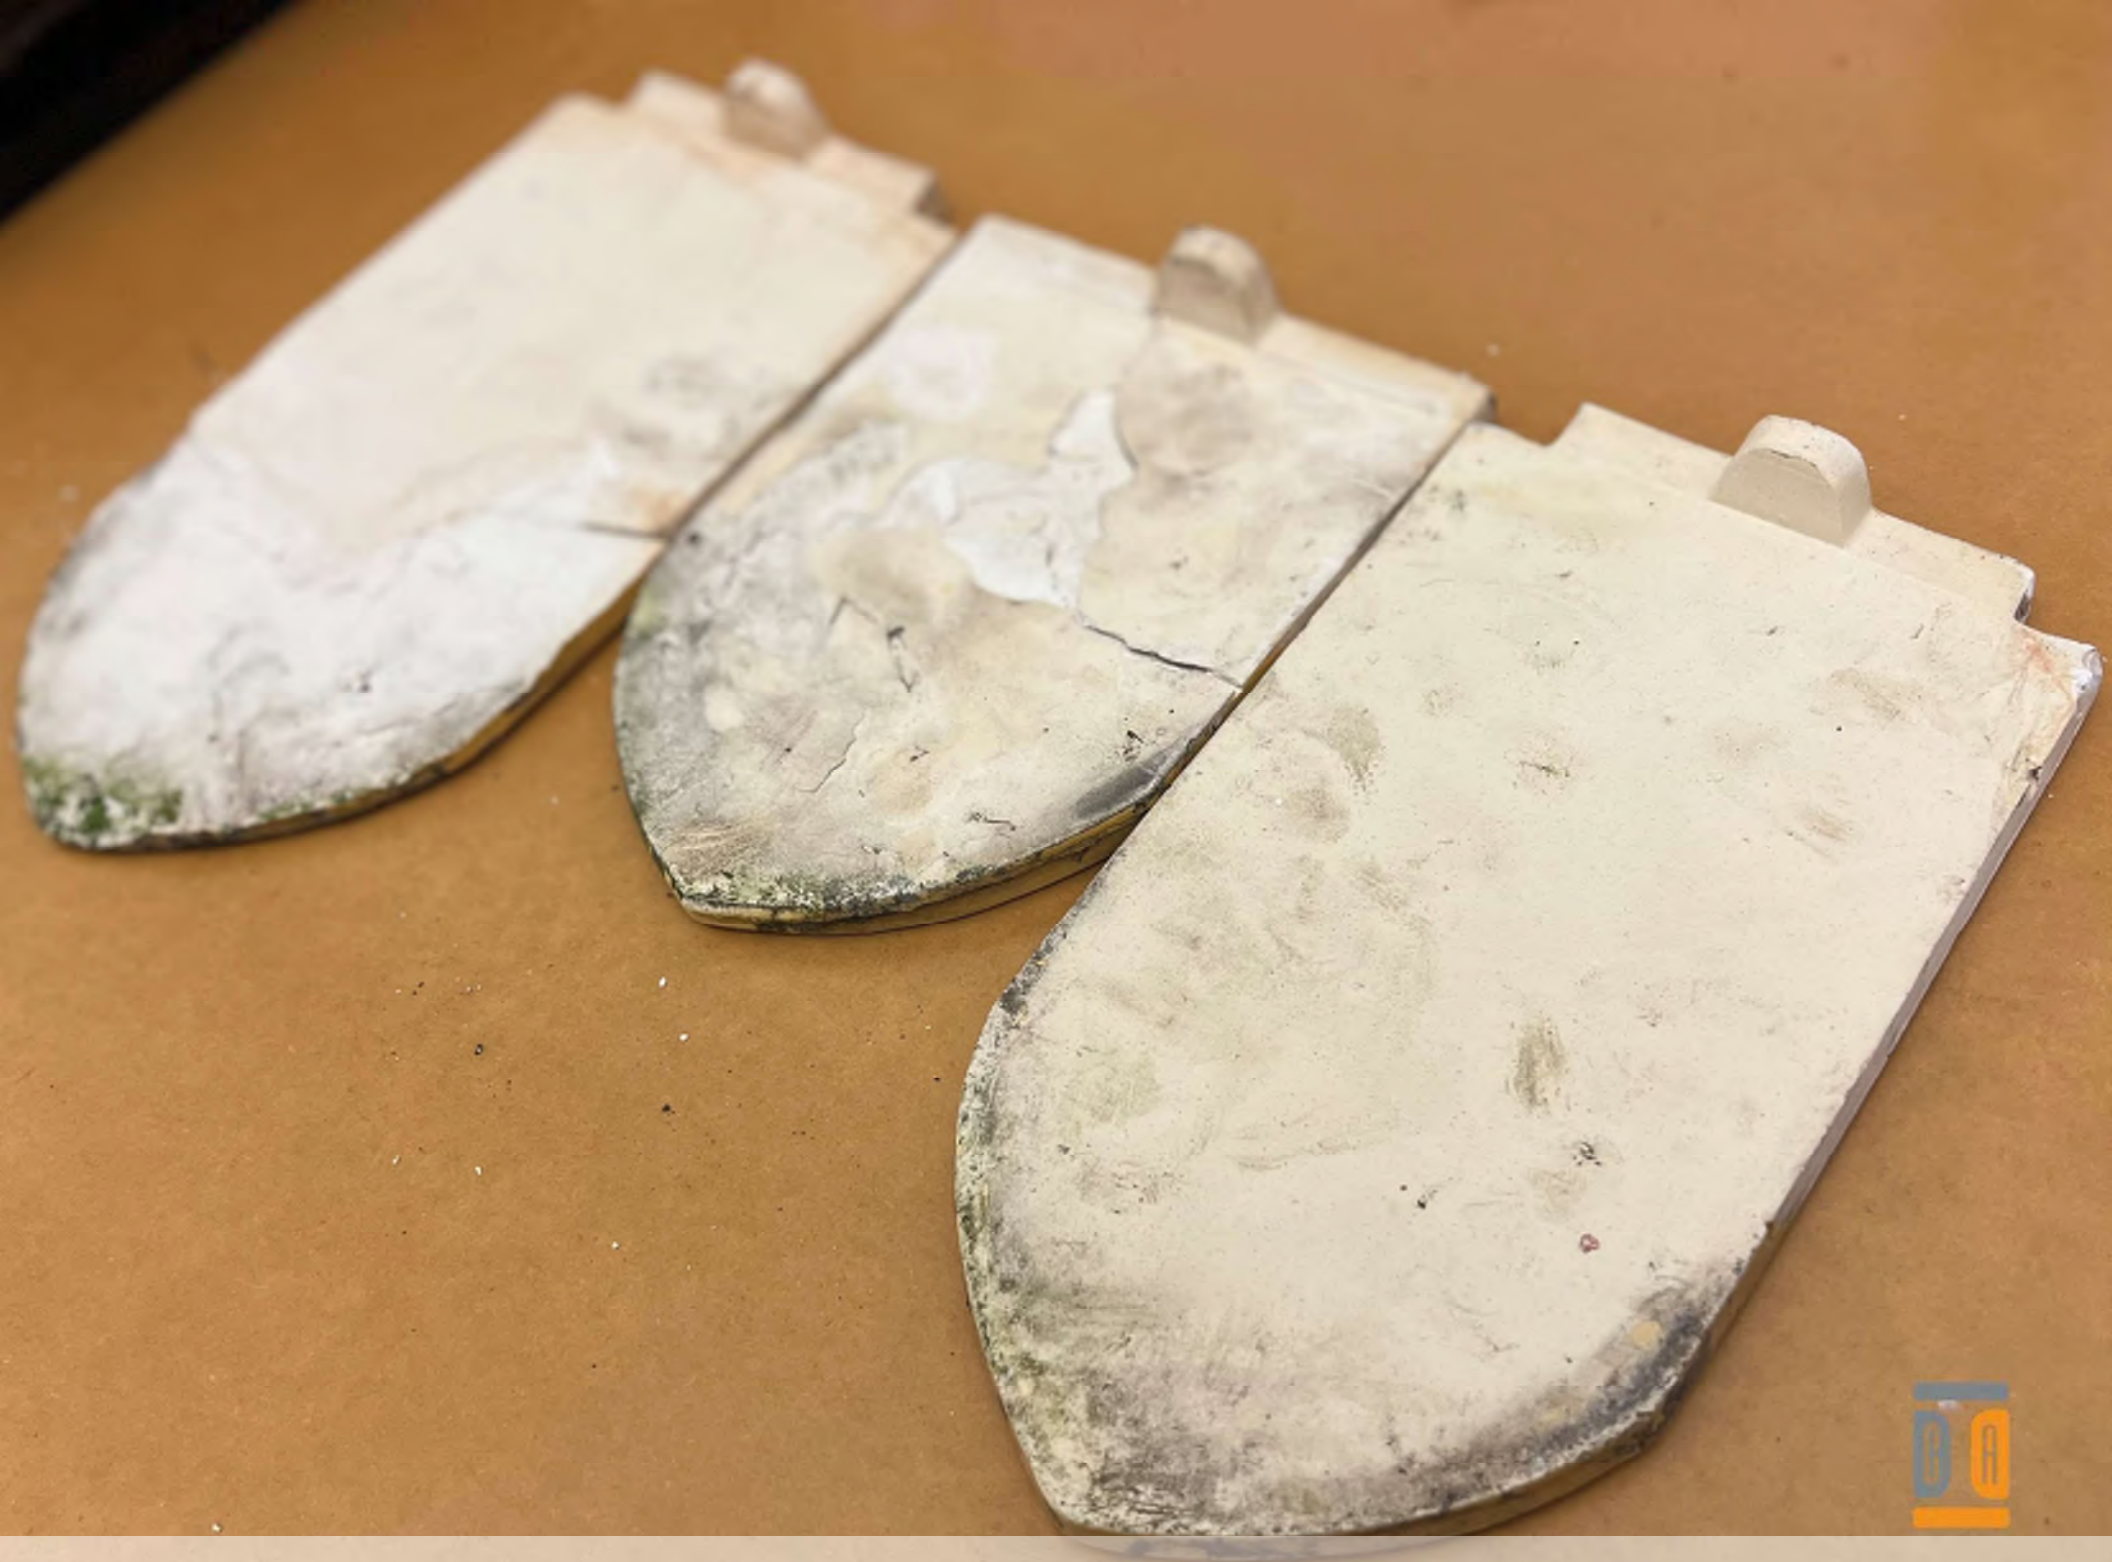
12. Grouping of three tiles removed for further study - Priority 1

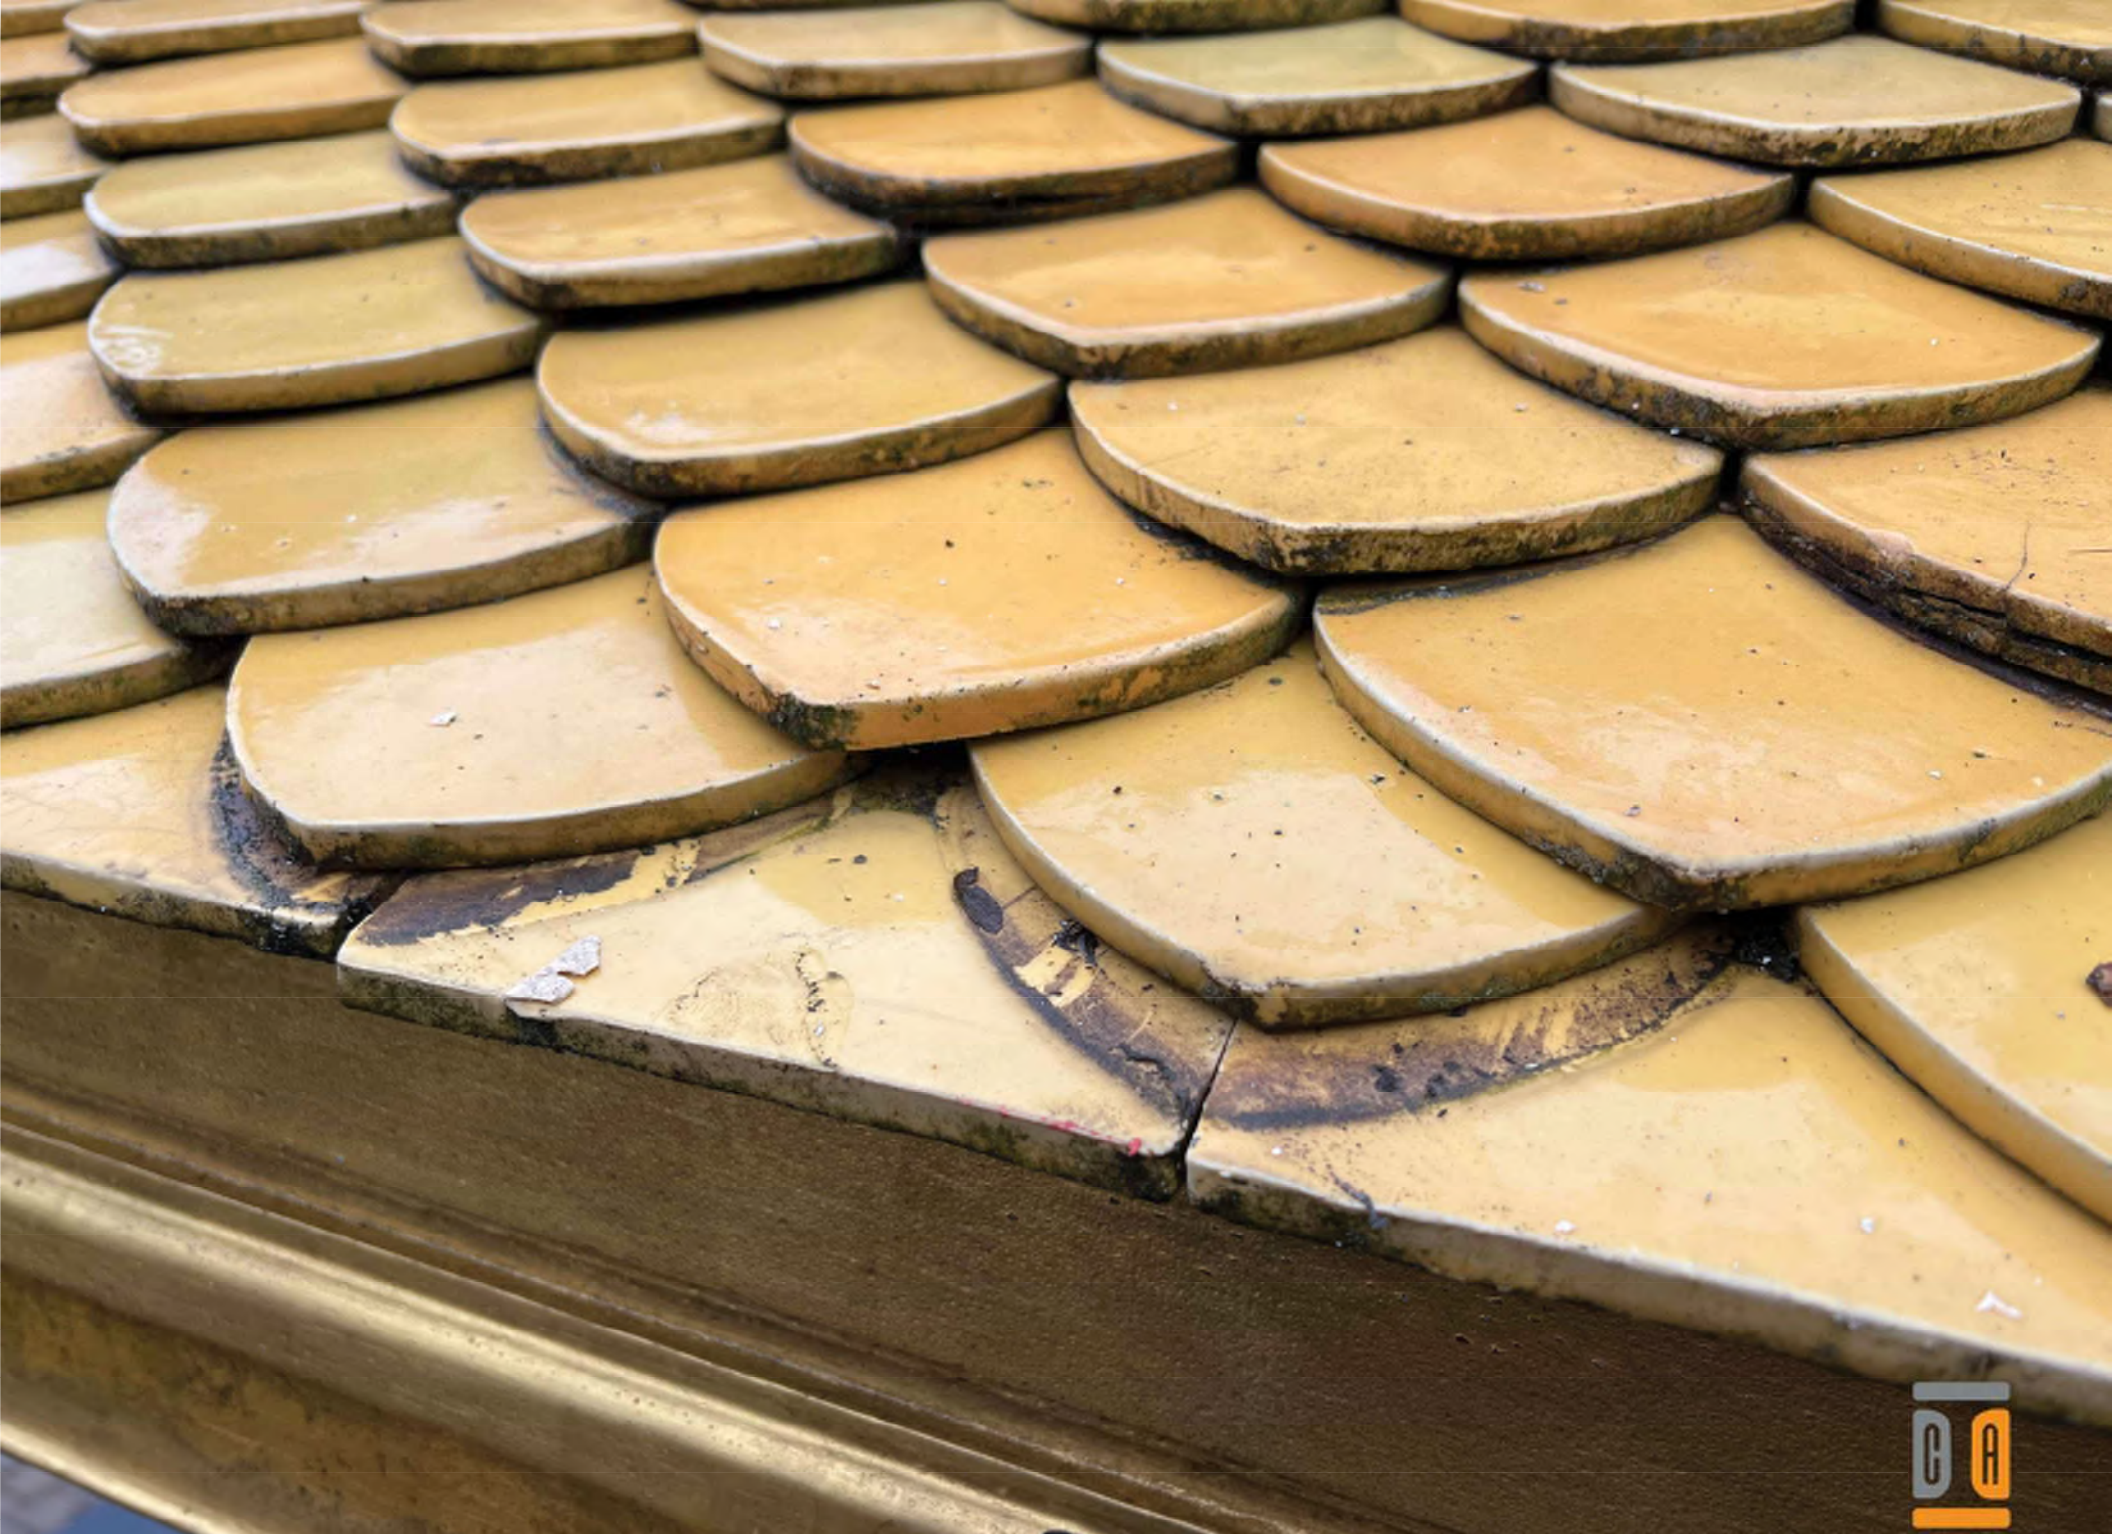
13. Displaced tile - broken lug - Priority 1
