OLBRICH BOTANICAL GARDENS ROYAL THAI PAVILION CONDITION ASSESSMENT REPORT

AUGUST 30, 2022

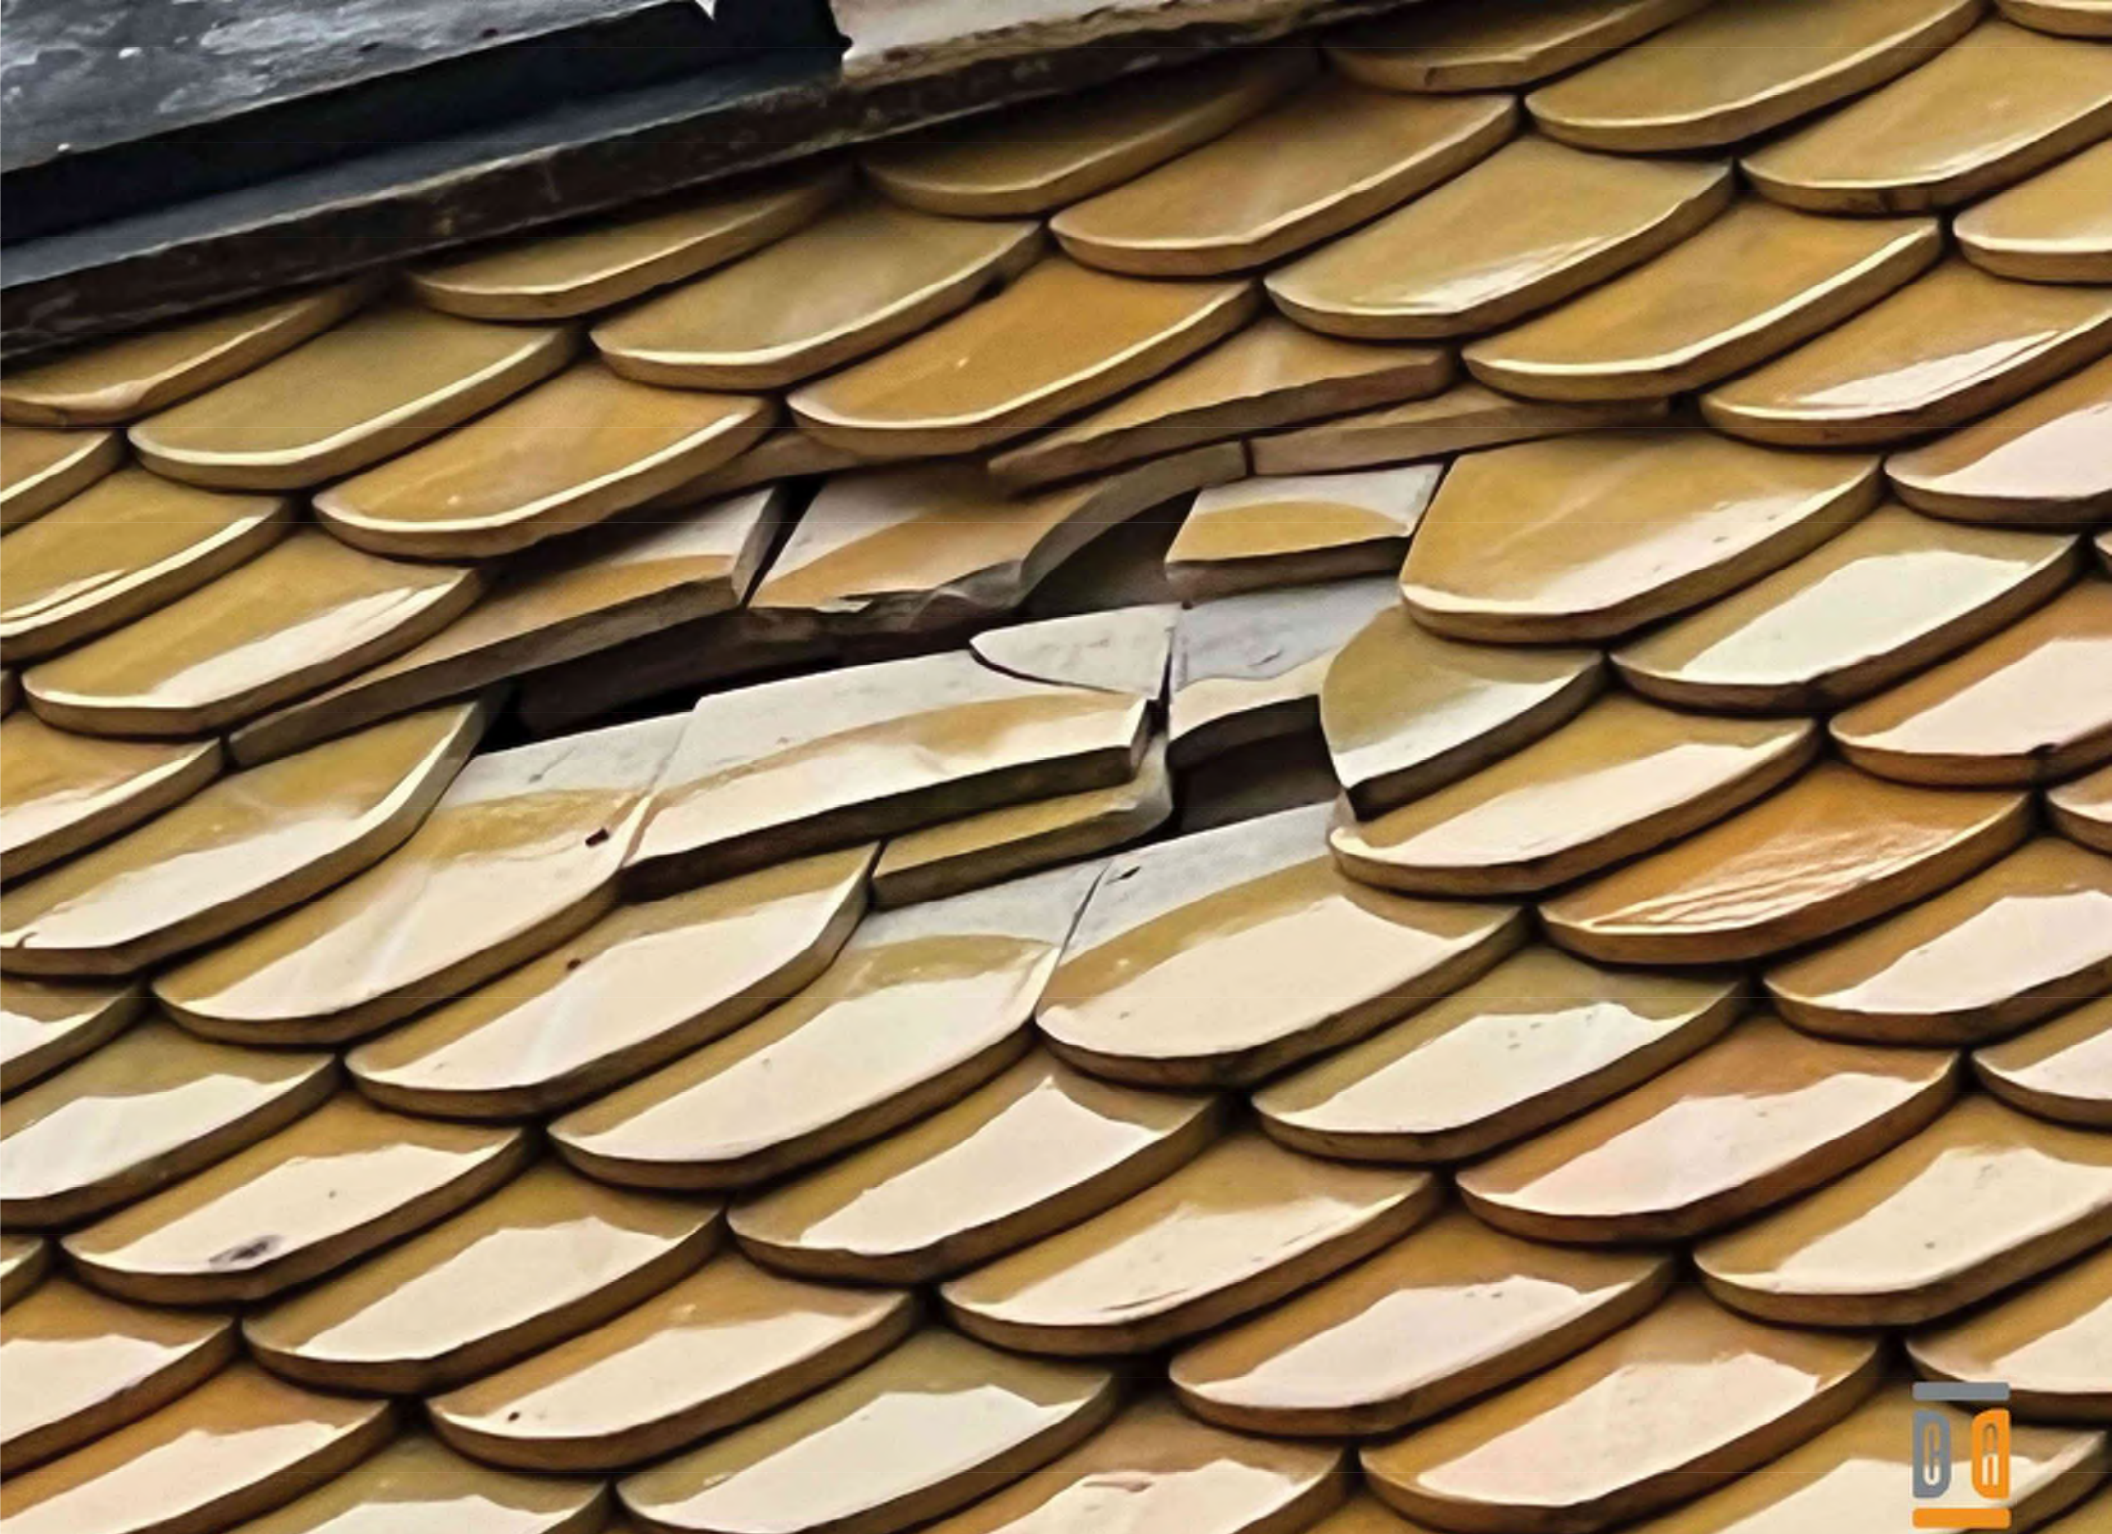
14. View of fractured tile – from impact or concentrated point load (assumed) - Priority 1

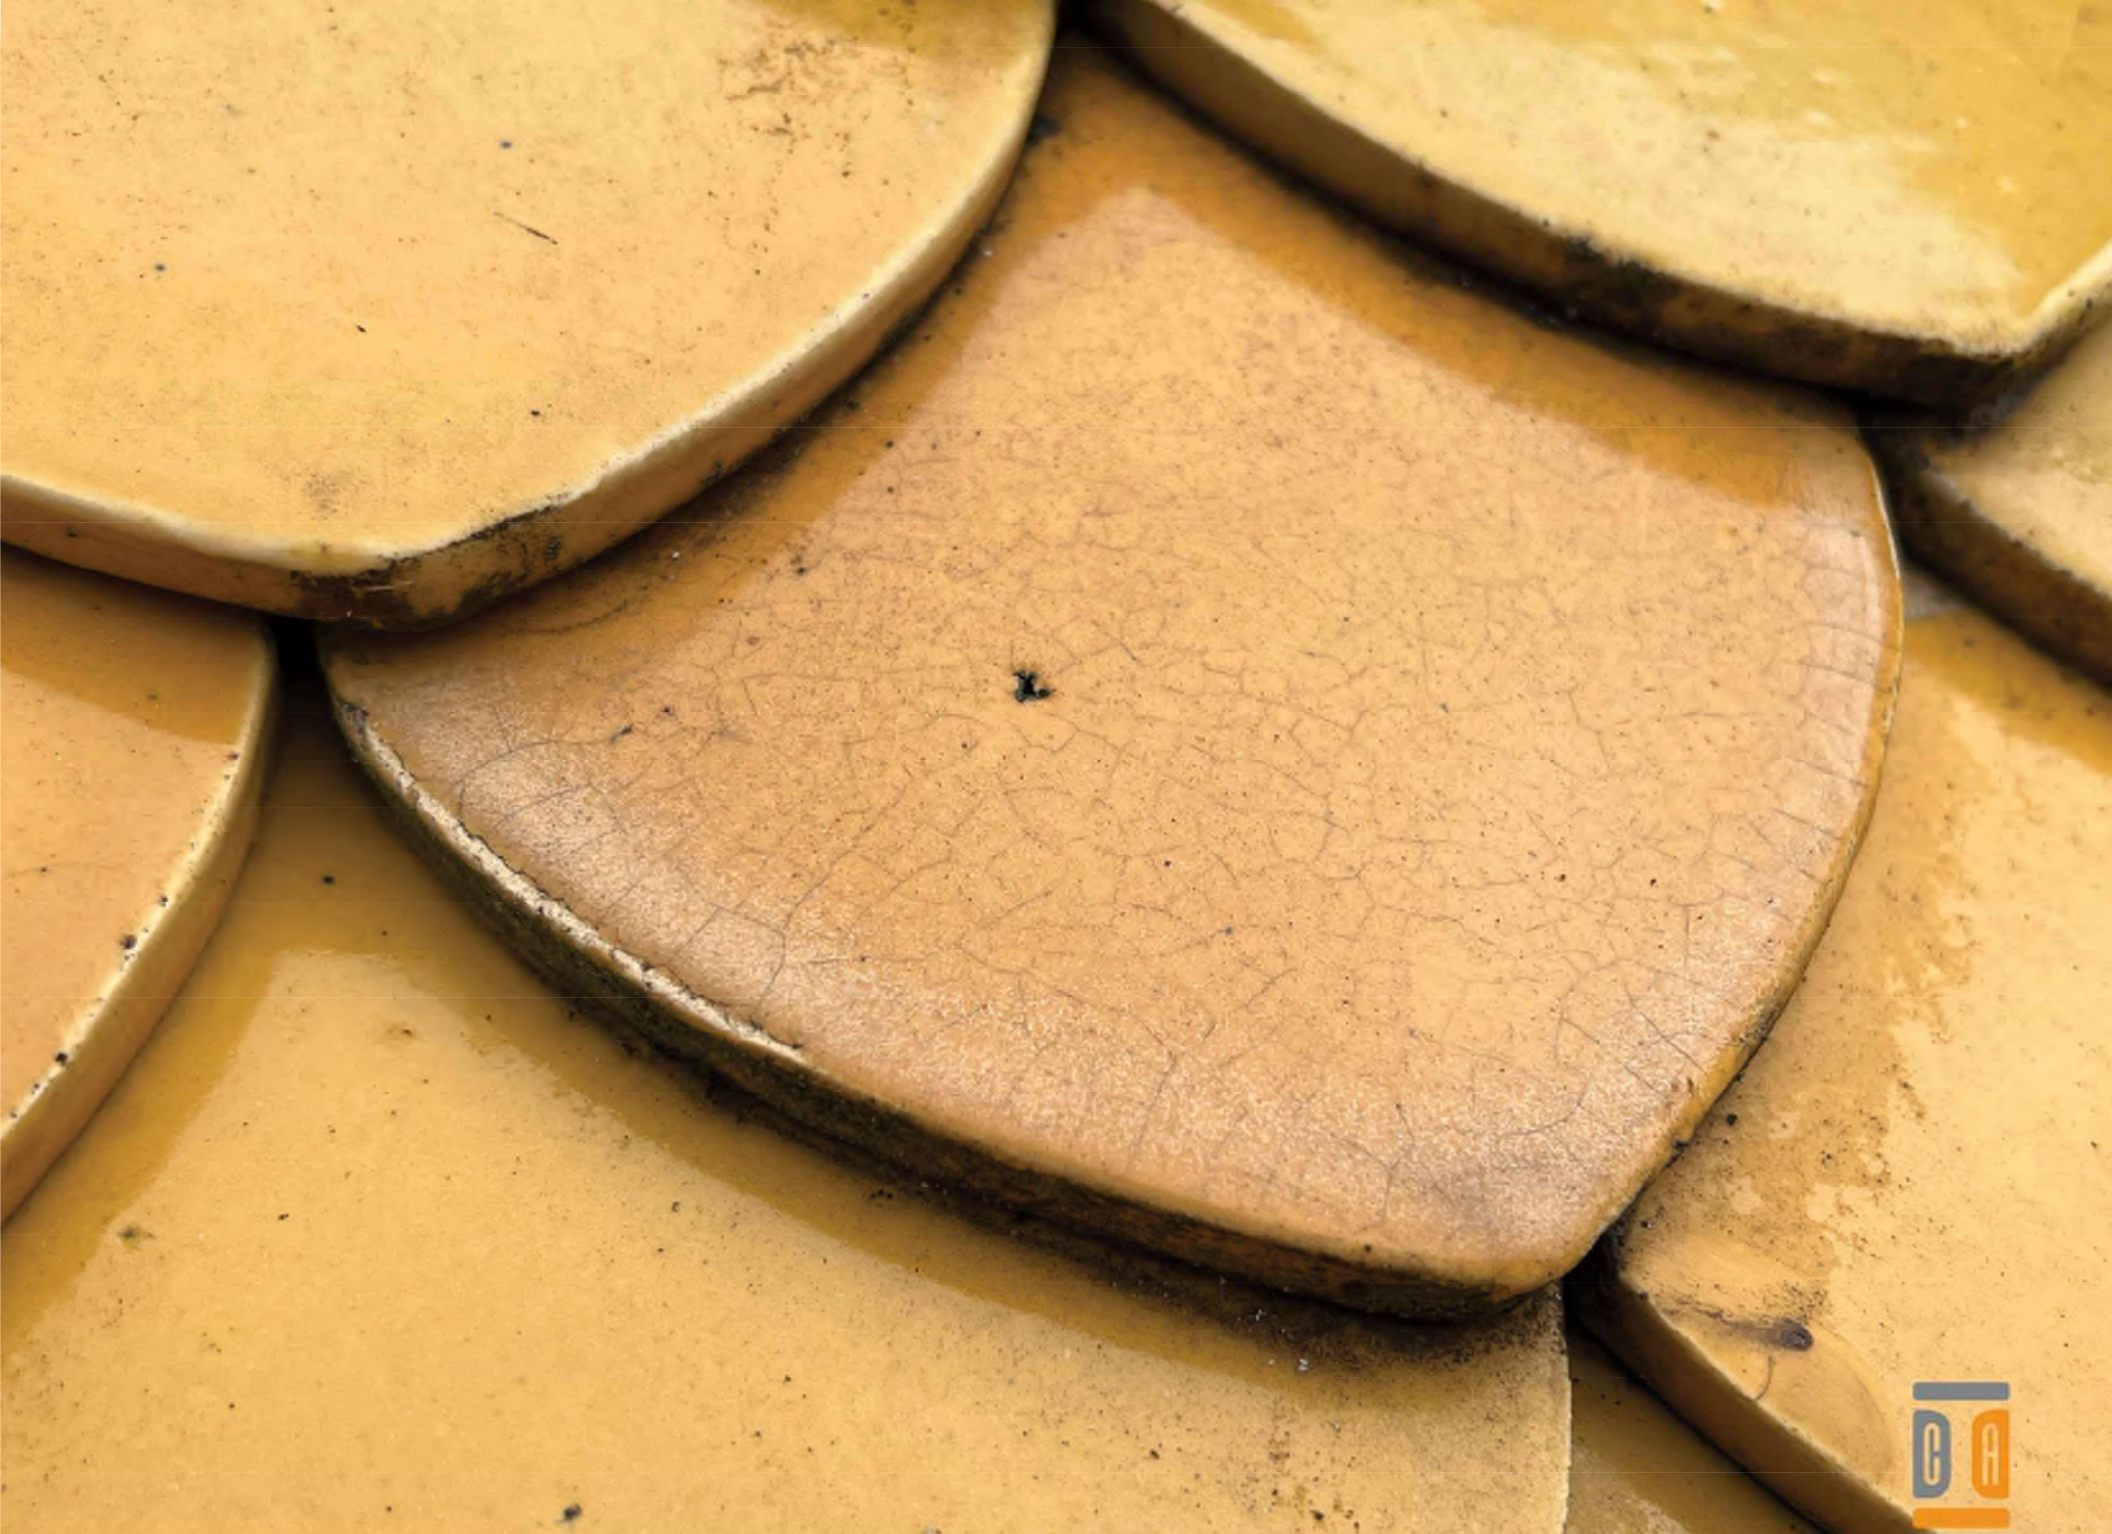
15. Fractured ceramic glaze – eventual water infiltration - Priority 1

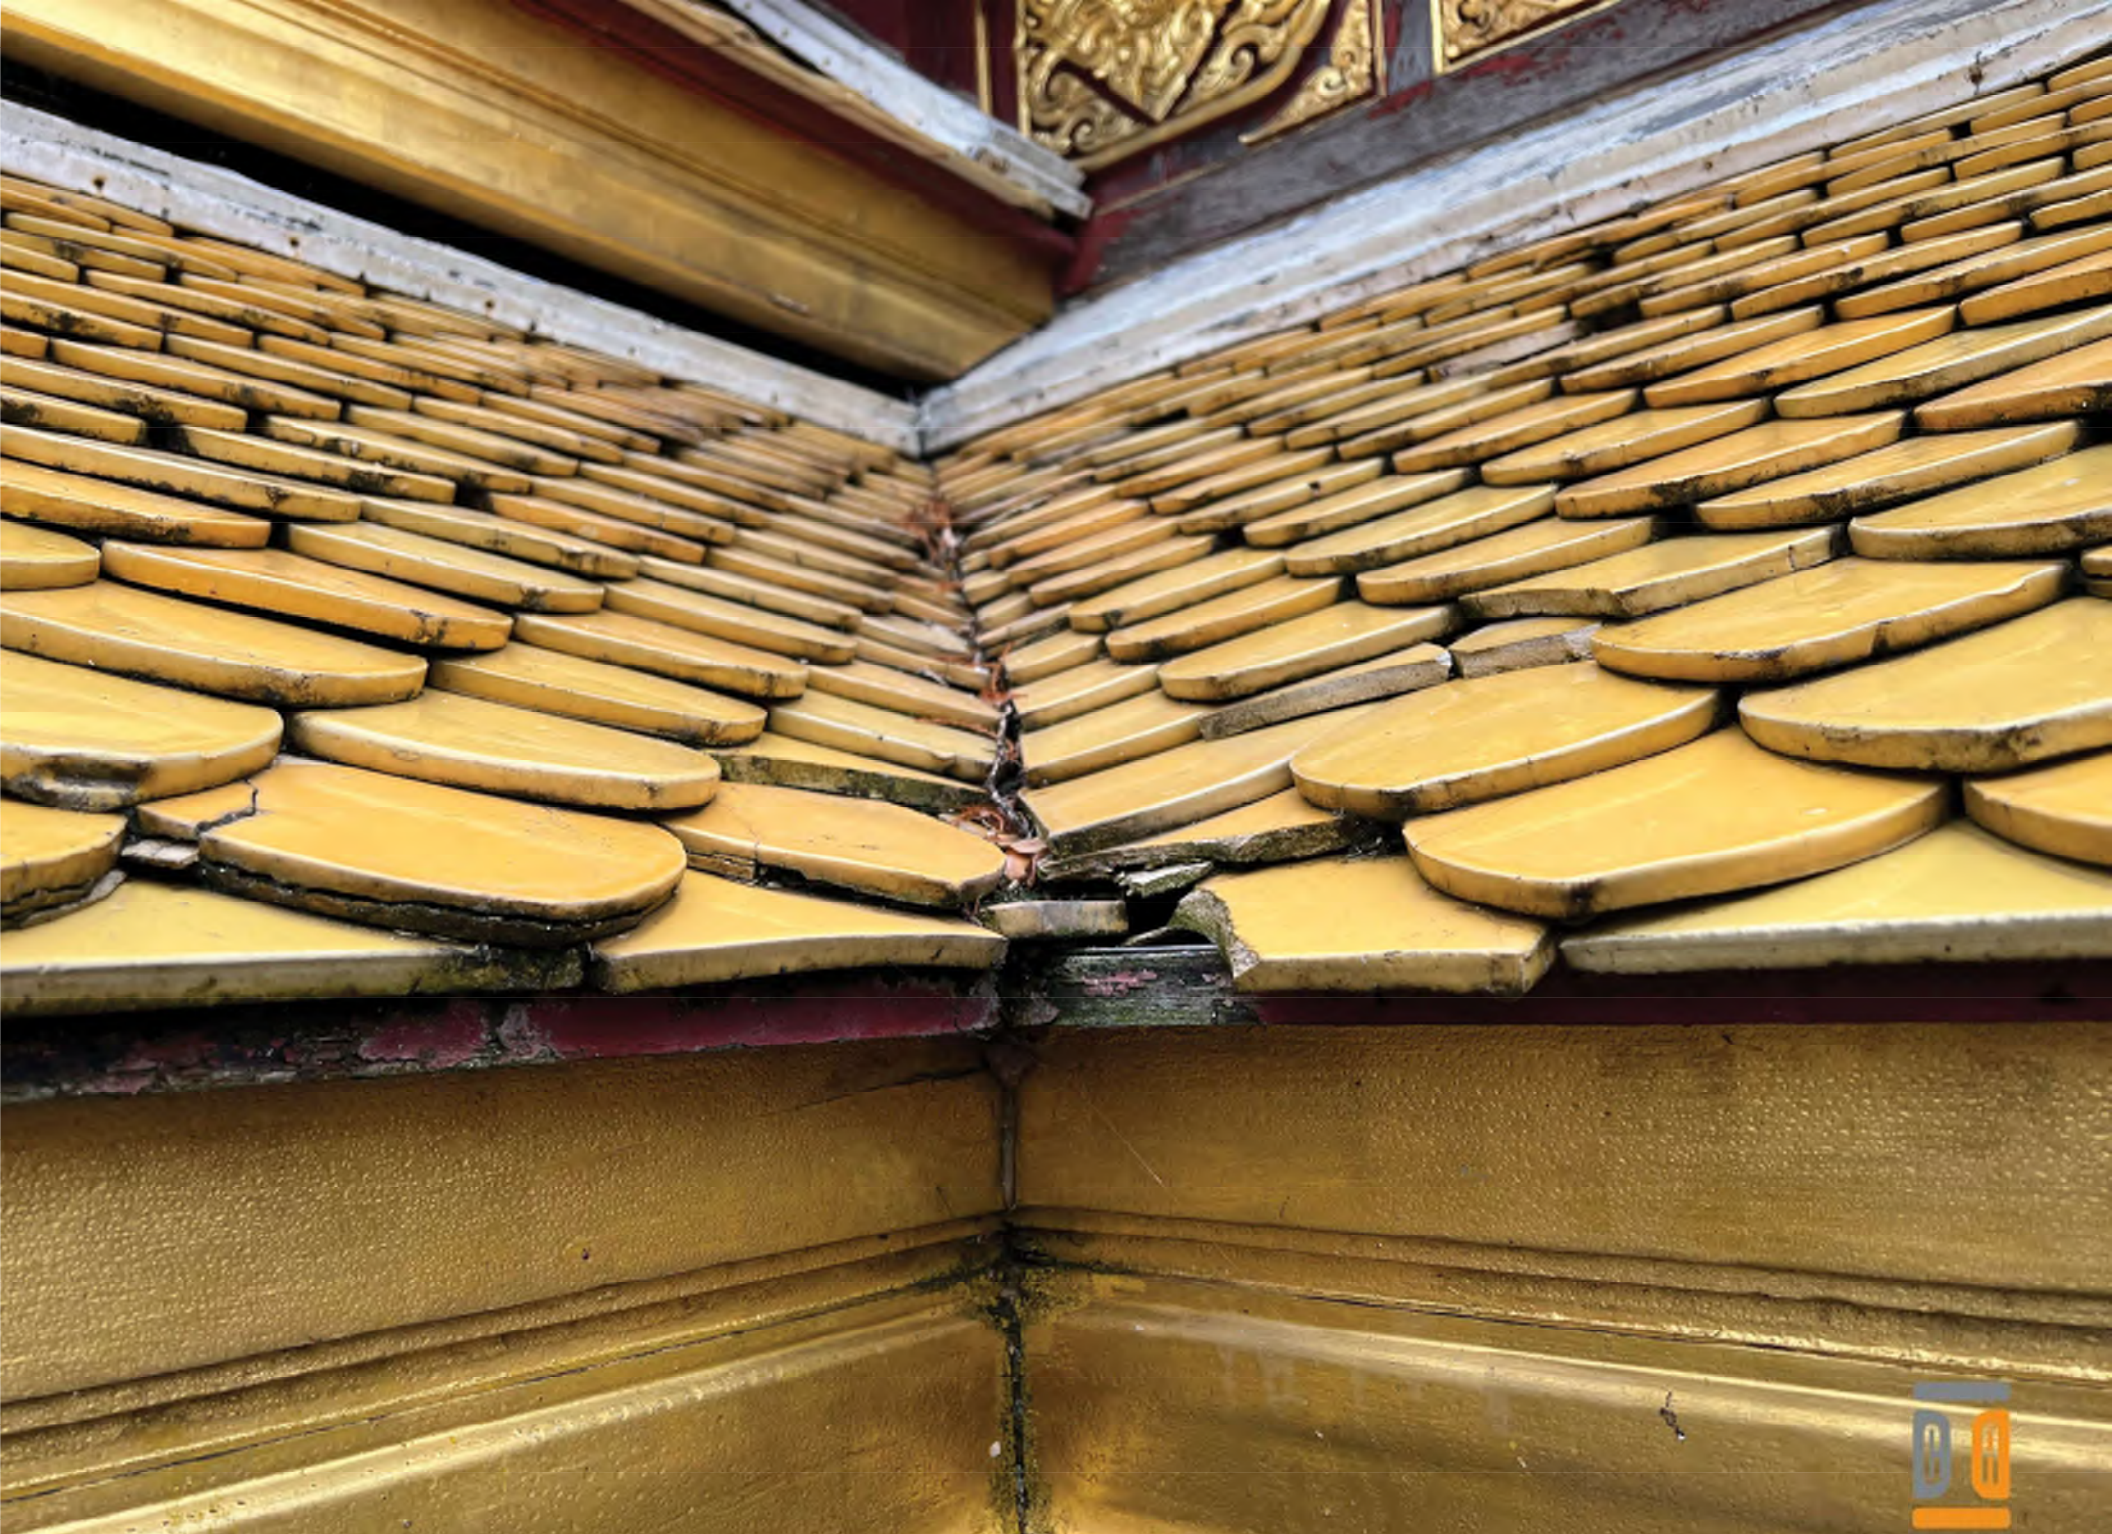
16. View up line of valley at the south side of West Main Gable - Priority 1

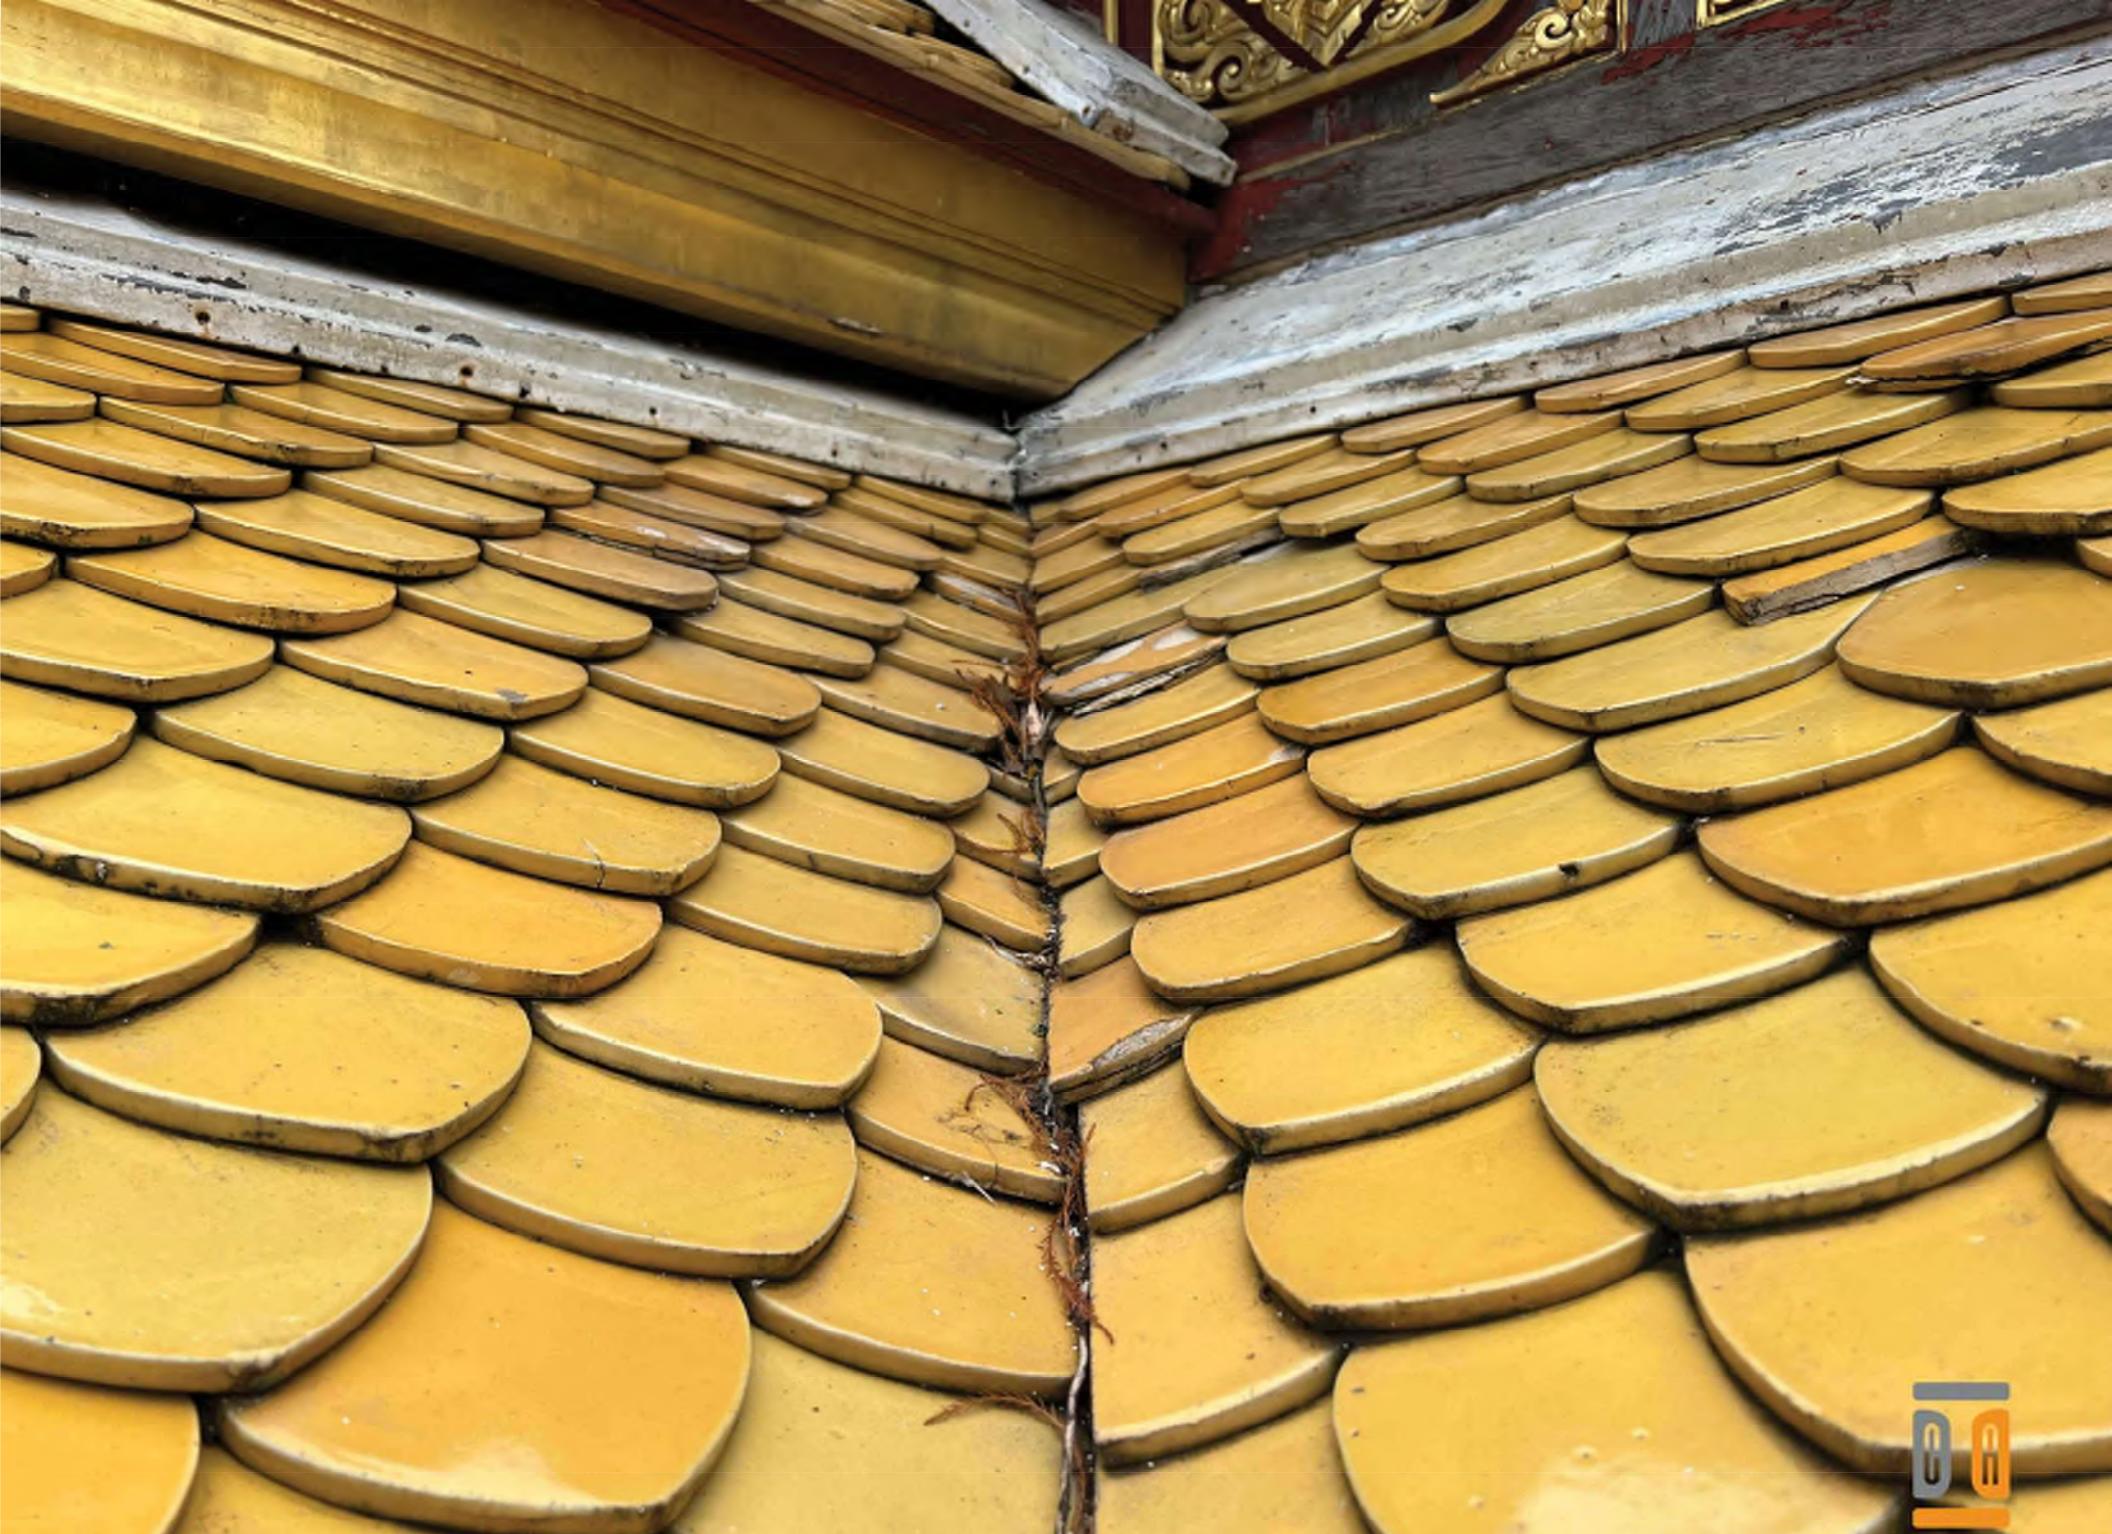
17. Overhead view up line of valley at the south side of West Main Gable - Priority 1

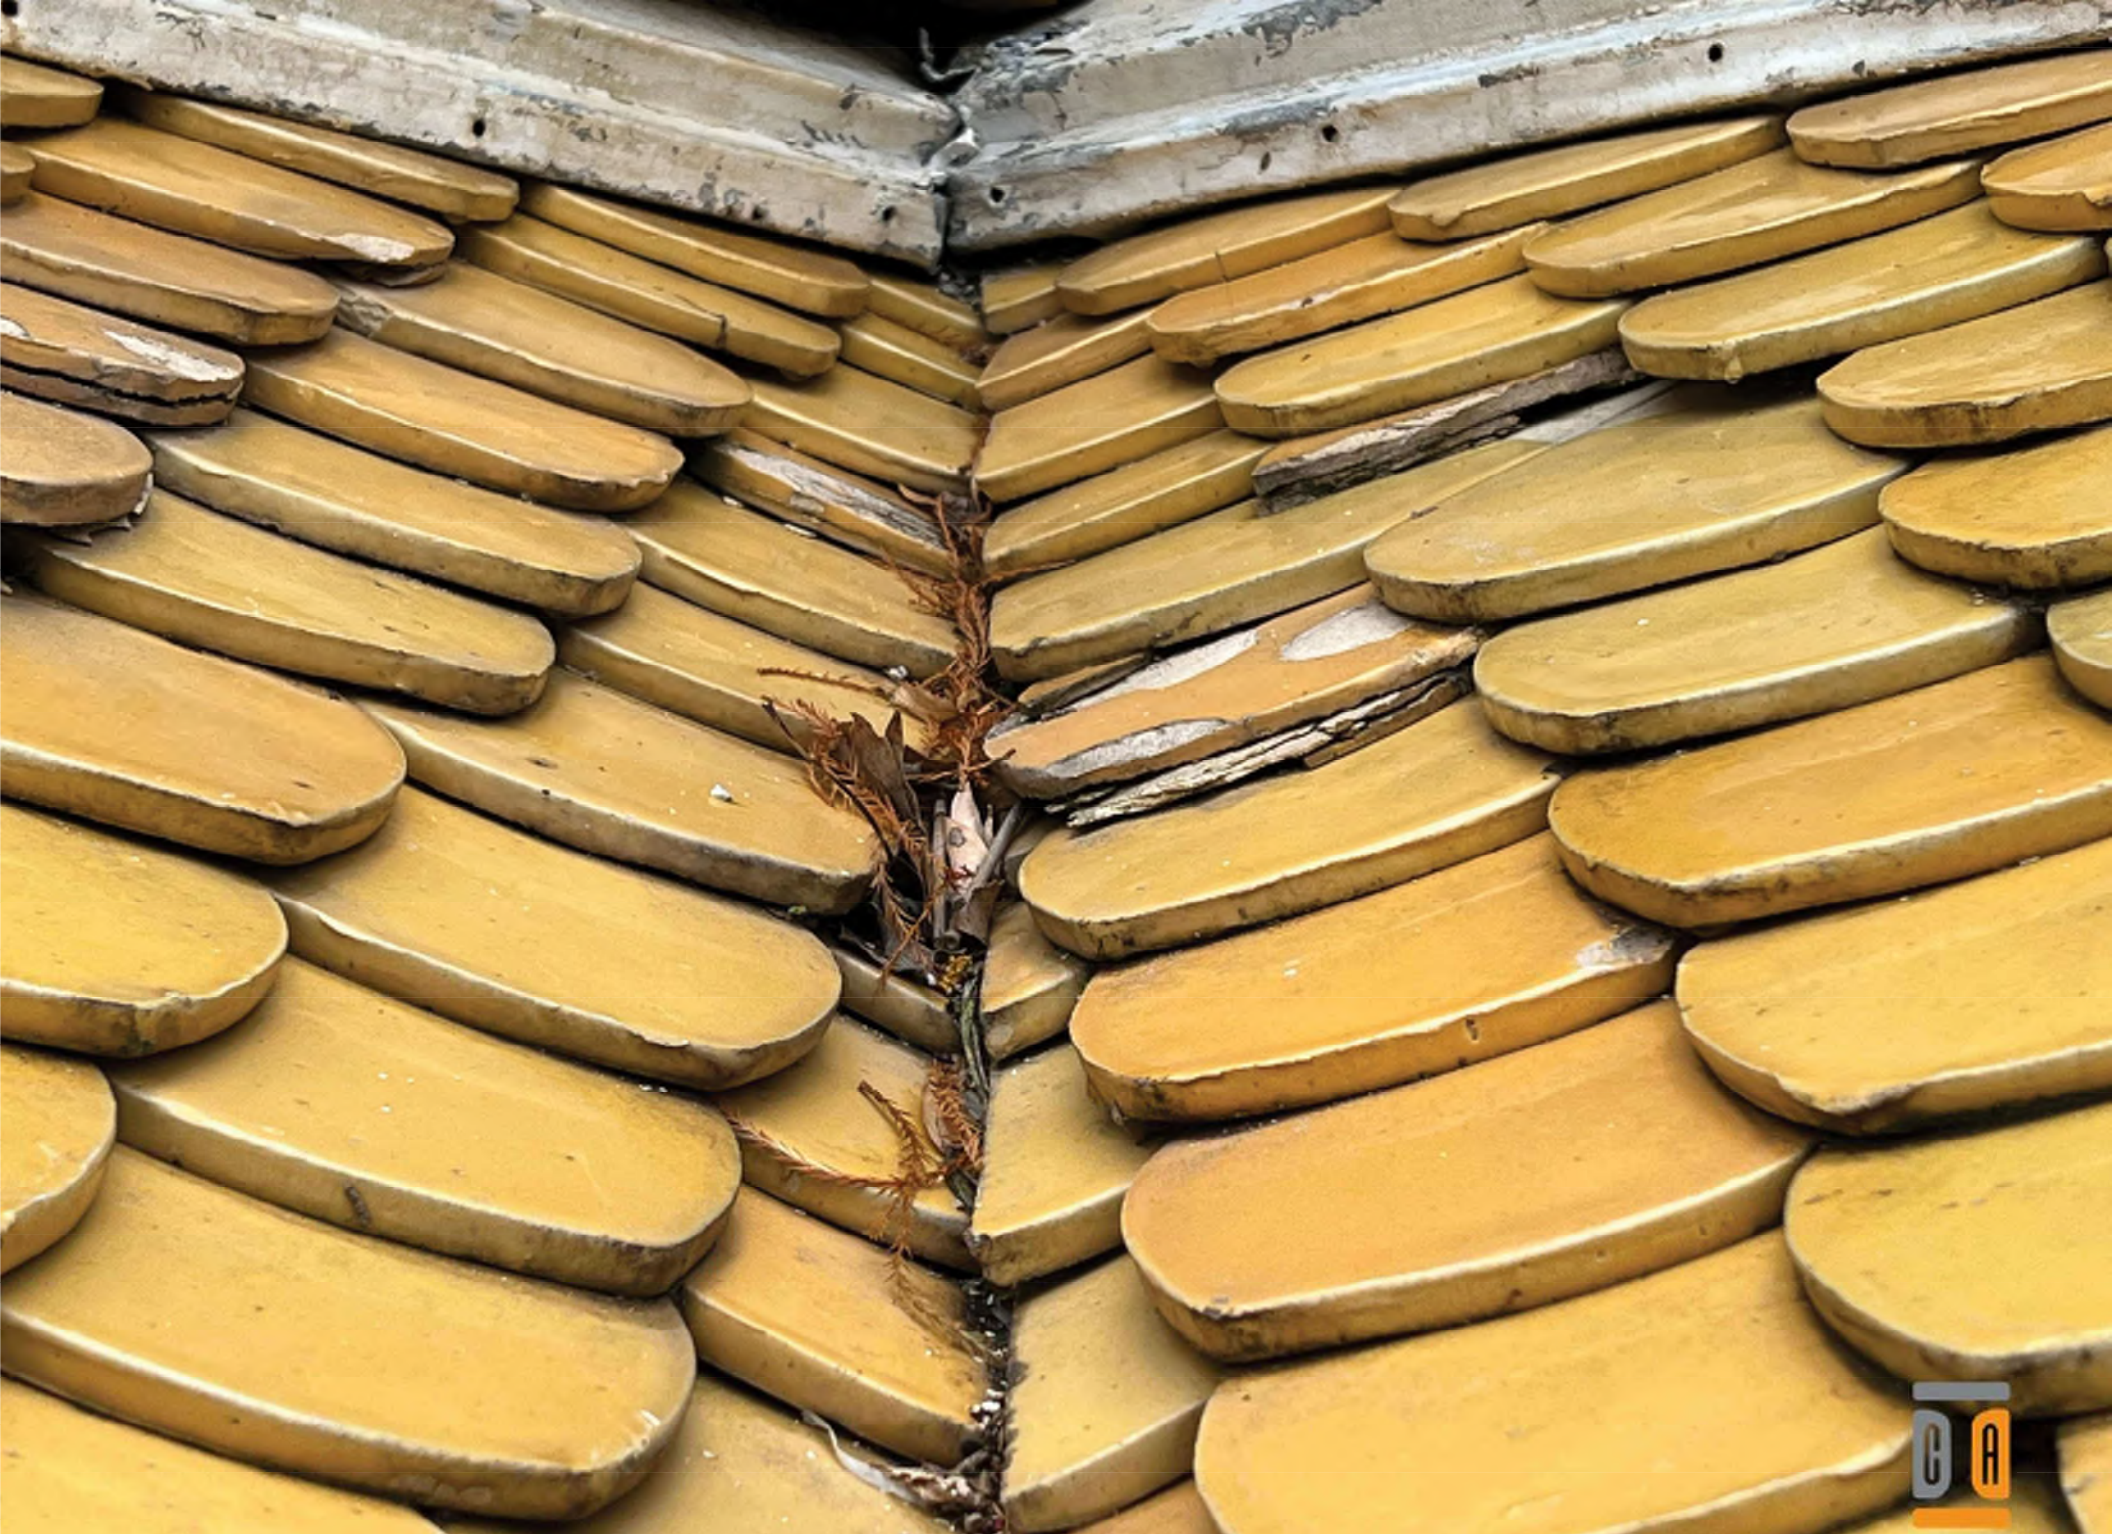
18. Closer view up the valley at the south side of West Main Gable - Priority 1

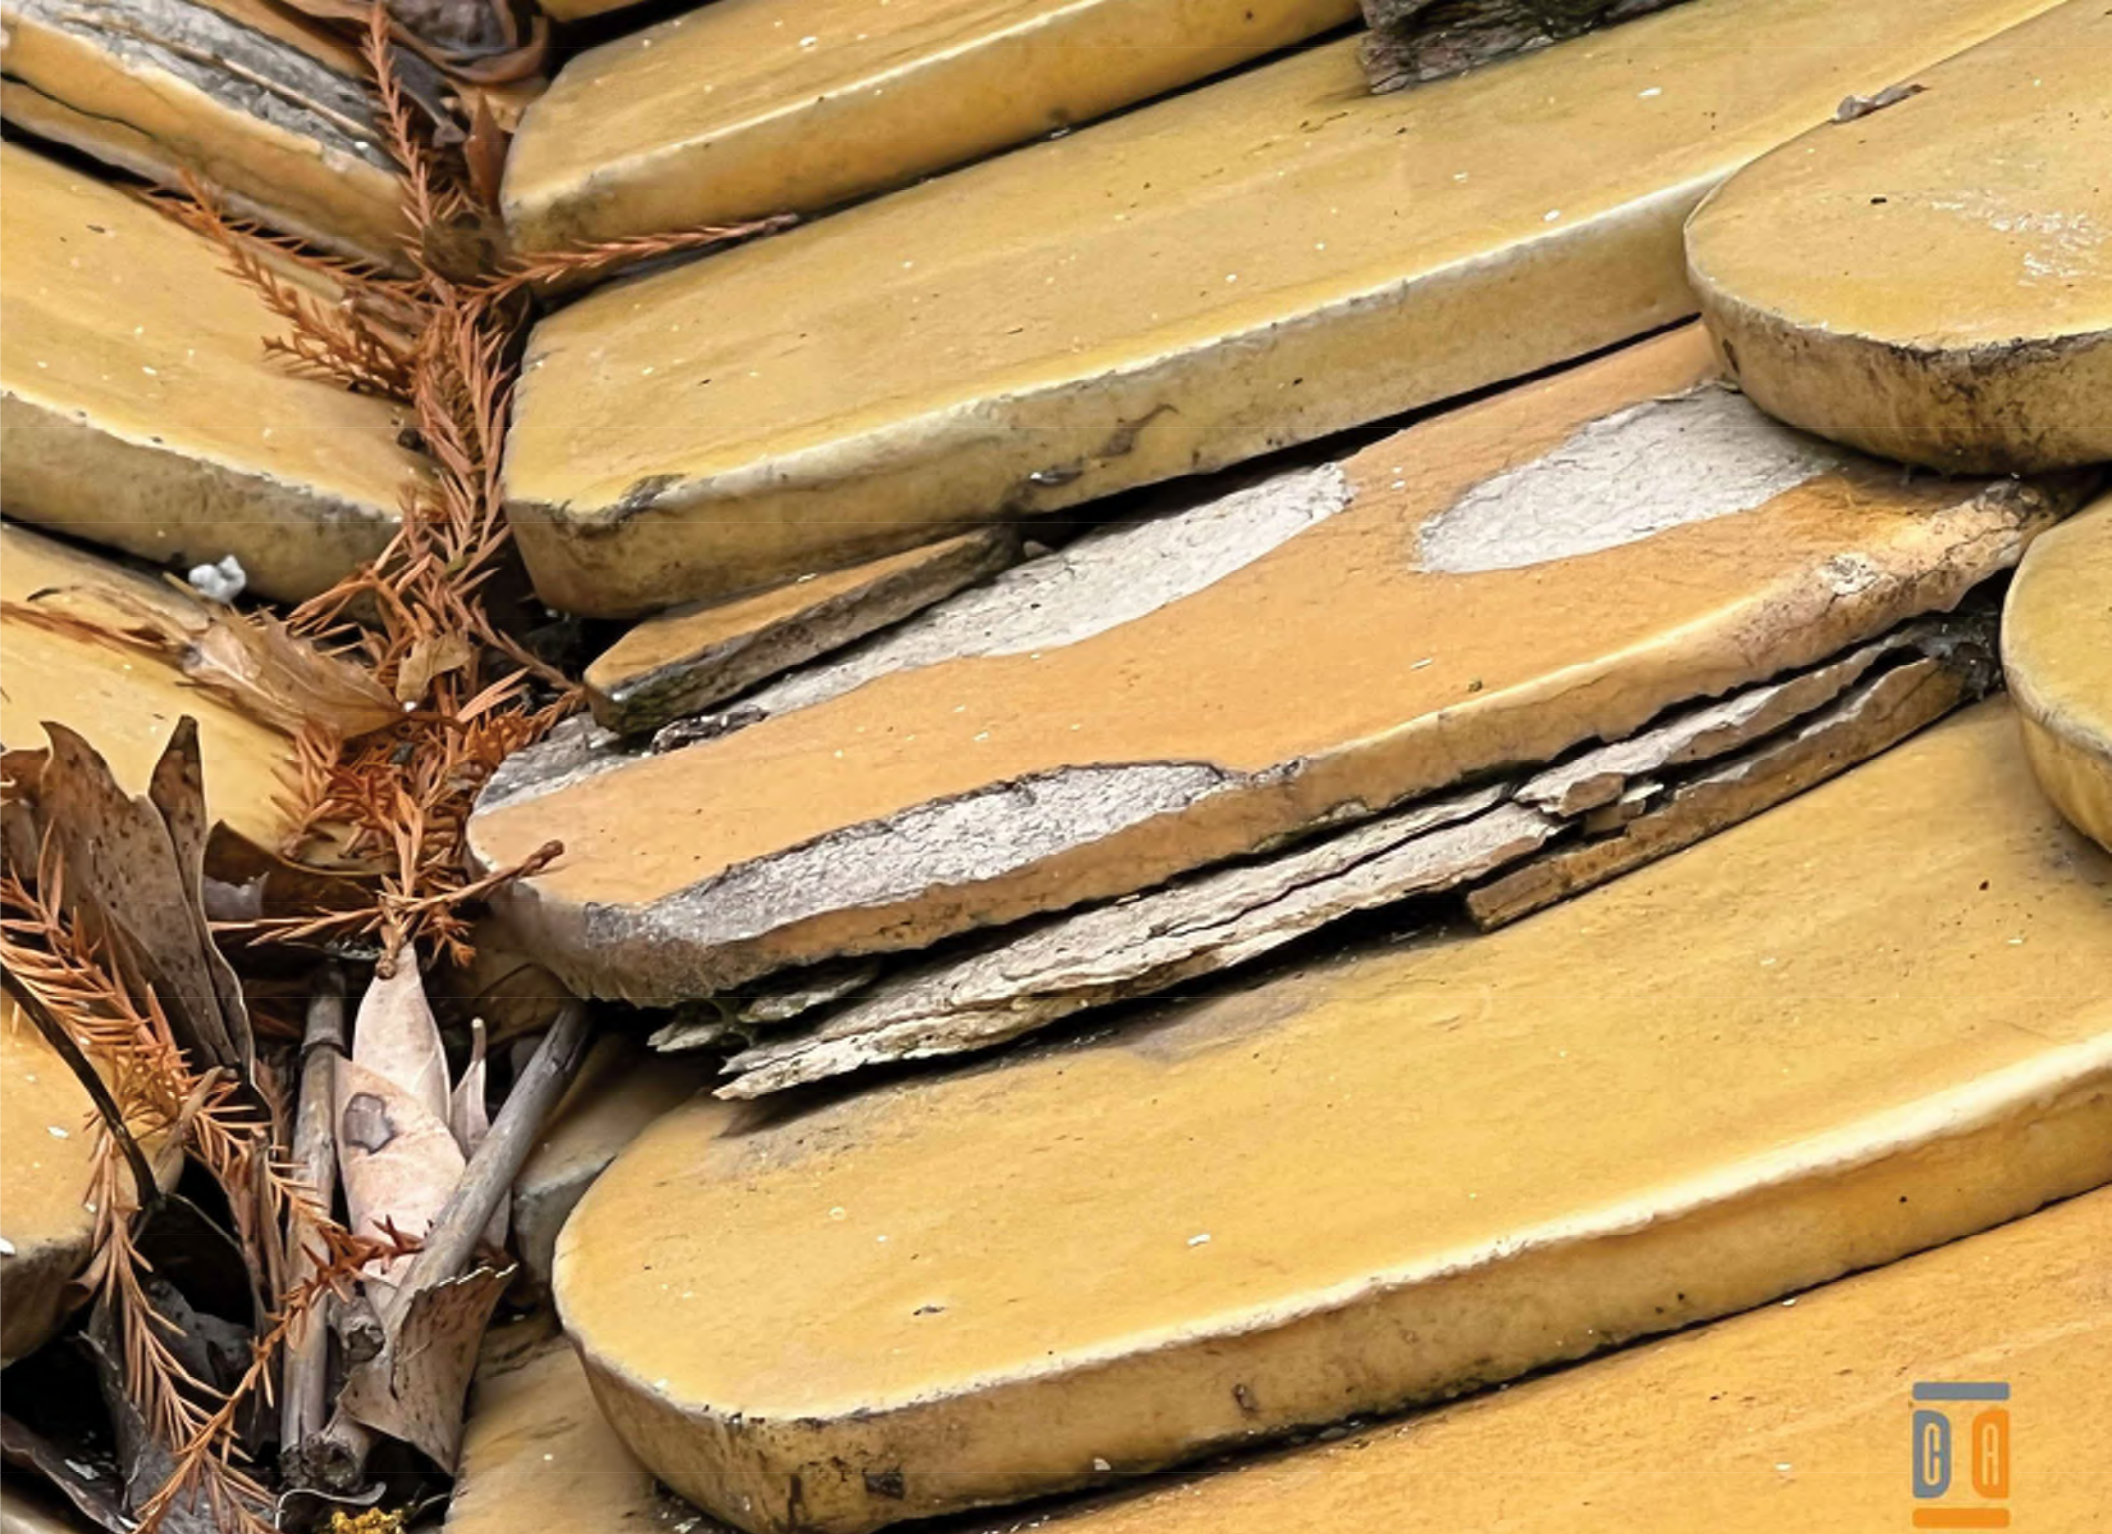
19. Close up of tile degradation at valley identified in images - Priority 1

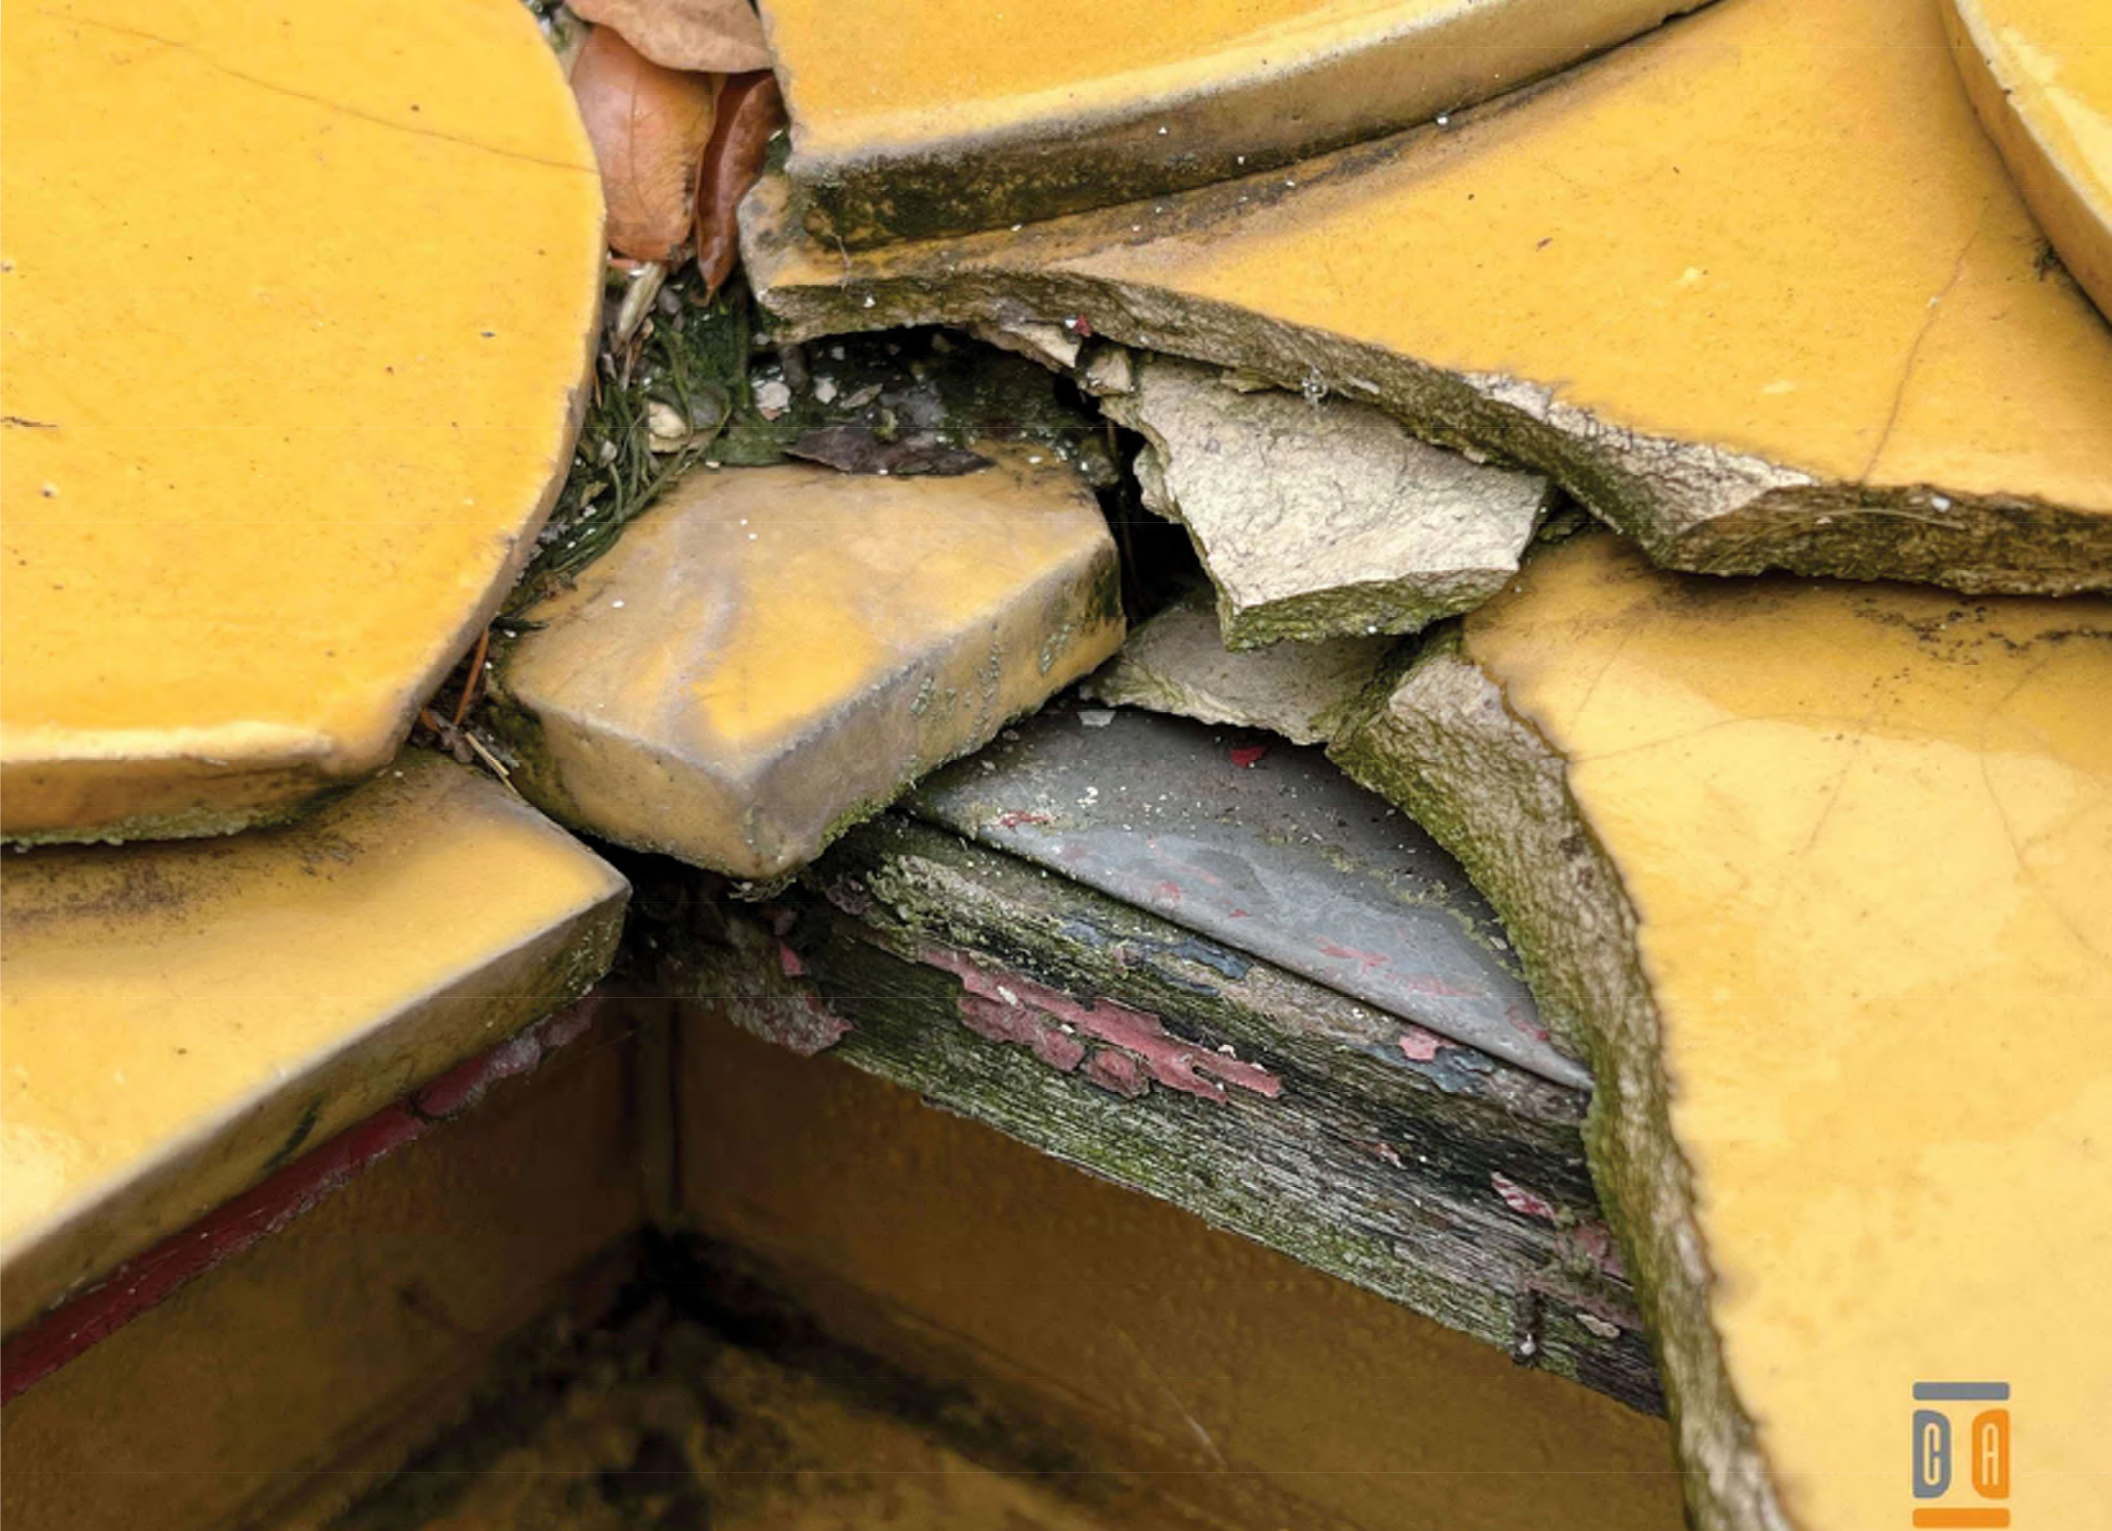
20. Close-up of valley termination at location referenced in images - Priority 1
