OLBRICH BOTANICAL GARDENS ROYAL THAI PAVILION CONDITION ASSESSMENT REPORT

AUGUST 30, 2022

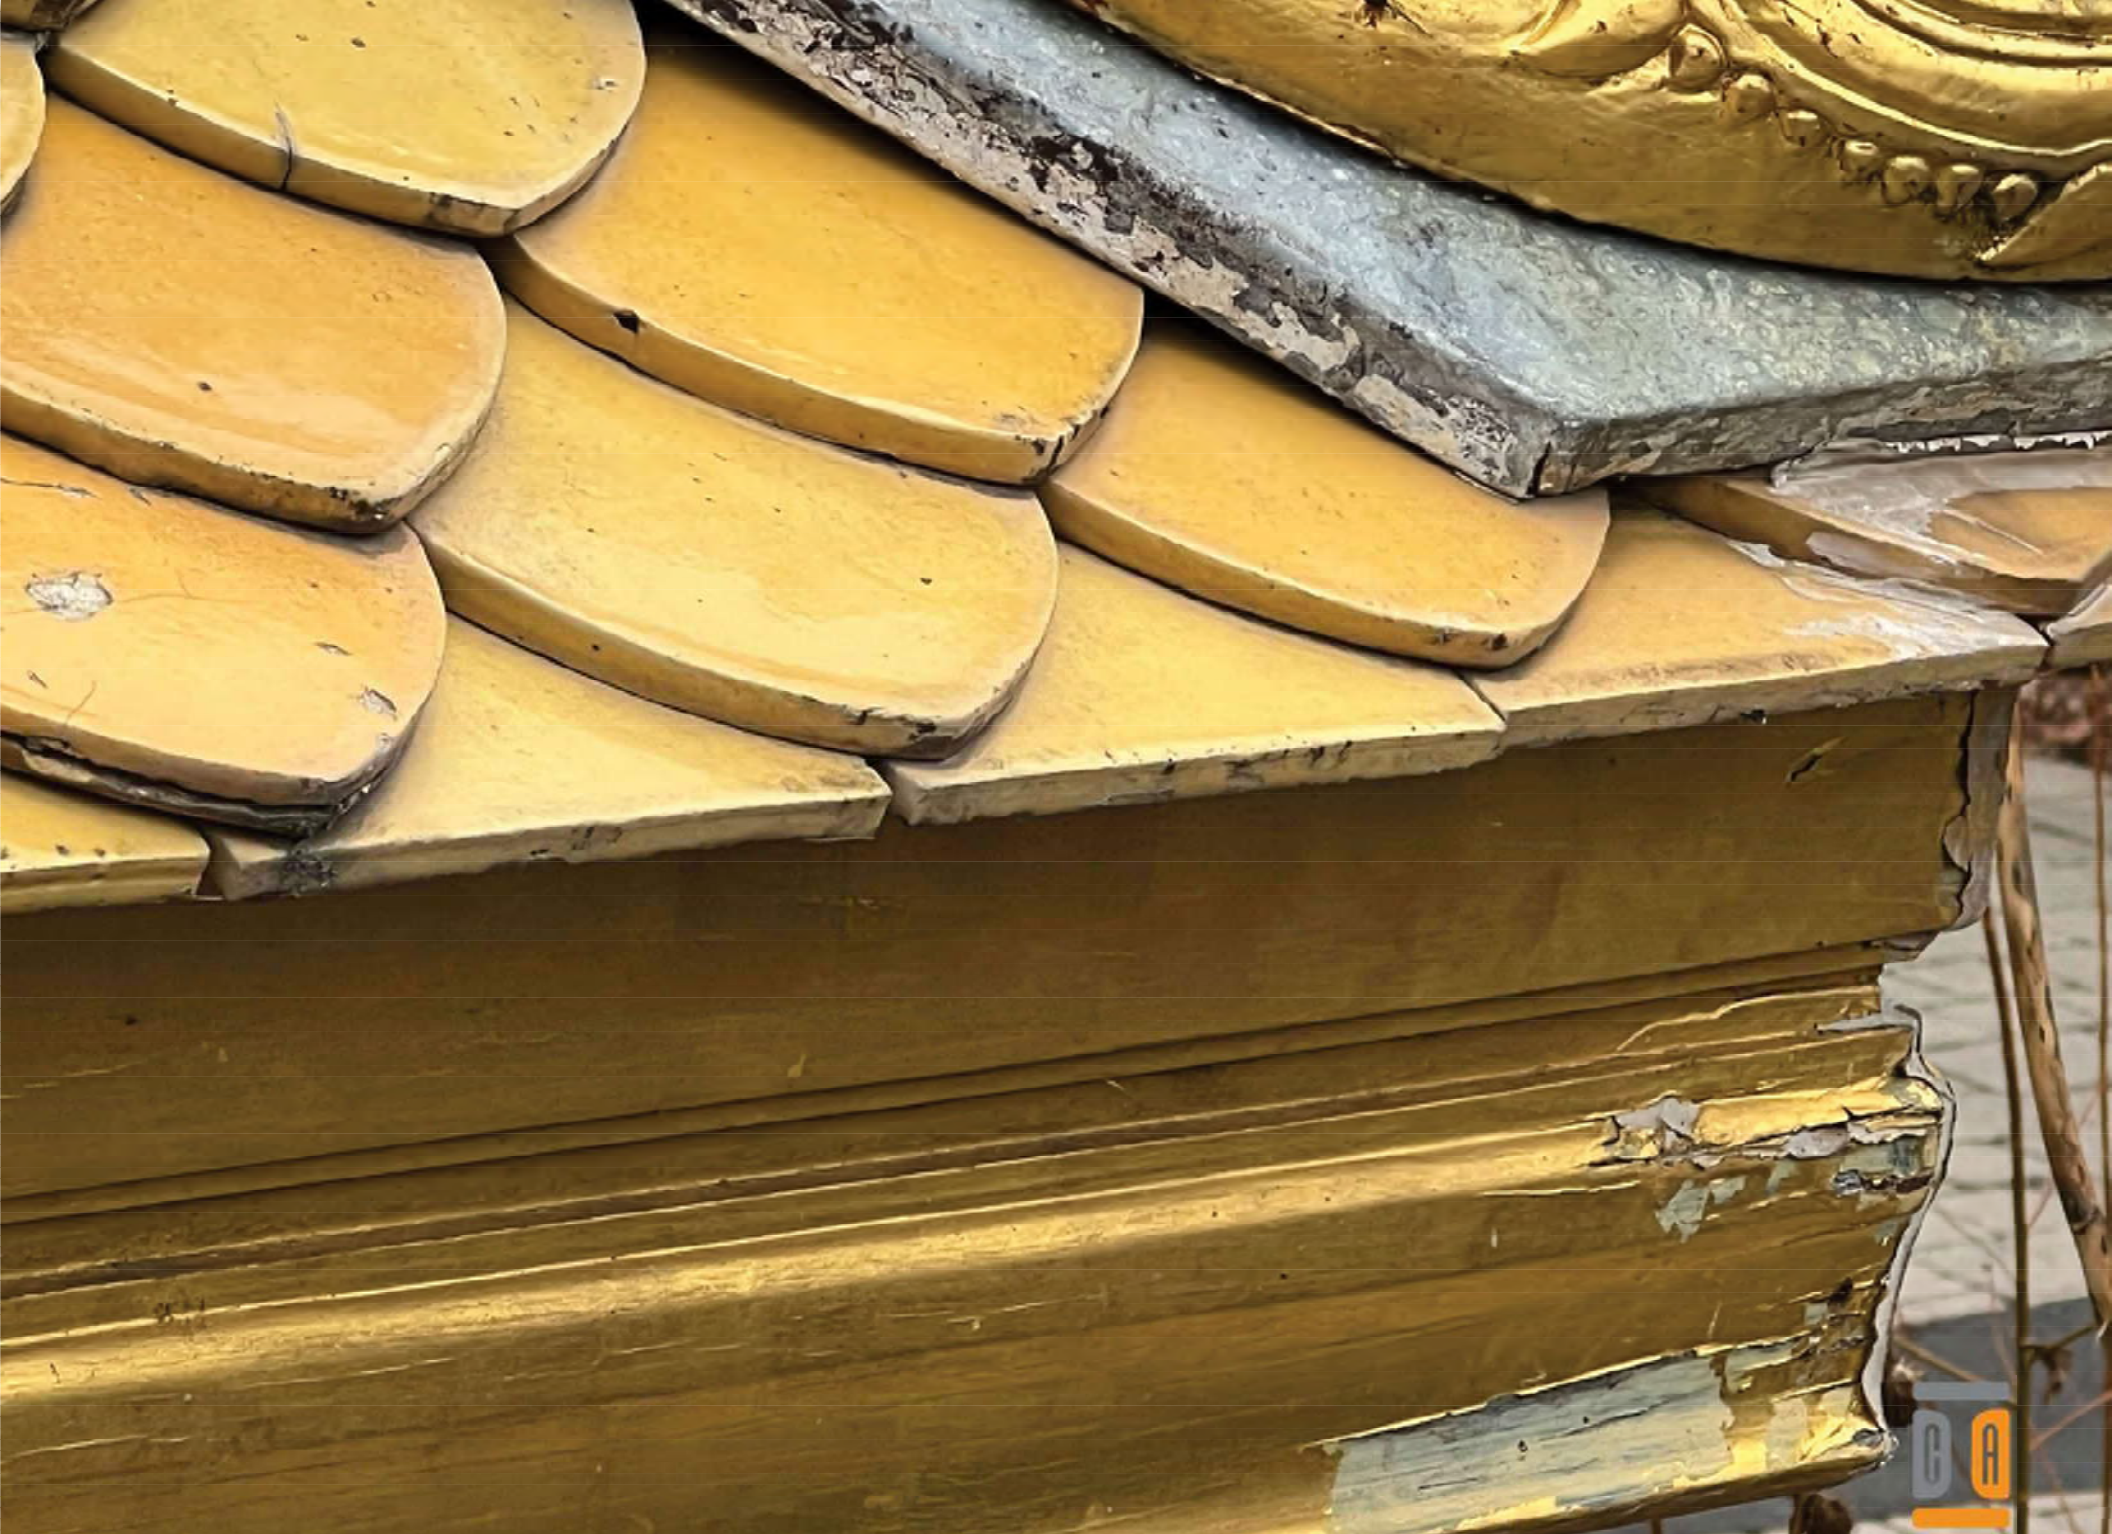
21. Repair attempts at base of hip ridge - Priority 1

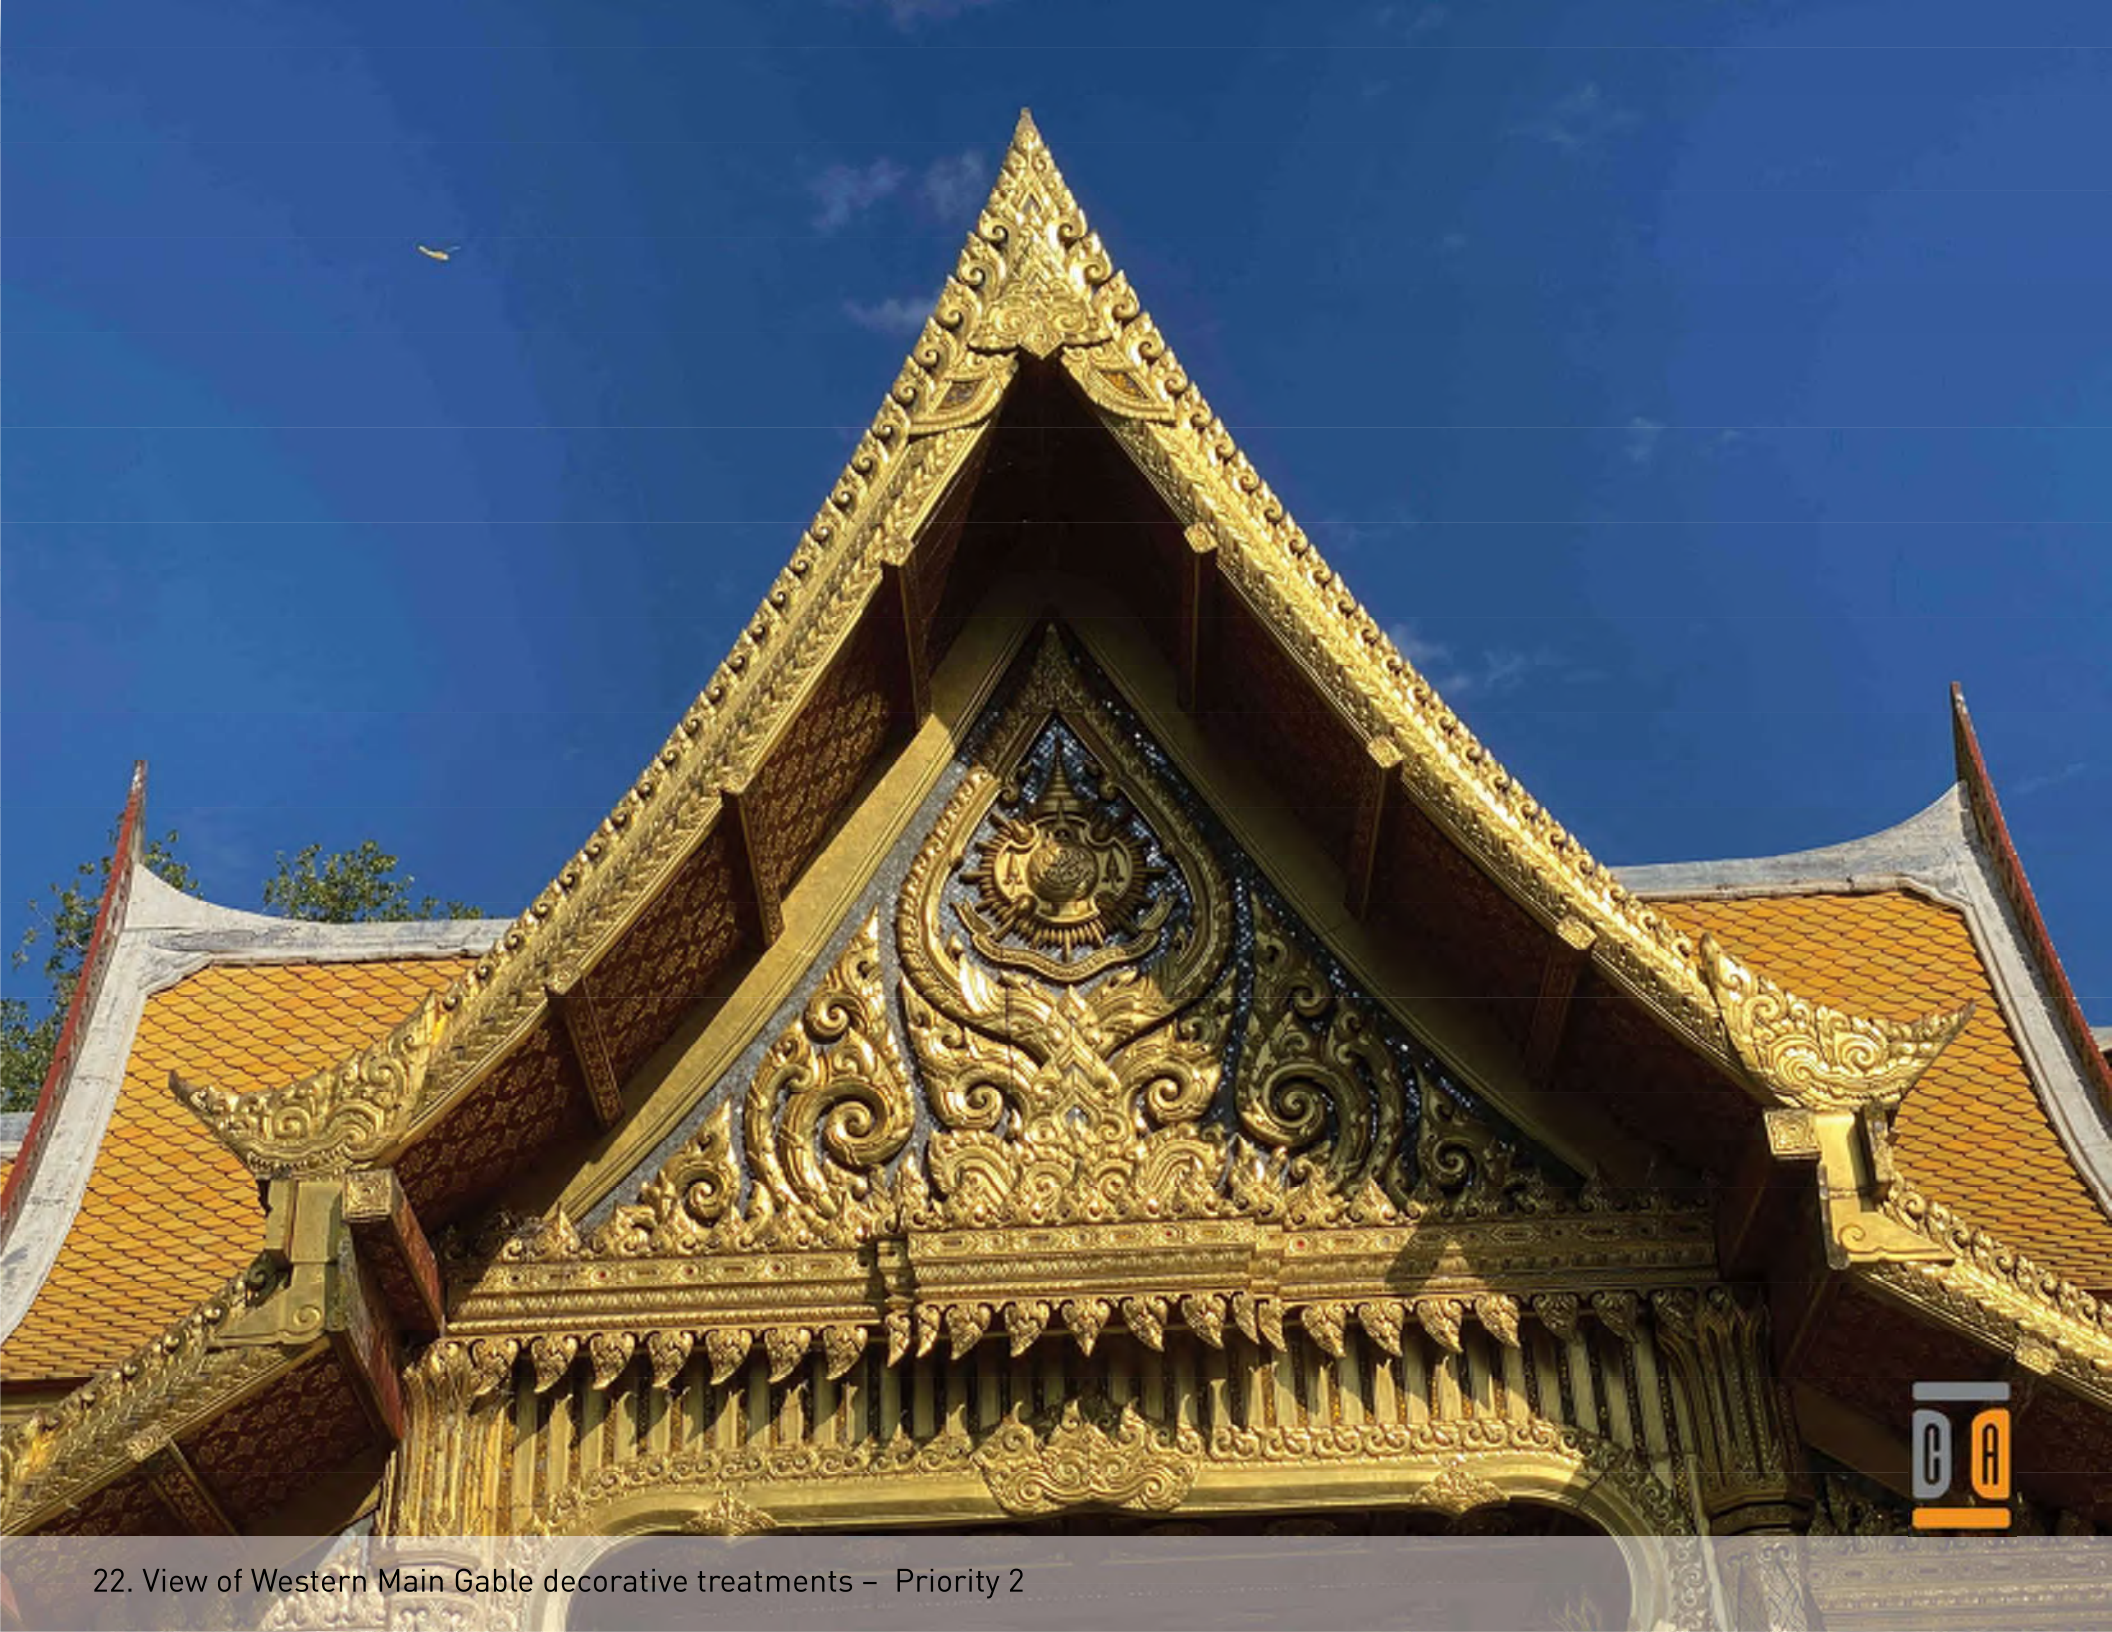
22. View of Western Main Gable decorative treatments – Priority 2

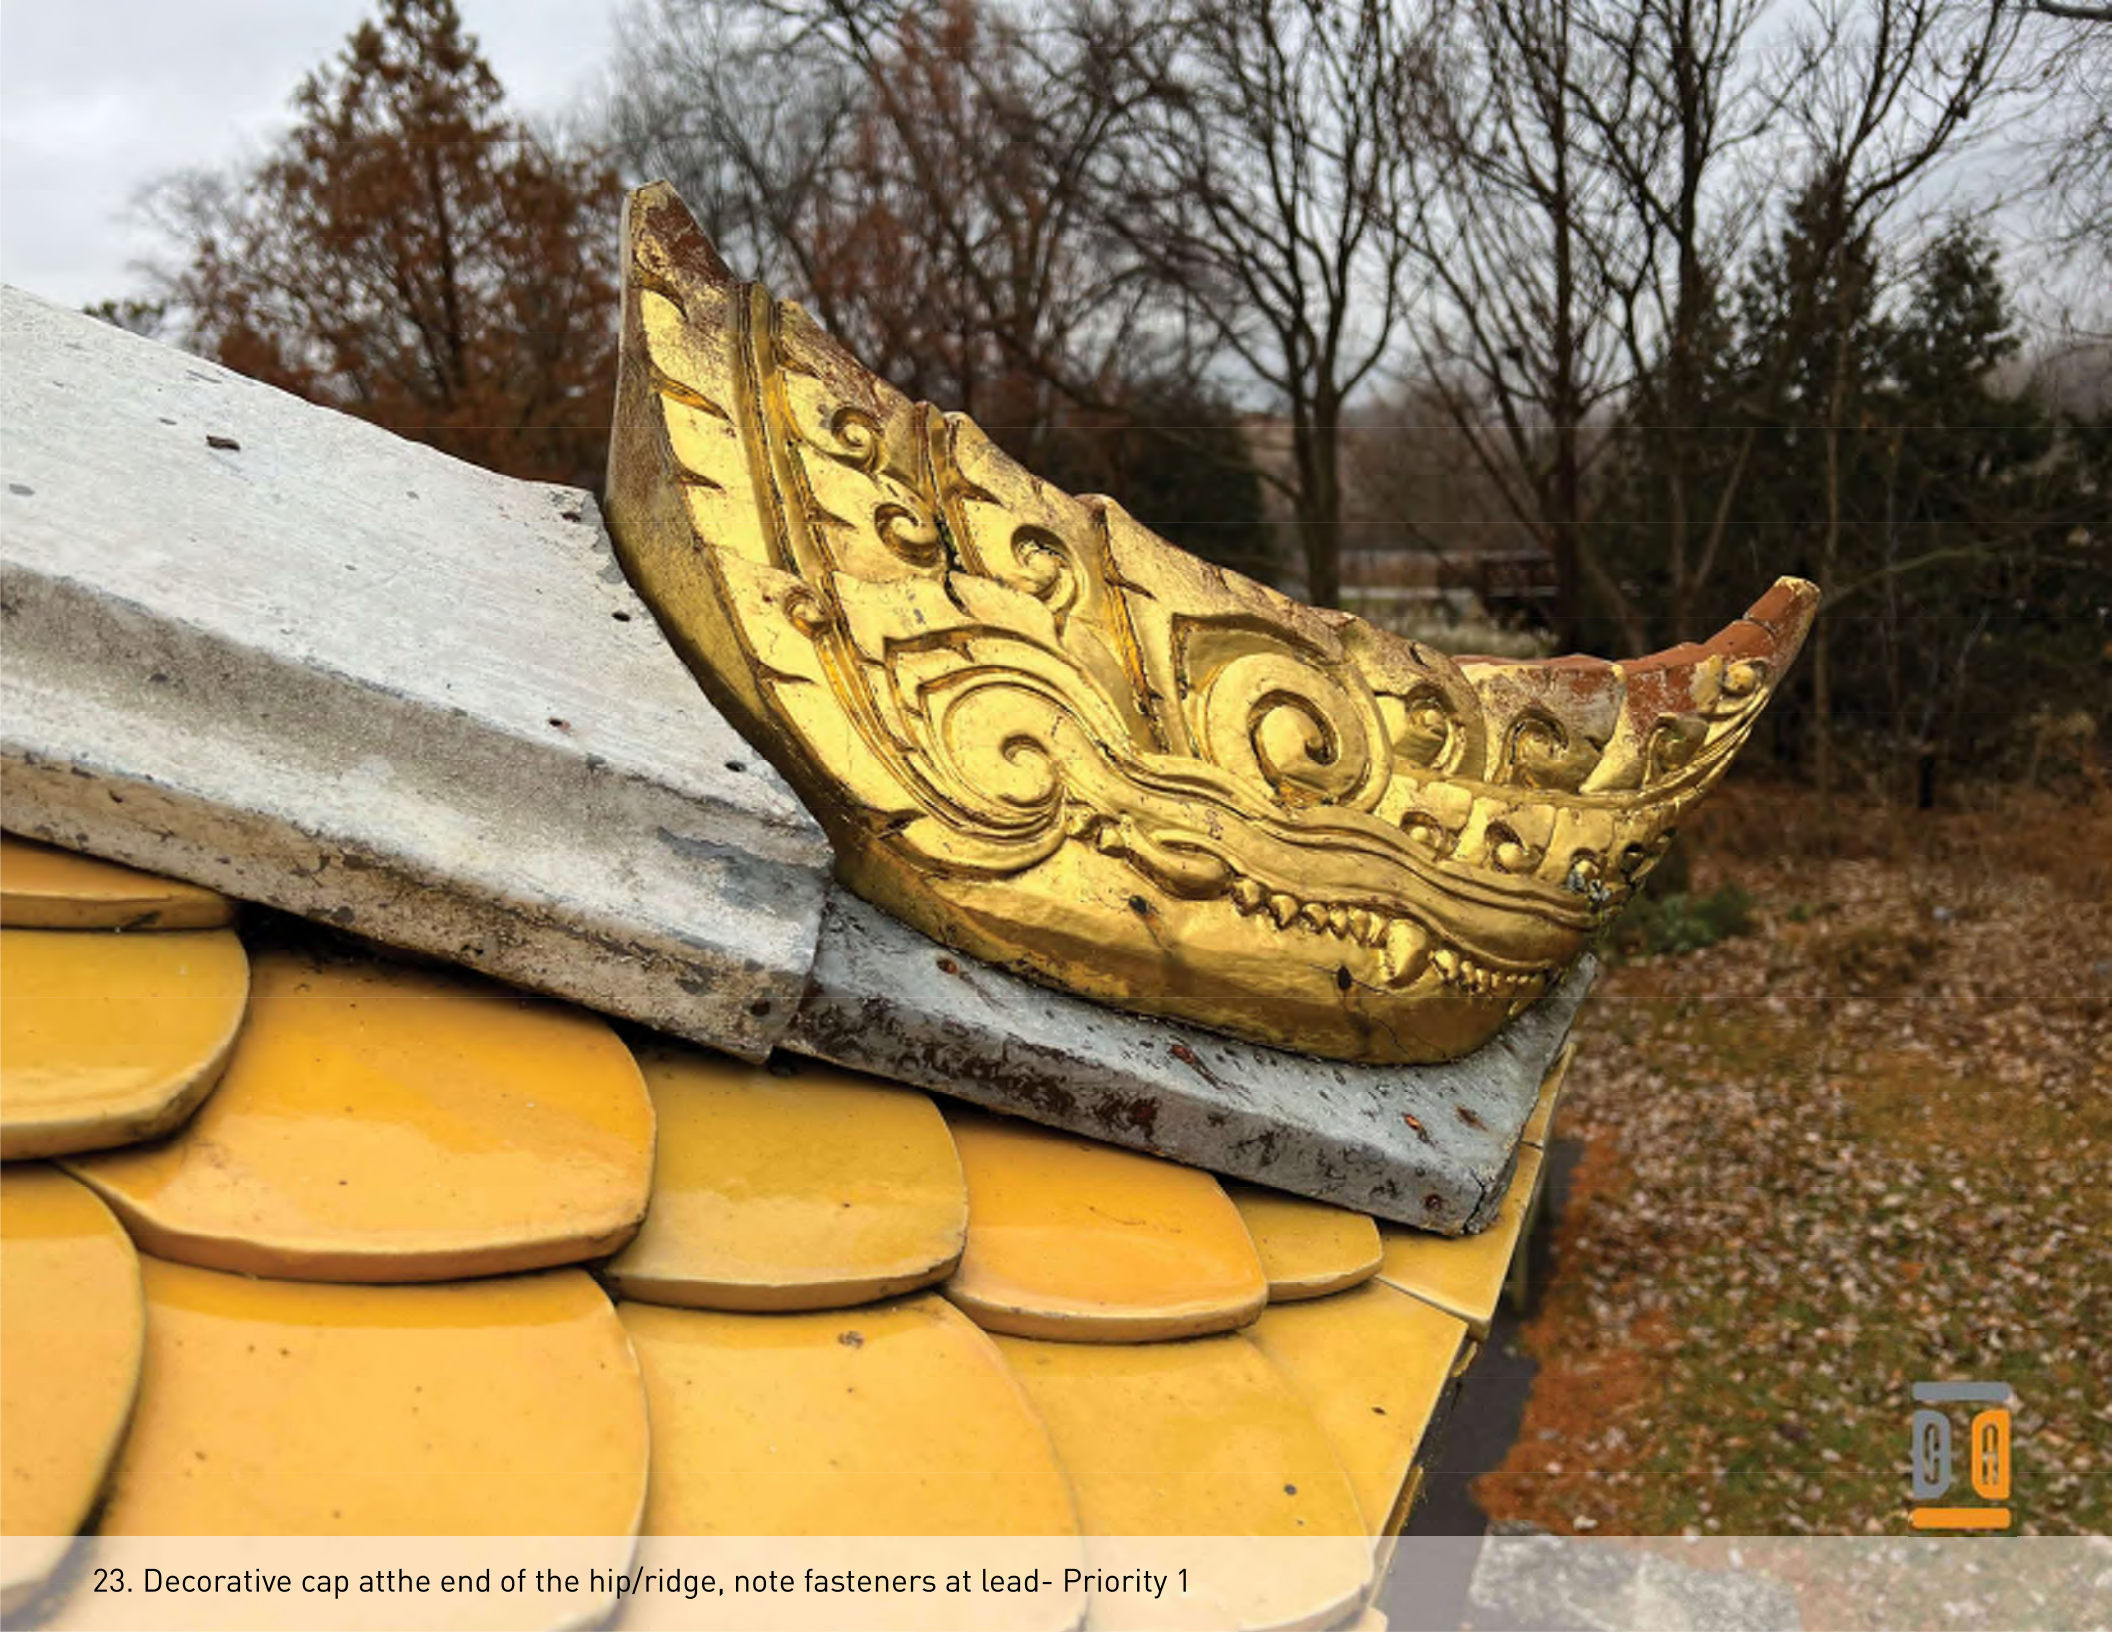
23. Decorative cap at the end of the hip/ridge, note fasteners at lead- Priority 1

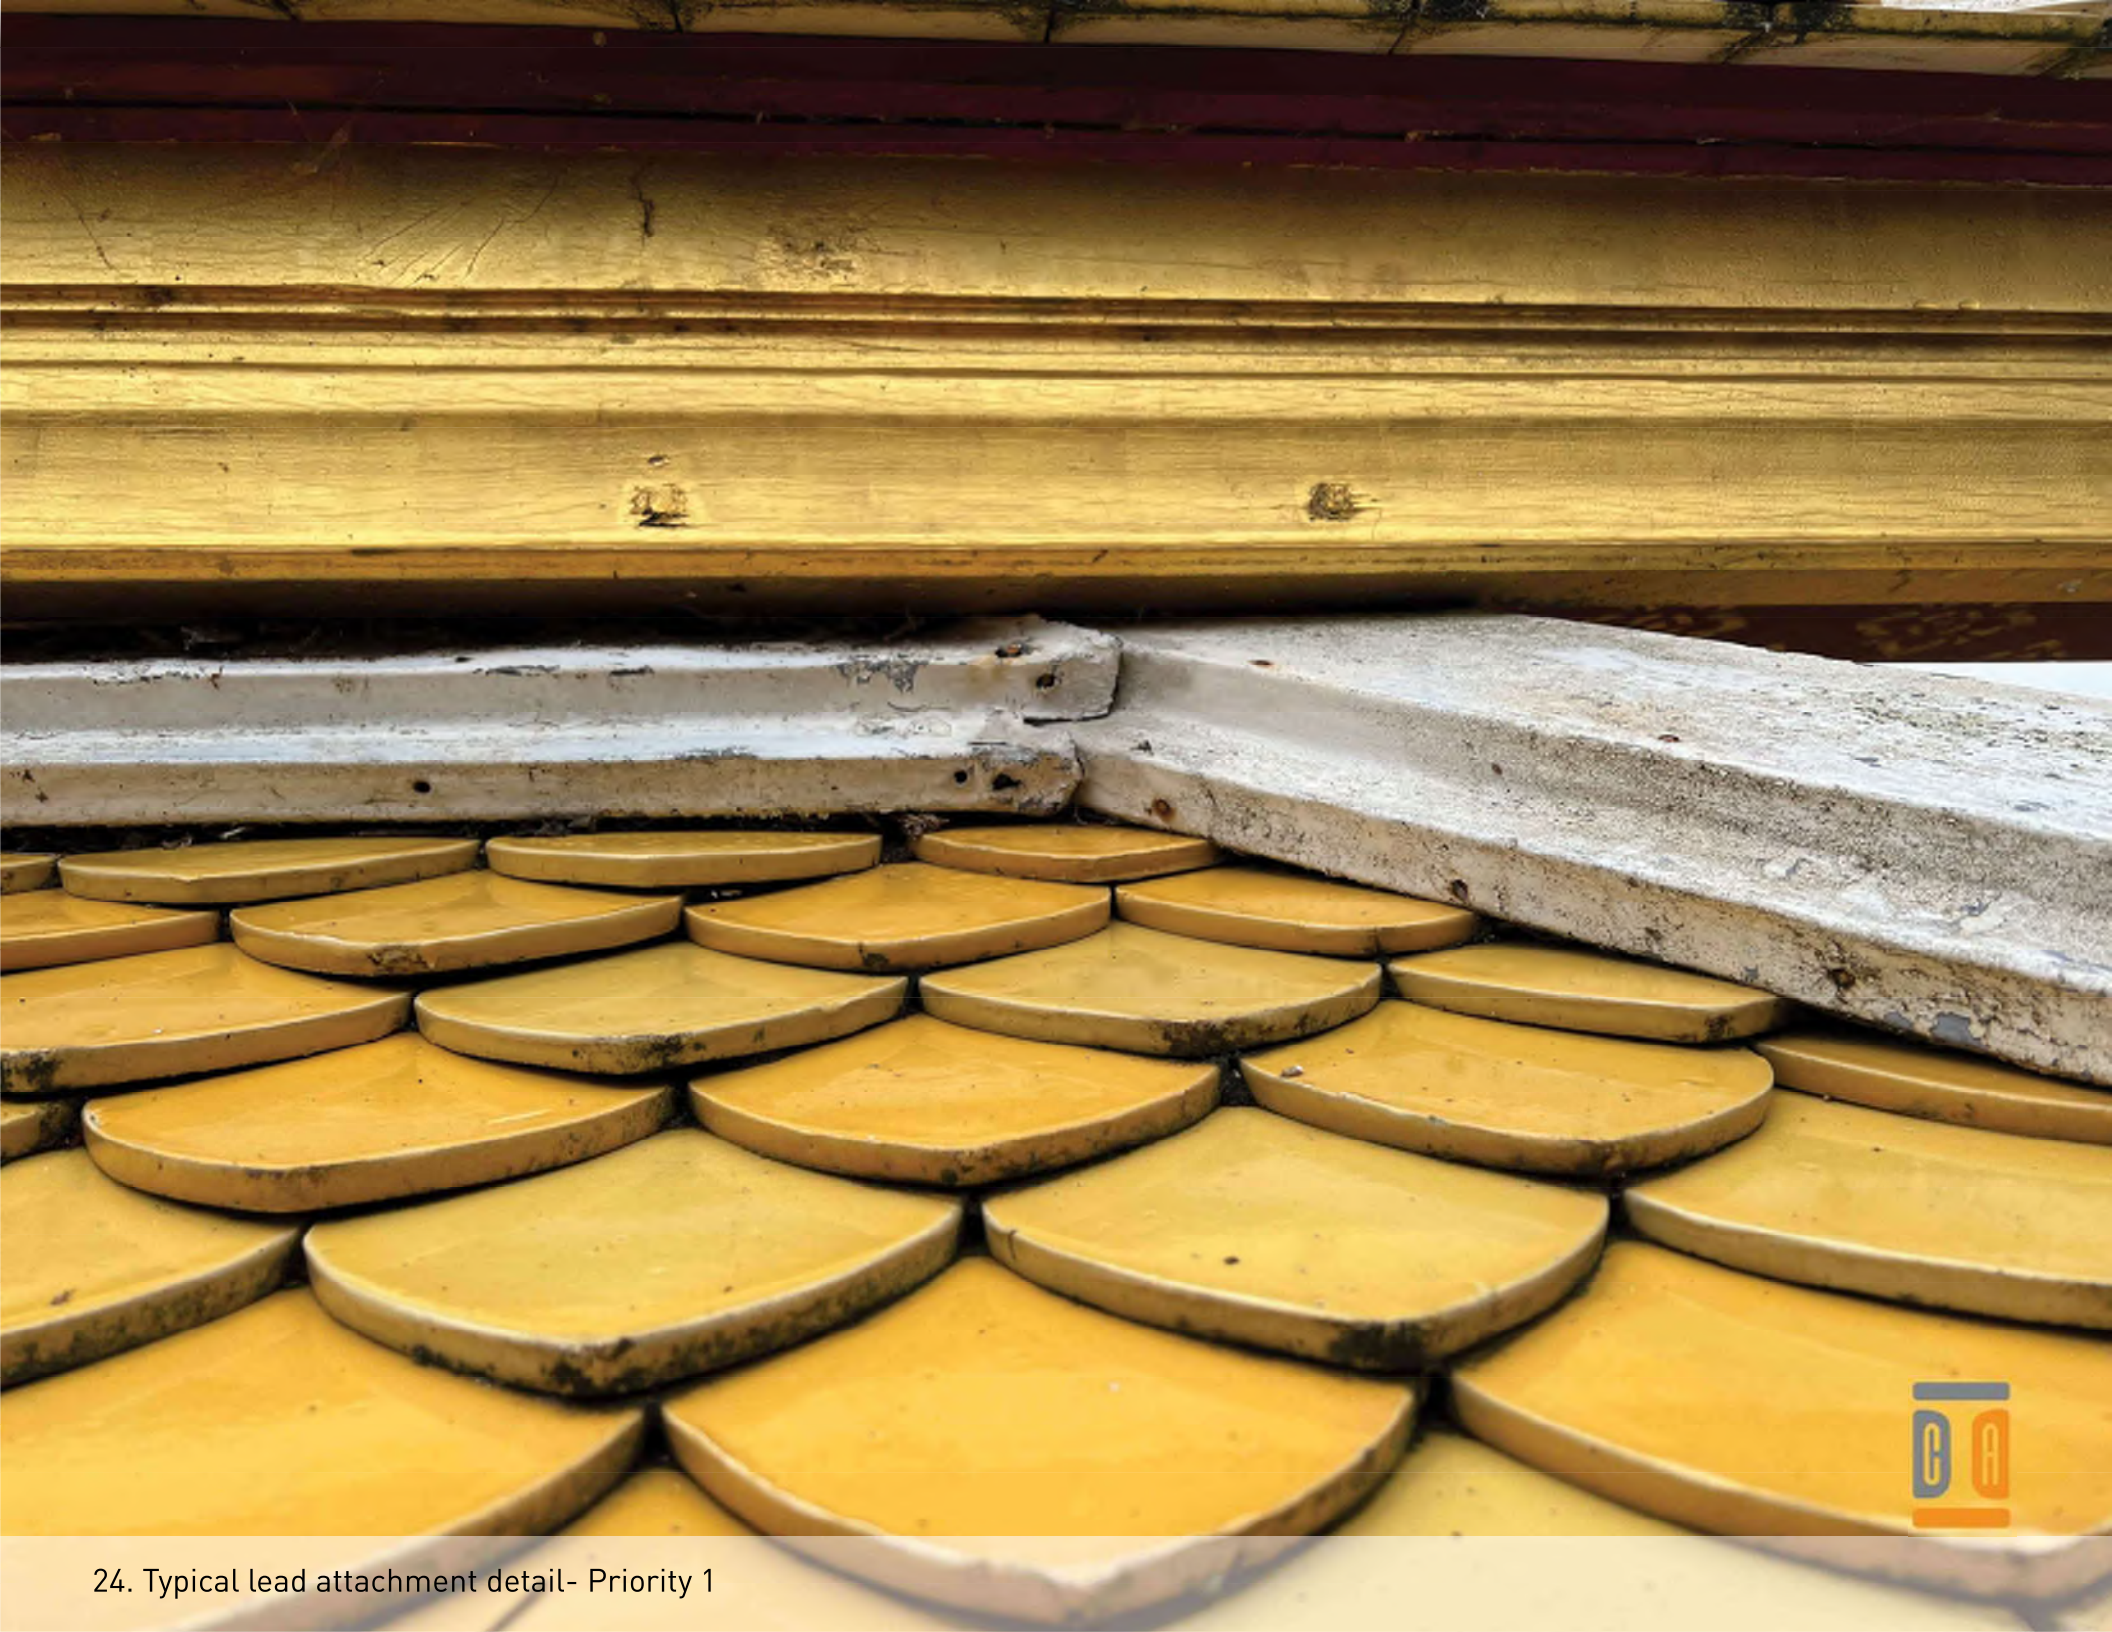
24. Typical lead attachment detail- Priority 1

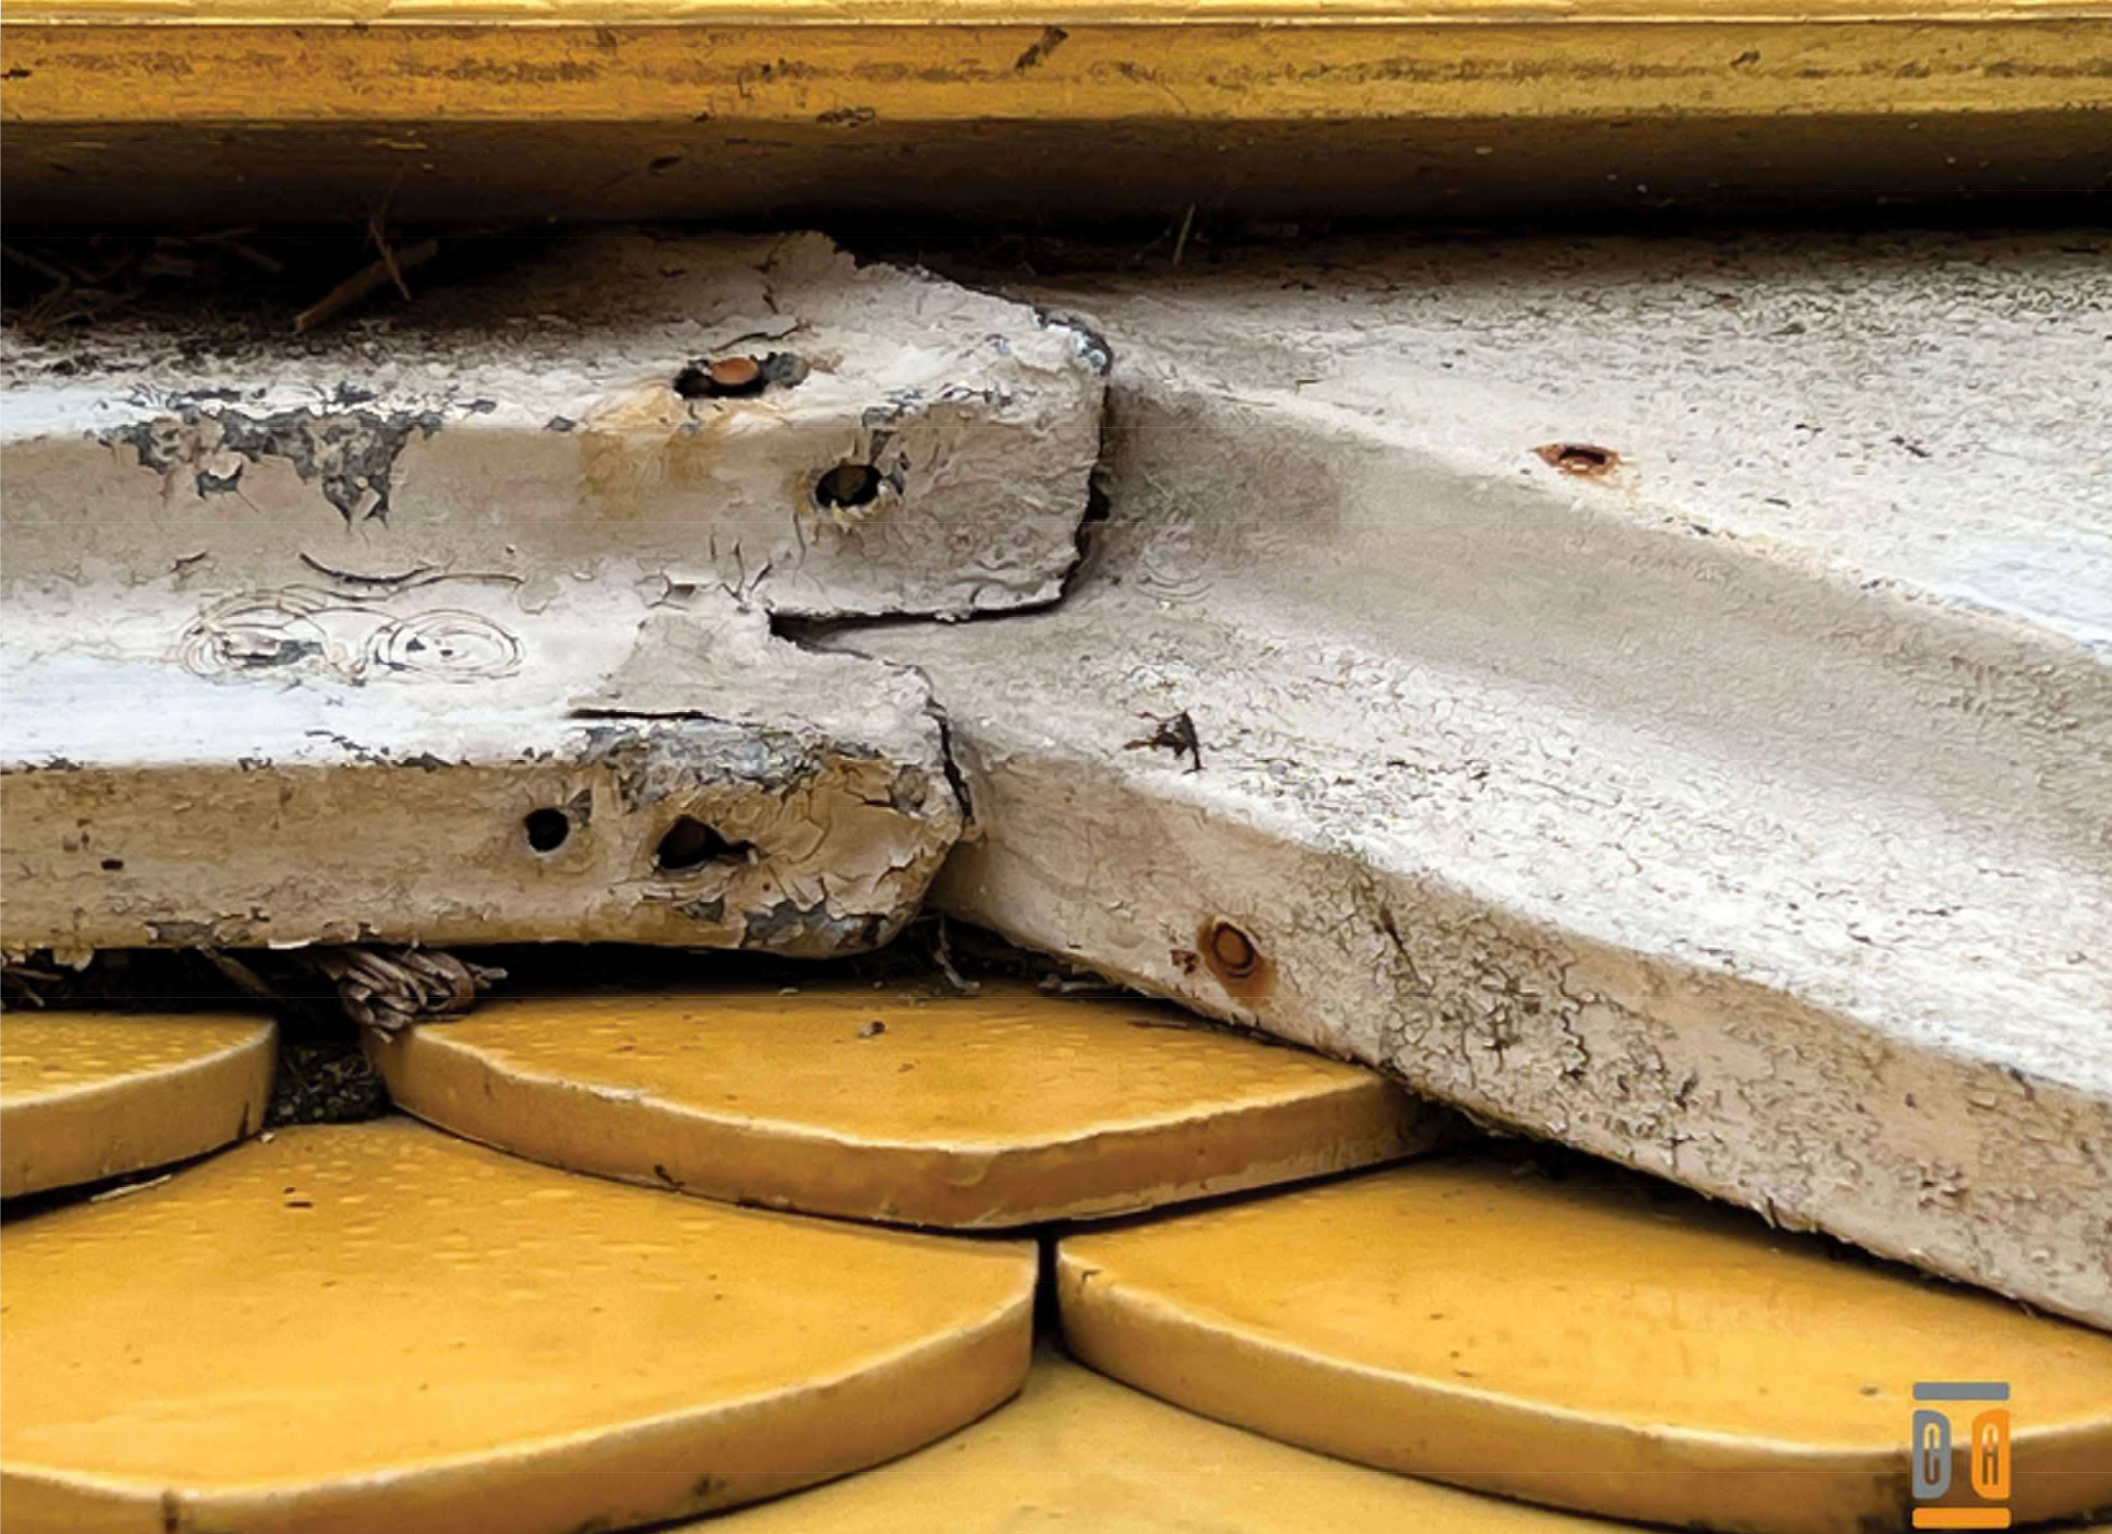
25. Close-up at intersecting lead - Priority 1

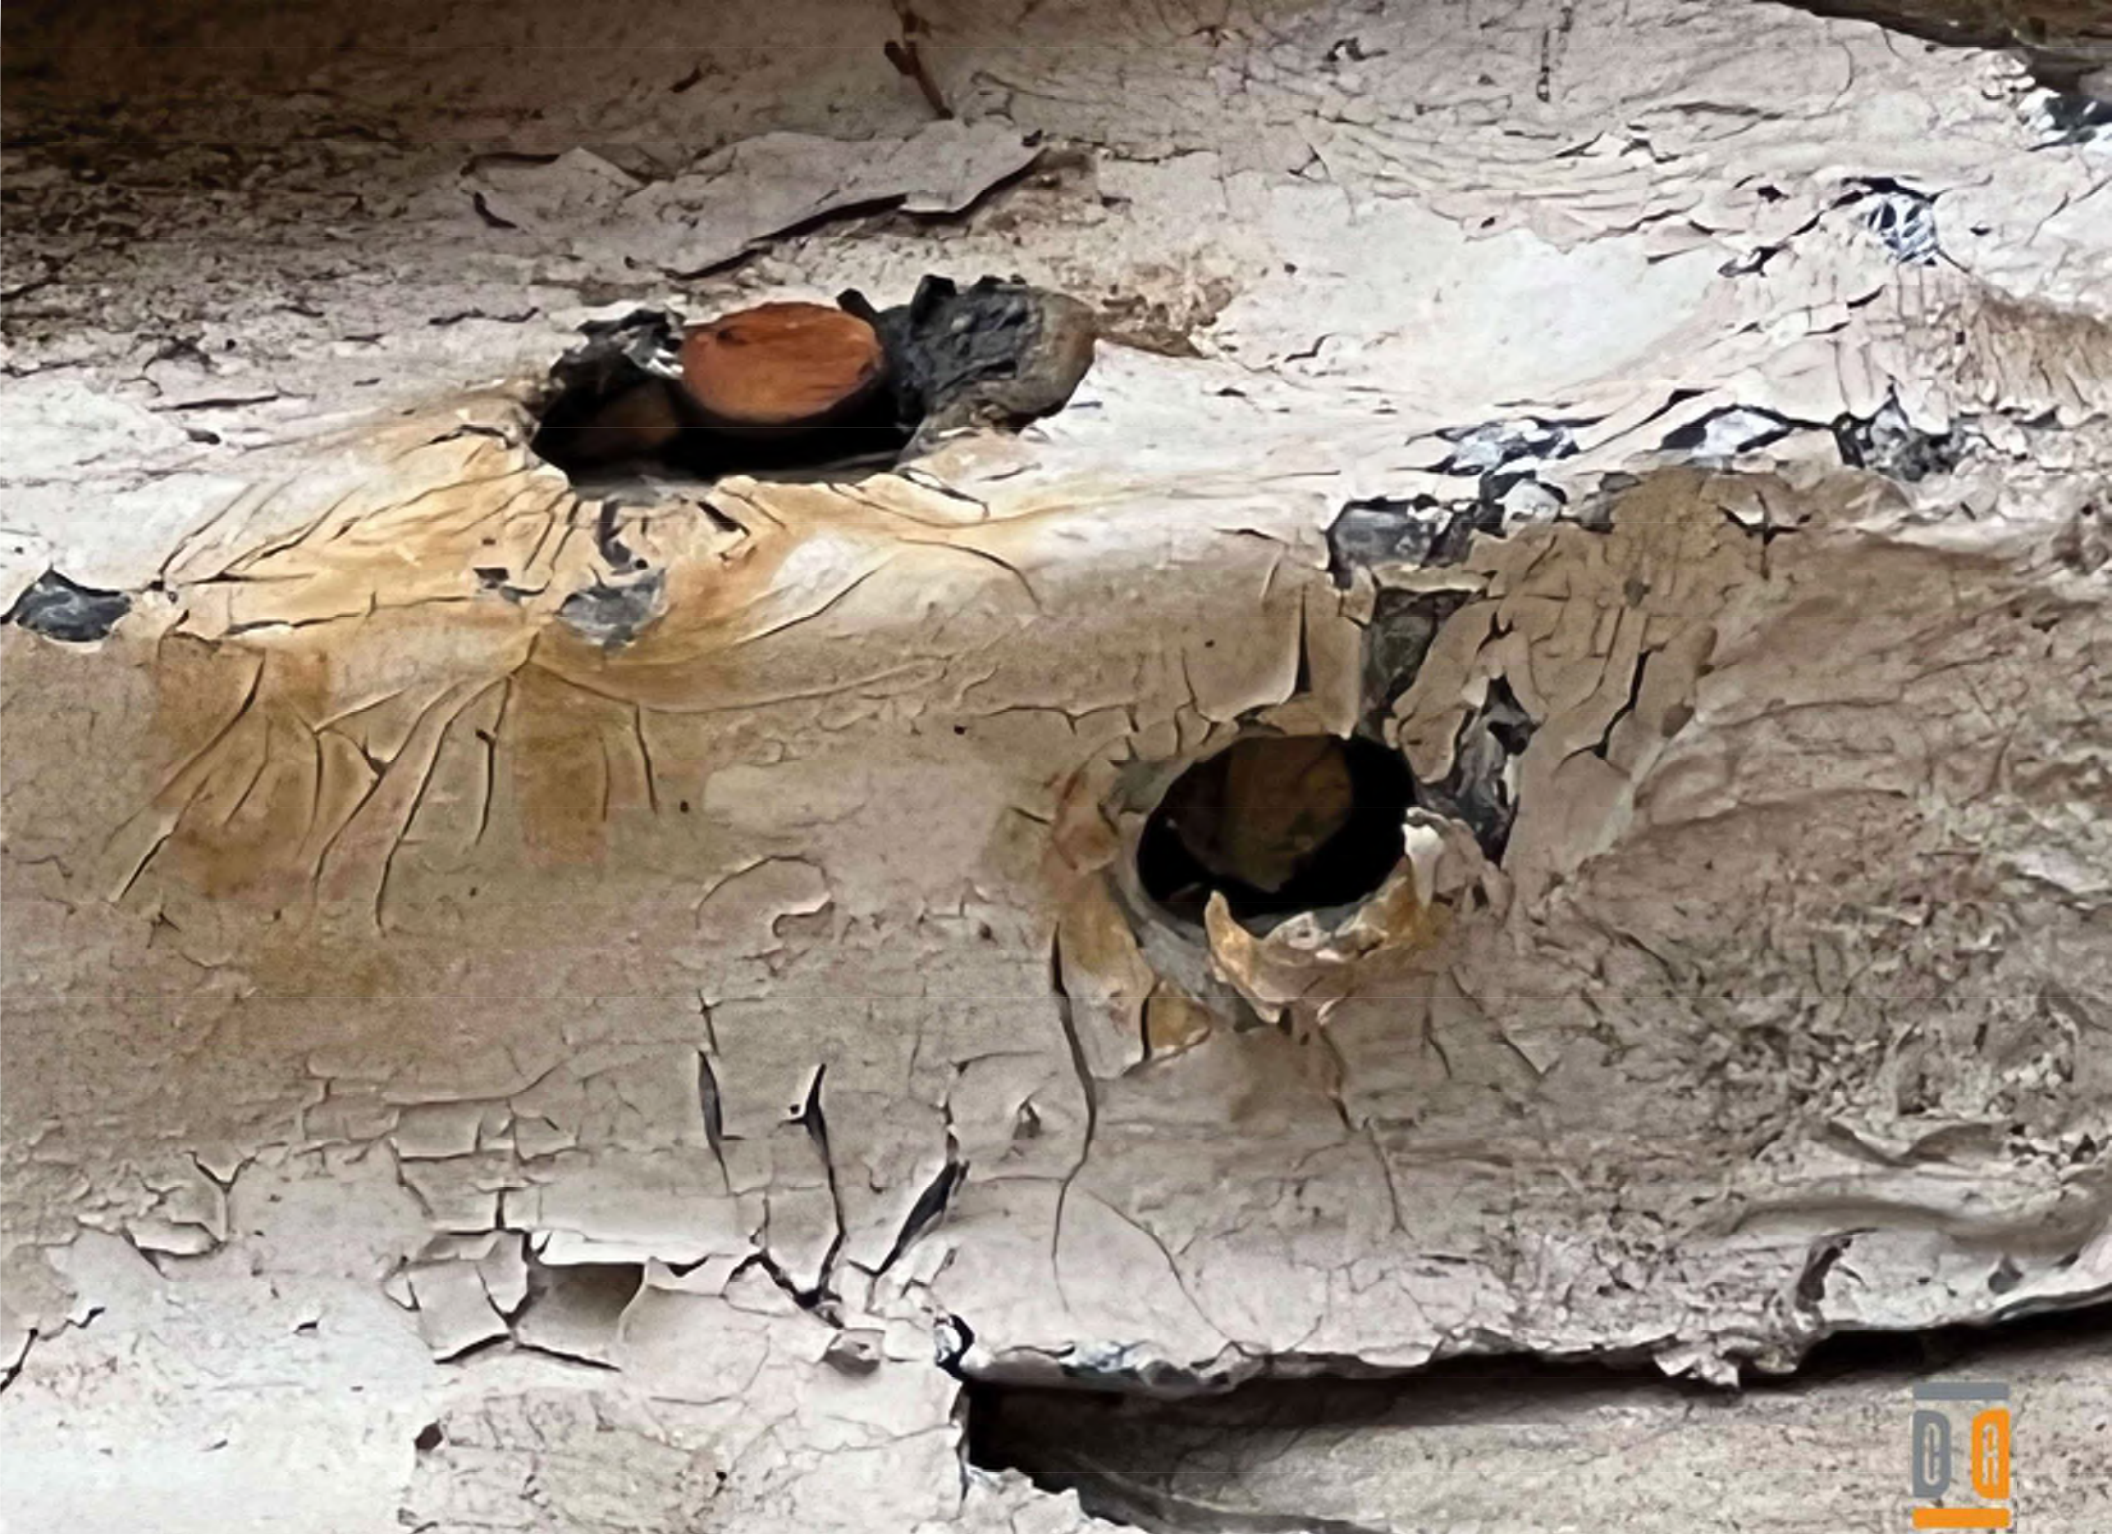
26. Failure as lead – galvanic cell oxidation failure - Priority 1
