OLBRICH BOTANICAL GARDENS ROYAL THAI PAVILION CONDITION ASSESSMENT REPORT

AUGUST 30, 2022

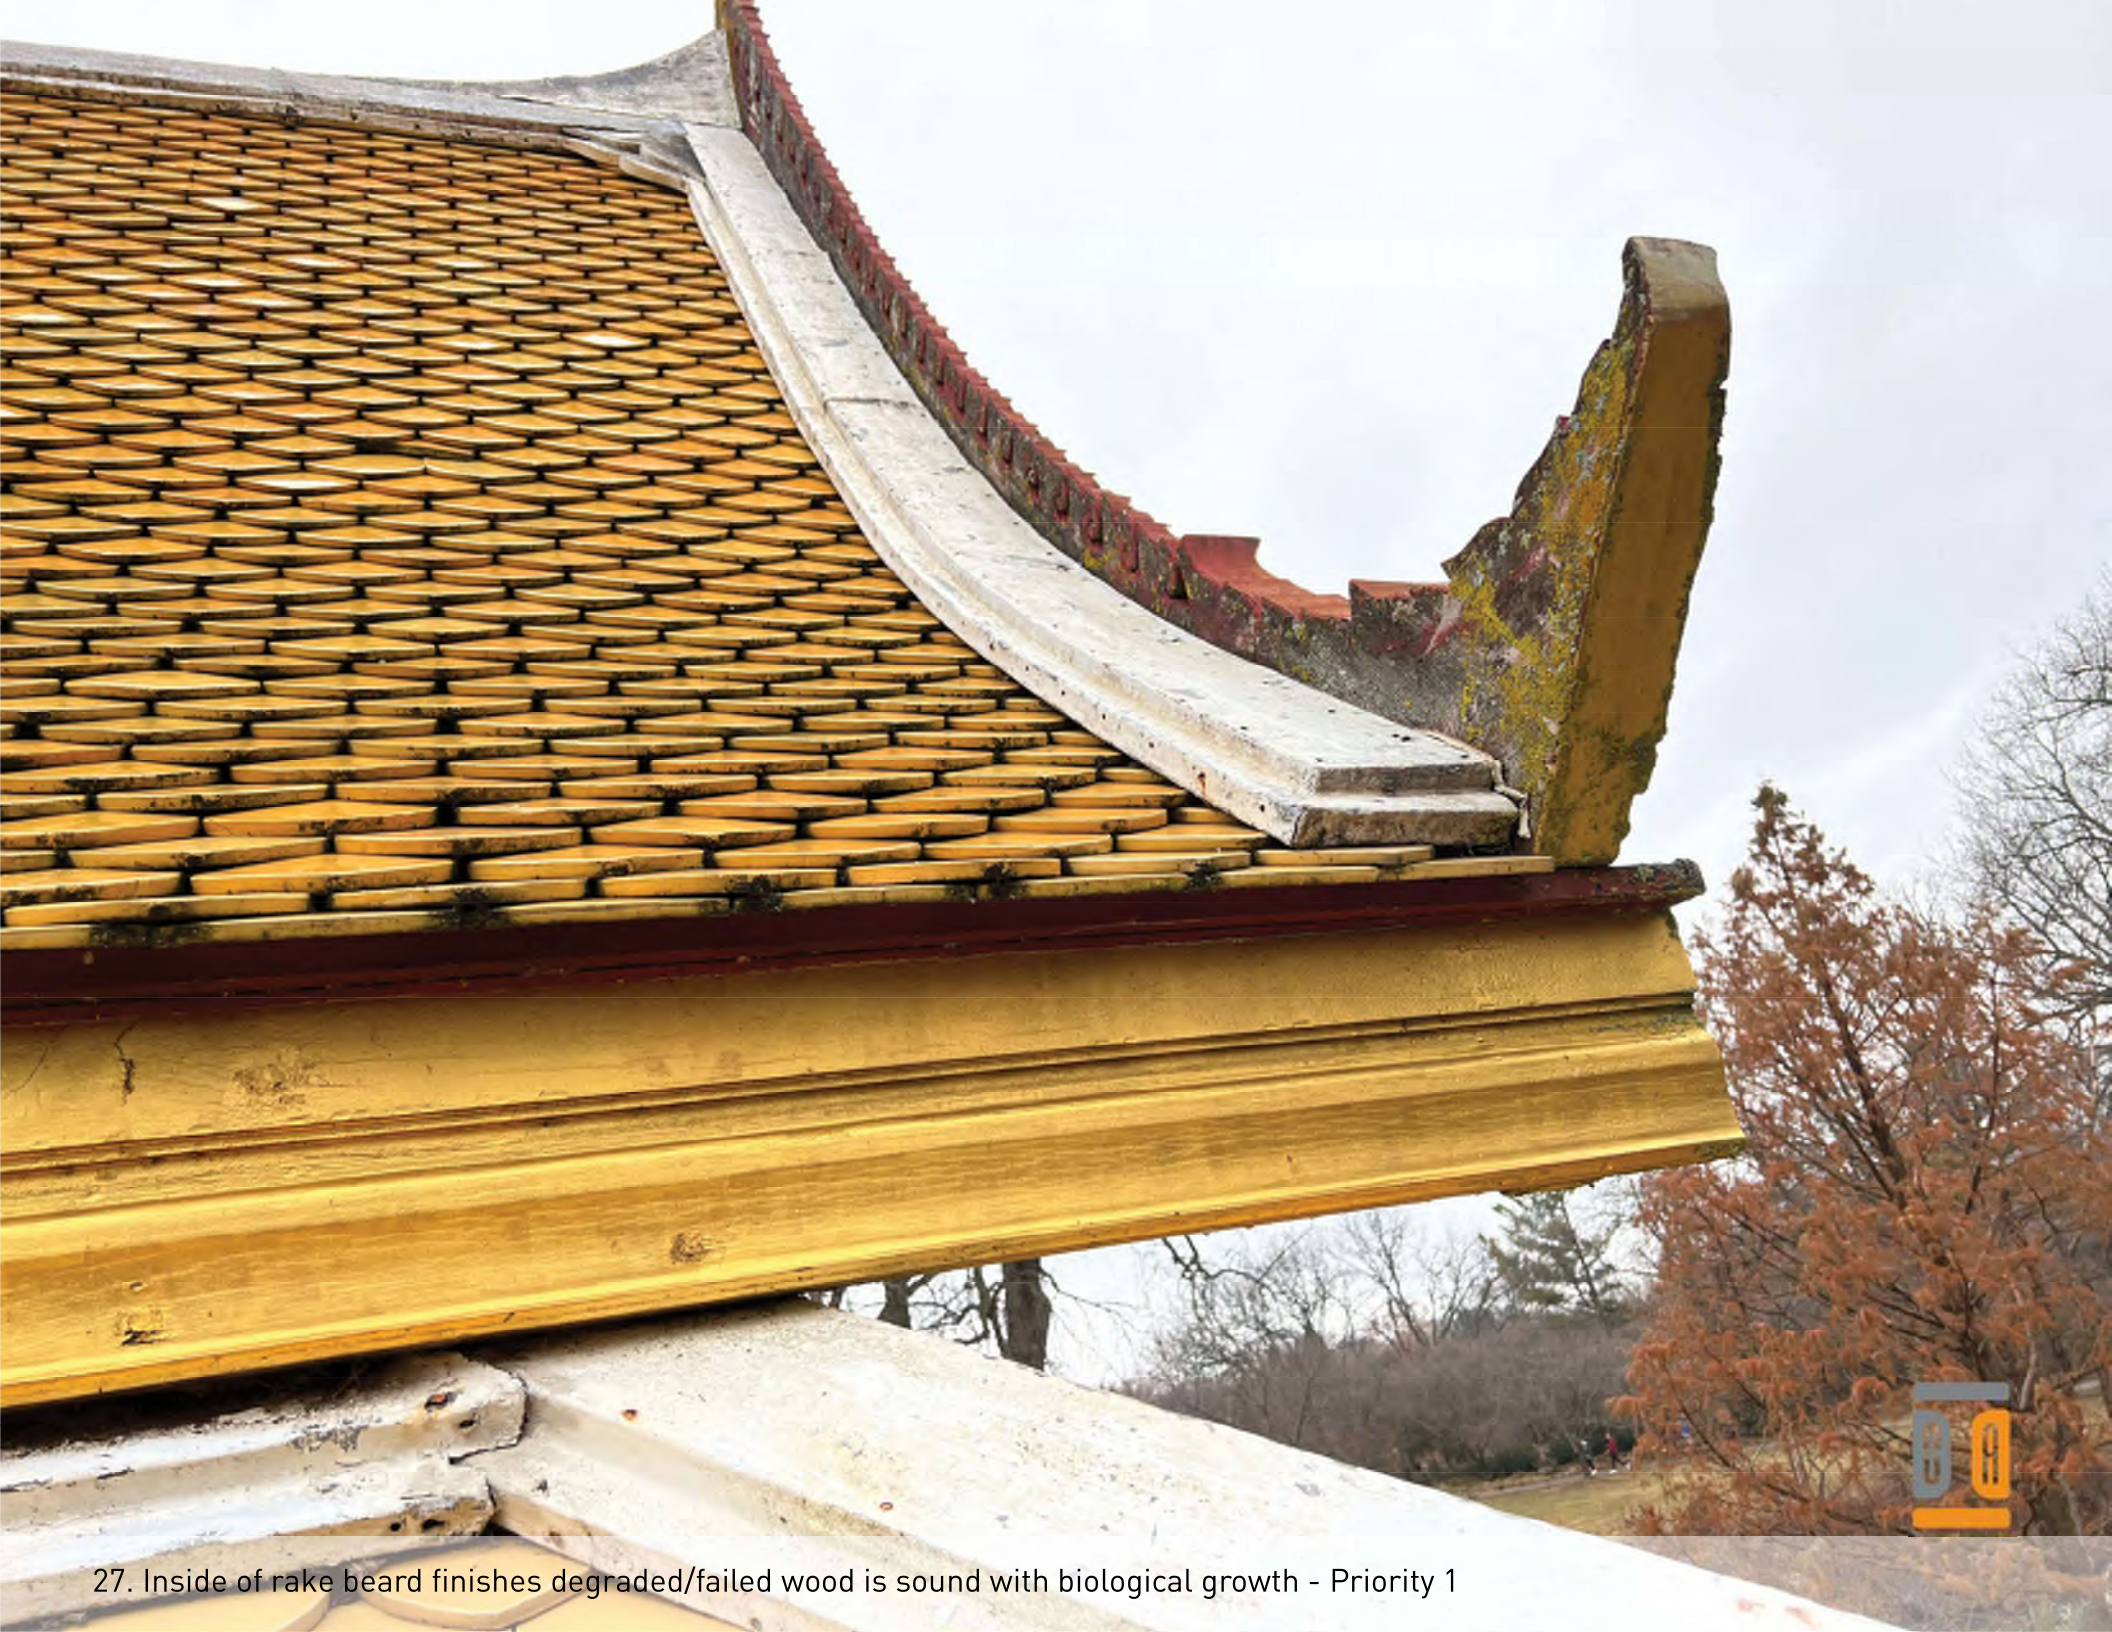
27. Inside of rake beard finishes degraded/failed wood is sound with biological growth - Priority 1

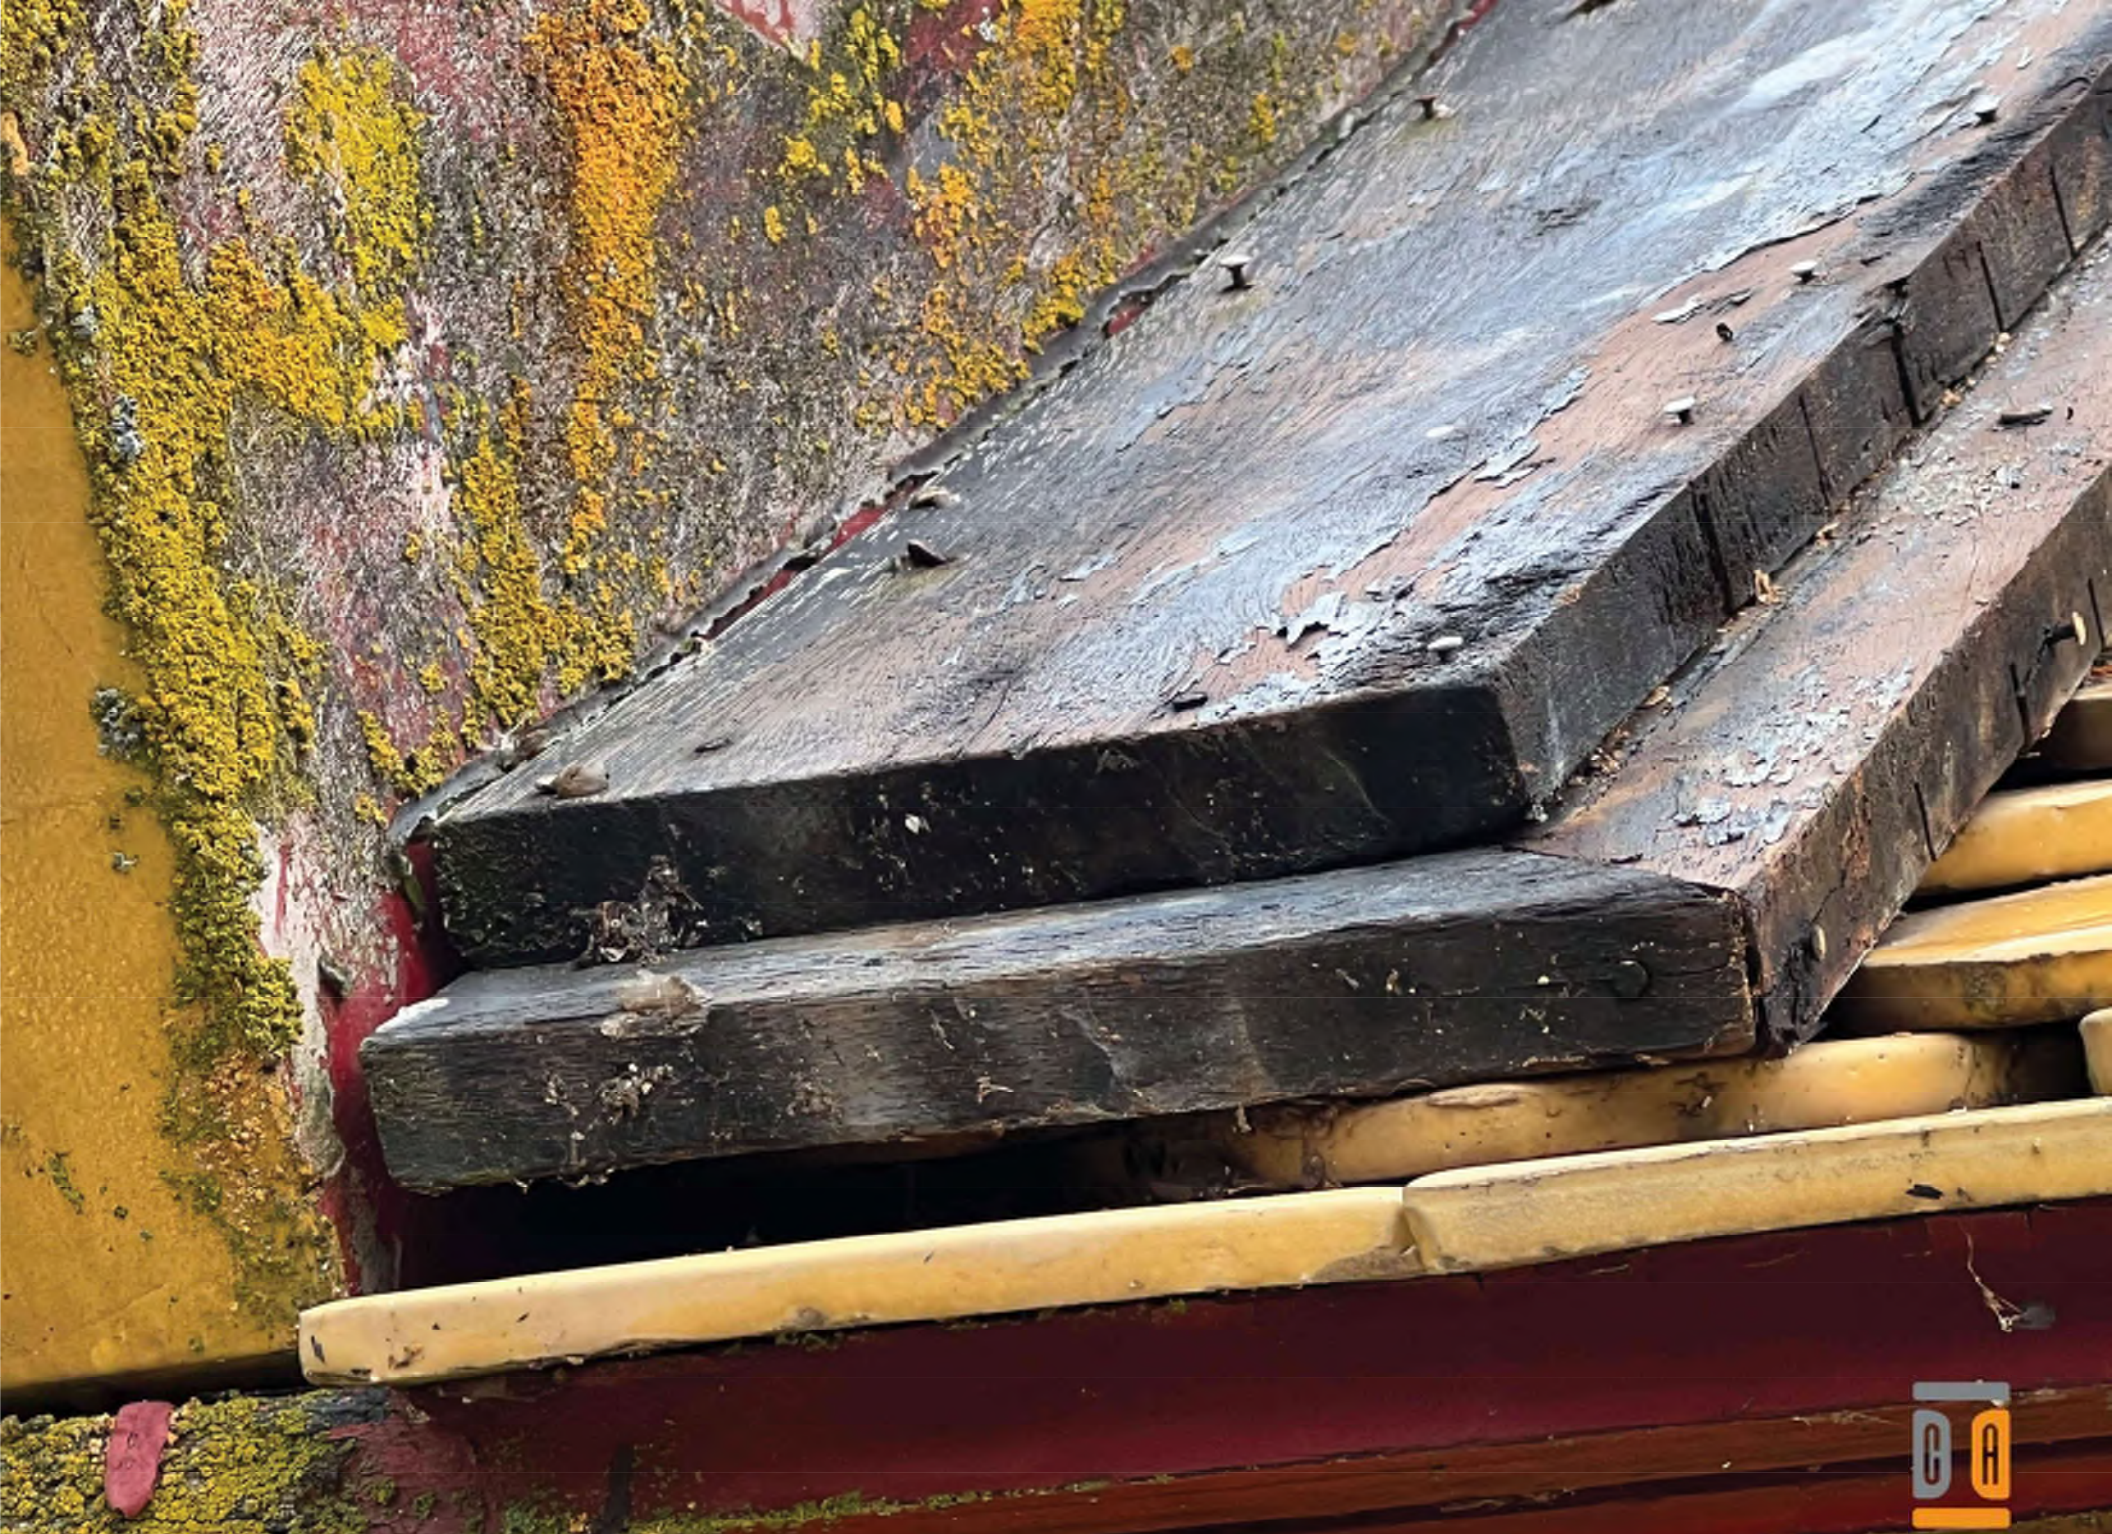
28. Batten boards at rake close-up, leads are gone, finishes failed wood is sound, and biological growth - Priority 1

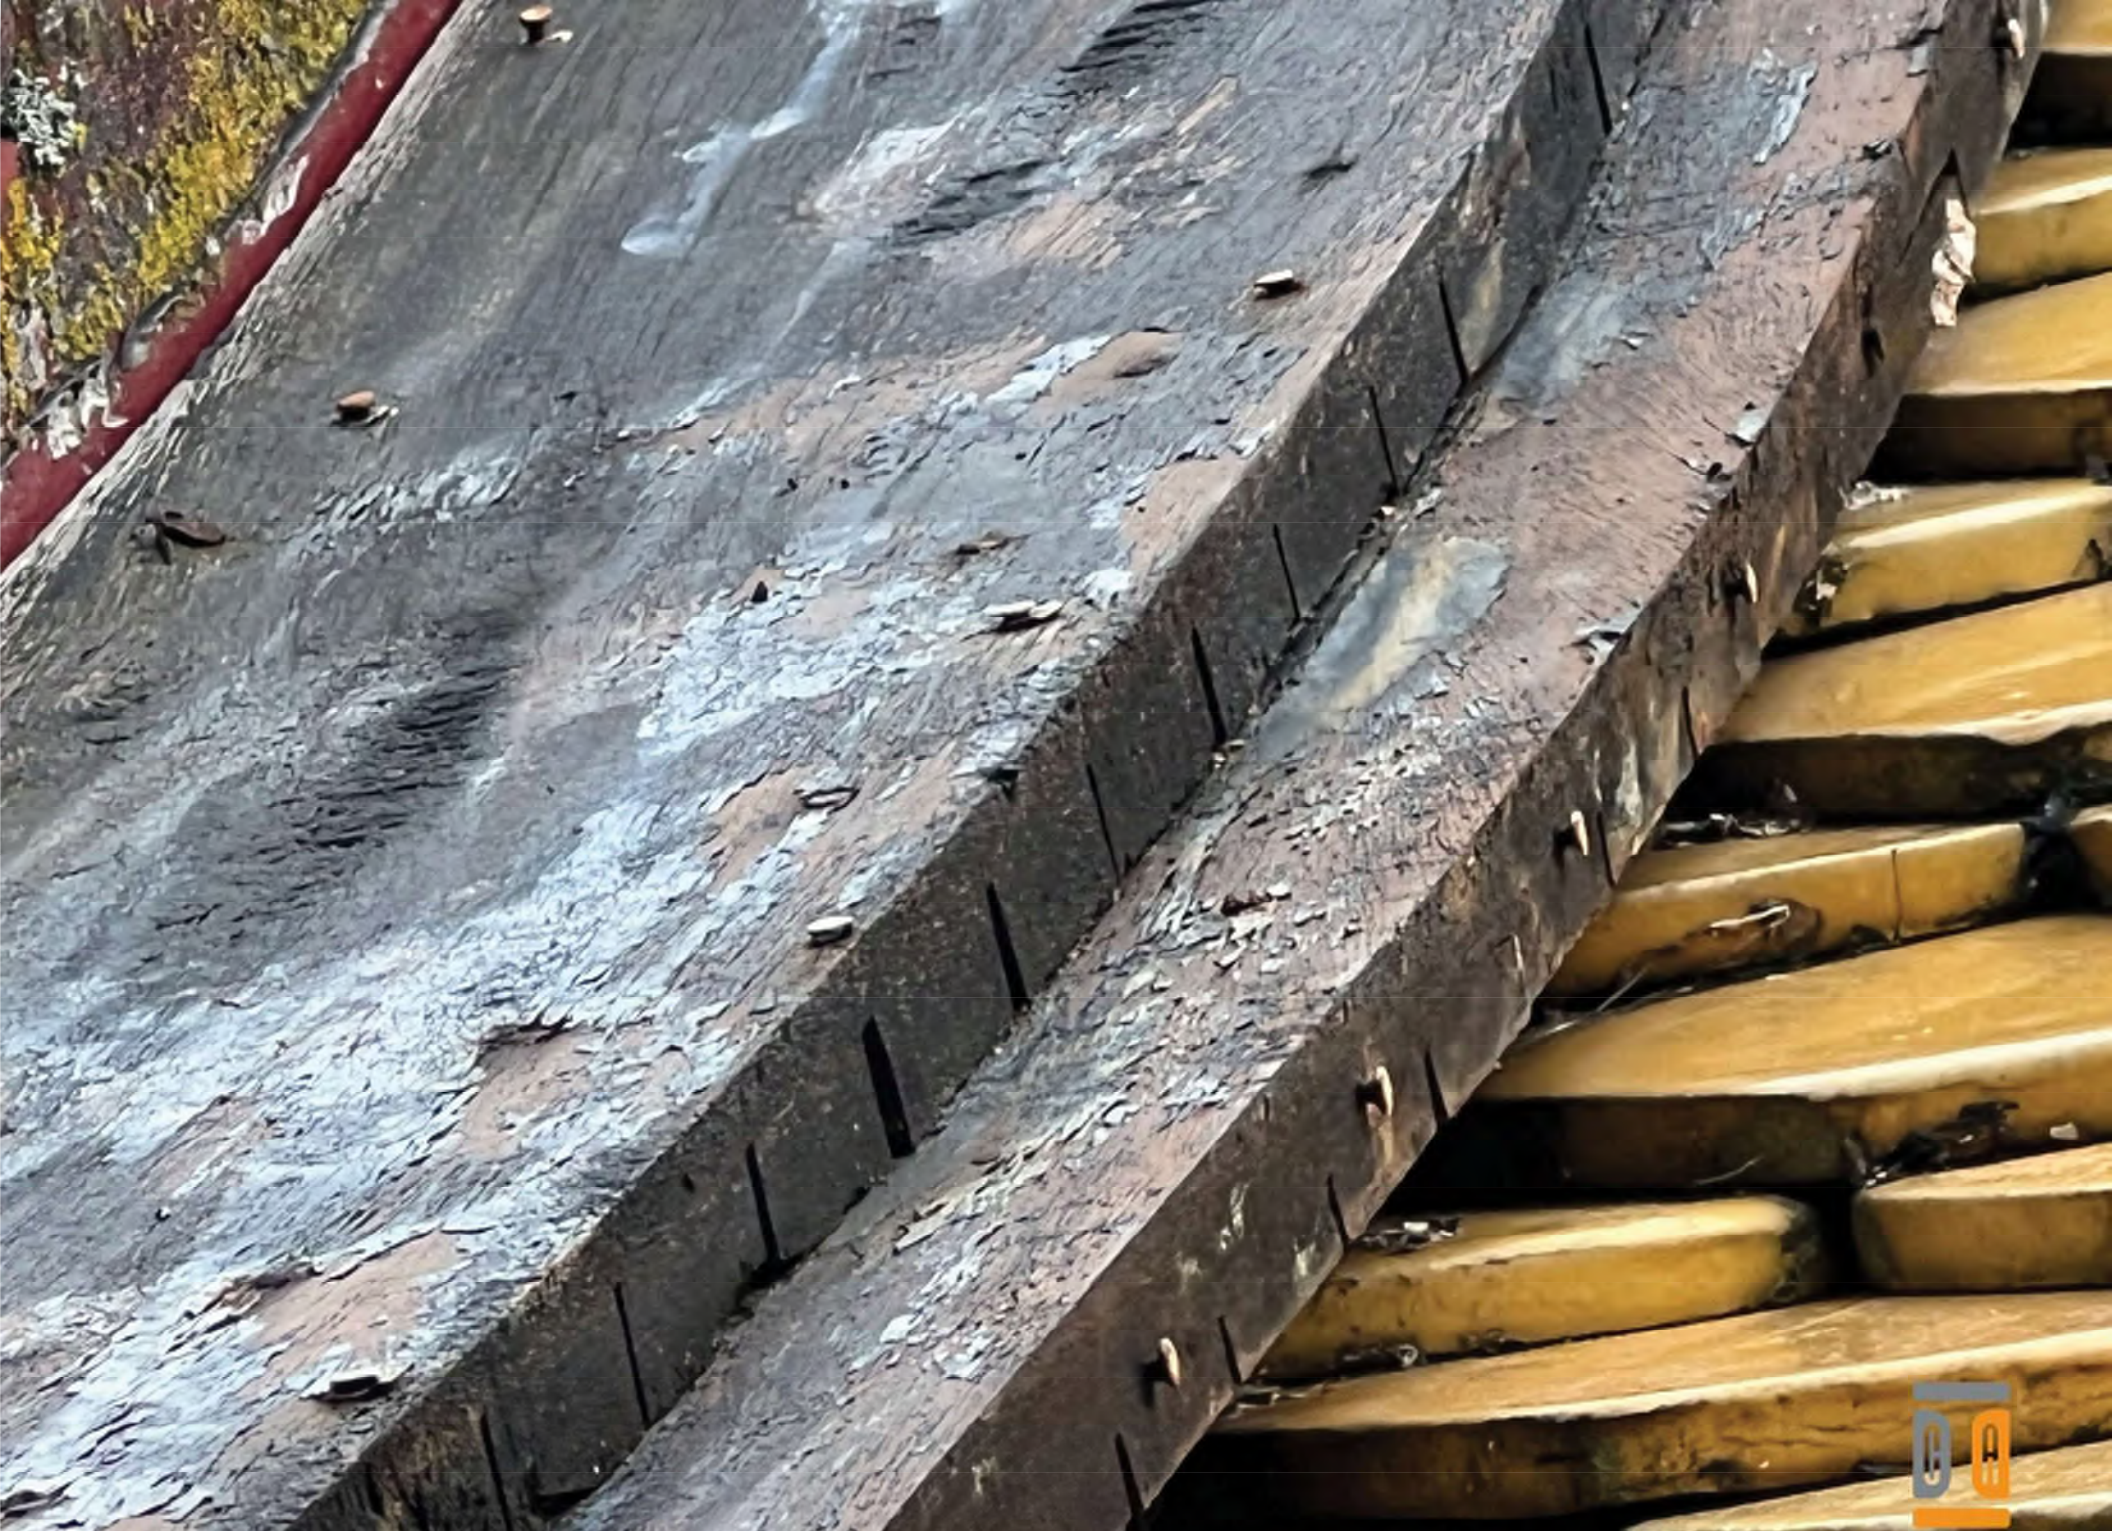
29. Batter boards at rake close-up, leads are gone, finishes failed wood is sound, note kerfs in sweat batter board and note failed coating - Priority 1

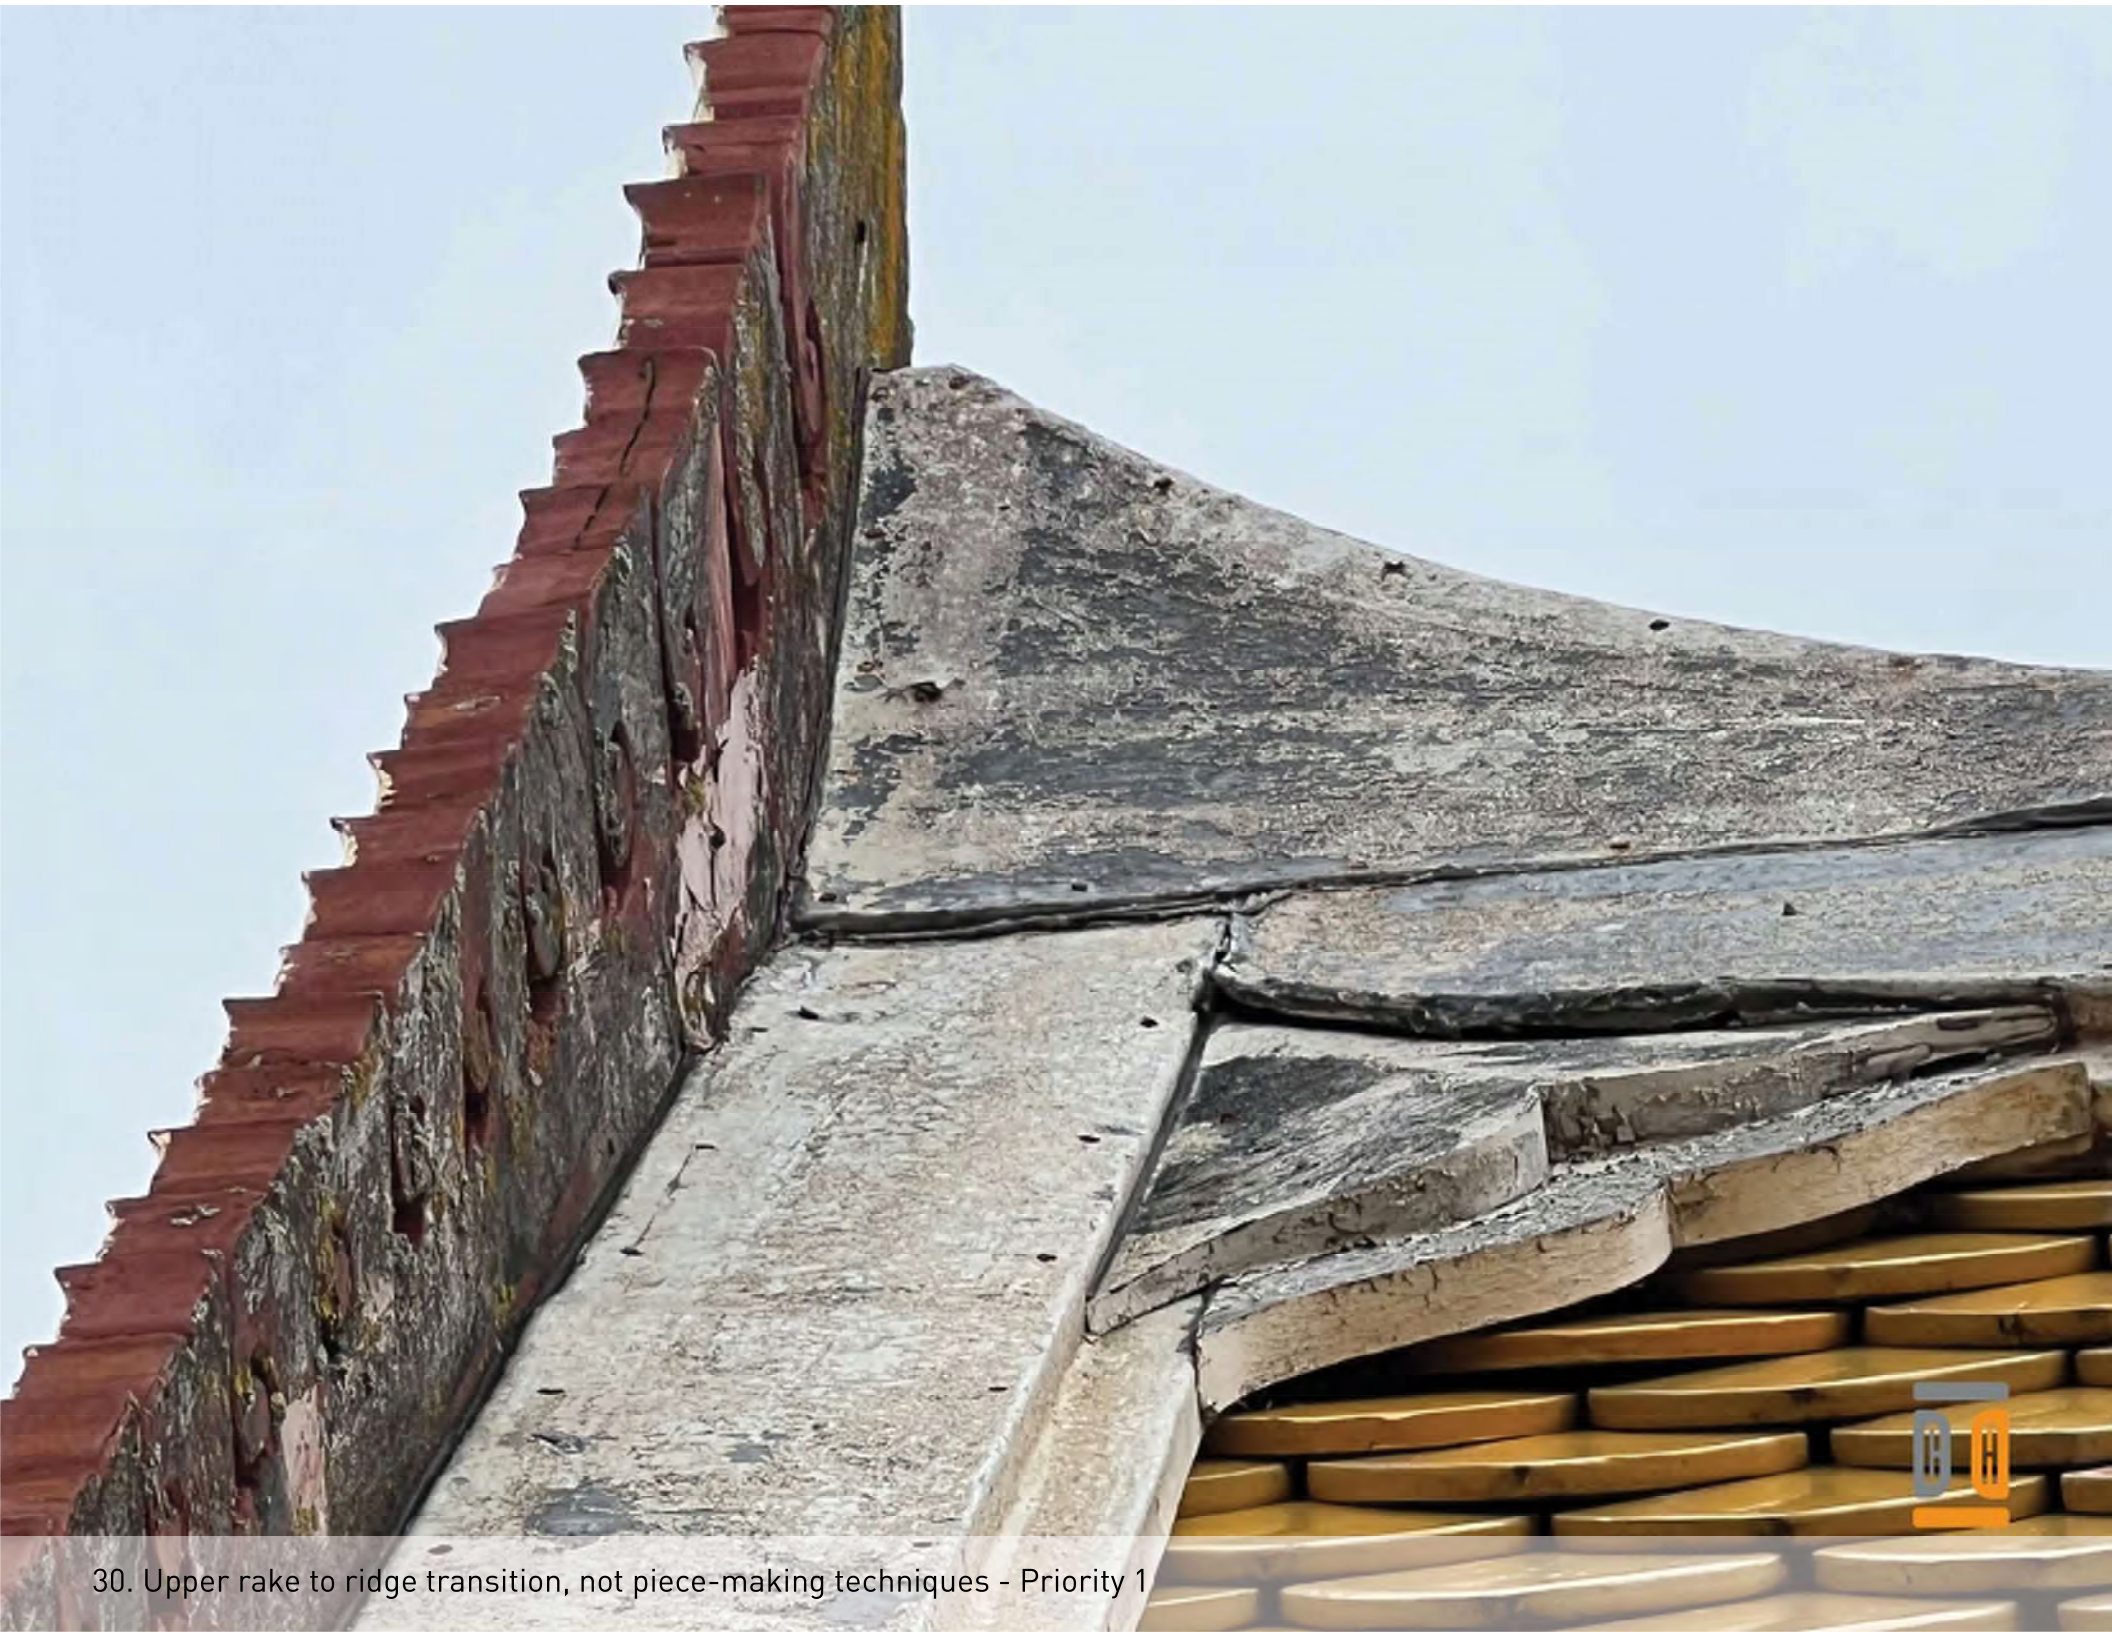
30. Upper rake to ridge transition, not piece-making techniques - Priority 1

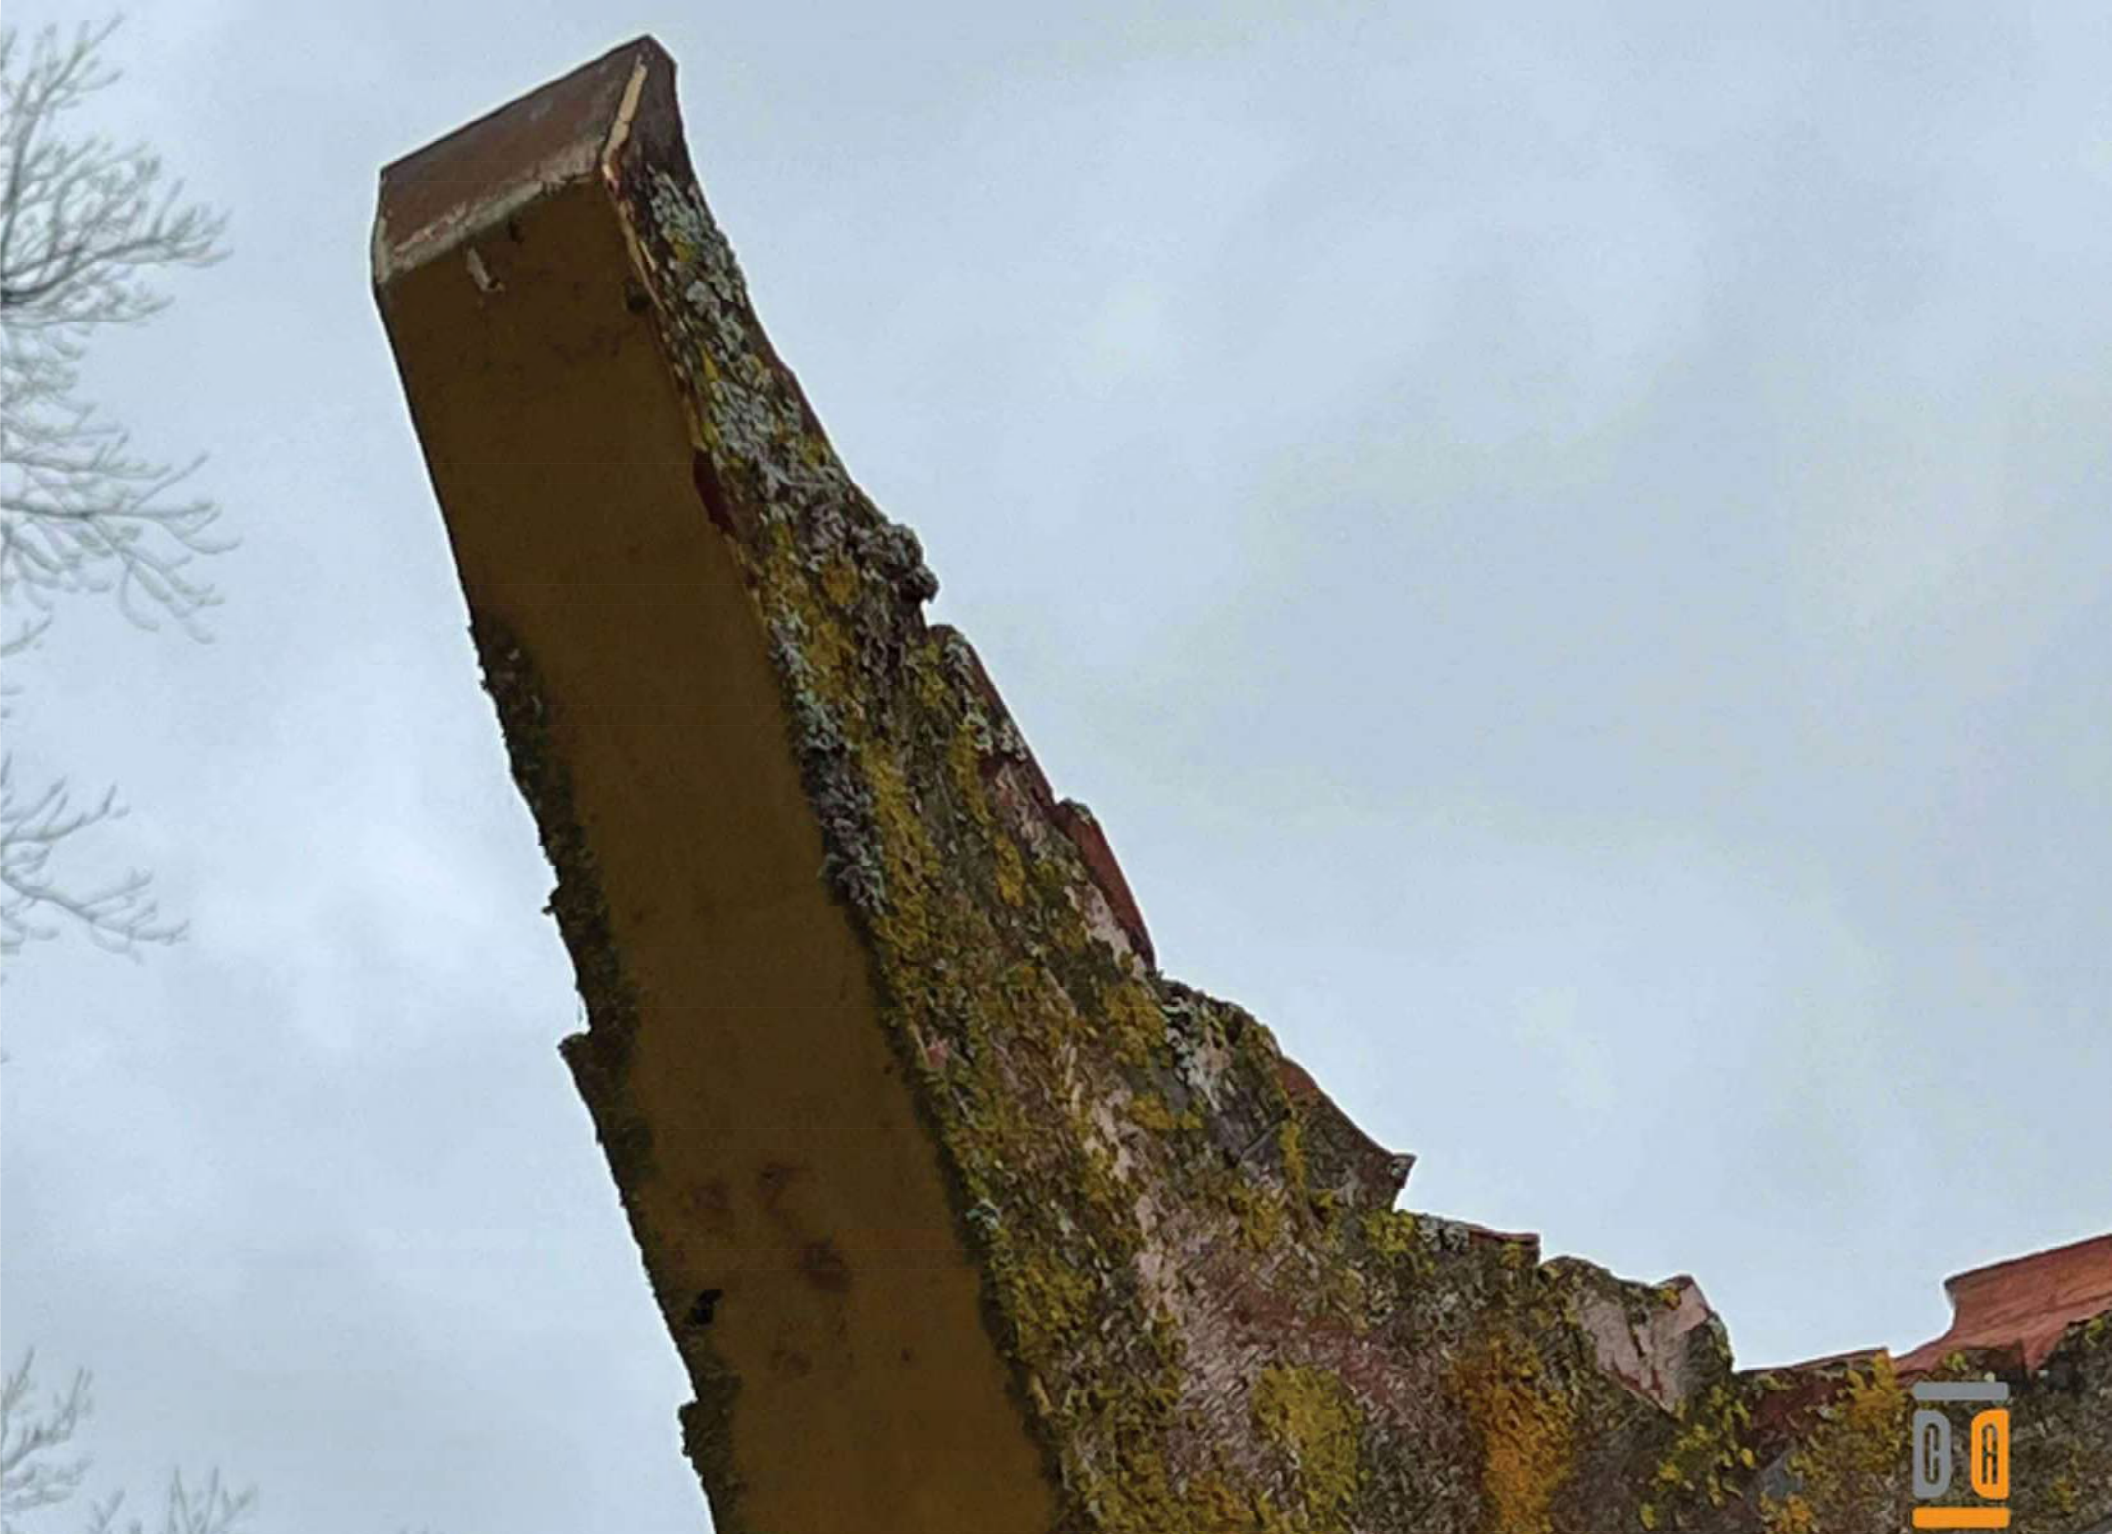
31. Batter boards at rake close-up leads are gone, finishes failed, biological growth, wood is sound - Priority 1

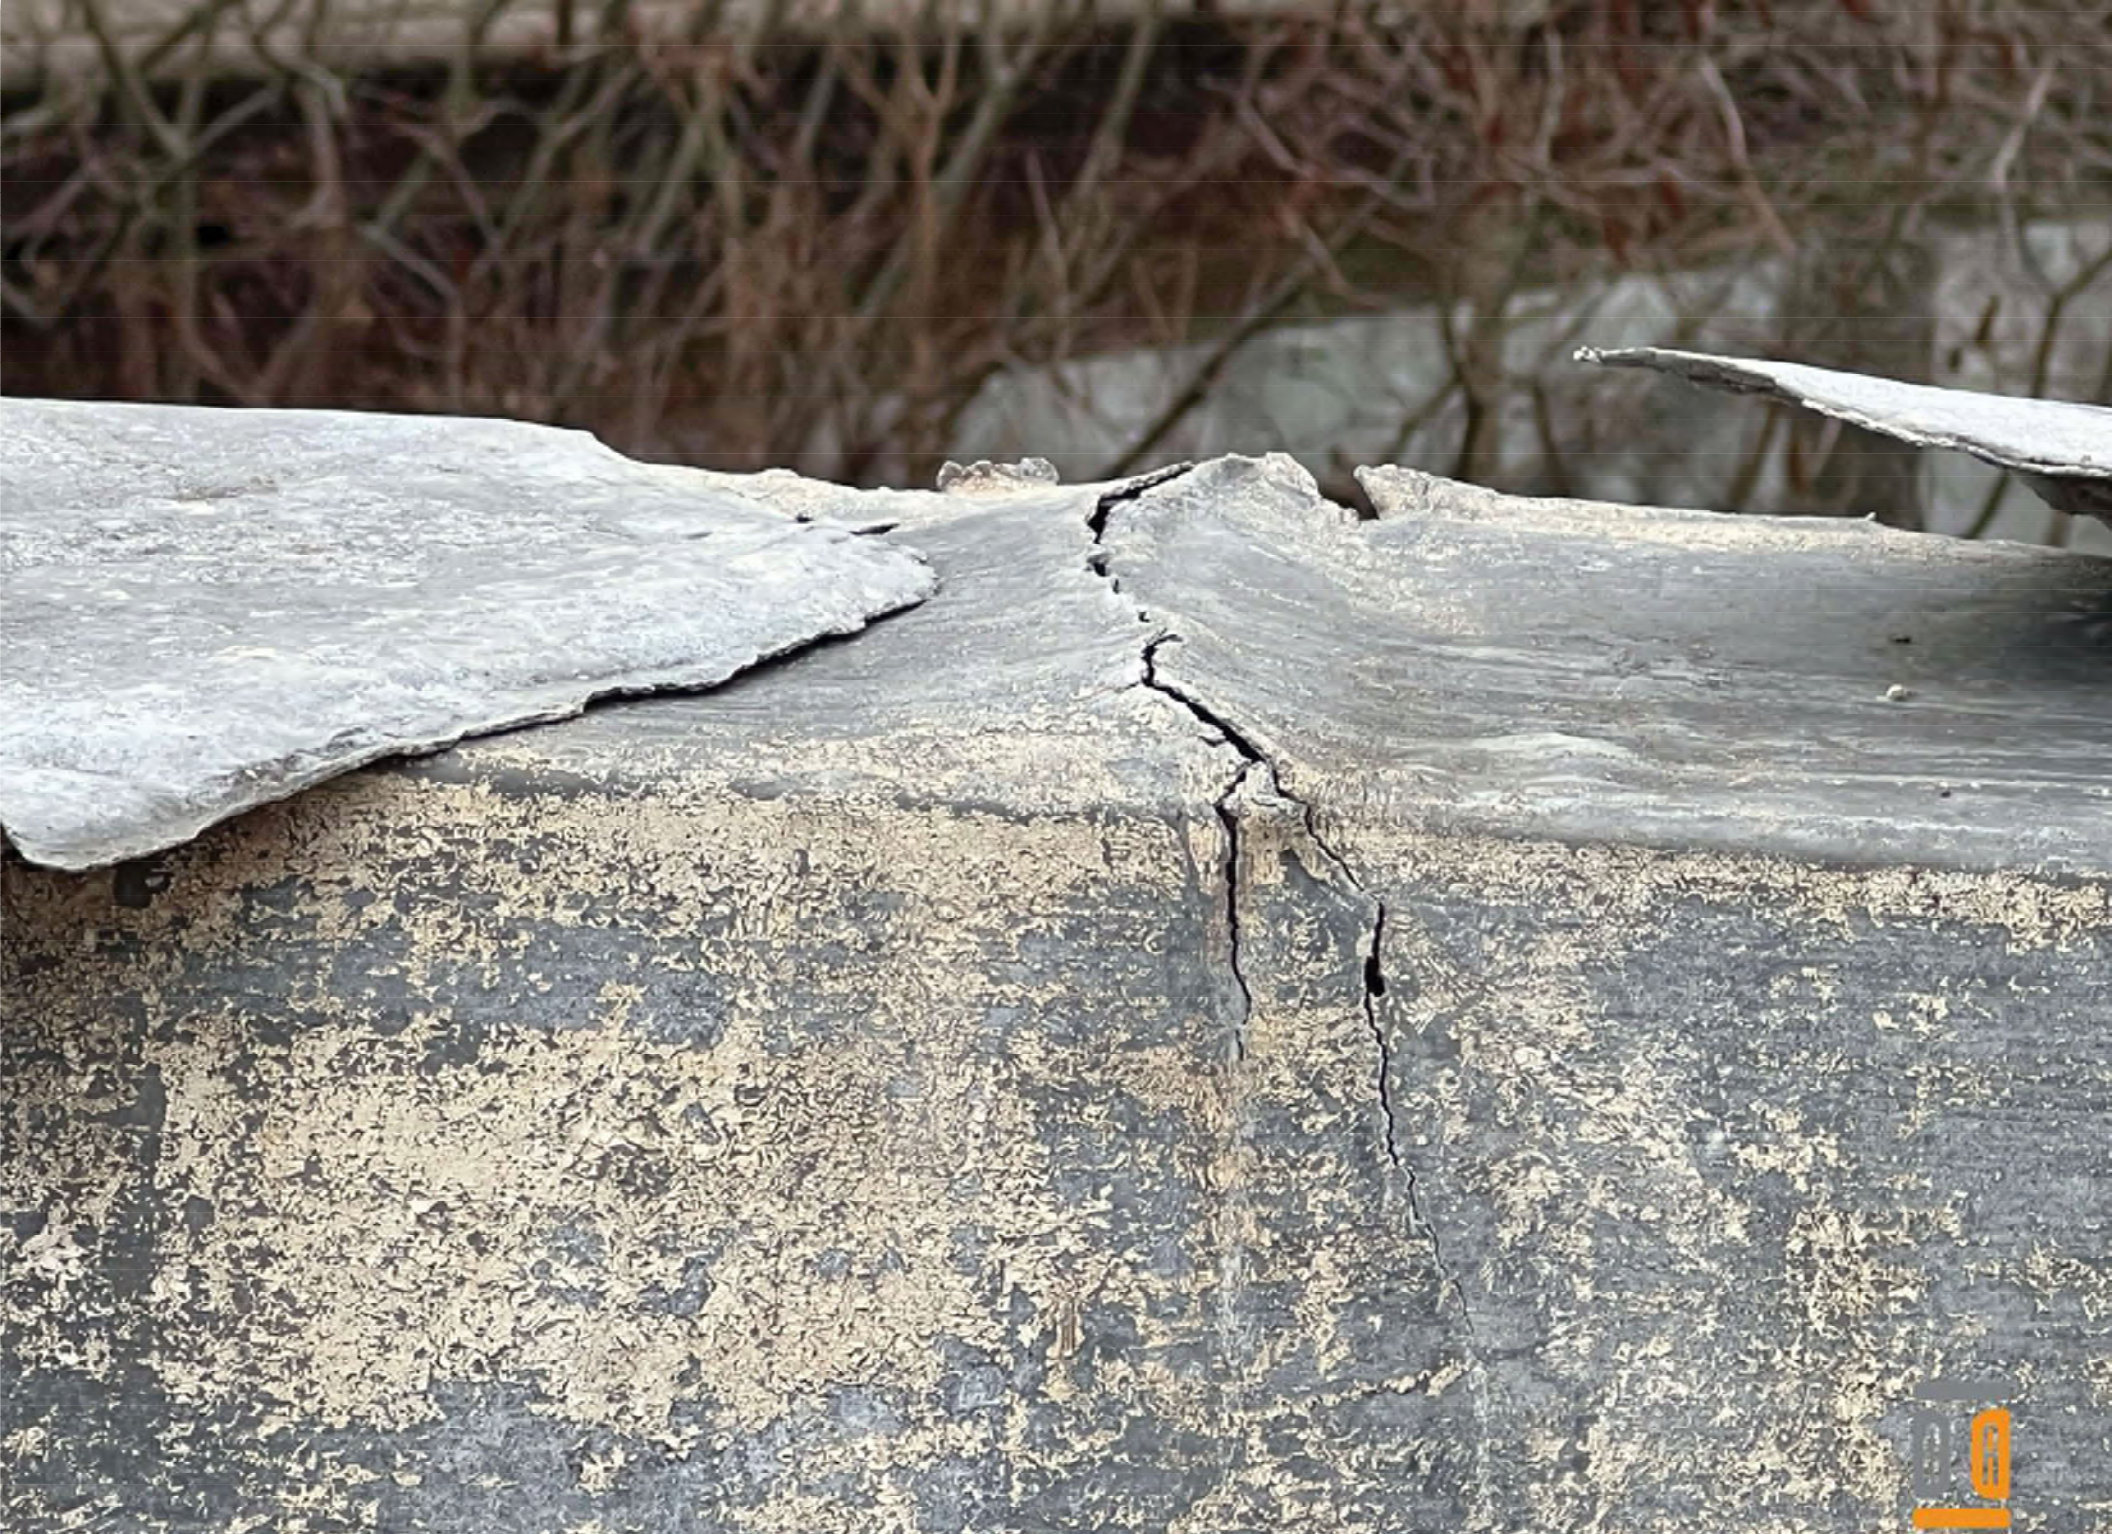
32. Degraded and fractured lead fasteners failure has led to cyclic fatigue and critical failure - Priority 1

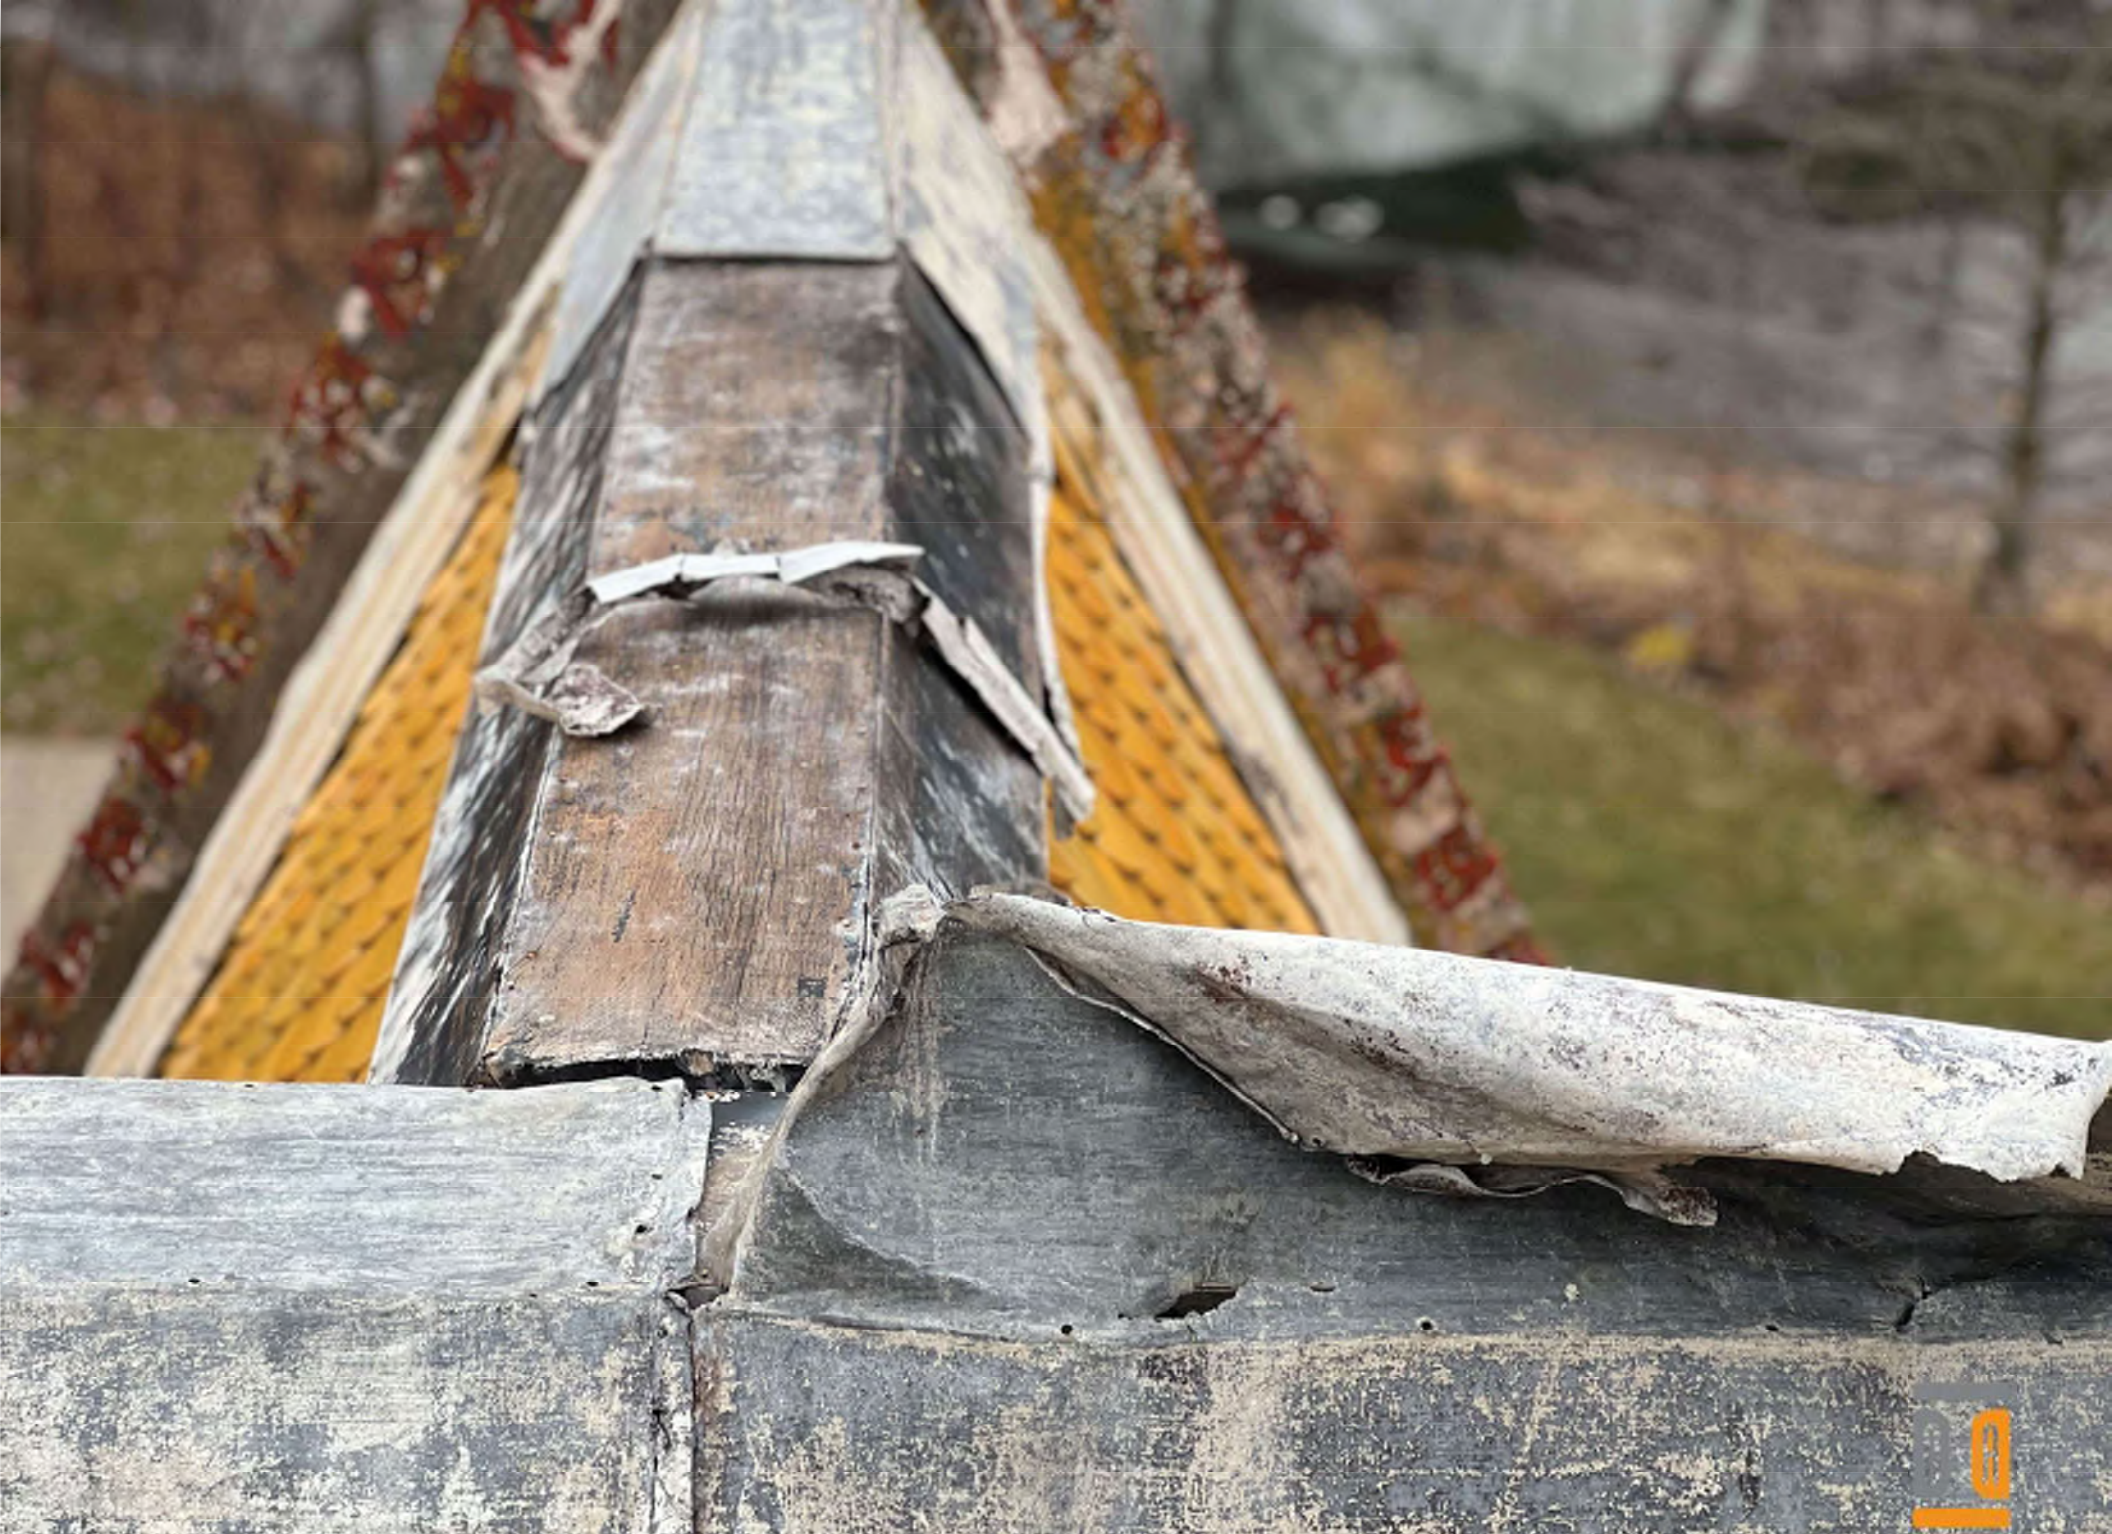
33. Lead failure at intersecting ridges - Priority 1
