OLBRICH BOTANICAL GARDENS ROYAL THAI PAVILION CONDITION ASSESSMENT REPORT

AUGUST 30, 2022

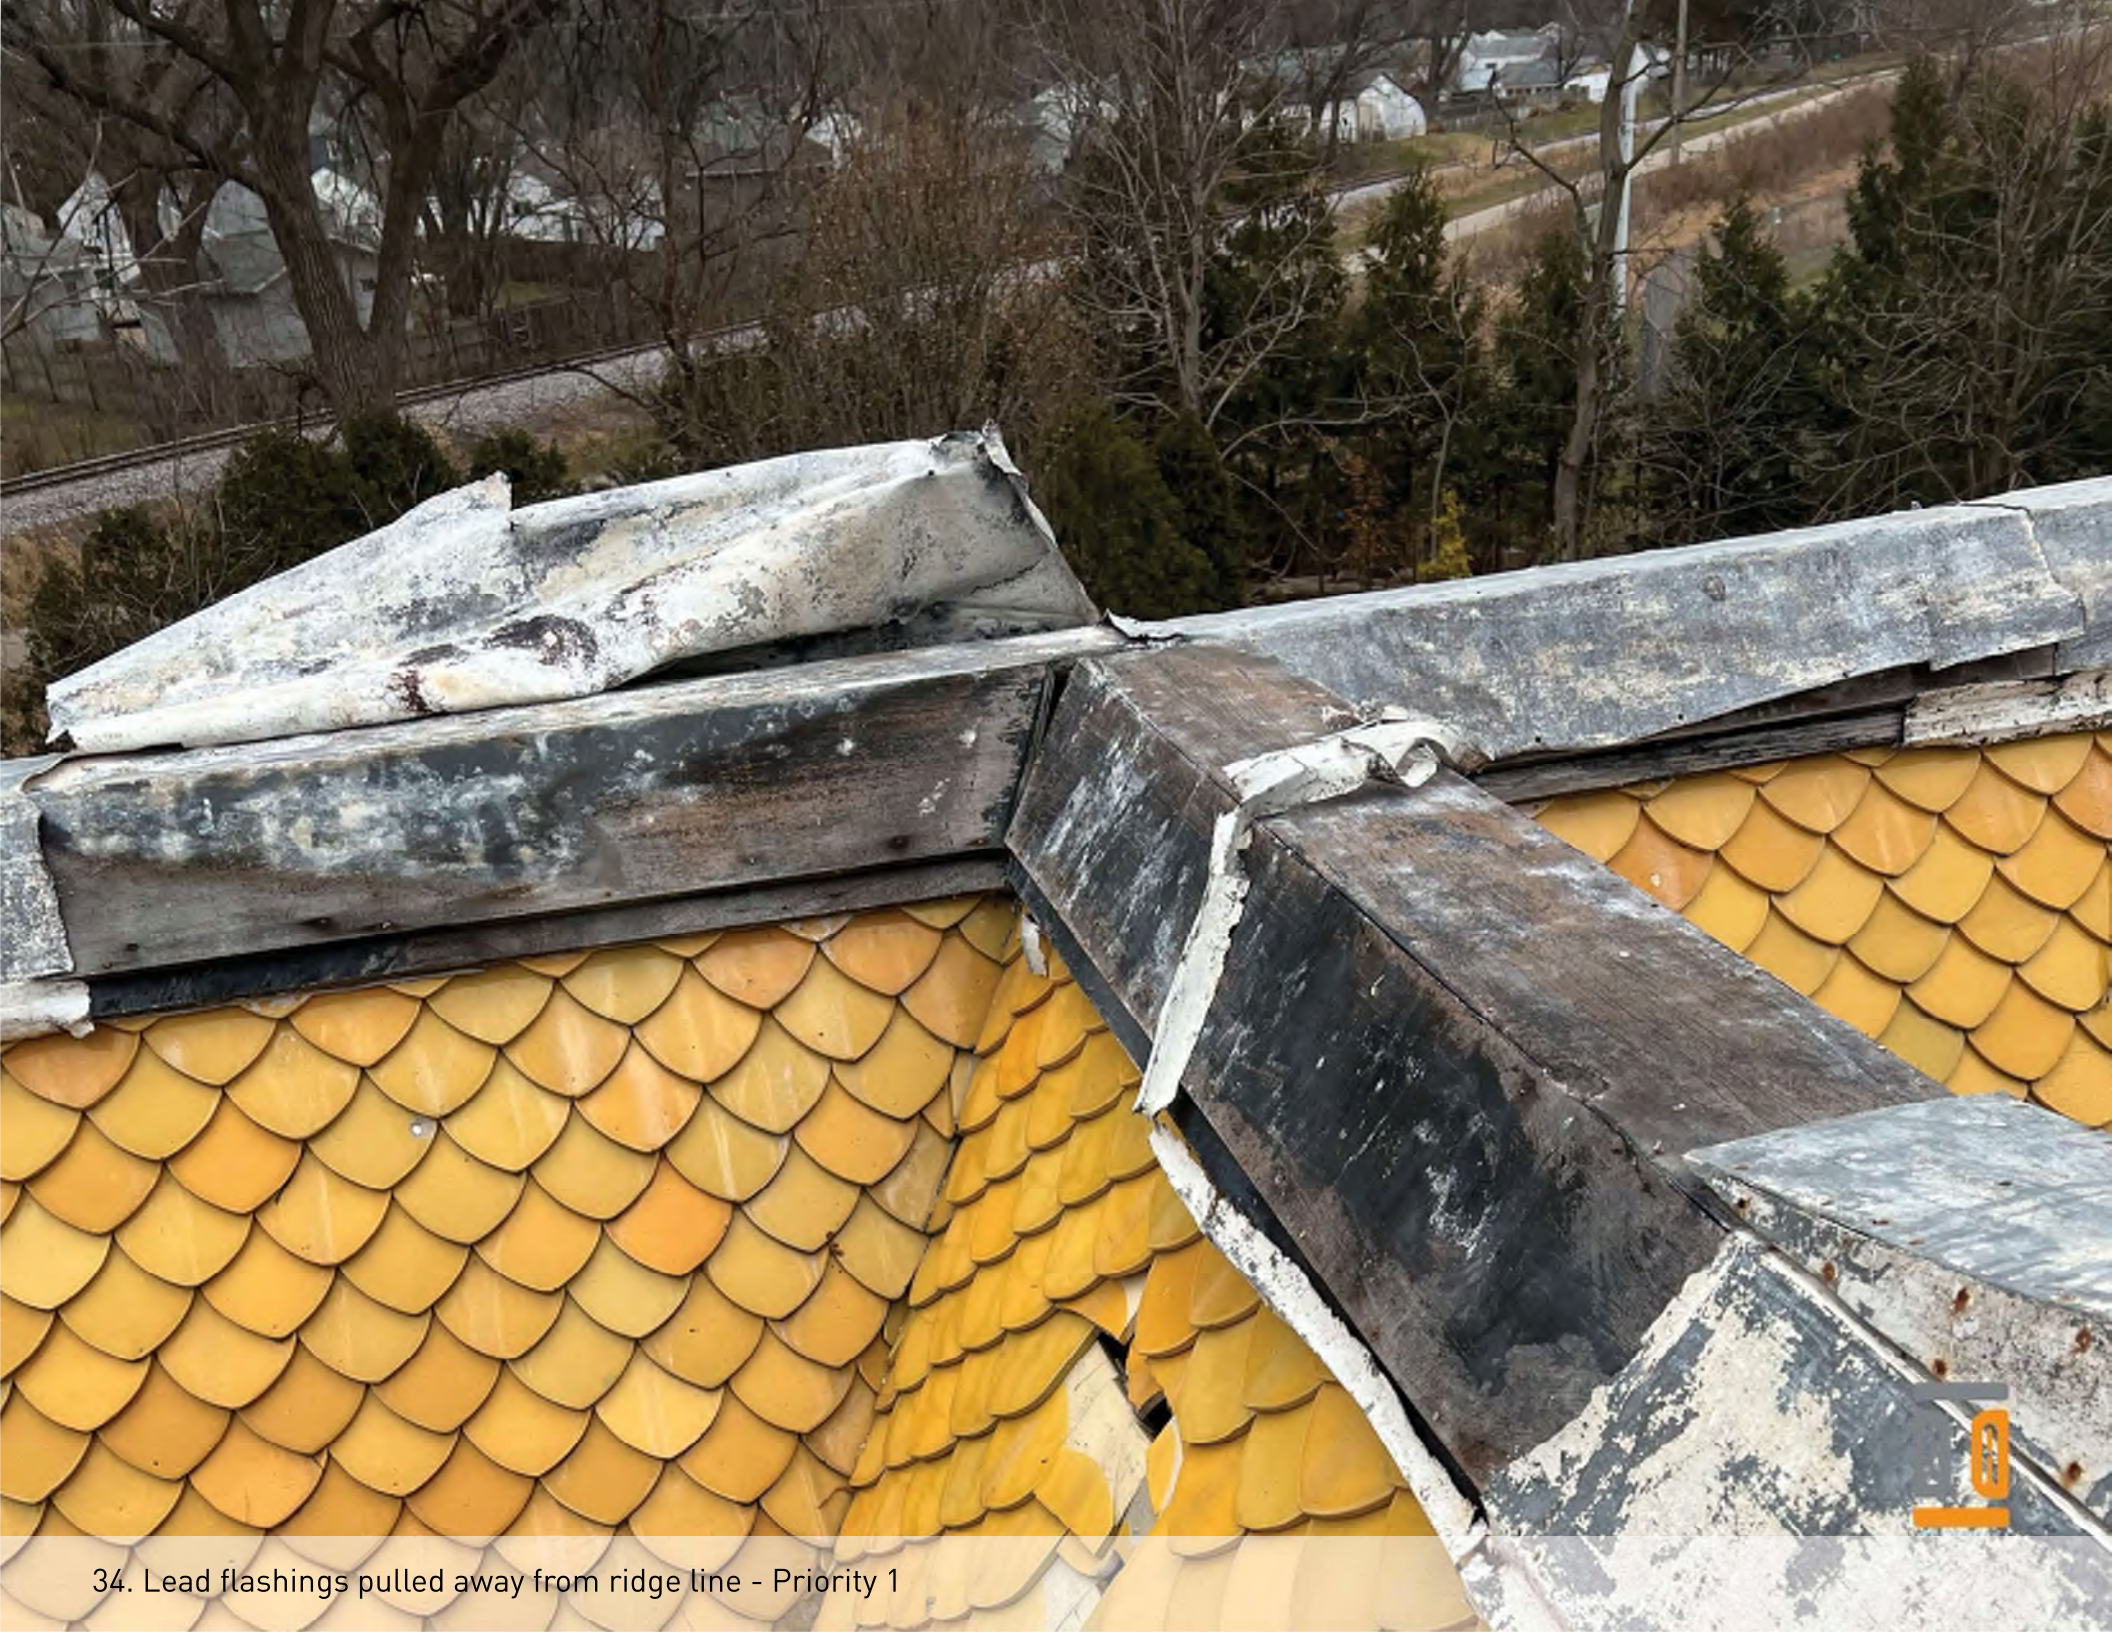
34. Lead flashings pulled away from ridge line - Priority 1

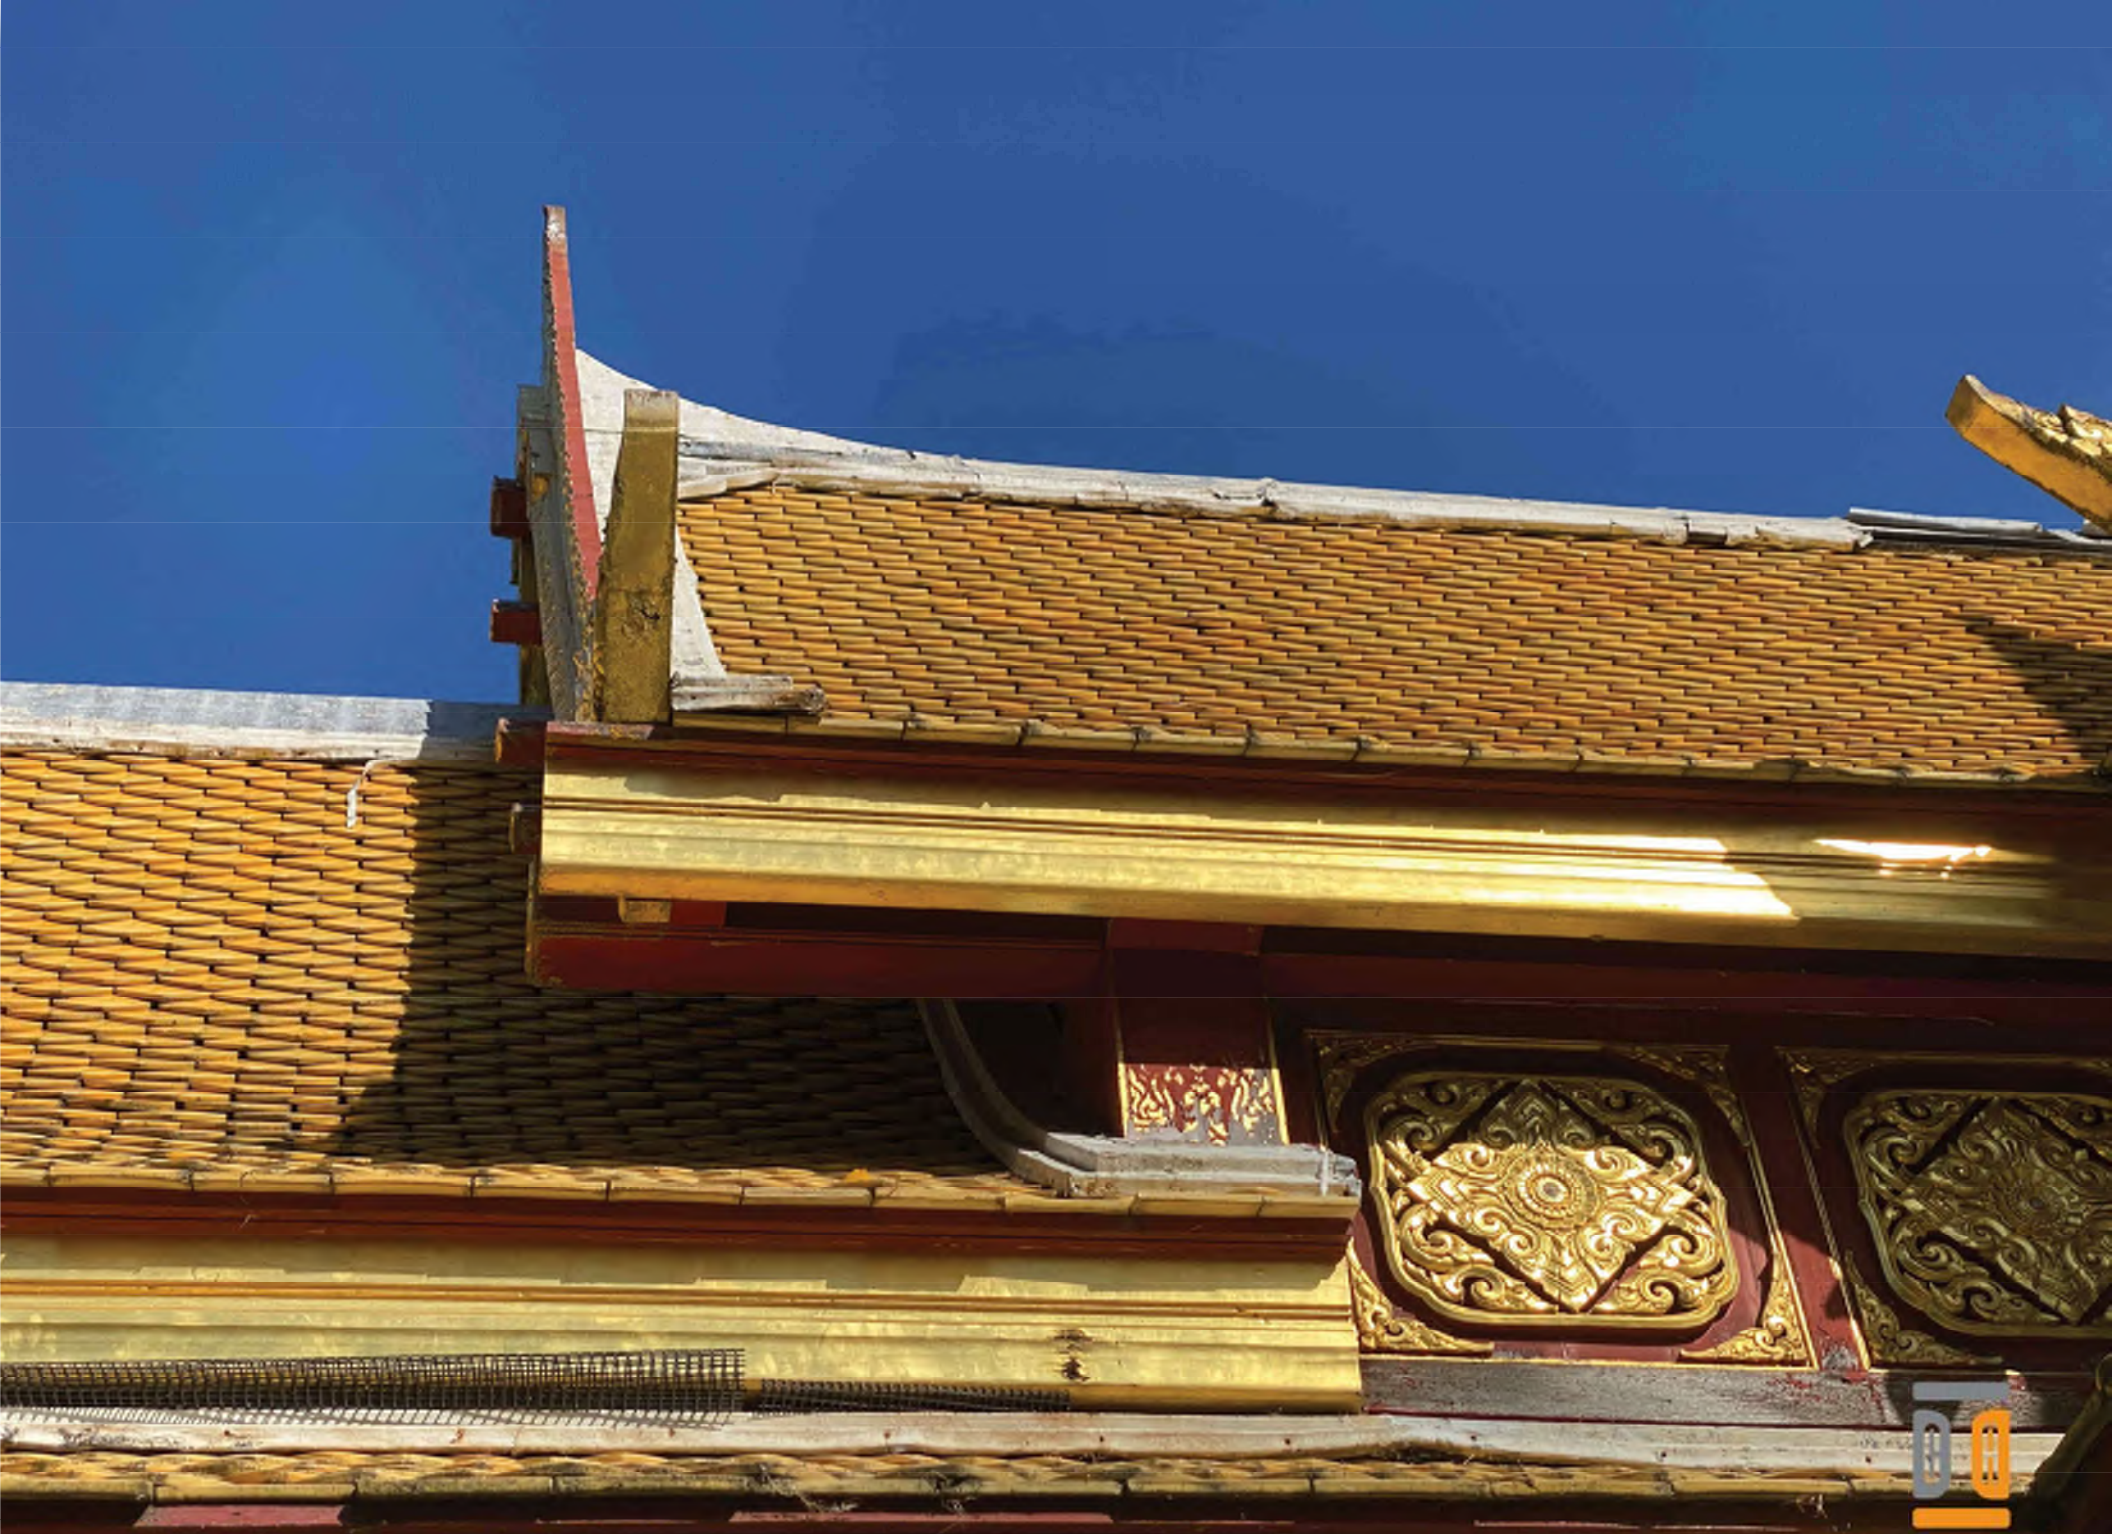
35. West view of upper roof condition - Priority 1

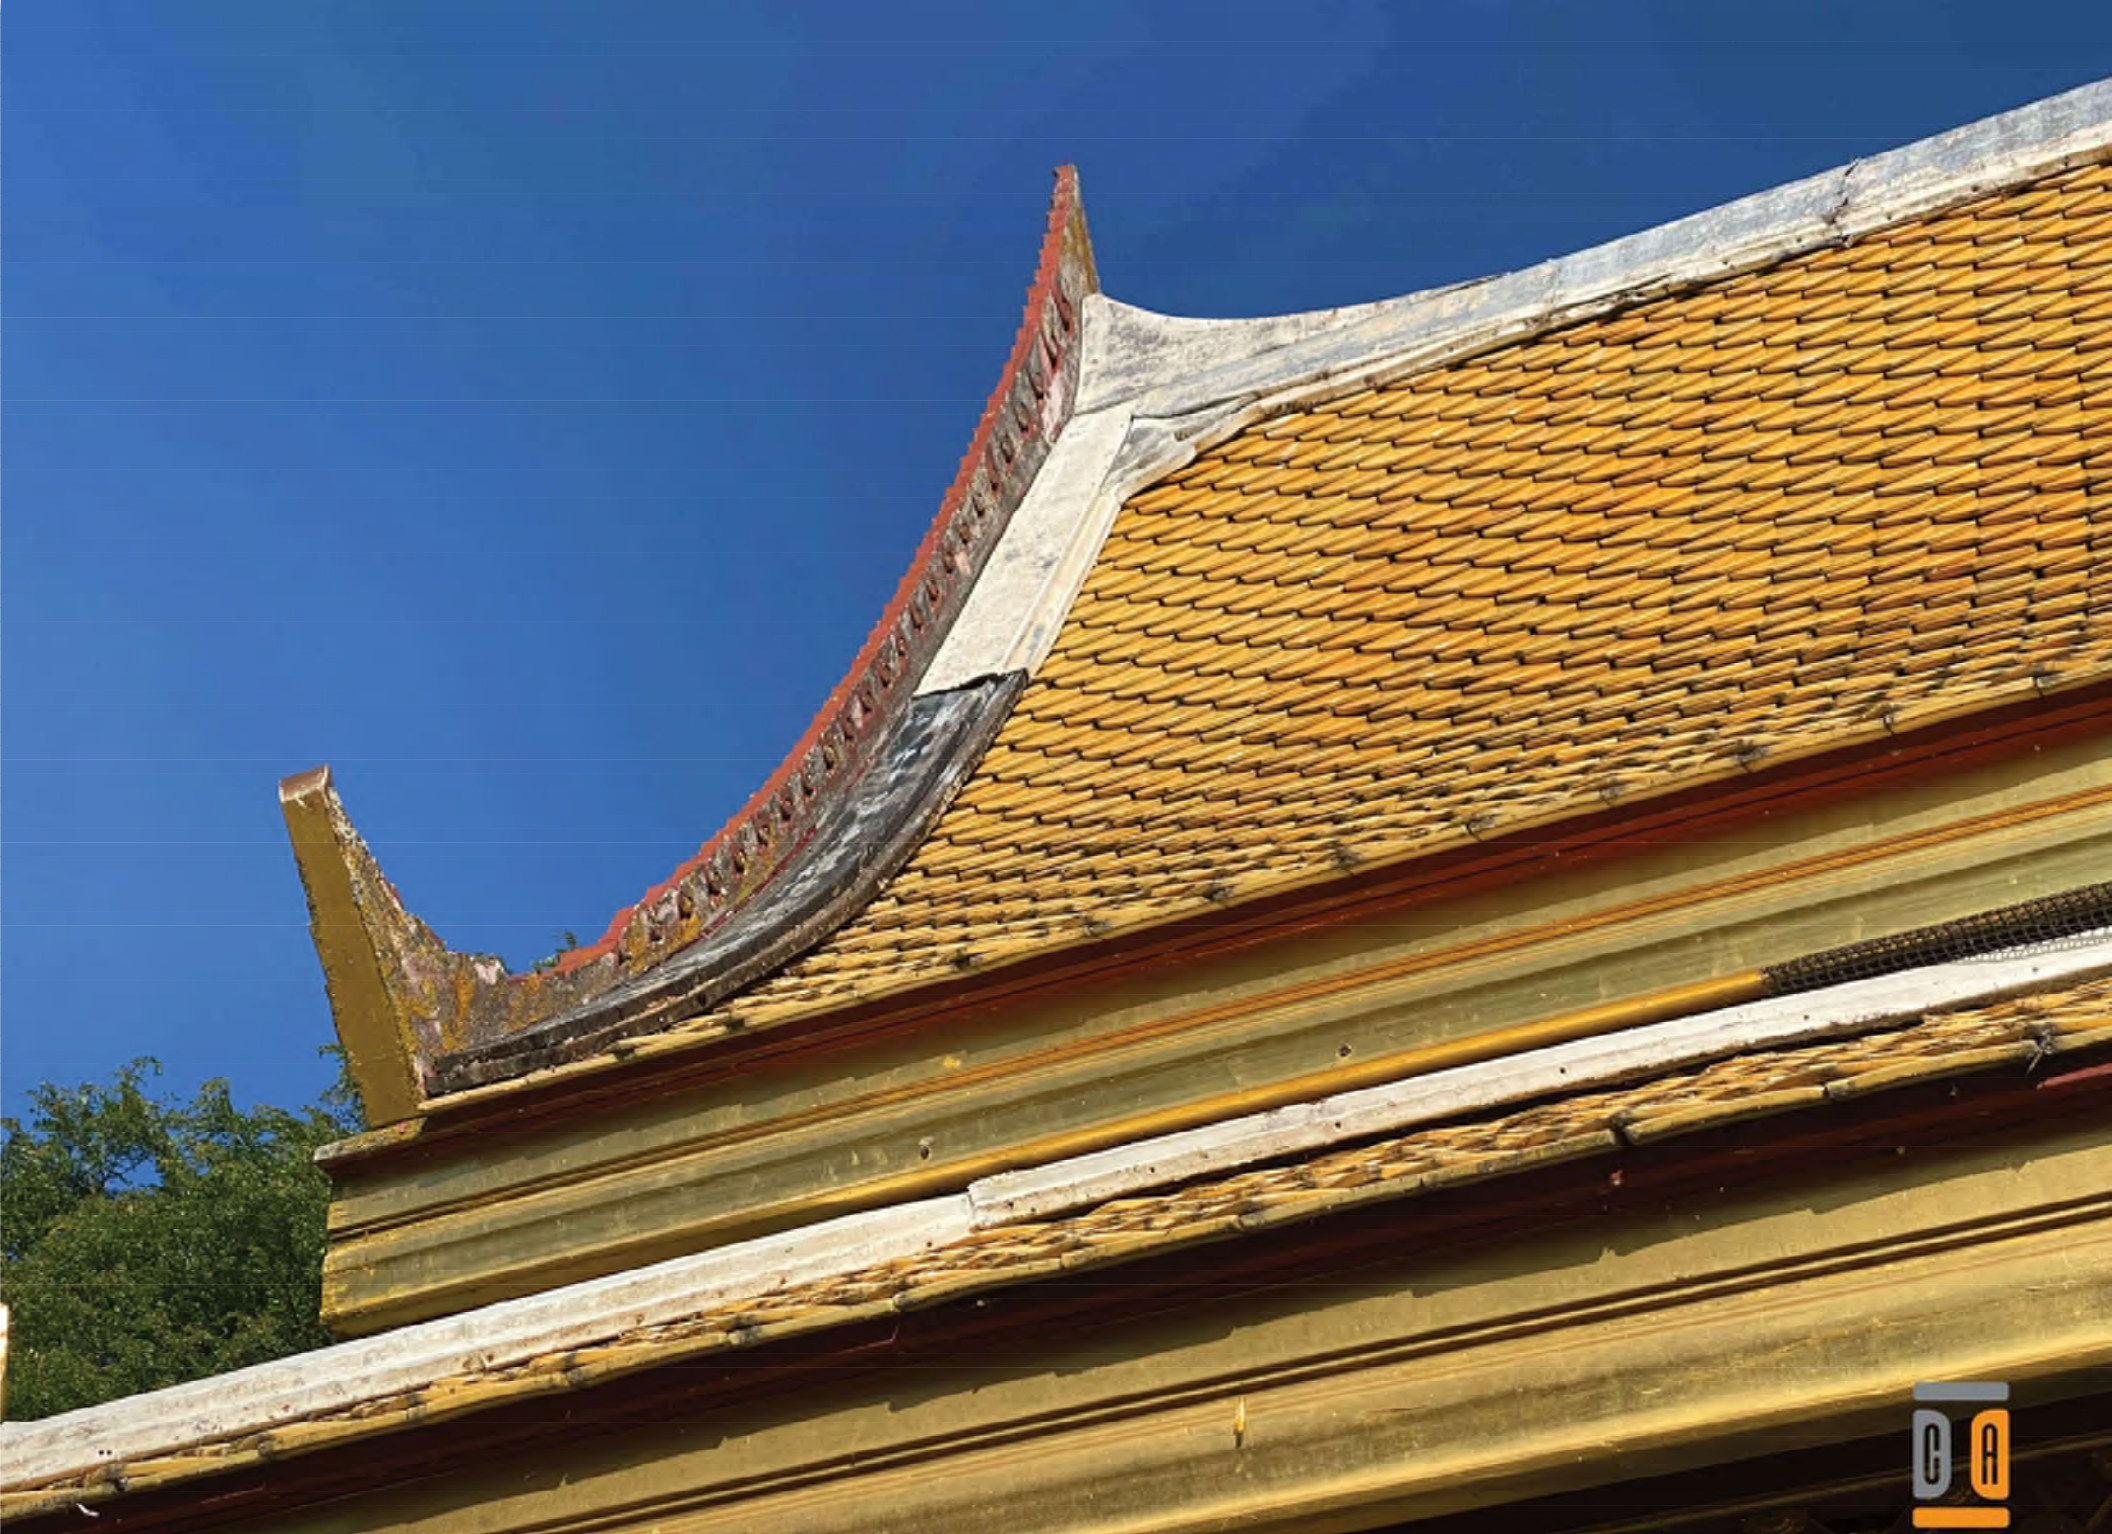
36. View of the back side North Gable end - Priority 1

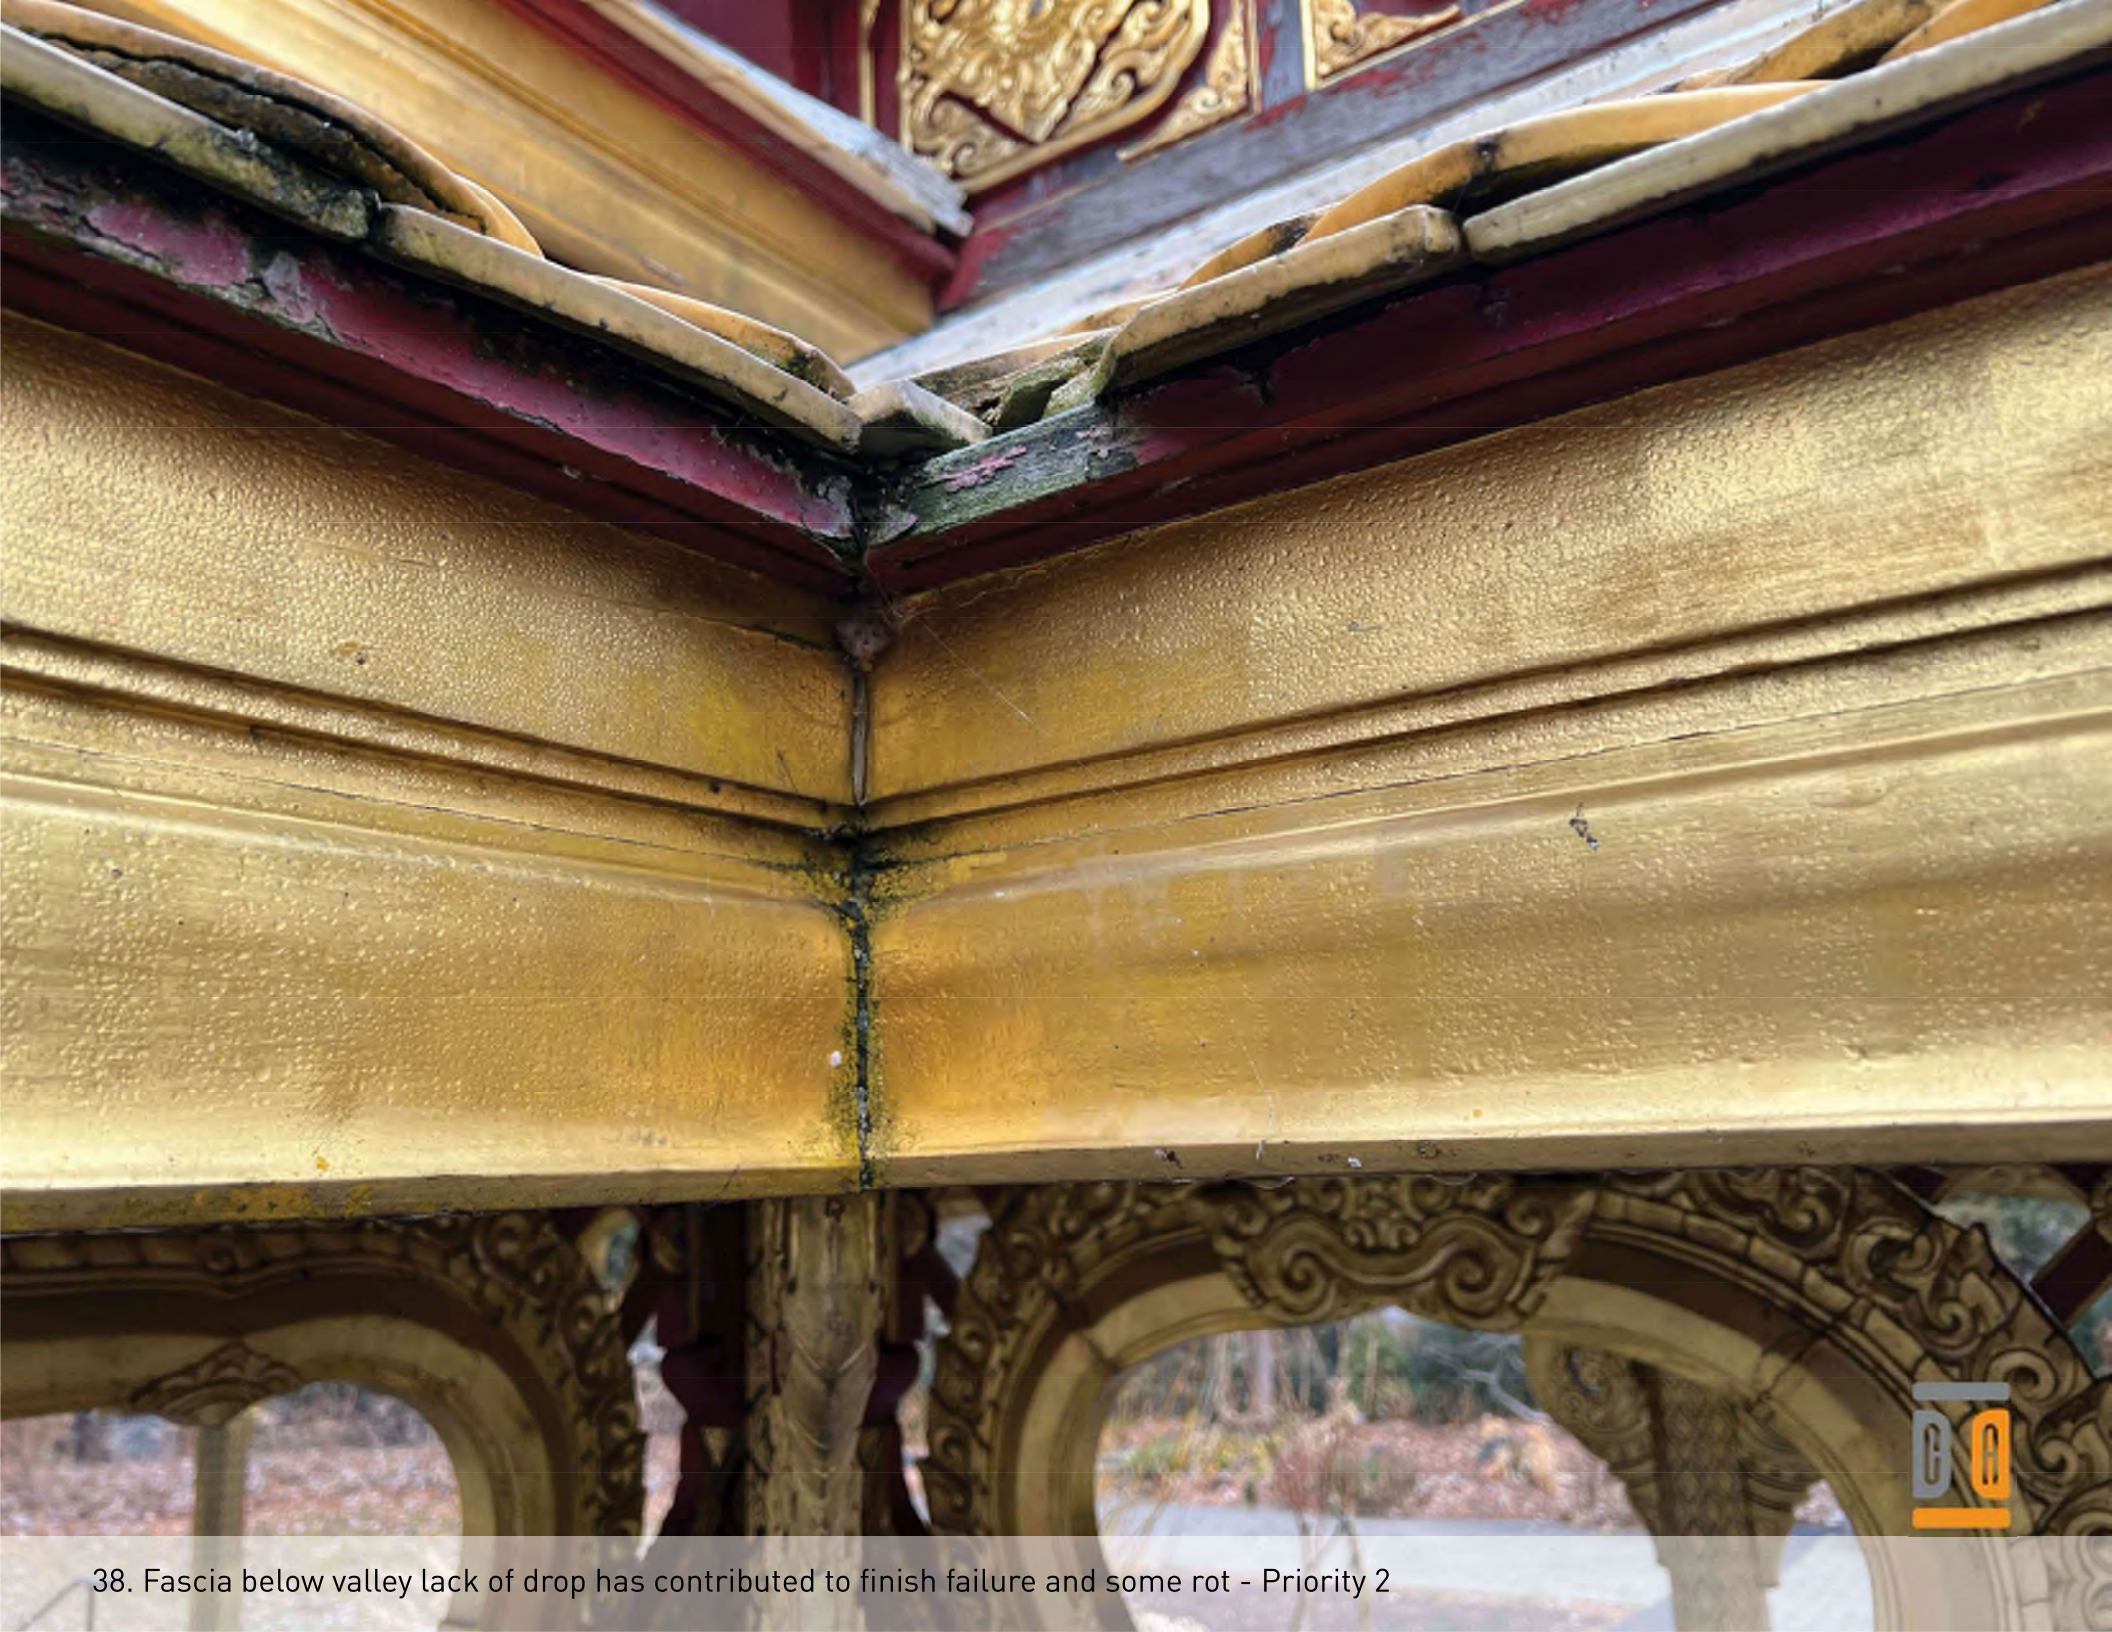
38. Fascia below valley lack of drop has contributed to finish failure and some rot - Priority 2

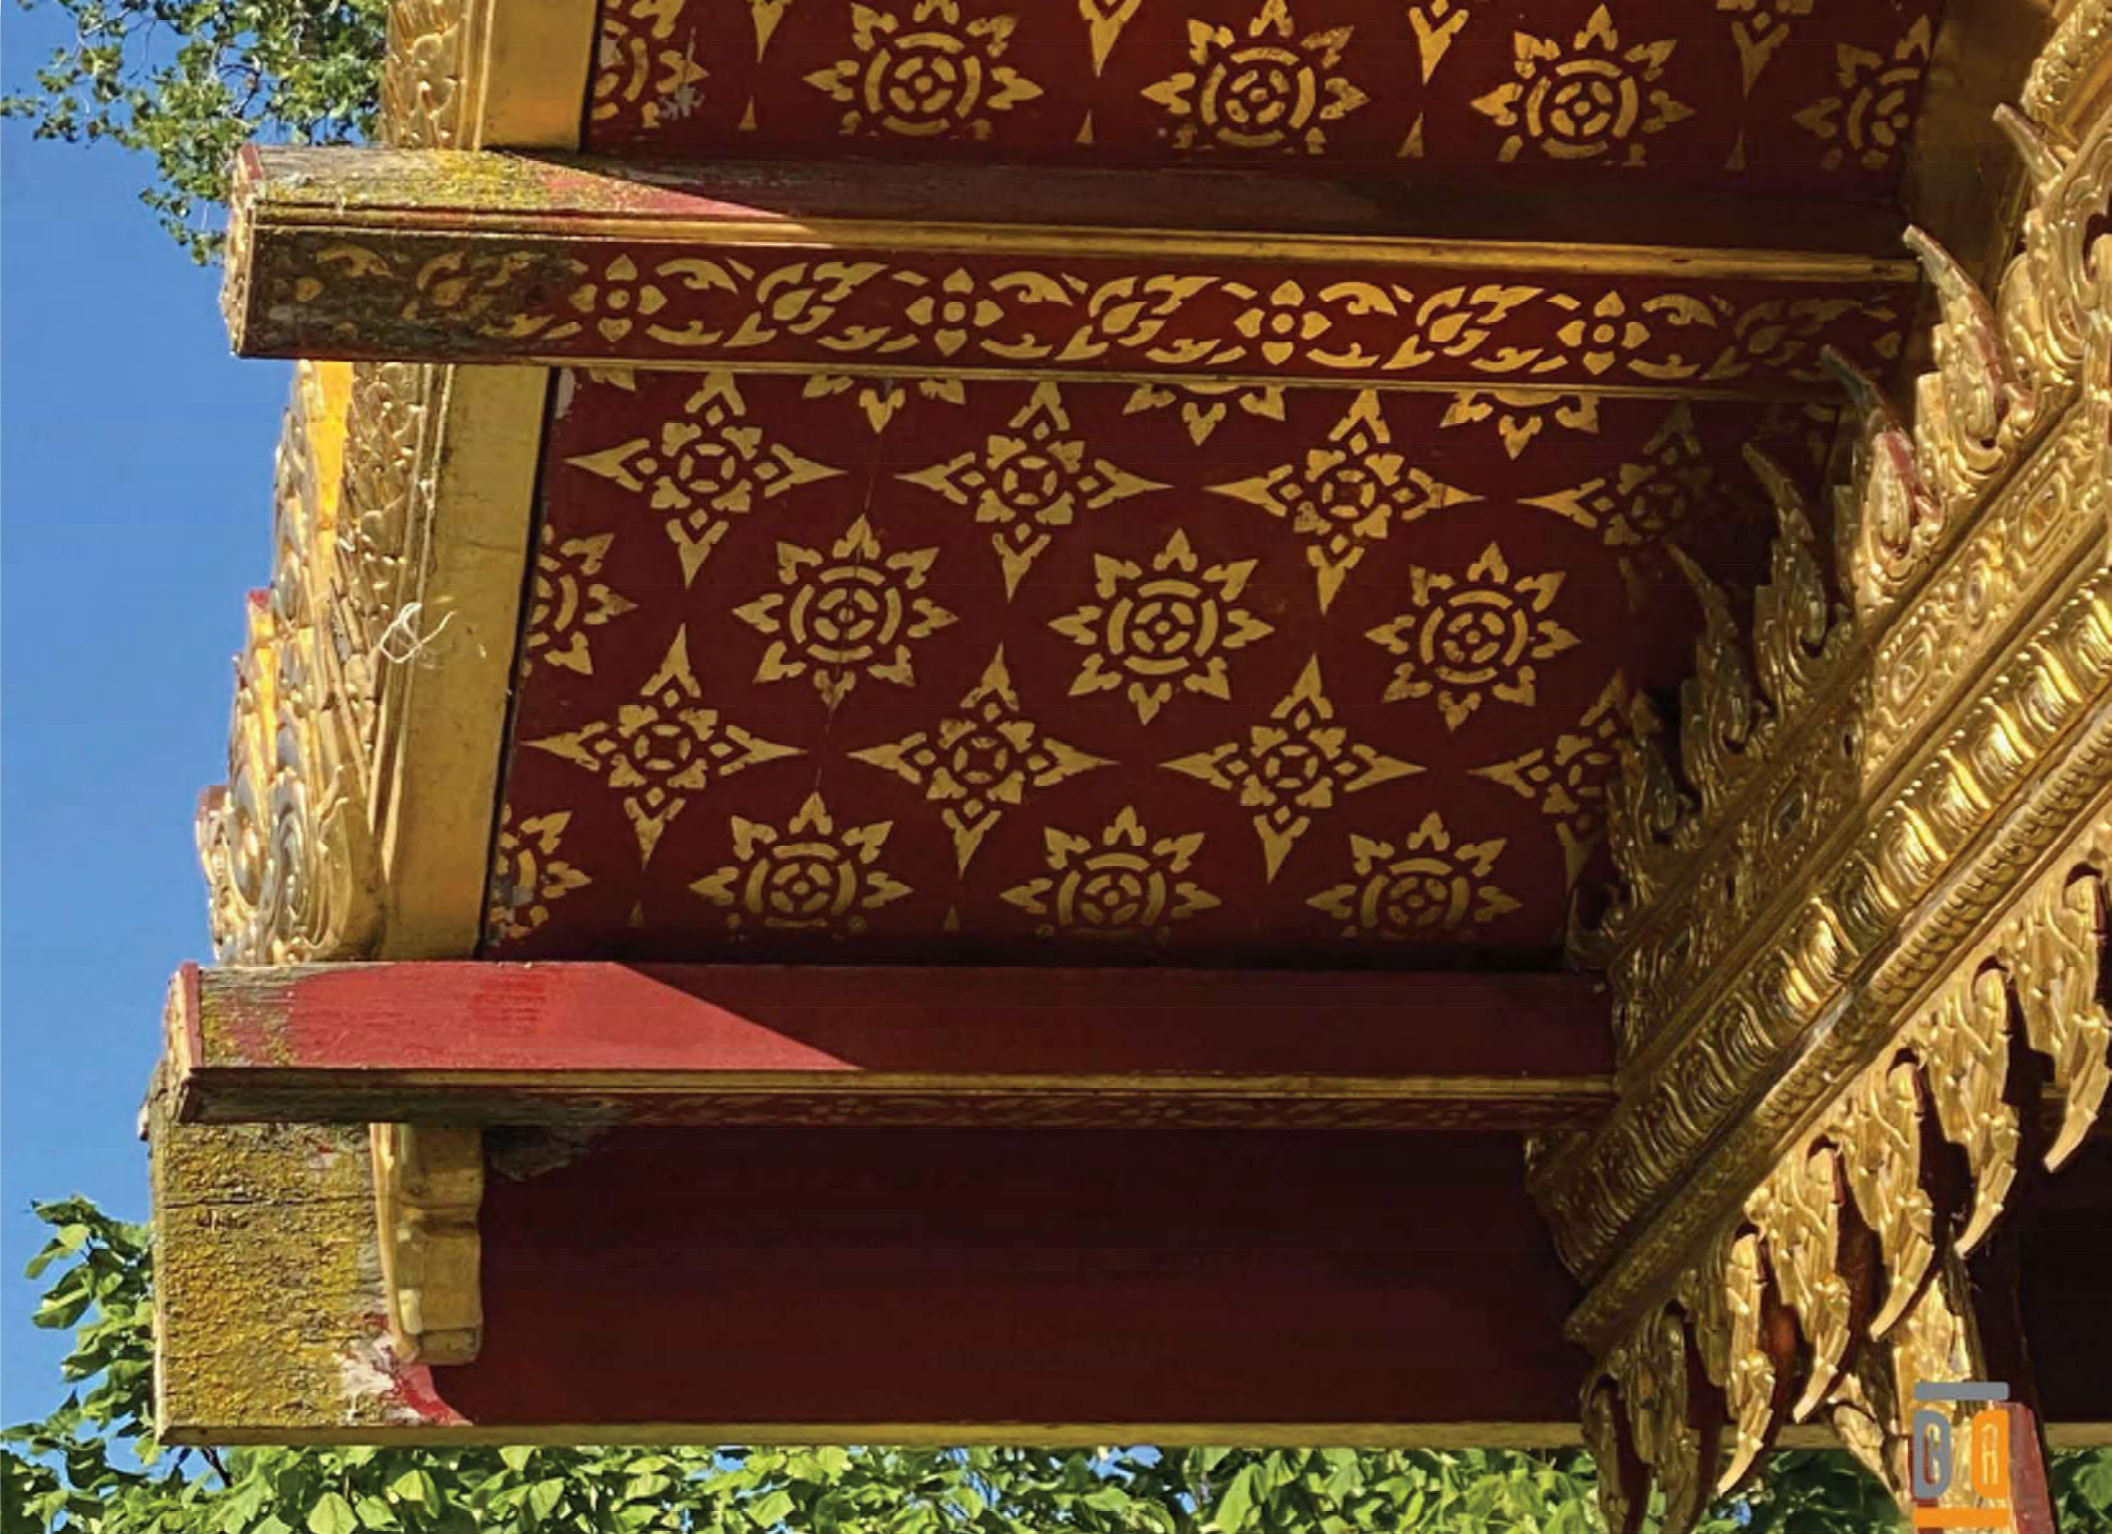
39. View of soffit and wood components showing dry-rotted wood and paint failures - Priority 2

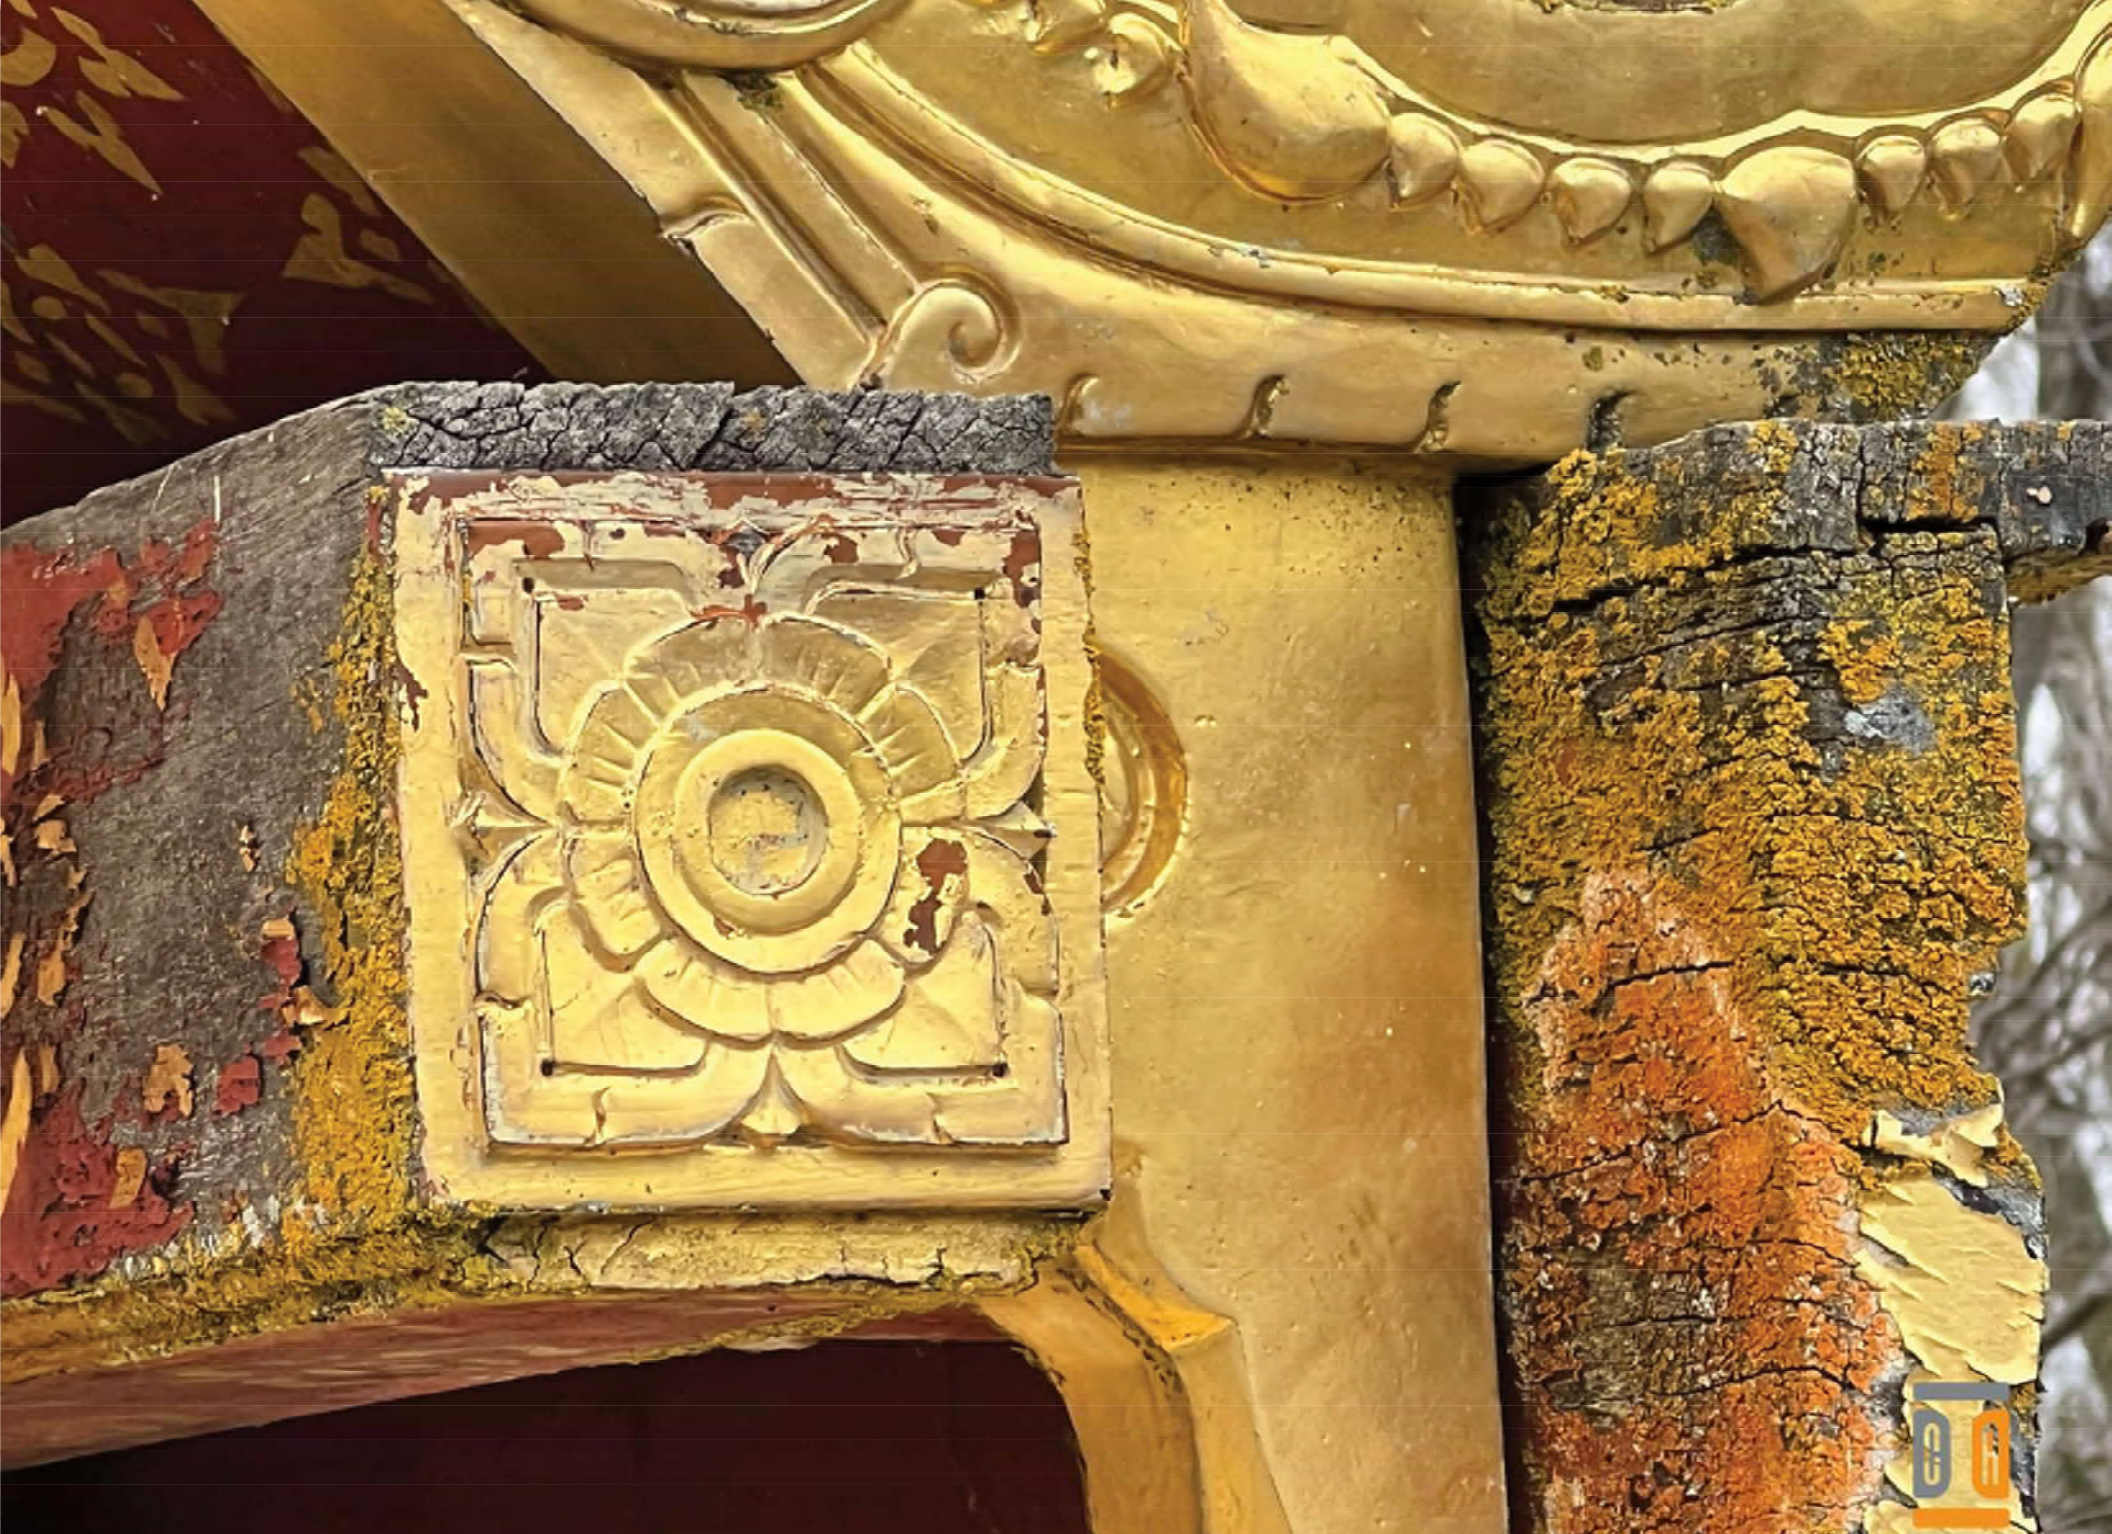
40. Representative image of degradation observed to finishes and wood substrate - Priority 2

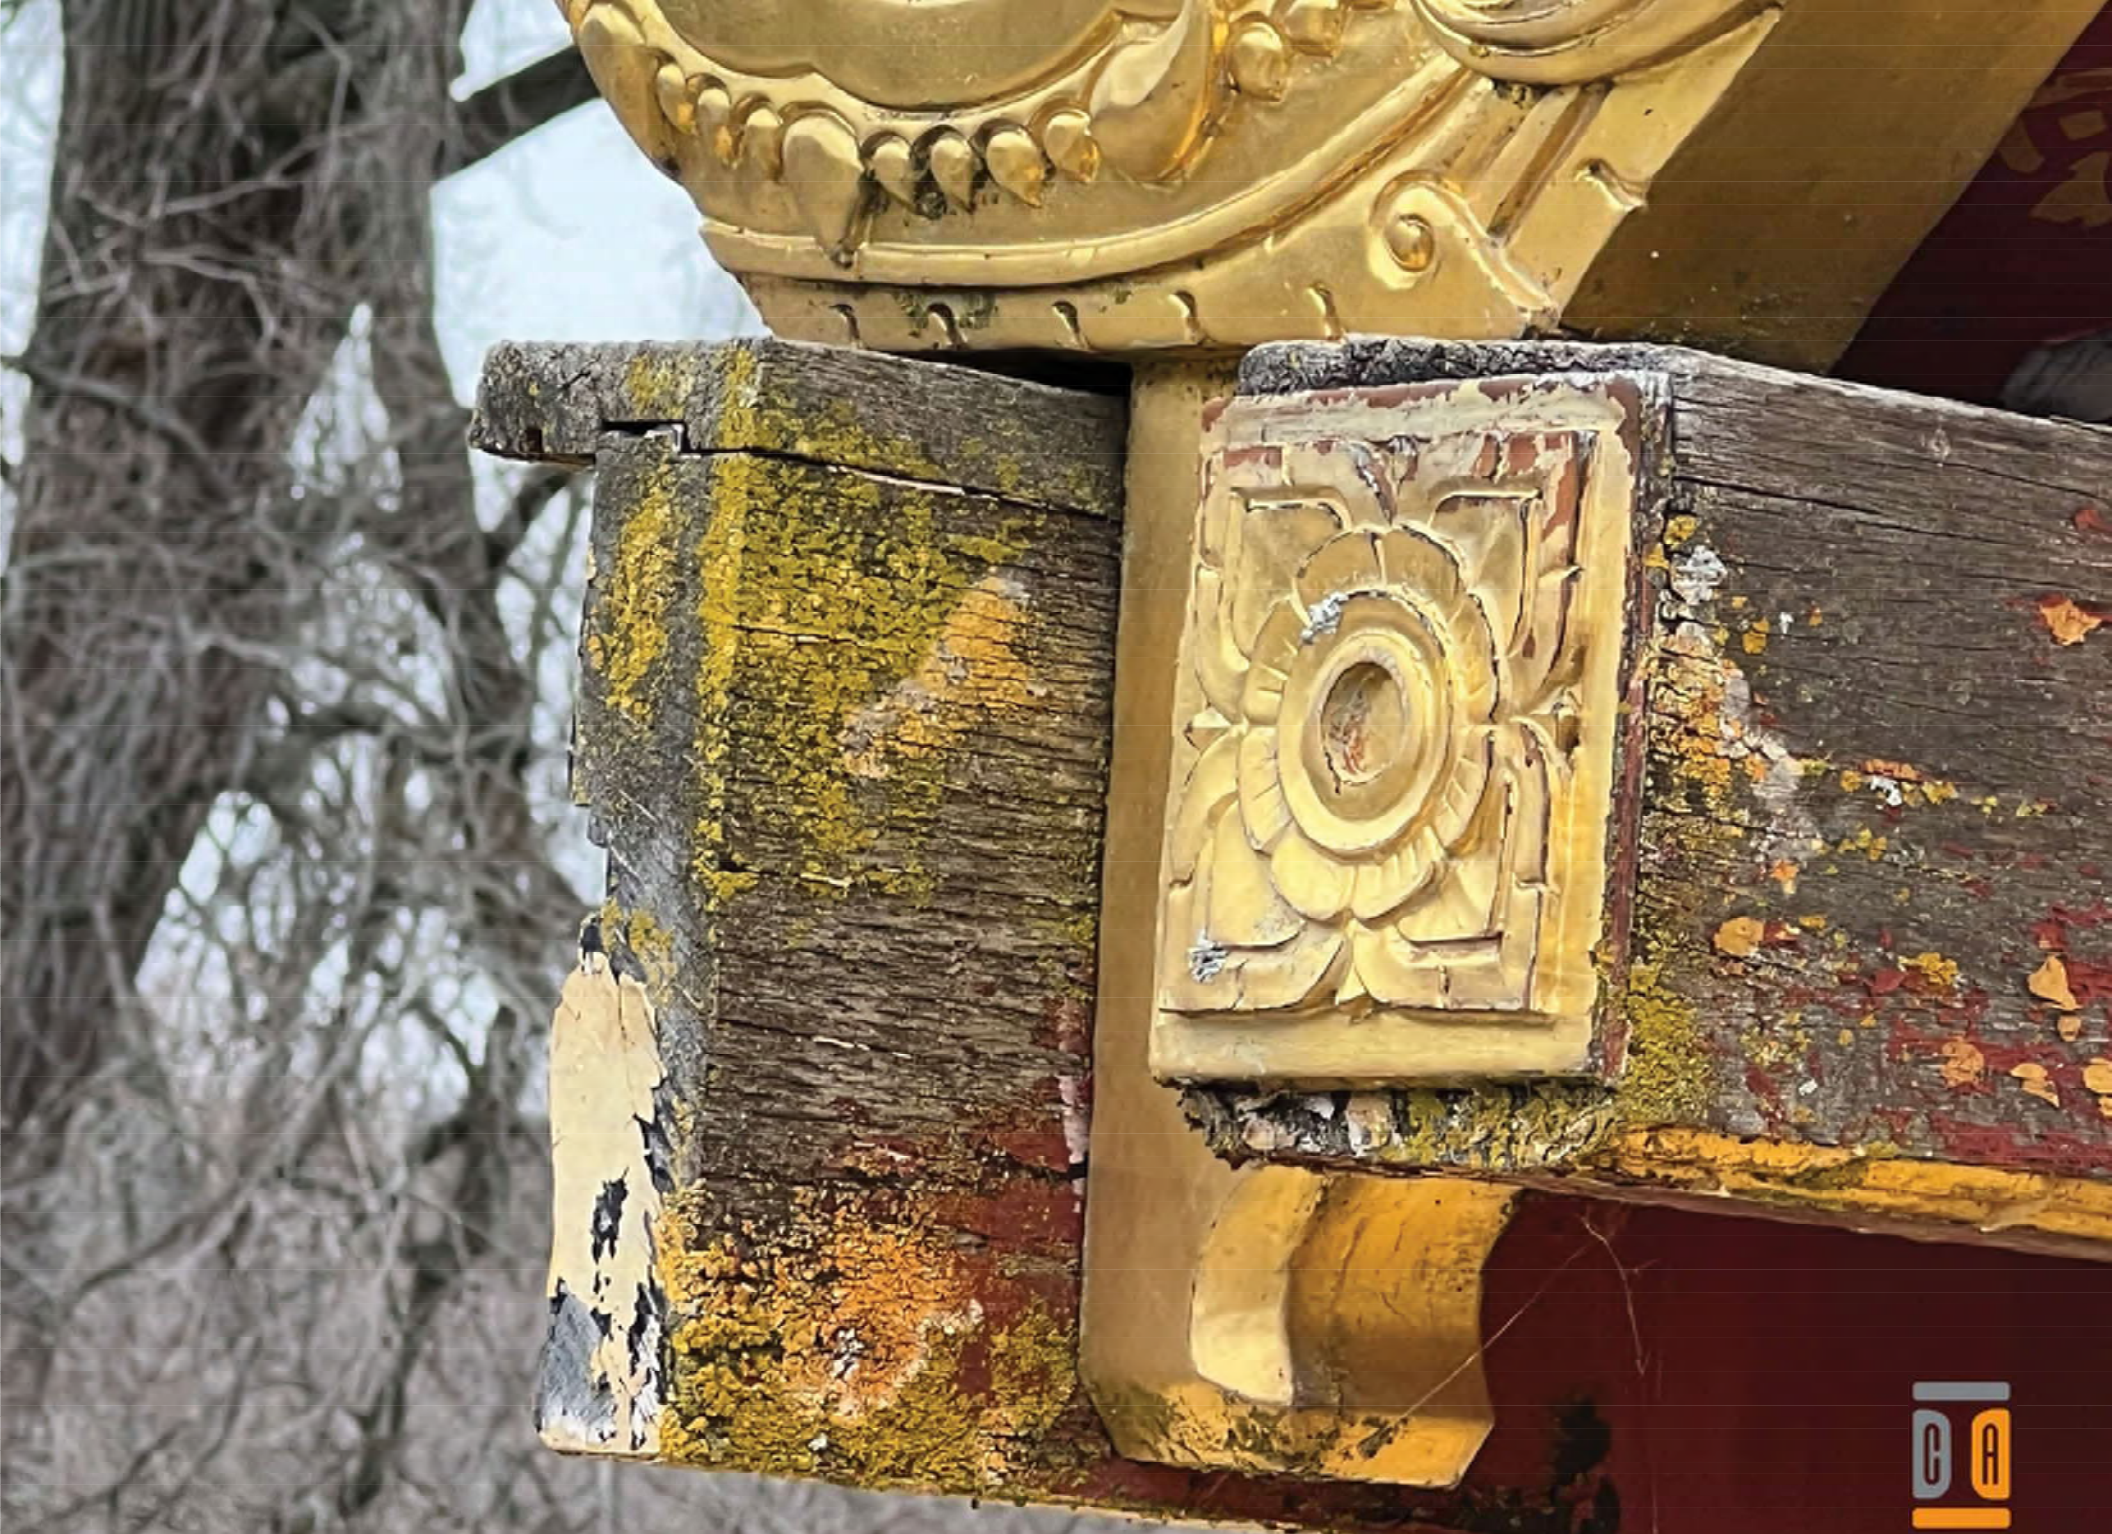
41. Repair attempts at base of hip ridge - Priority 2
