OLBRICH BOTANICAL GARDENS ROYAL THAI PAVILION CONDITION ASSESSMENT REPORT

AUGUST 30, 2022

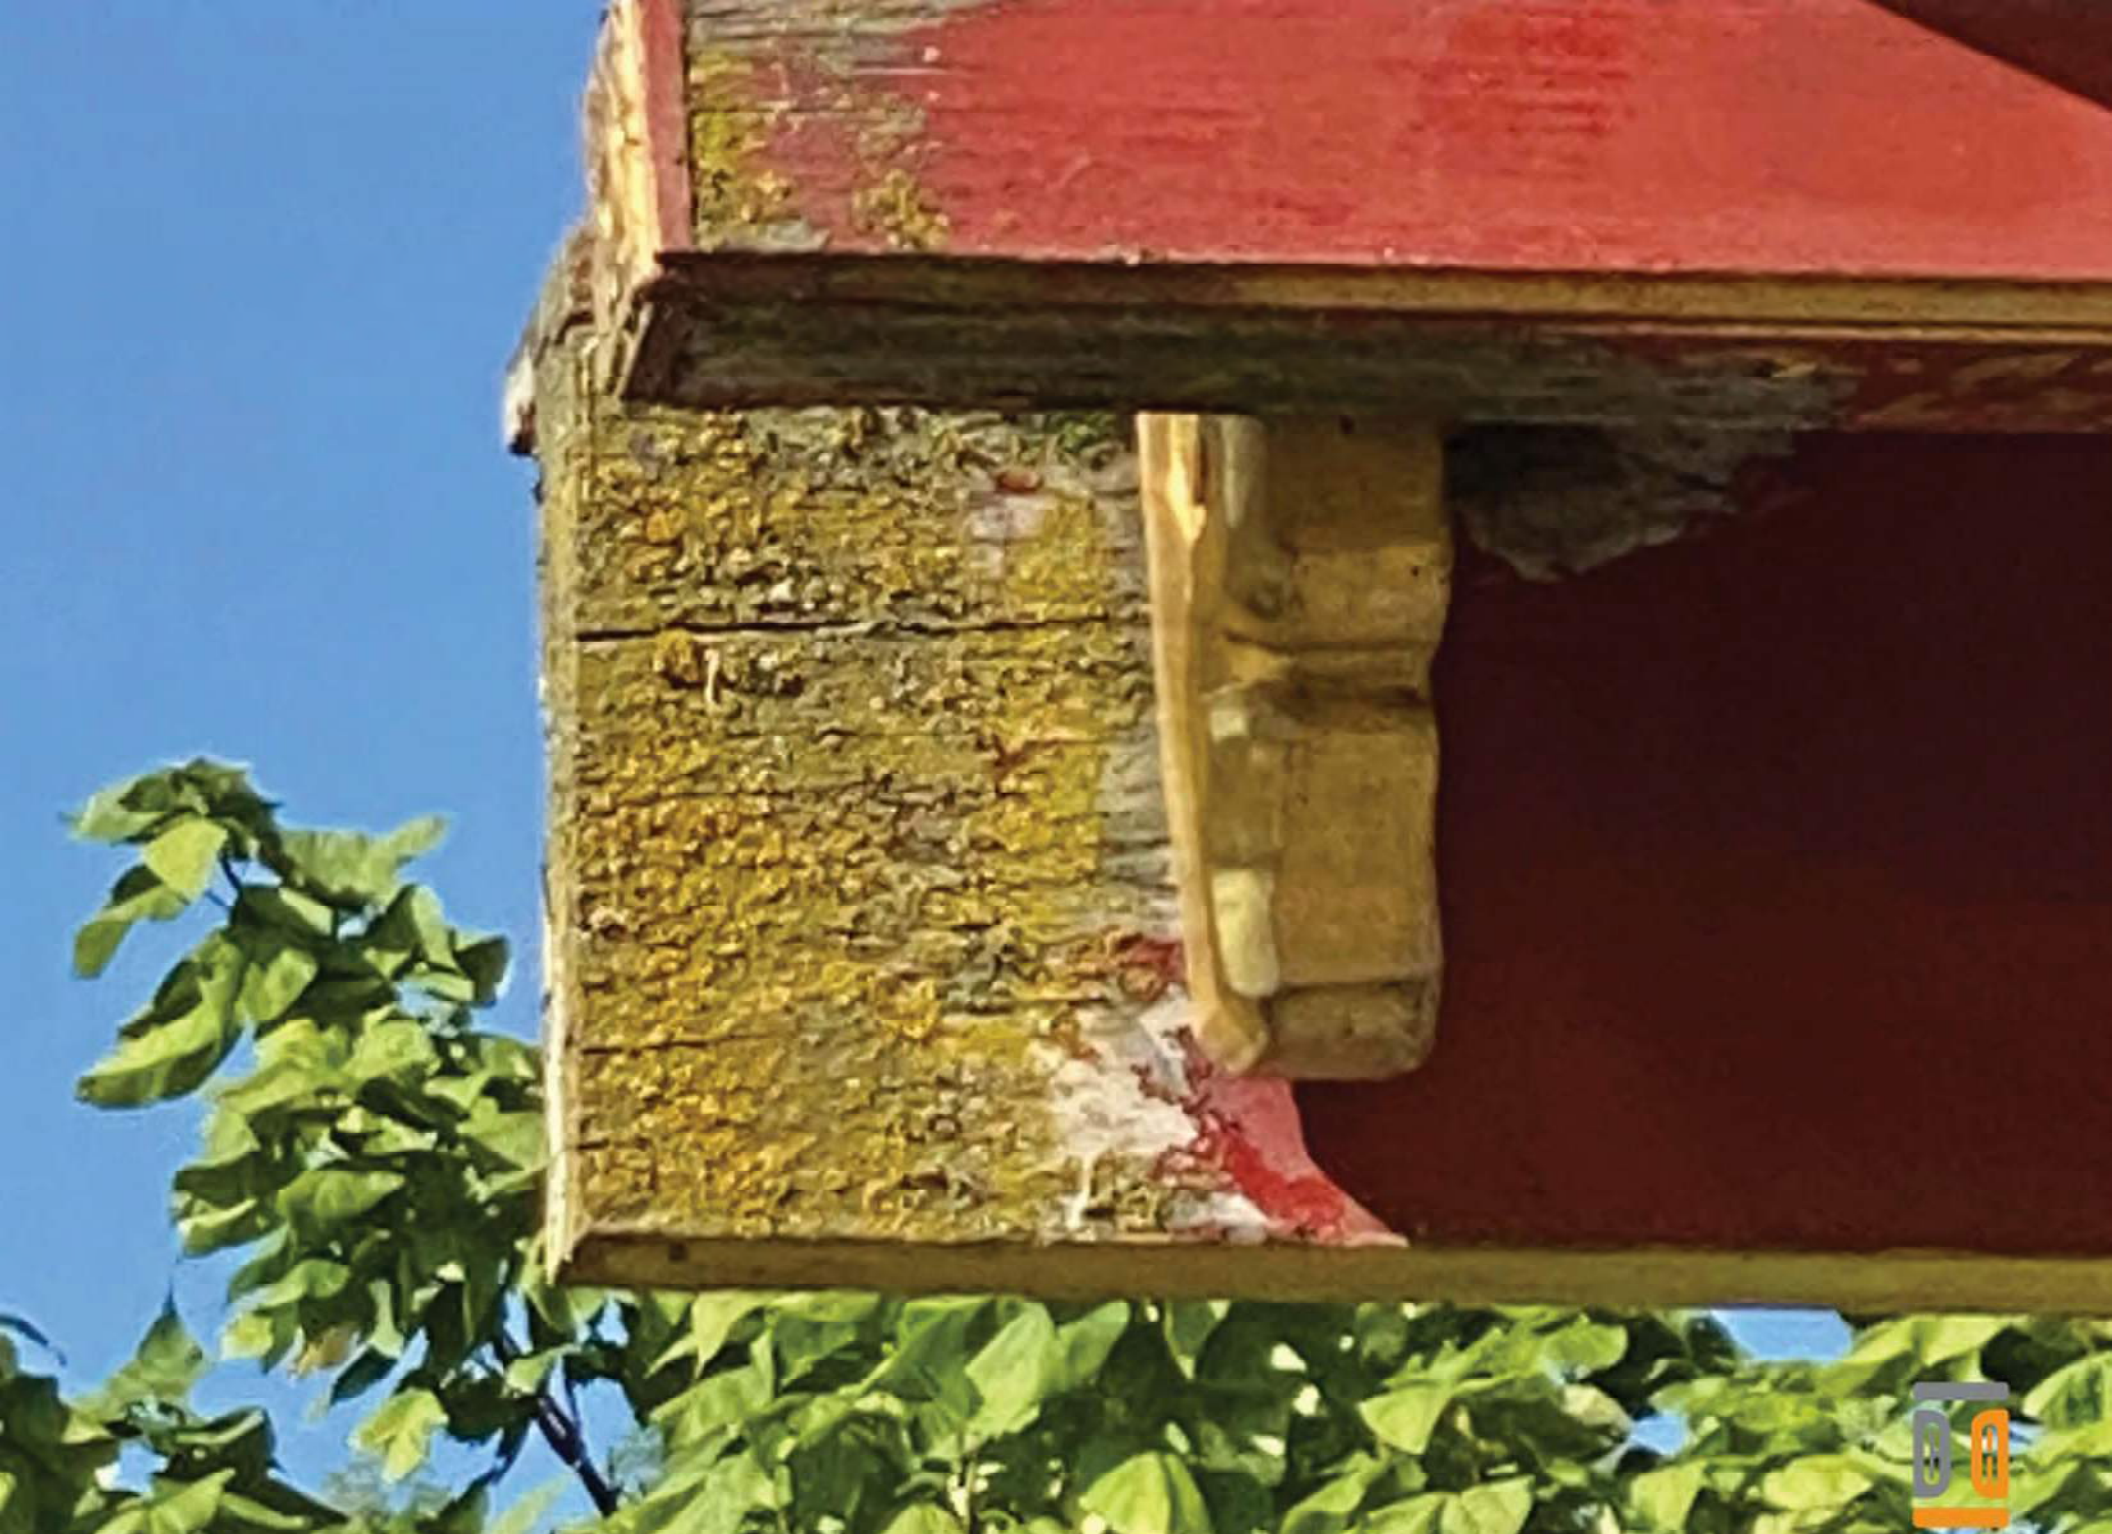
42. Representative image of degradation observed to finishes and wood substrate - Priority 2

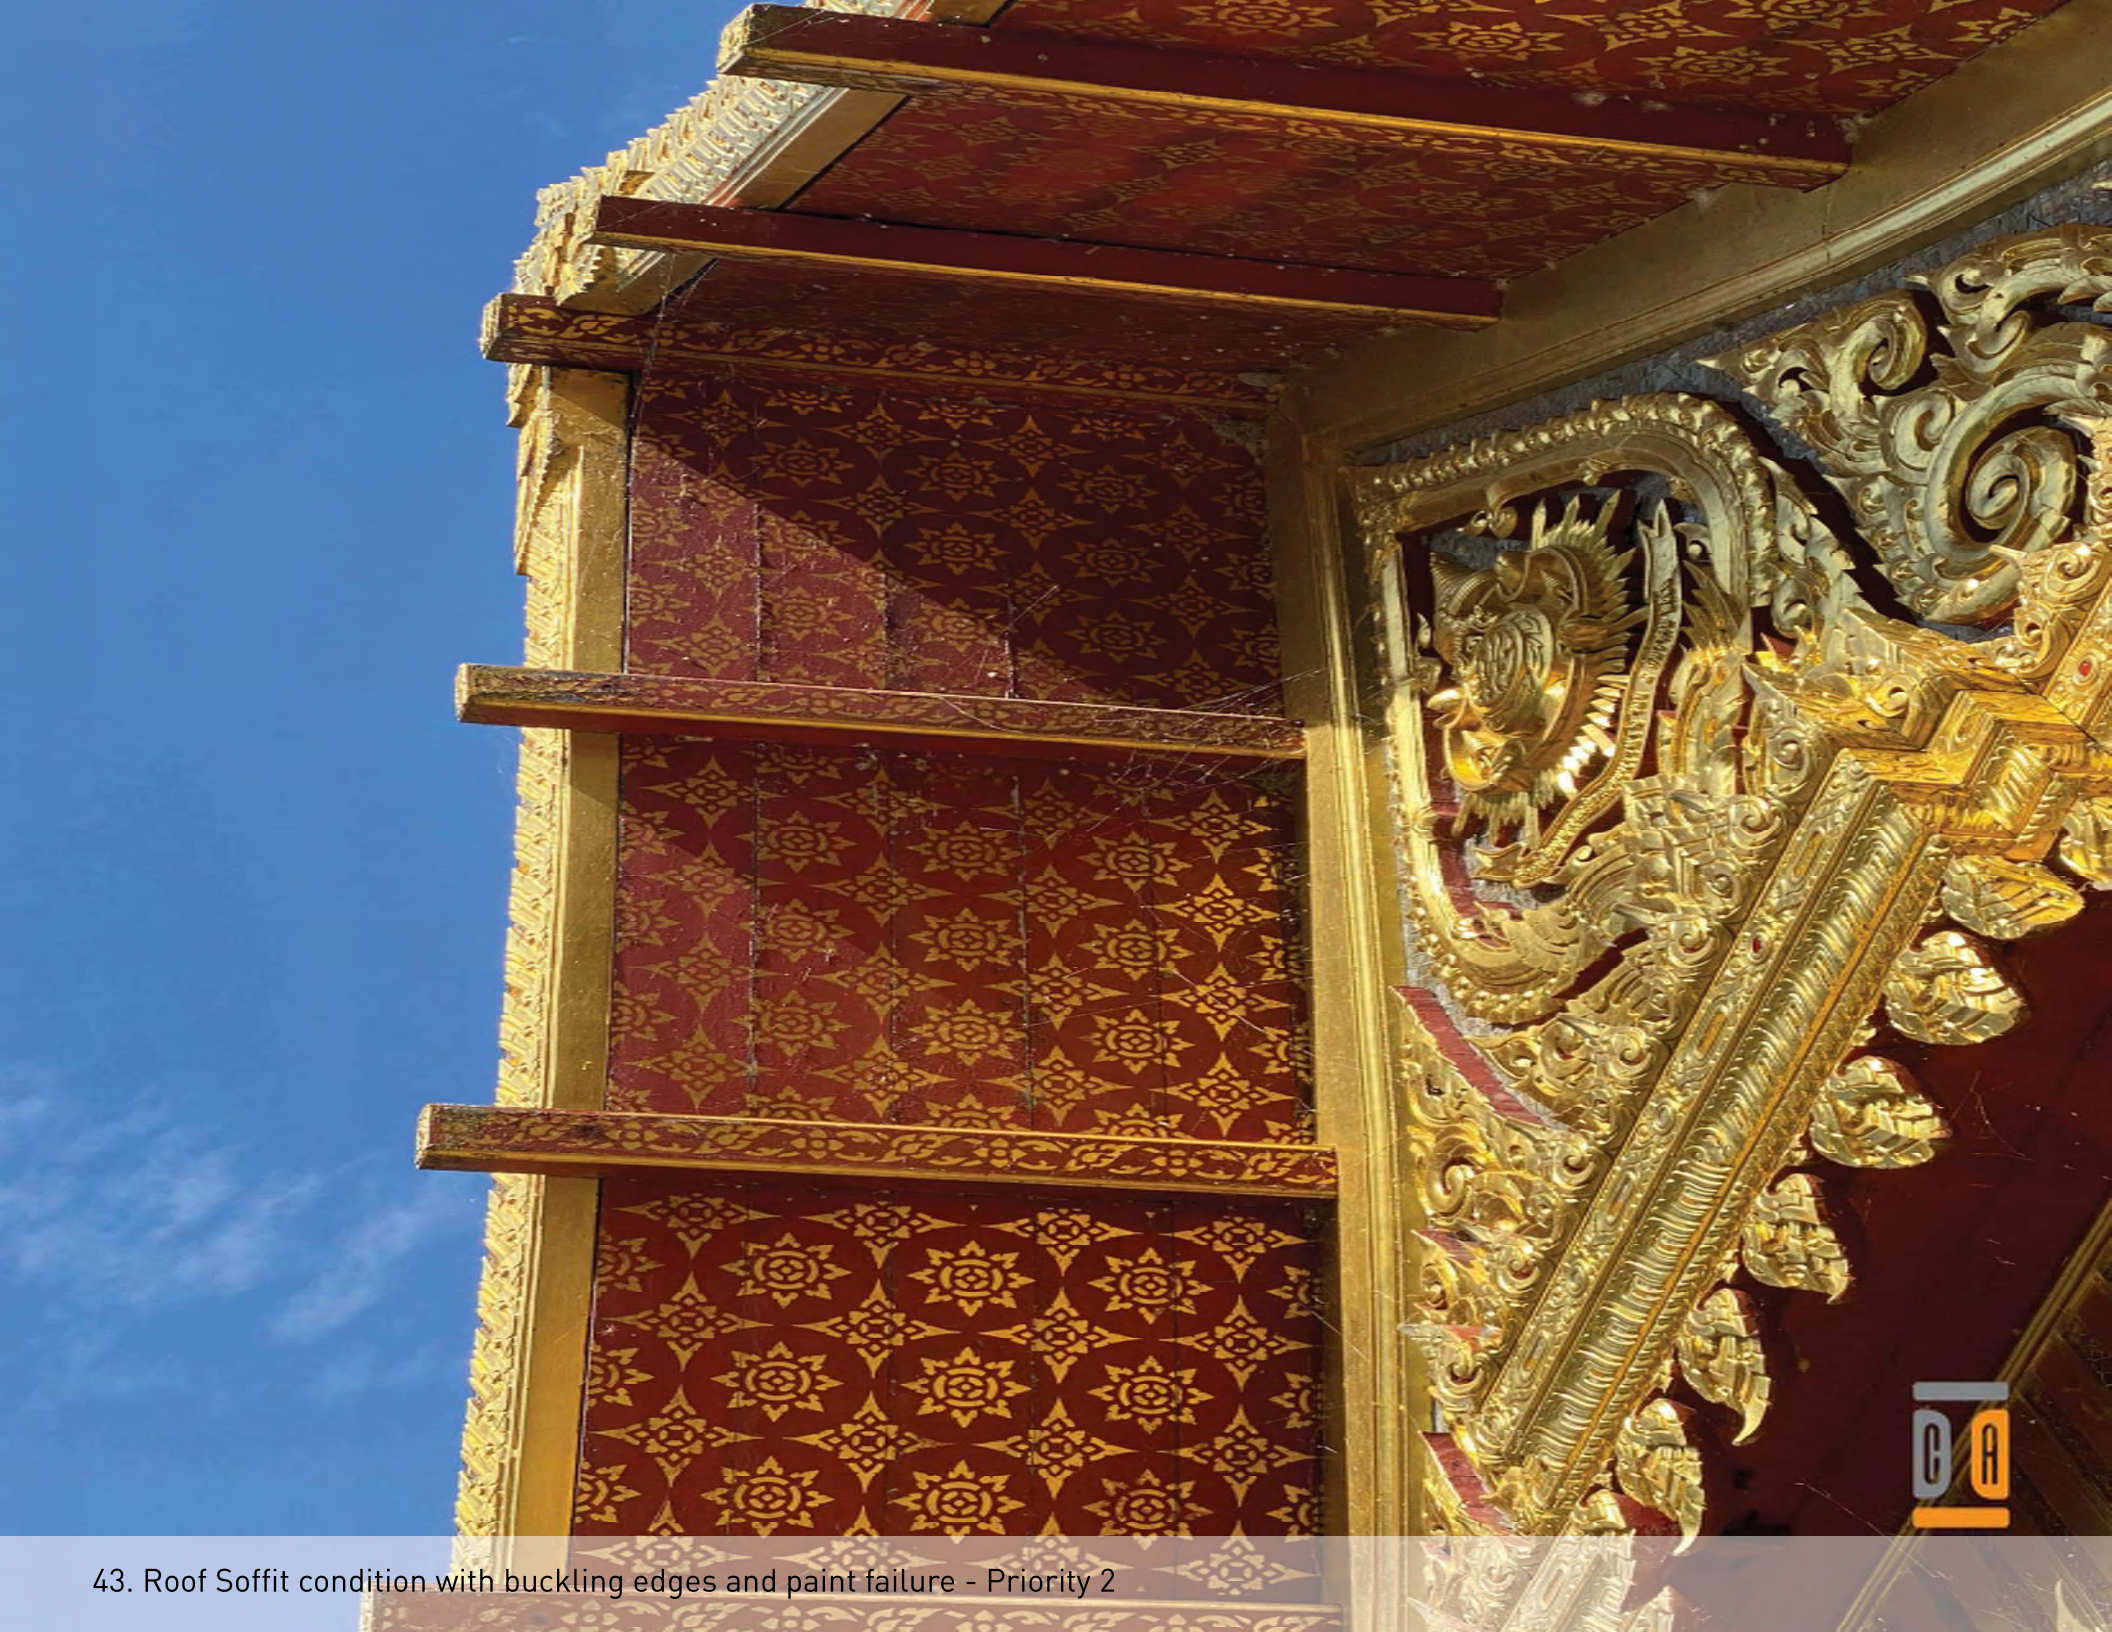
43. Roof Soffit condition with buckling edges and paint failure - Priority 2

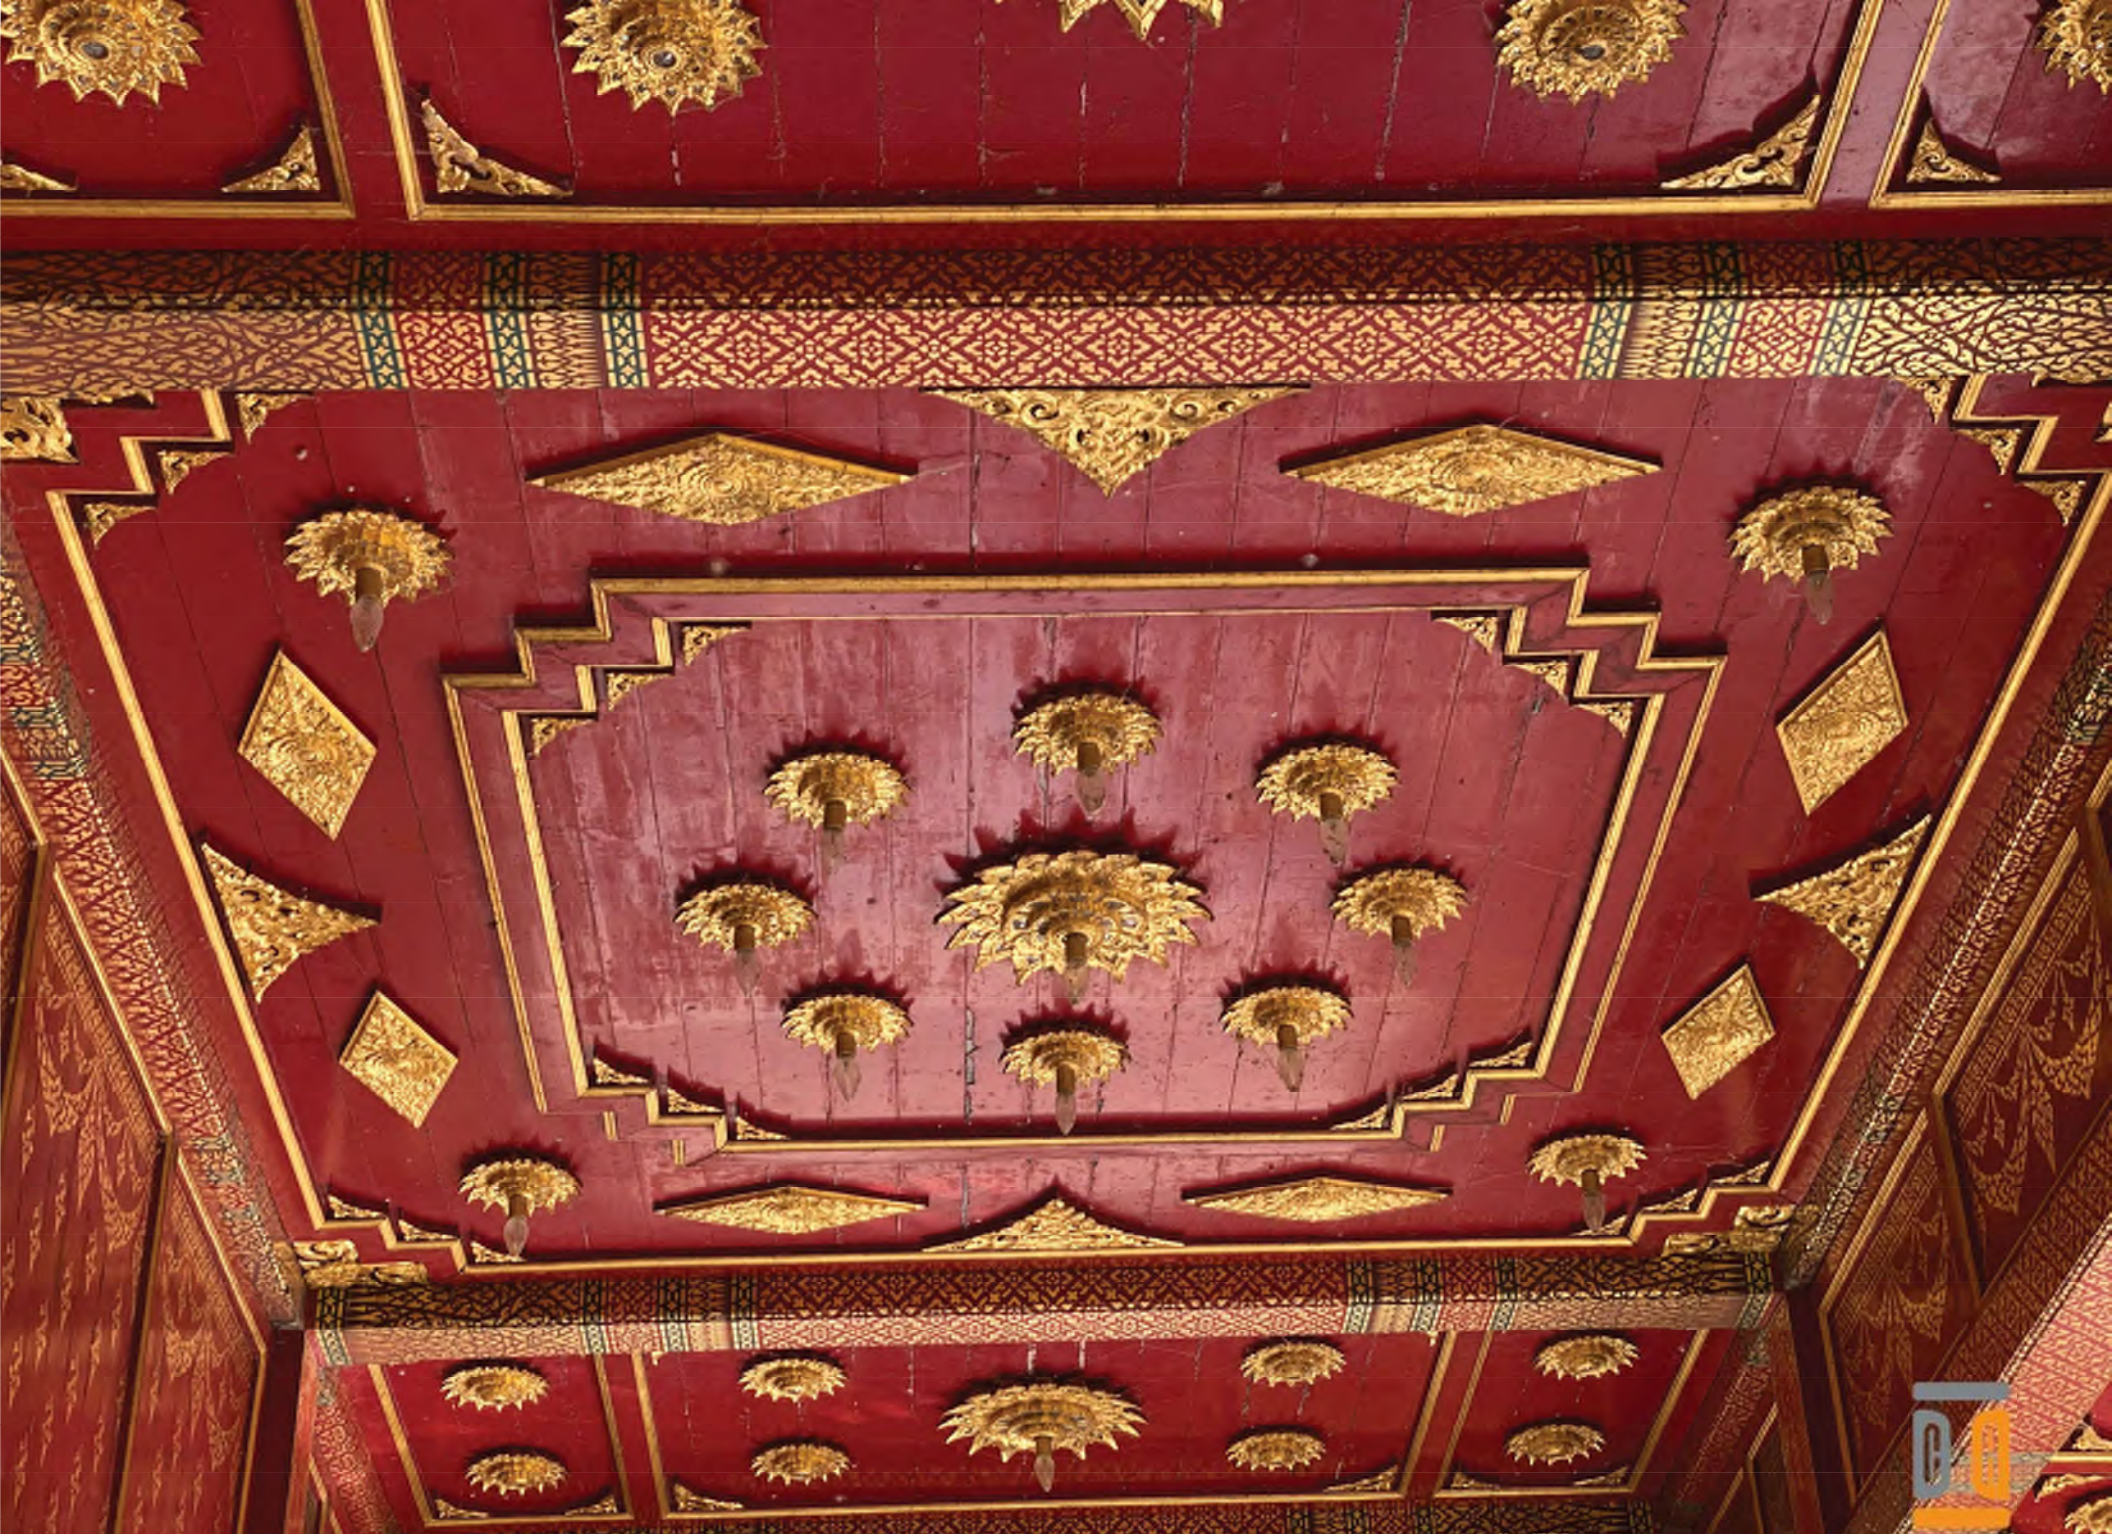
44. Interior Ceiling condition with buckling edges and paint failure - Priority 2

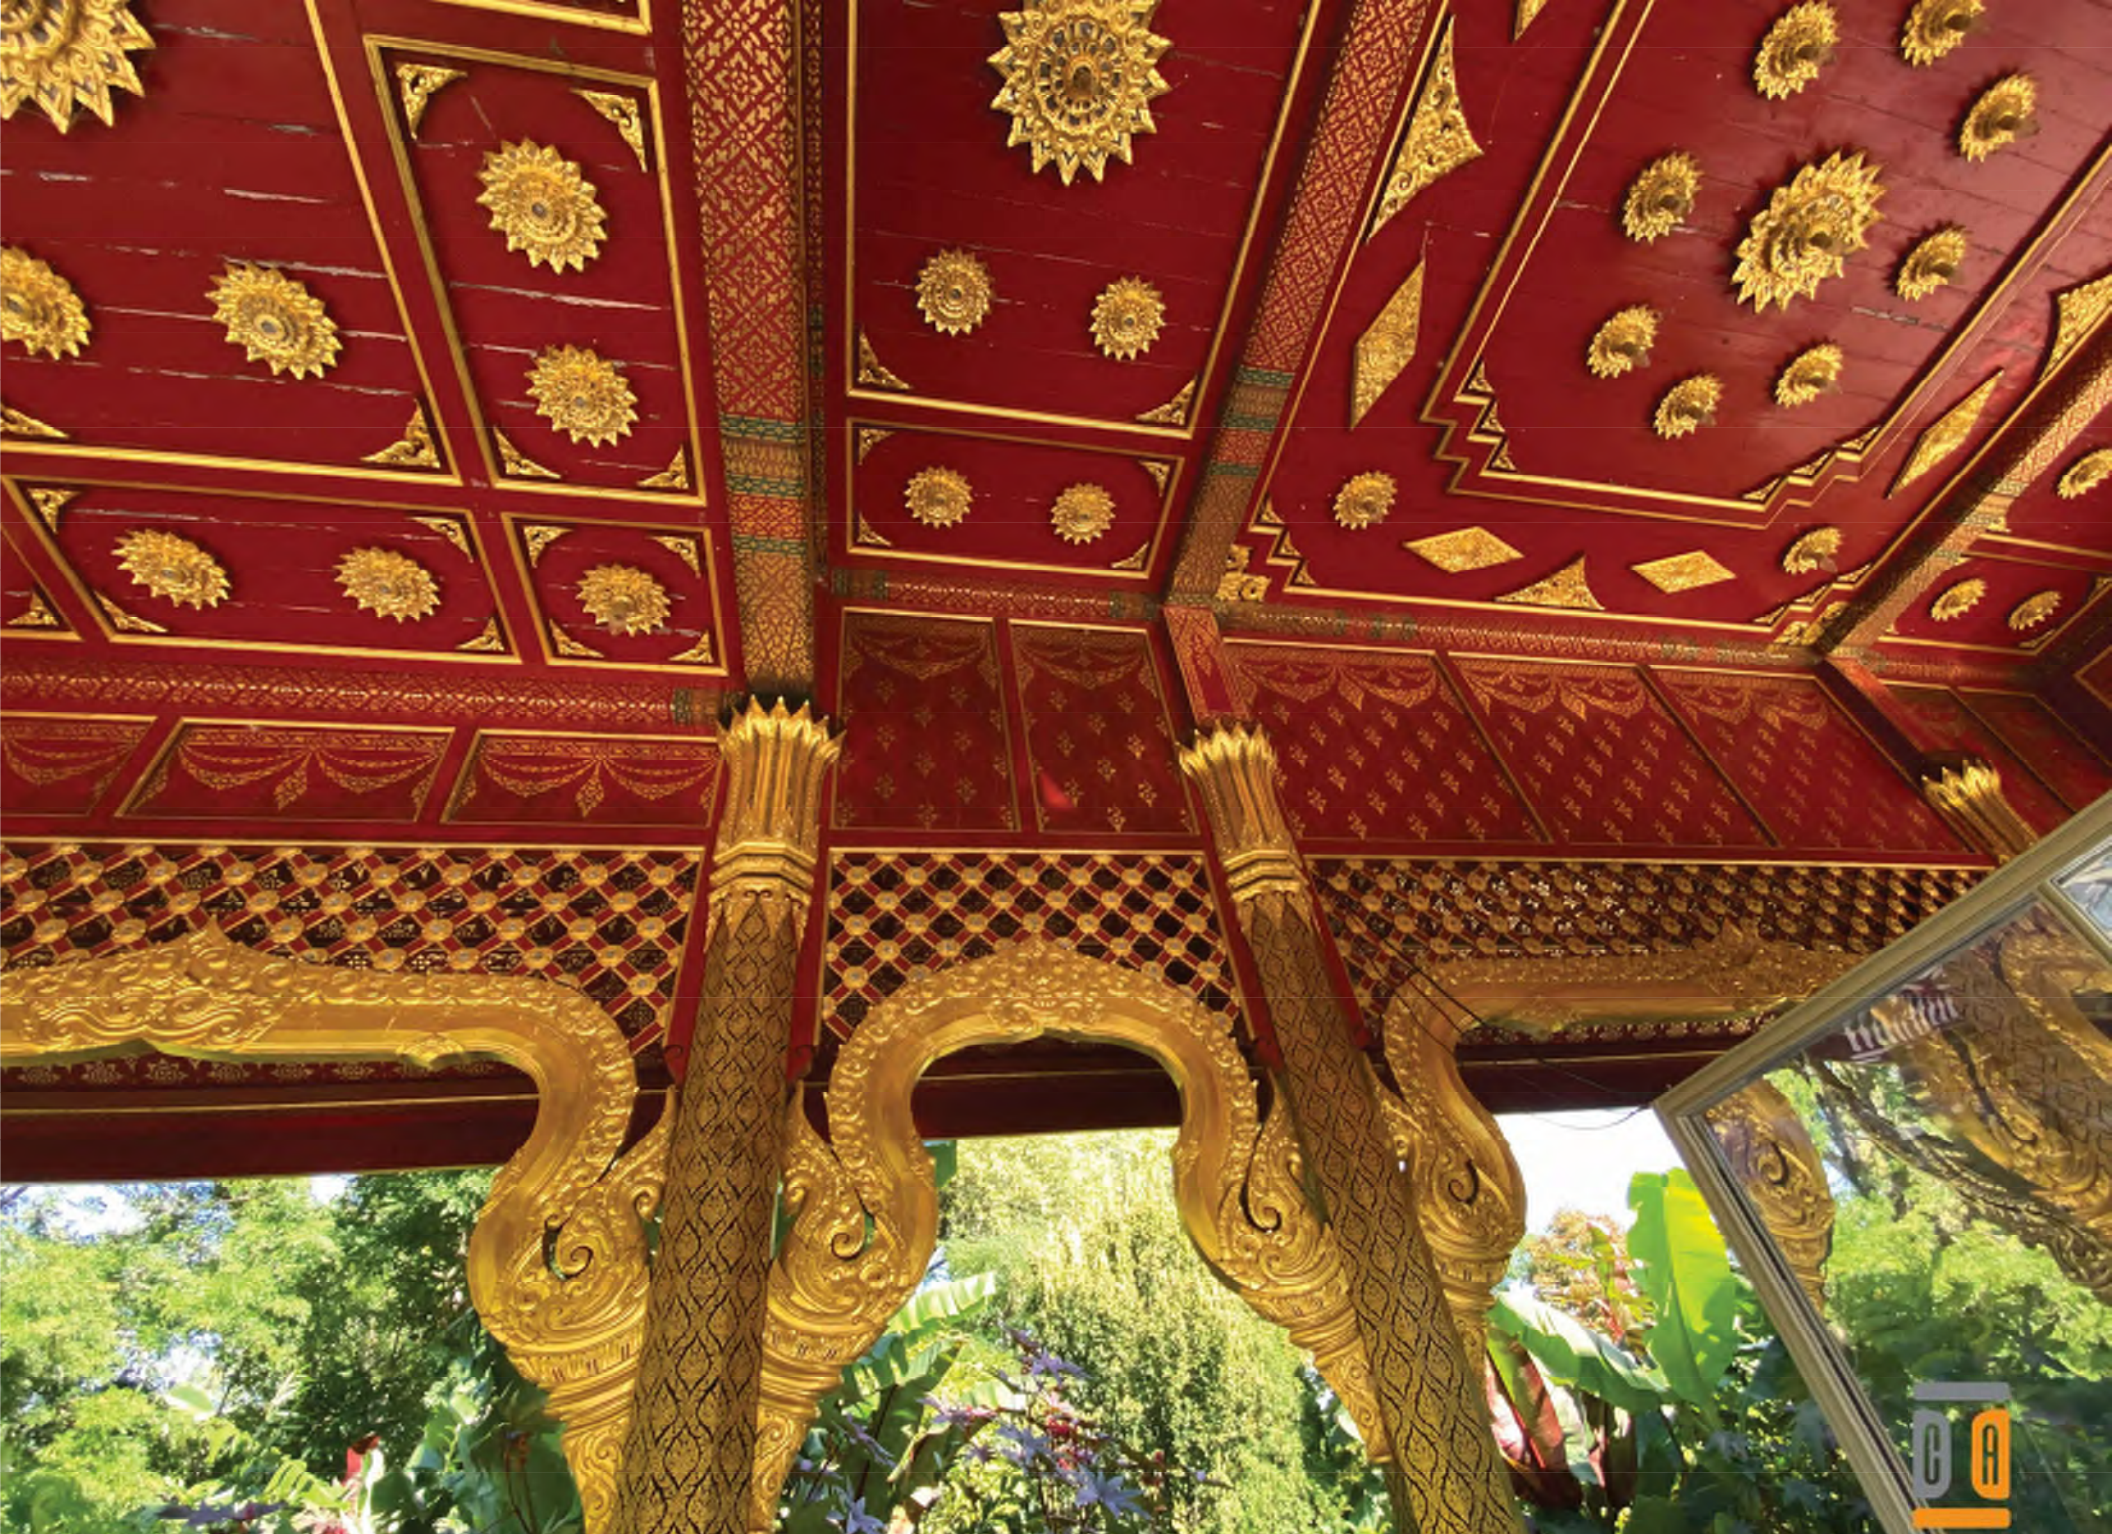
45. Interior Ceiling condition with buckling edges and paint failure - Priority 2

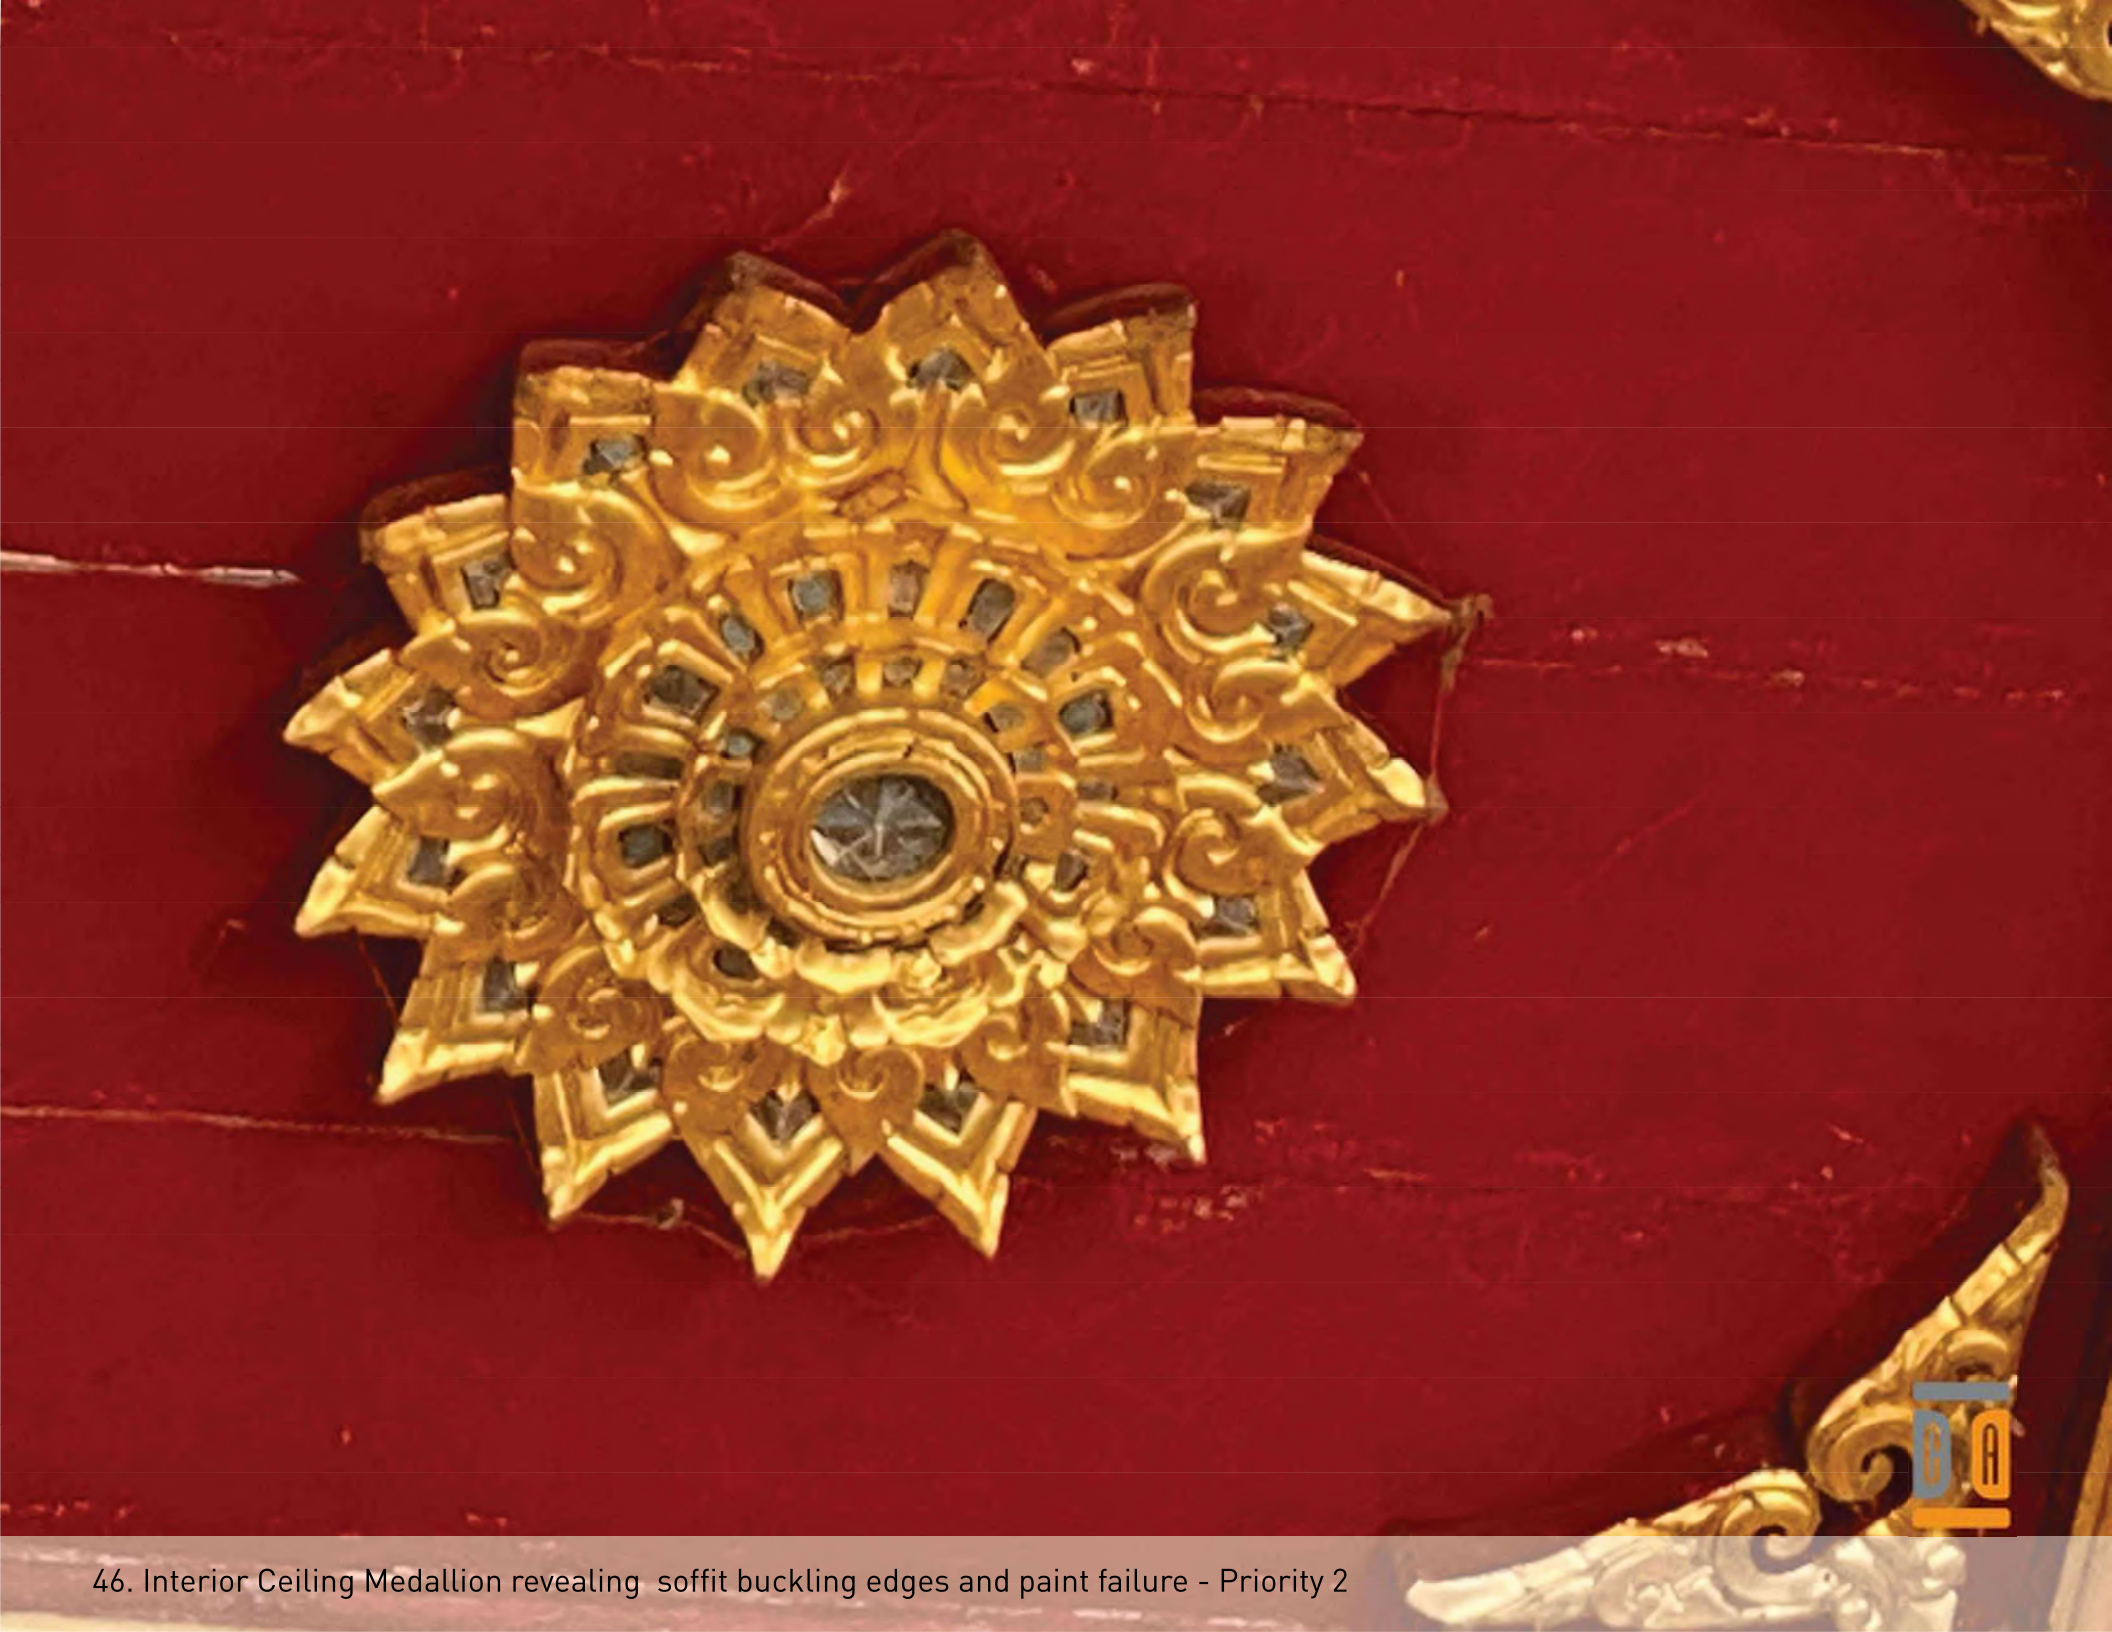
46. Interior Ceiling Medallion revealing soffit buckling edges and paint failure - Priority 2

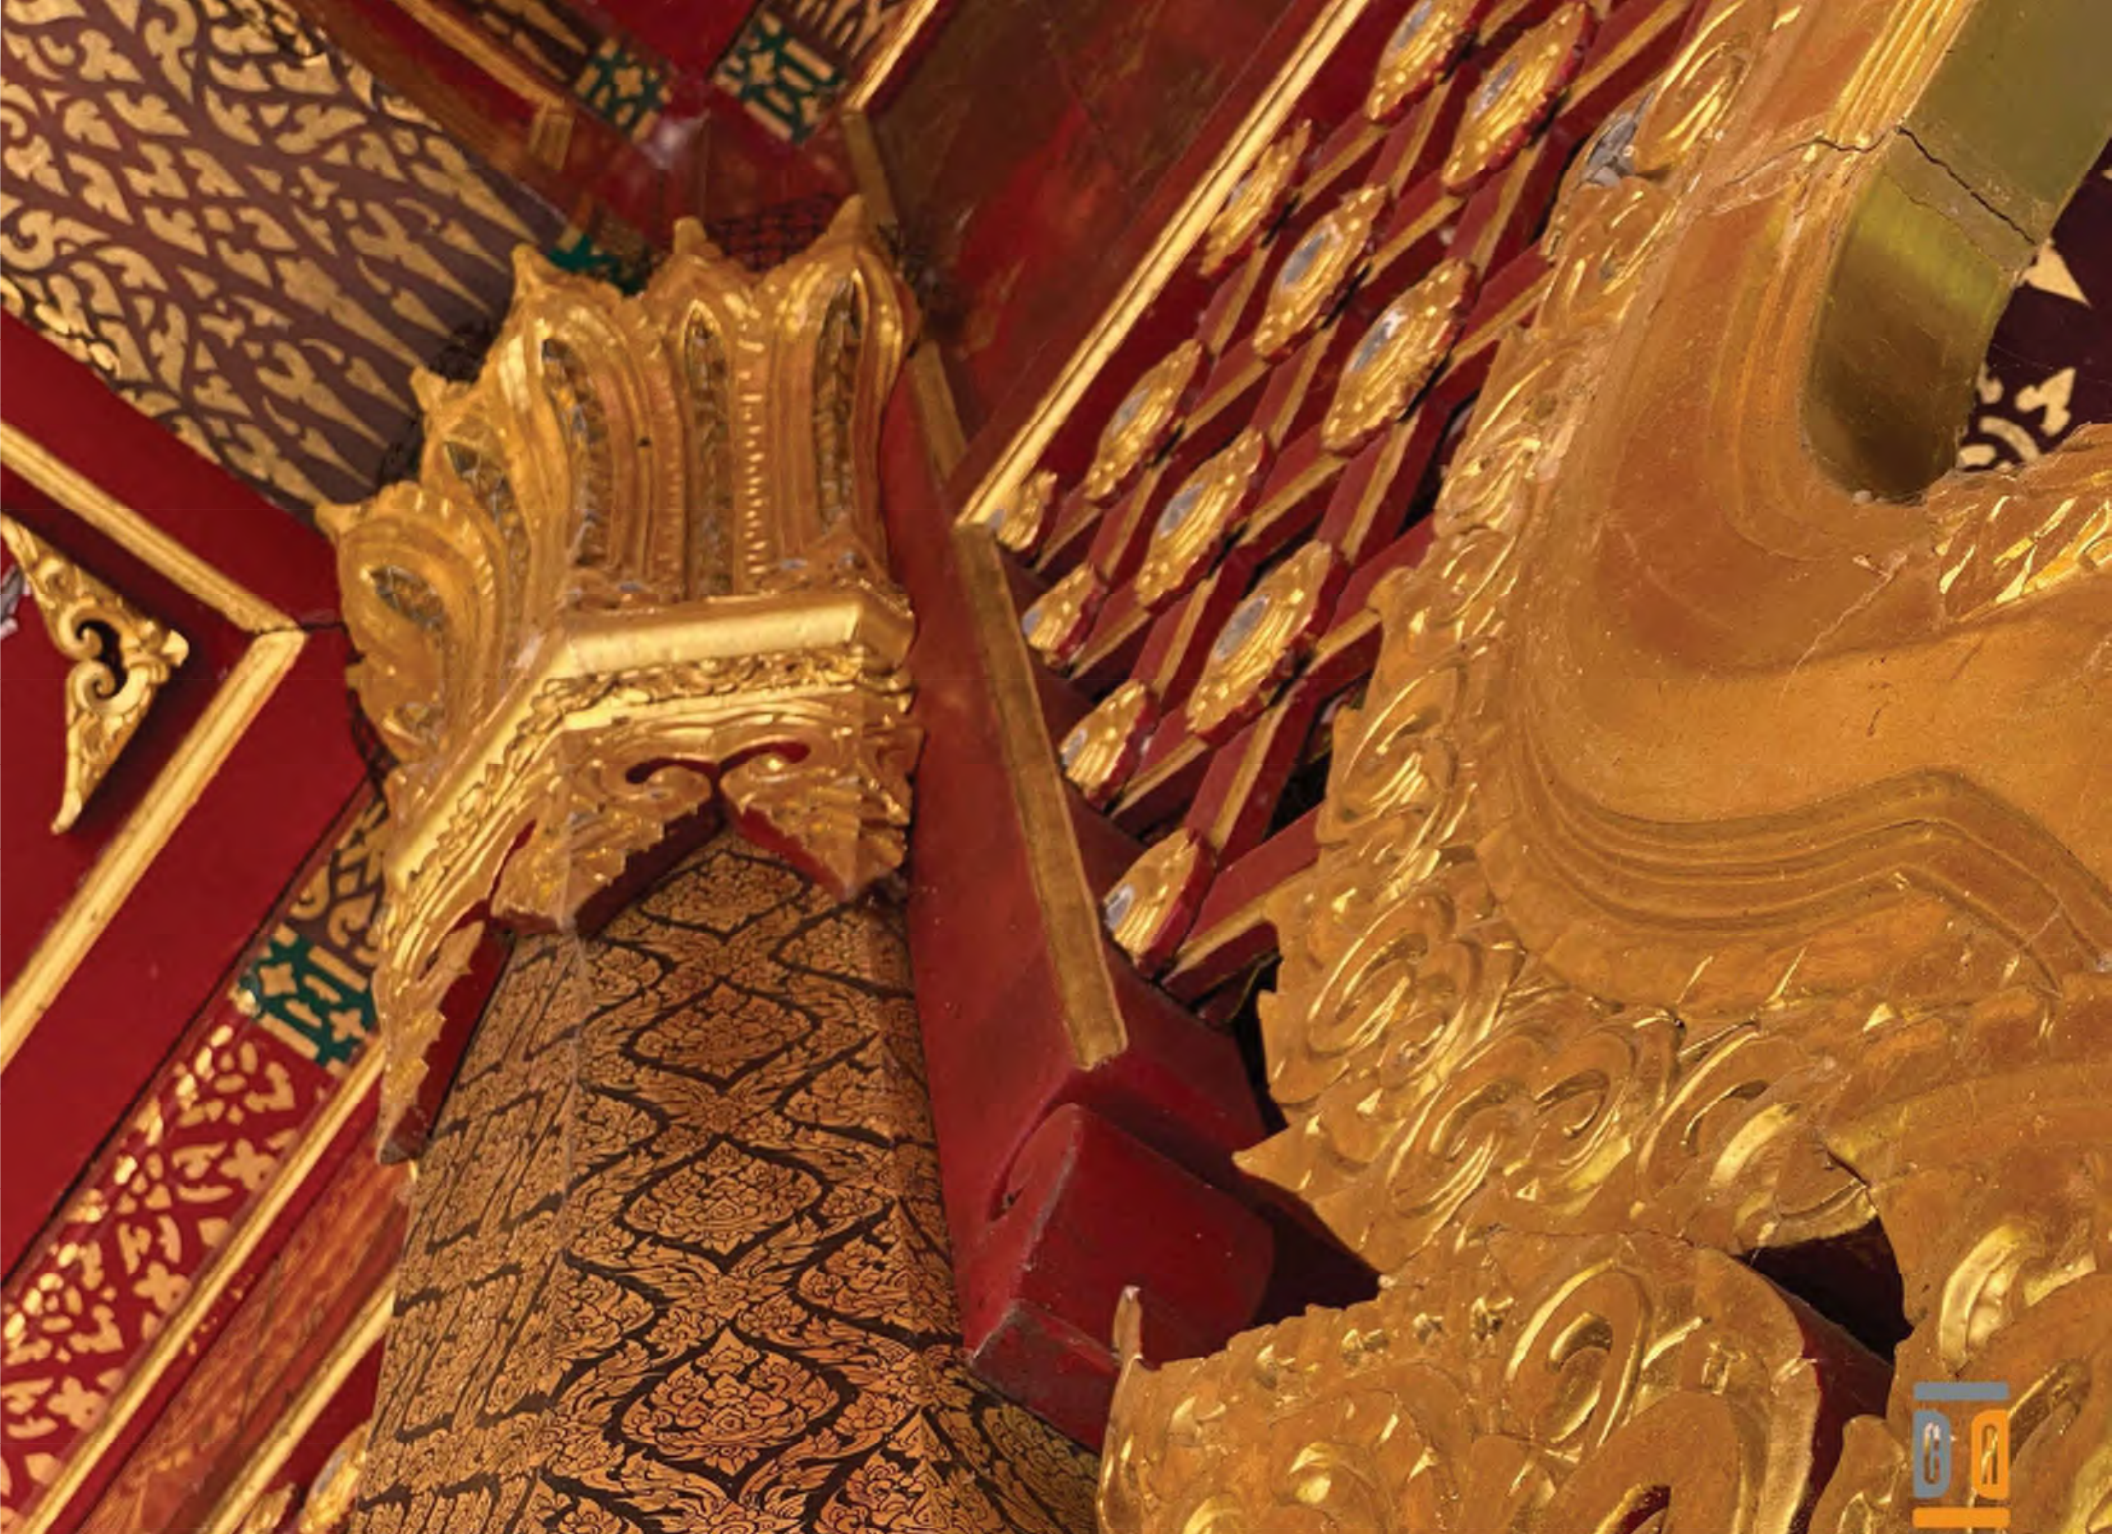
47. Interior Condition of column capital - Priority 2

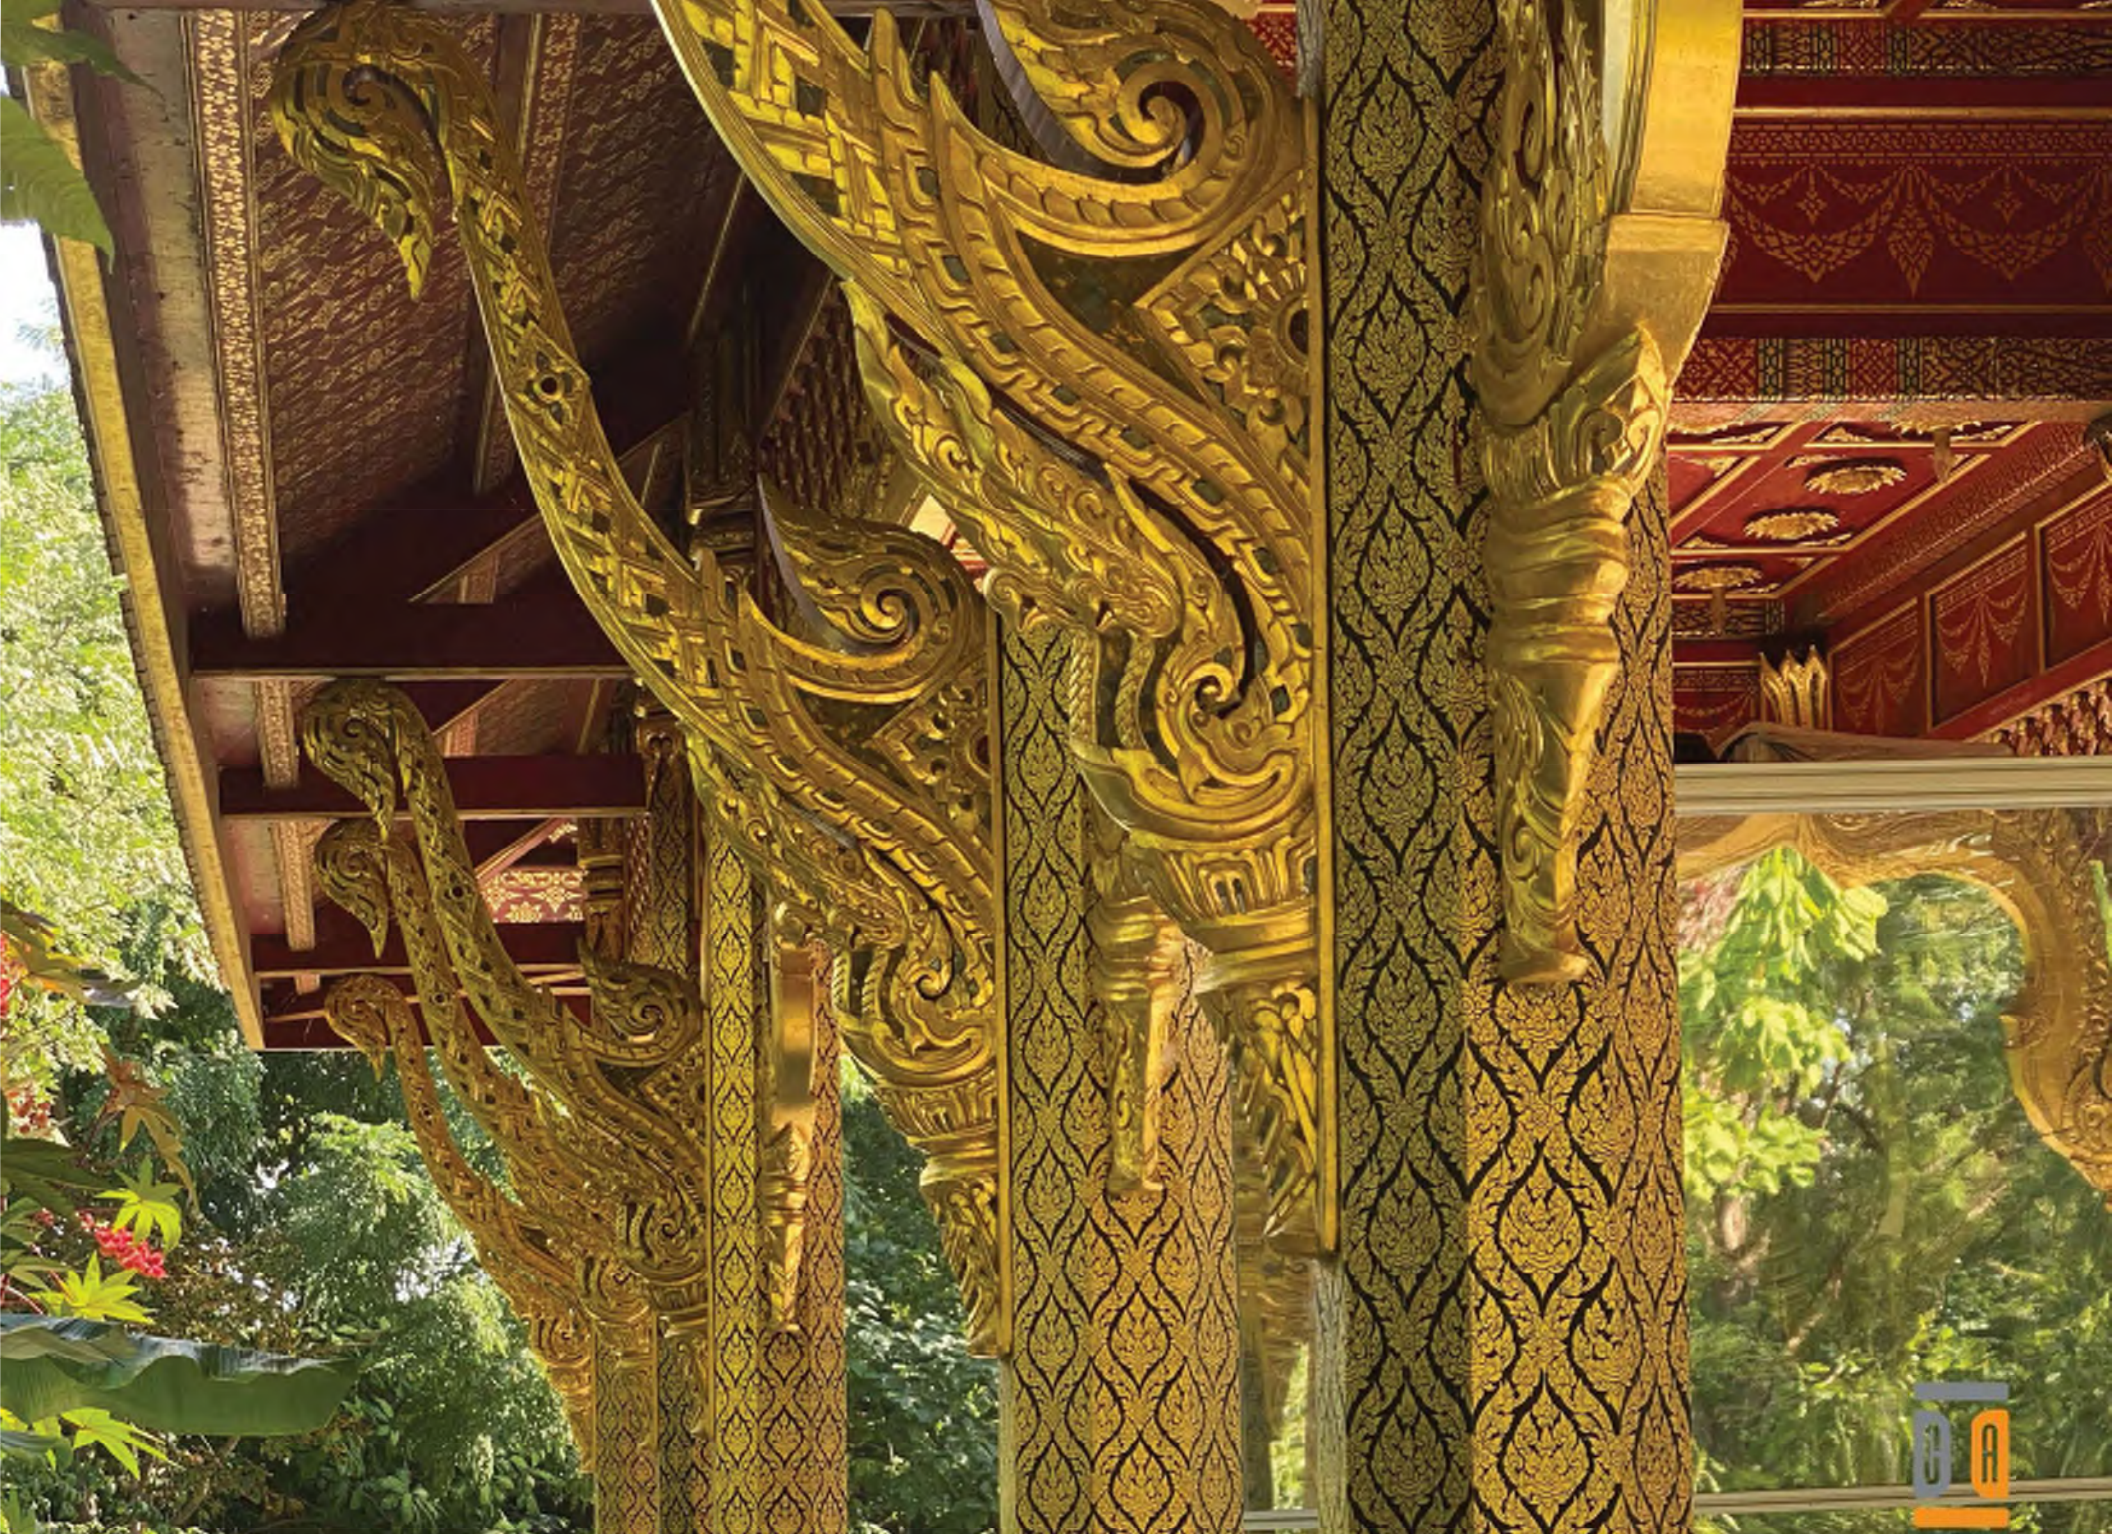
48. Exterior Condition of column capital - Priority 3
