OLBRICH BOTANICAL GARDENS ROYAL THAI PAVILION CONDITION ASSESSMENT REPORT

AUGUST 30, 2022

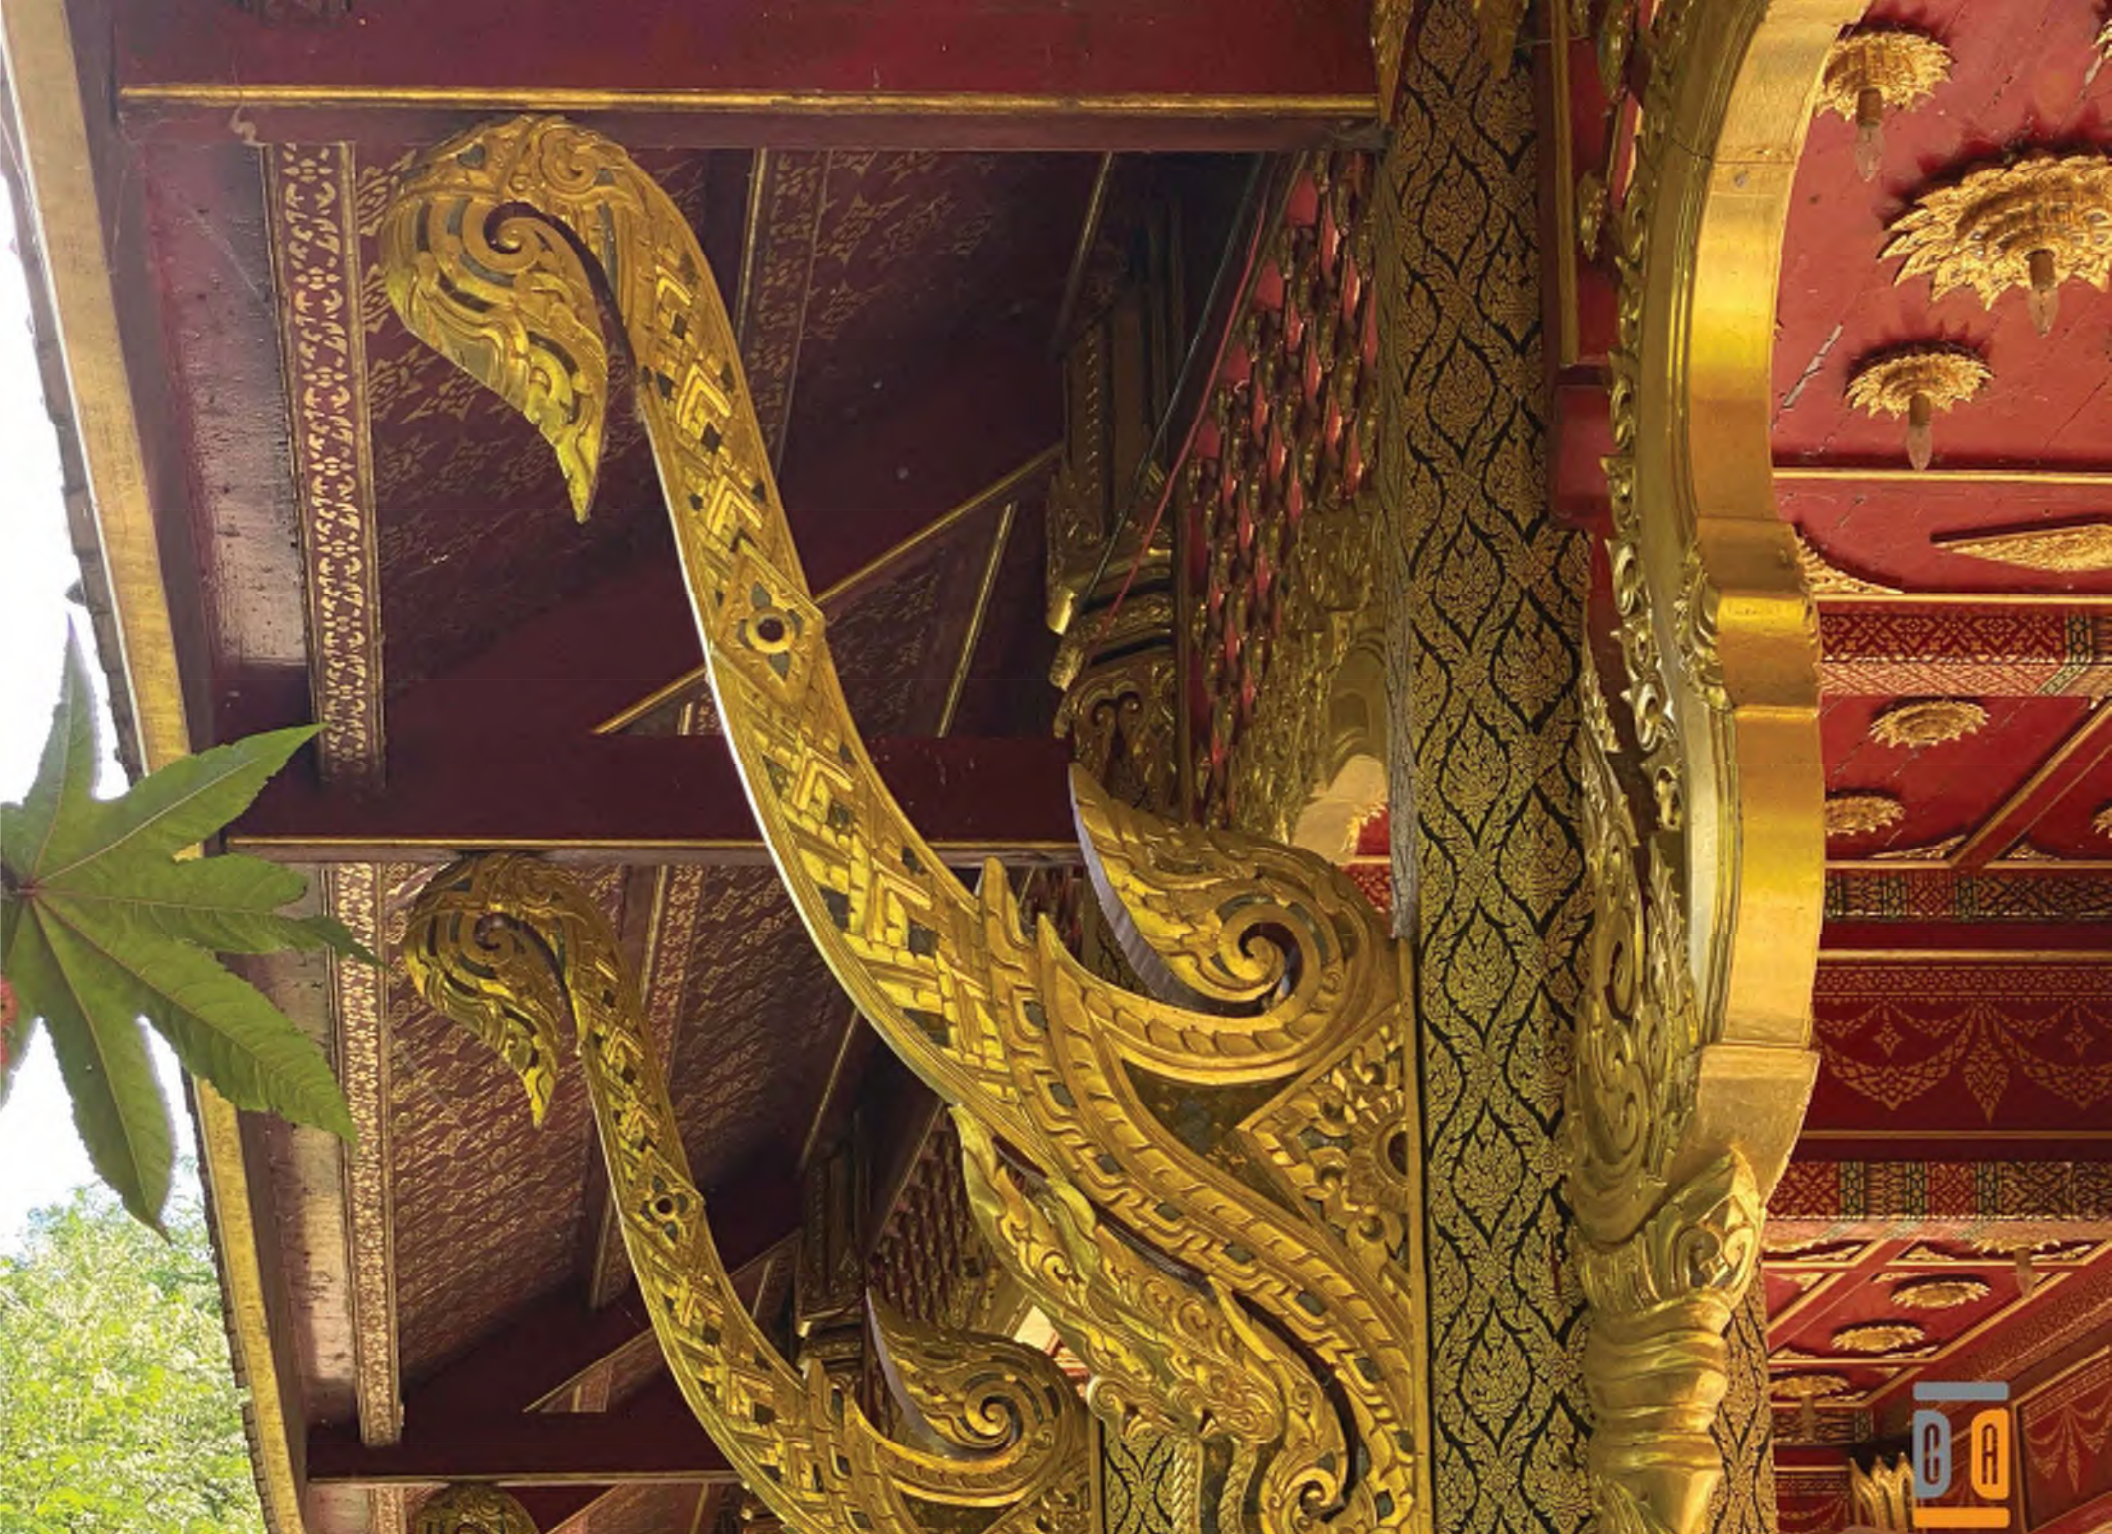
49. Exterior Condition of column capital - Priority 3

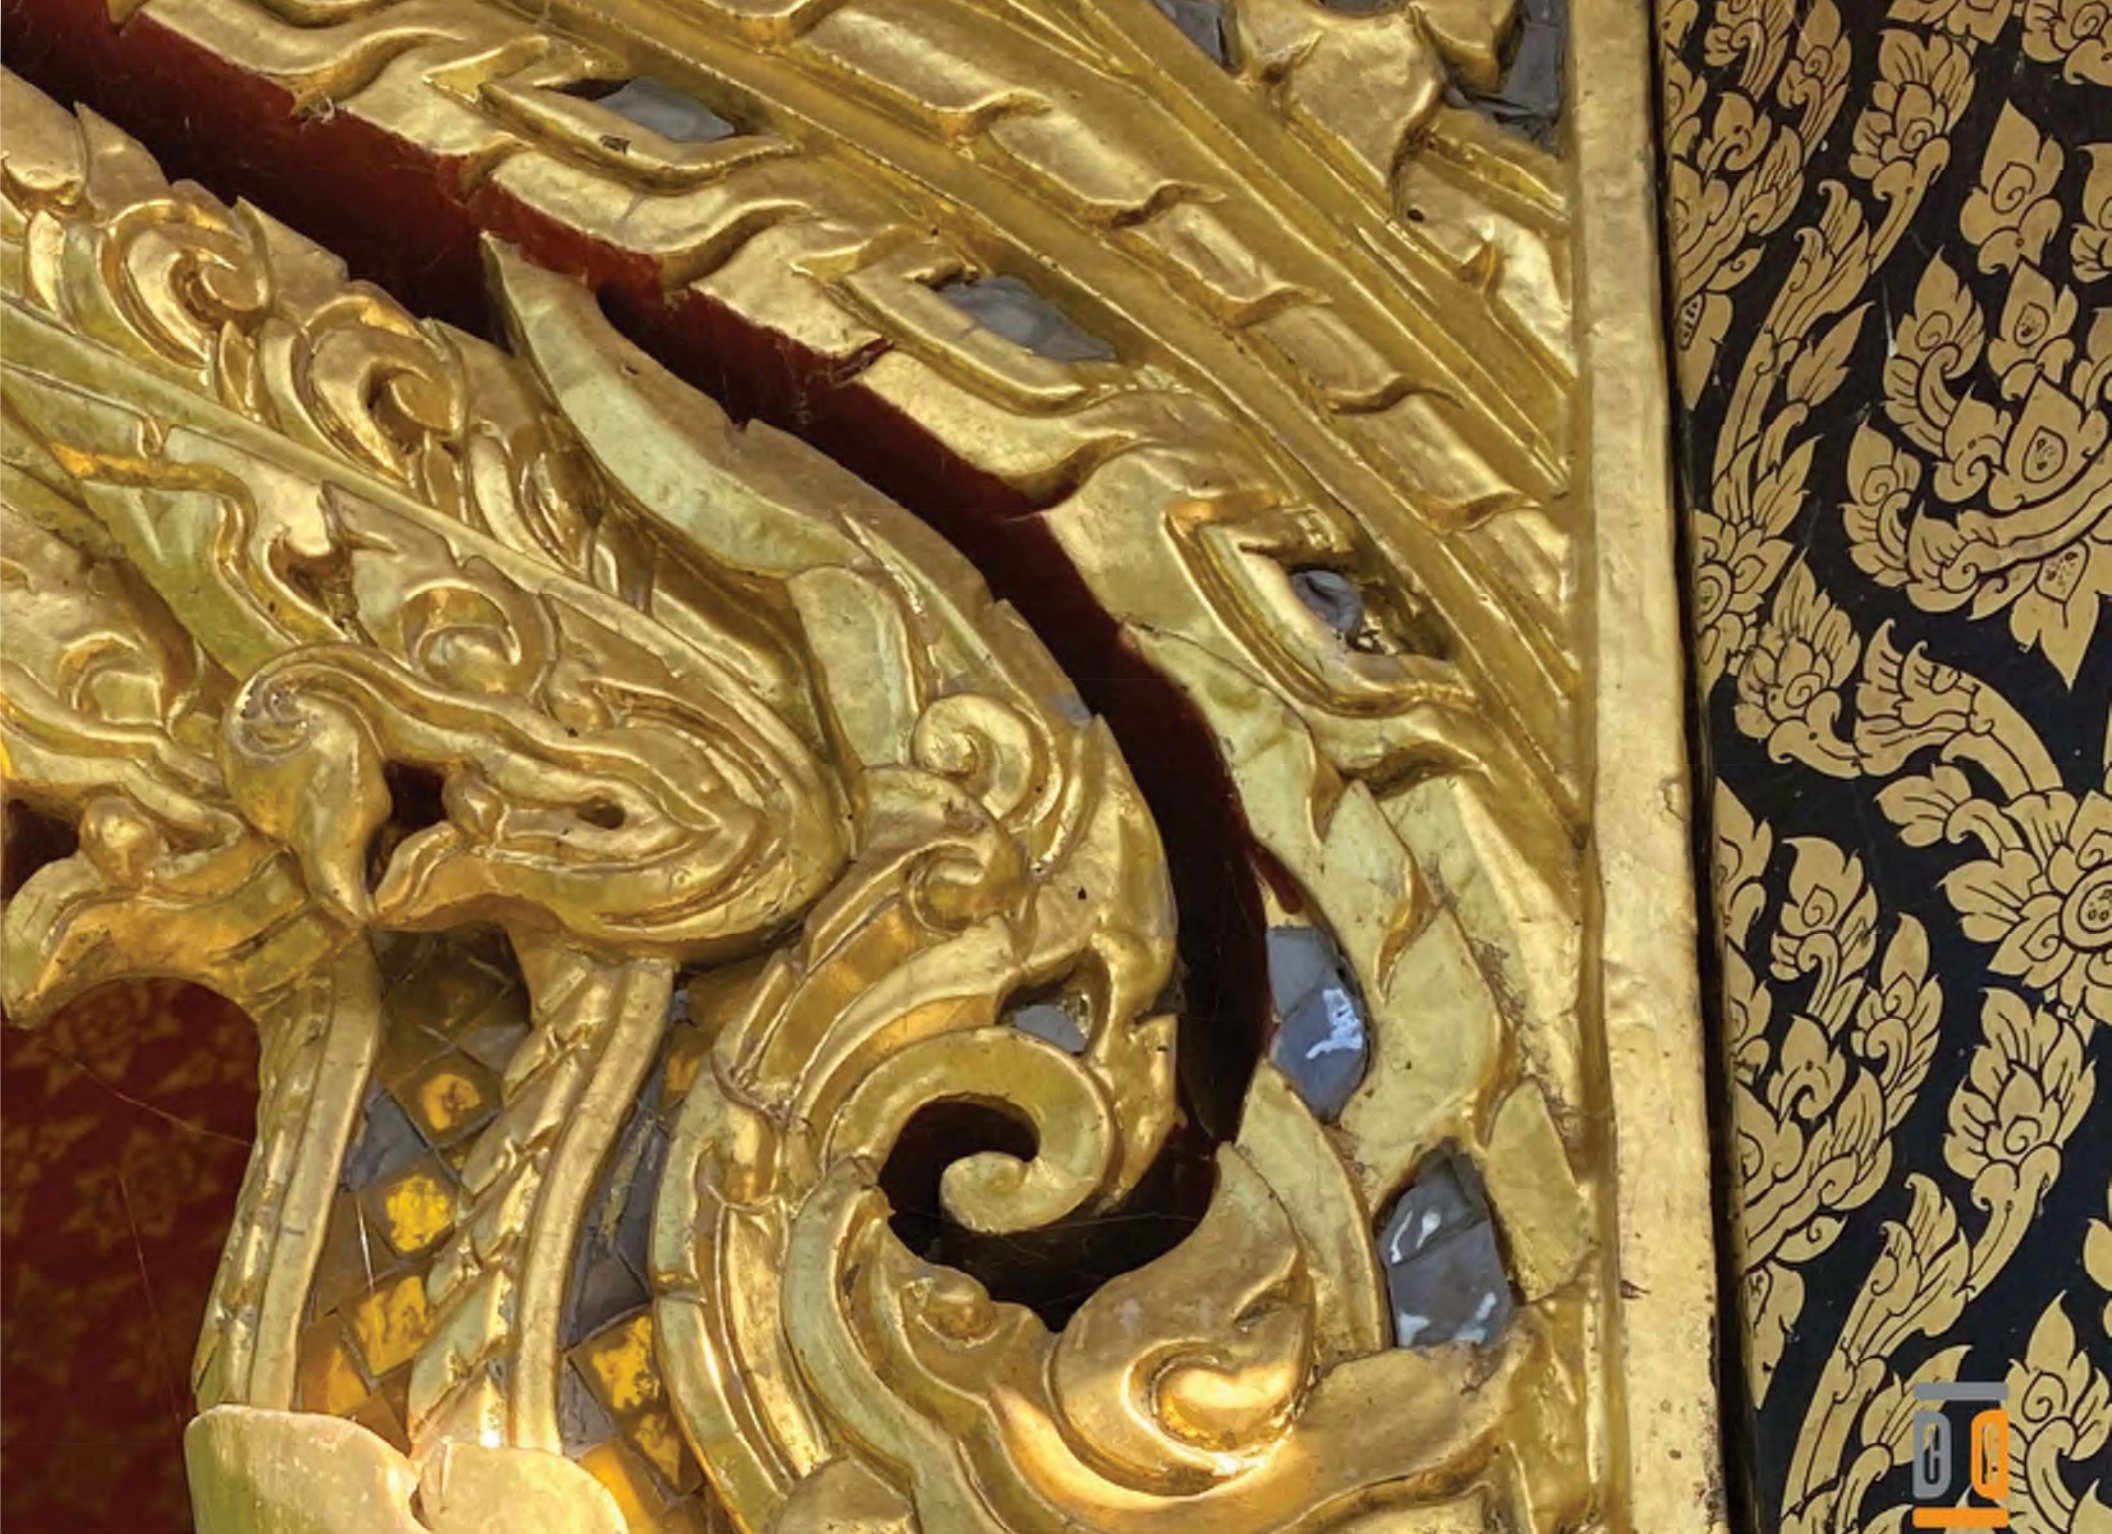
50. Exterior Condition of column capital - Priority 3

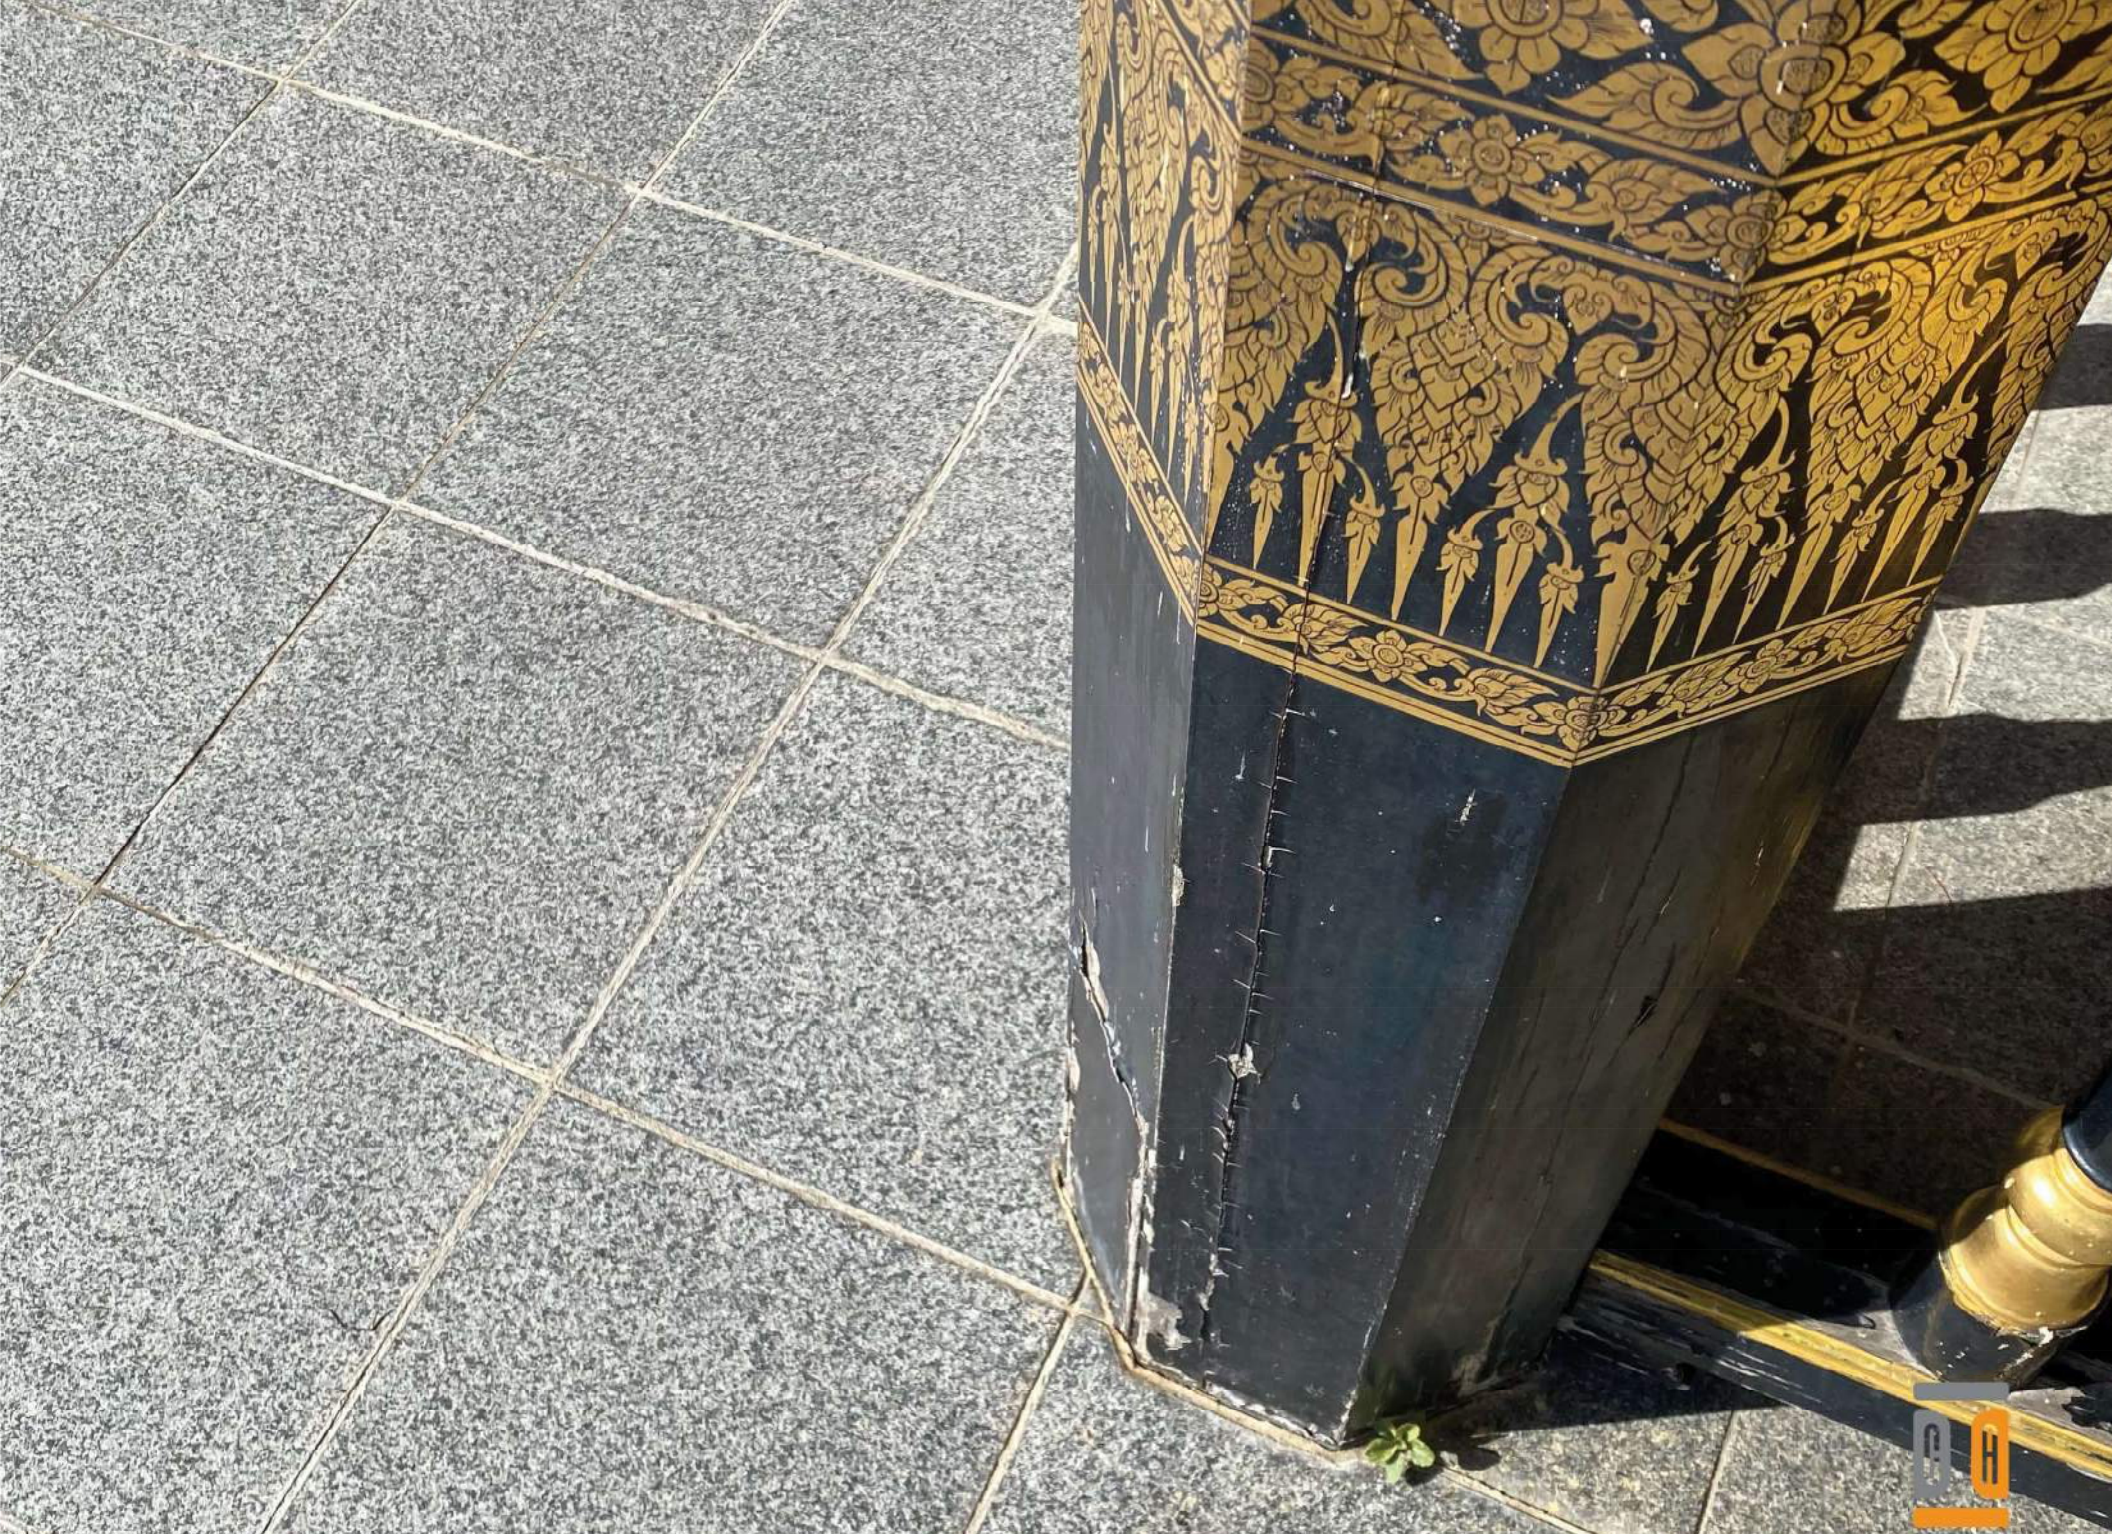
52. Column Base Condition with buckling wood seams and some dry rot - Priority 2
