OLBRICH BOTOANICAL GARDENS ROYAL THAI PAVILION CONDITION ASSESSMENT REPORT

MAY 20, 2022

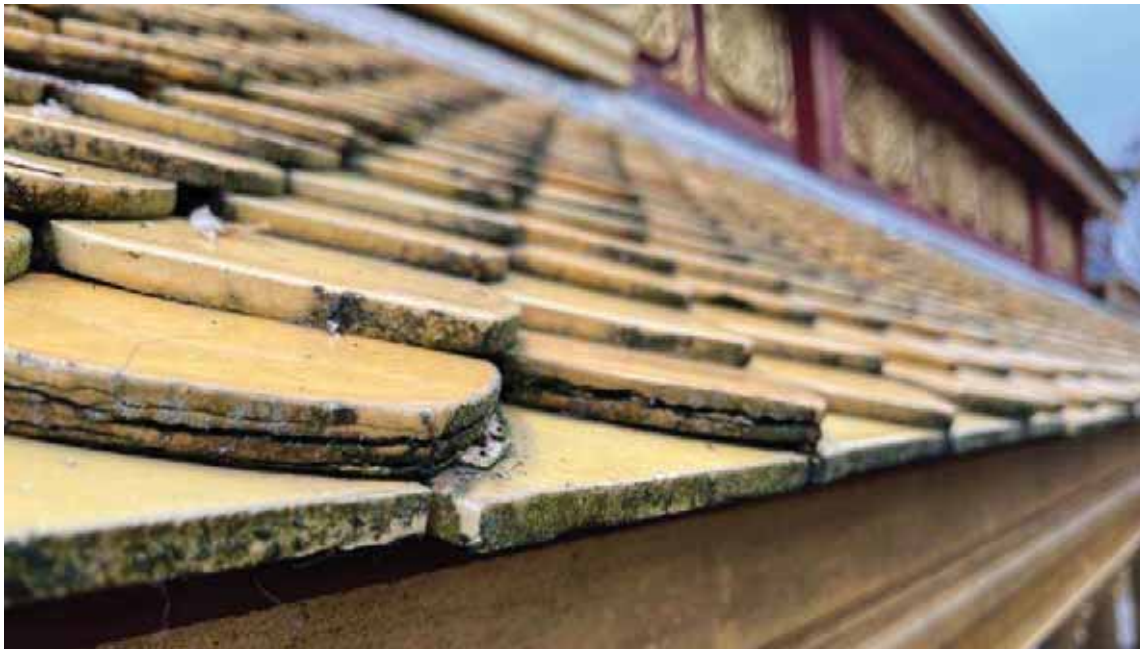
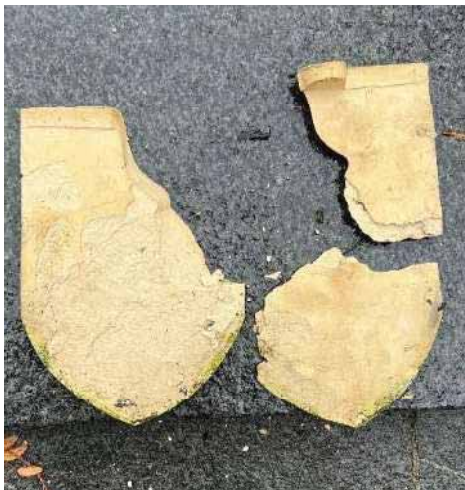
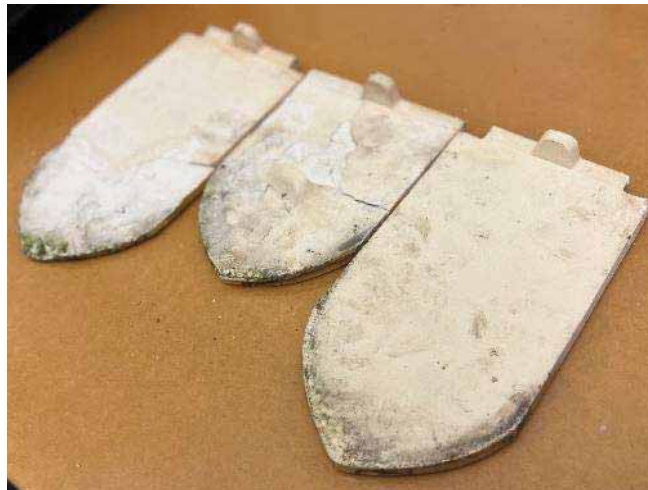
The condition of the roofing tiles is **CRITICAL**. The tiles are failing through splitting or shaling due to continued water exposure, and further deteriorating

through our Wisconsin climate's freeze-thaw cycle. It is assumed that more than 40% of the tiles are currently damaged. While testing has not been conducted on the existing tile nor the attic stock on hand, it is generally assumed that it is the Thai buff clay substrate that is not well-acclimated to withstand the typical weather patterns of our northern climate, regardless of enhanced treatments.

This damage classification is evaluated as the most extreme condition since the tiles were observed and have an extreme likelihood of falling off the roof, which could cause harm to the public below. It is recommended that, in the short term, barricades or netting be put into place to prevent any possible injury. Upon review of the fall zone with a structural engineer, a barricade should be placed a minimum of eight feet from the structure to isolate the fall zone for the tiles.

A full replacement of the roofing tiles is recommended. The replacement tiles themselves should be recreated in shape, size, and glazed color, yet be made of an alternate clay material that is compatible with the Wisconsin climate. The tile should be convex to match the existing tiles for aesthetic and technical reasons. The overall surface of the tile will look much more uniform if the tiles are manufactured in this way. The tile should be laid in the same pattern and method, utilizing the tabs as originally designed. Modern substrate materials and roofing methods should be incorporated to prevent further water infiltration to the remaining structure. These will include contemporary synthetic underlayments, sub-tile membrane, and flashing systems. These systems must be carefully engineered to allow for the freest possible flow of water vapor and resist bulk water from above being introduced to the interior portions of the pavilion.

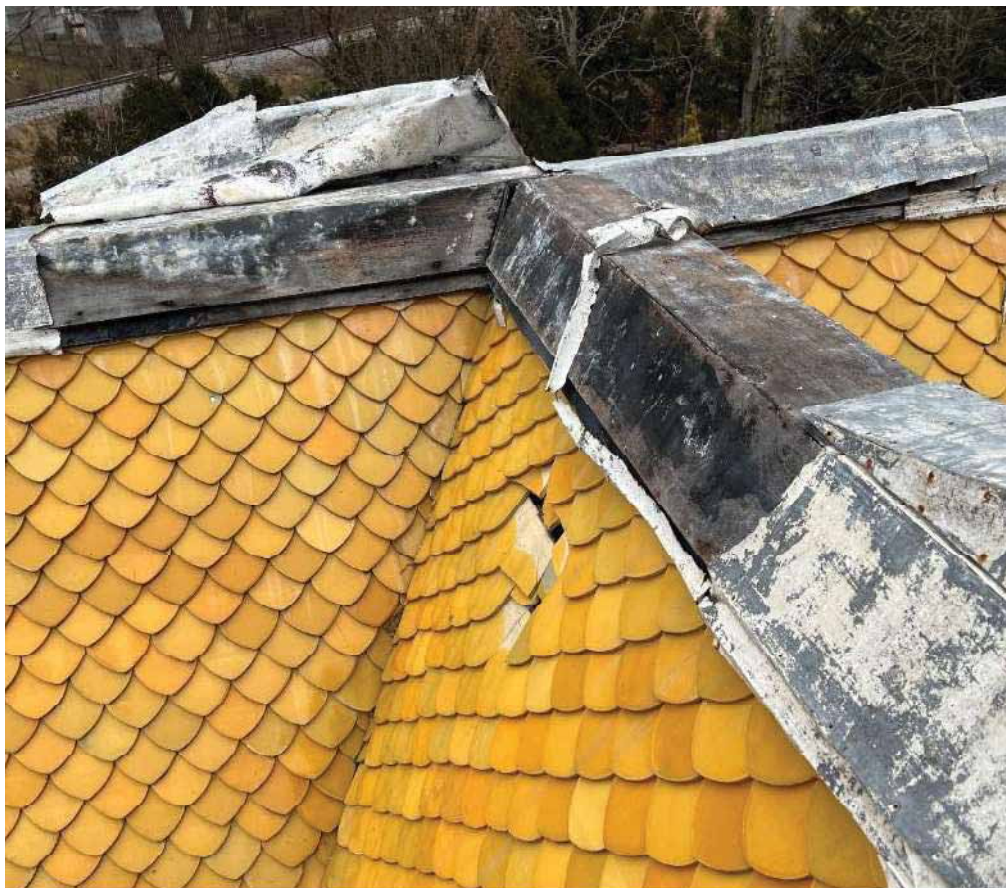
The existing lead flashings were observed to be under designed; a heavier grade of lead would have resisted some of the damage that has obviously been done to the flashings. Further exacerbating the issue is the lead flashing attachment material and method. Carbon steel fasteners were used in the installation which have caused a cascade of issues that include the degradation and failure of both the fasteners and the lead due to galvanic cell action. Cyclic fatigue brought about by a loosely attached flashing (due to the galvanic degradation noted above) has opened significant voids in the flashings

which has allowed water infiltration at the fastener locations as well as at the areas that have pulled apart from the wood substructure. The lead flashings are entirely missing or severely deformed in several locations, again, due to the lack of adequate material, attachment and the cyclic fatigue brought about by the constant effect of wind and the occasional high wind event. The use of standard steel fasteners and nails has also caused rust and enlarged holes in the lead loosening their fastening ability. This open condition is also now subsequently exposing the formerly concealed untreated wood components below these areas also causing premature decay and deterioration. For this reason, we classify these areas as **CRITICAL** conditions.

A secondary challenge to the structure is the lack of adequate flashing systems at the valleys and wall to roof junctures (wall and apron flashings). These conditions are contributing to the premature failure of some finish materials, and degradation of some of the teak structural elements. Proper flashing design and installation will help to prevent wind-driven rainwater from entering the structure and contributing to further wood decay of the roof substructure and associated finishes. These areas are also considered **SEVERE** conditions.

It is recommended that all flashings be replaced in kind with new materials that match the existing in all ways except in their overall grade, or weight. Replacement materials should be fastened minimally with double hot-dipped galvanized nails that have been confirmed to be compatible with new flashings. Additionally, the **MINIMAL** use of some Ice & Water Shield would also assist in the proper drainage of the roof areas. This material may be used very sparingly and must not be considered as a final, primary roofing substrate.

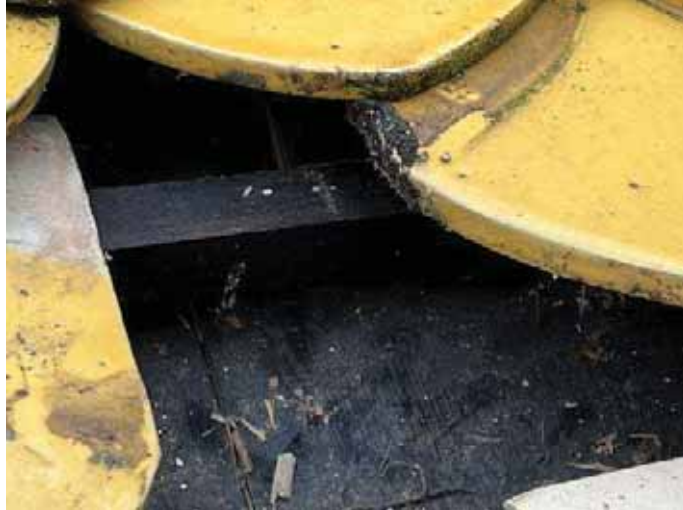
The wood roof substructure is in **GOOD** overall condition; no significant work should be anticipated for this building component.

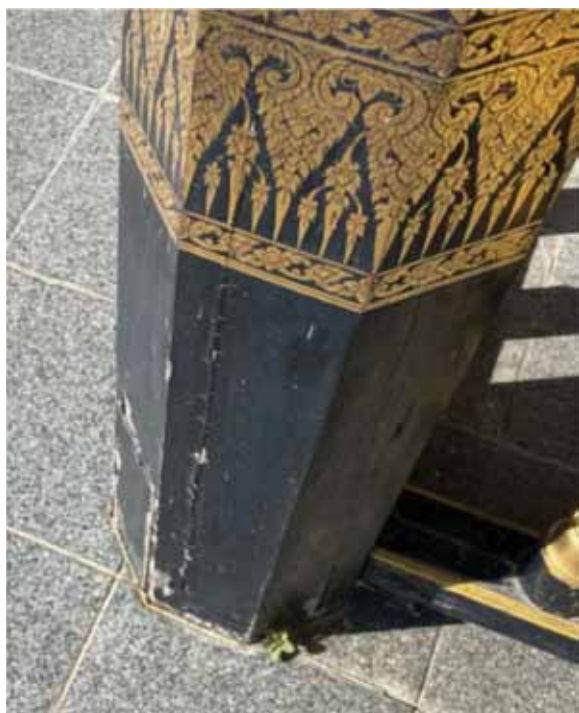
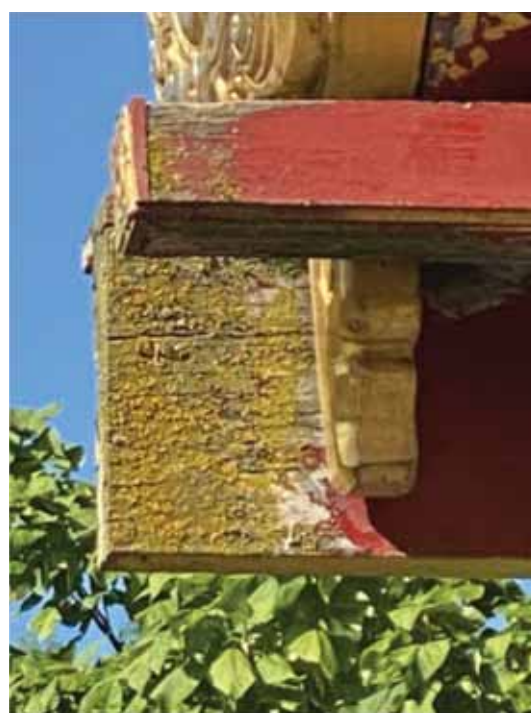
These elements are in **FAIR to POOR** overall condition. Water damage to these elements is causing some collateral deterioration. The wood columns reveal water damage at the bases. The rafter ends are becoming dry rotted and require repair. The painted wood ceiling and soffit panels show signs of buckling seams and popping paint.

It is recommended that the repair of these elements commence after the water issues (especially those that are reaching the interior components) are completed. Wood consolidation repairs will be employed in areas where differential weathering will not be an issue. Partial replacement dutchman repairs can be used in very limited locations depending on the skill of the carpenters and craftspeople working on the project. Full replacement of any wood element will only be completed as a last-resort response to an area that will not be able to repaired to the point where other less invasive repairs will provide a long-term/permanent solution. New paint/lacquer coatings should be applied to consolidate the exposed areas.

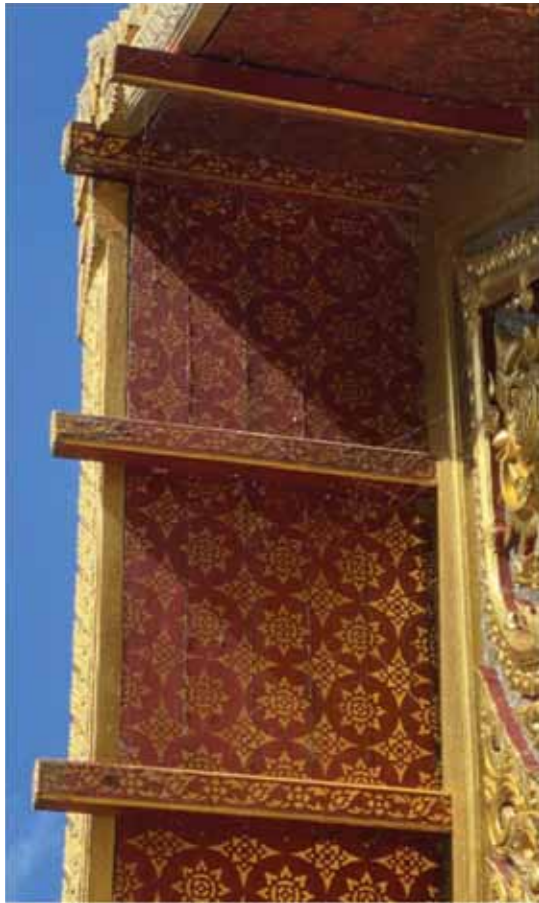
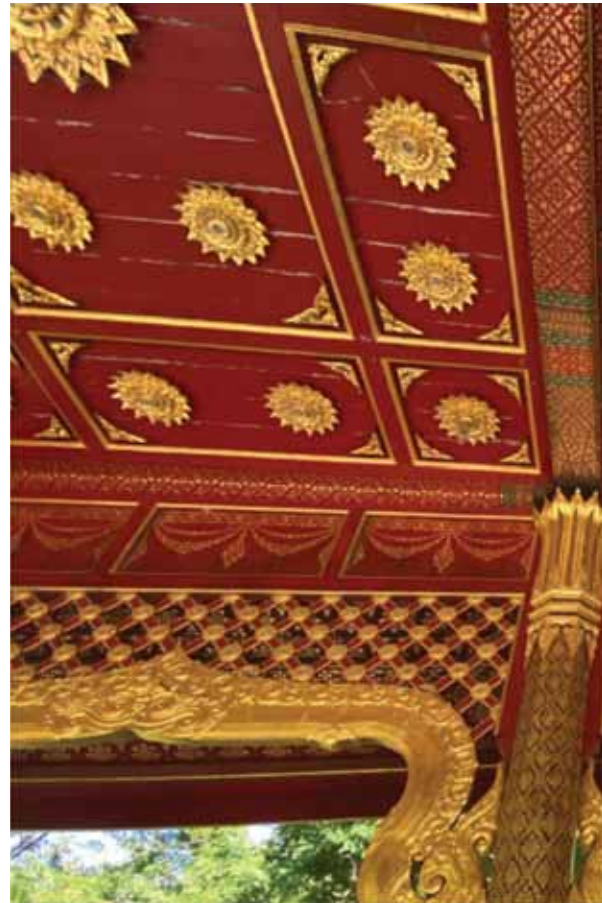
The conditions of the decorative finishes are in generally **FAIR** overall condition, yet **CRITICAL** in some locations. The existing finishes exceed their standard life period and the relatively harsh Wisconsin winters have taken their toll. Areas at extreme water exposure have seen their finishes completely washed away – most notably at rafter ends, ceiling boards, and column bases. Ongoing gold leaf maintenance is required, and could be as often as every few years when exposed to the elements.

The structure is in need of new coats of lacquer and gold leaf. These remedial finishes should be done under the instruction of Thai artists to ensure the proper techniques are used to refresh the building.

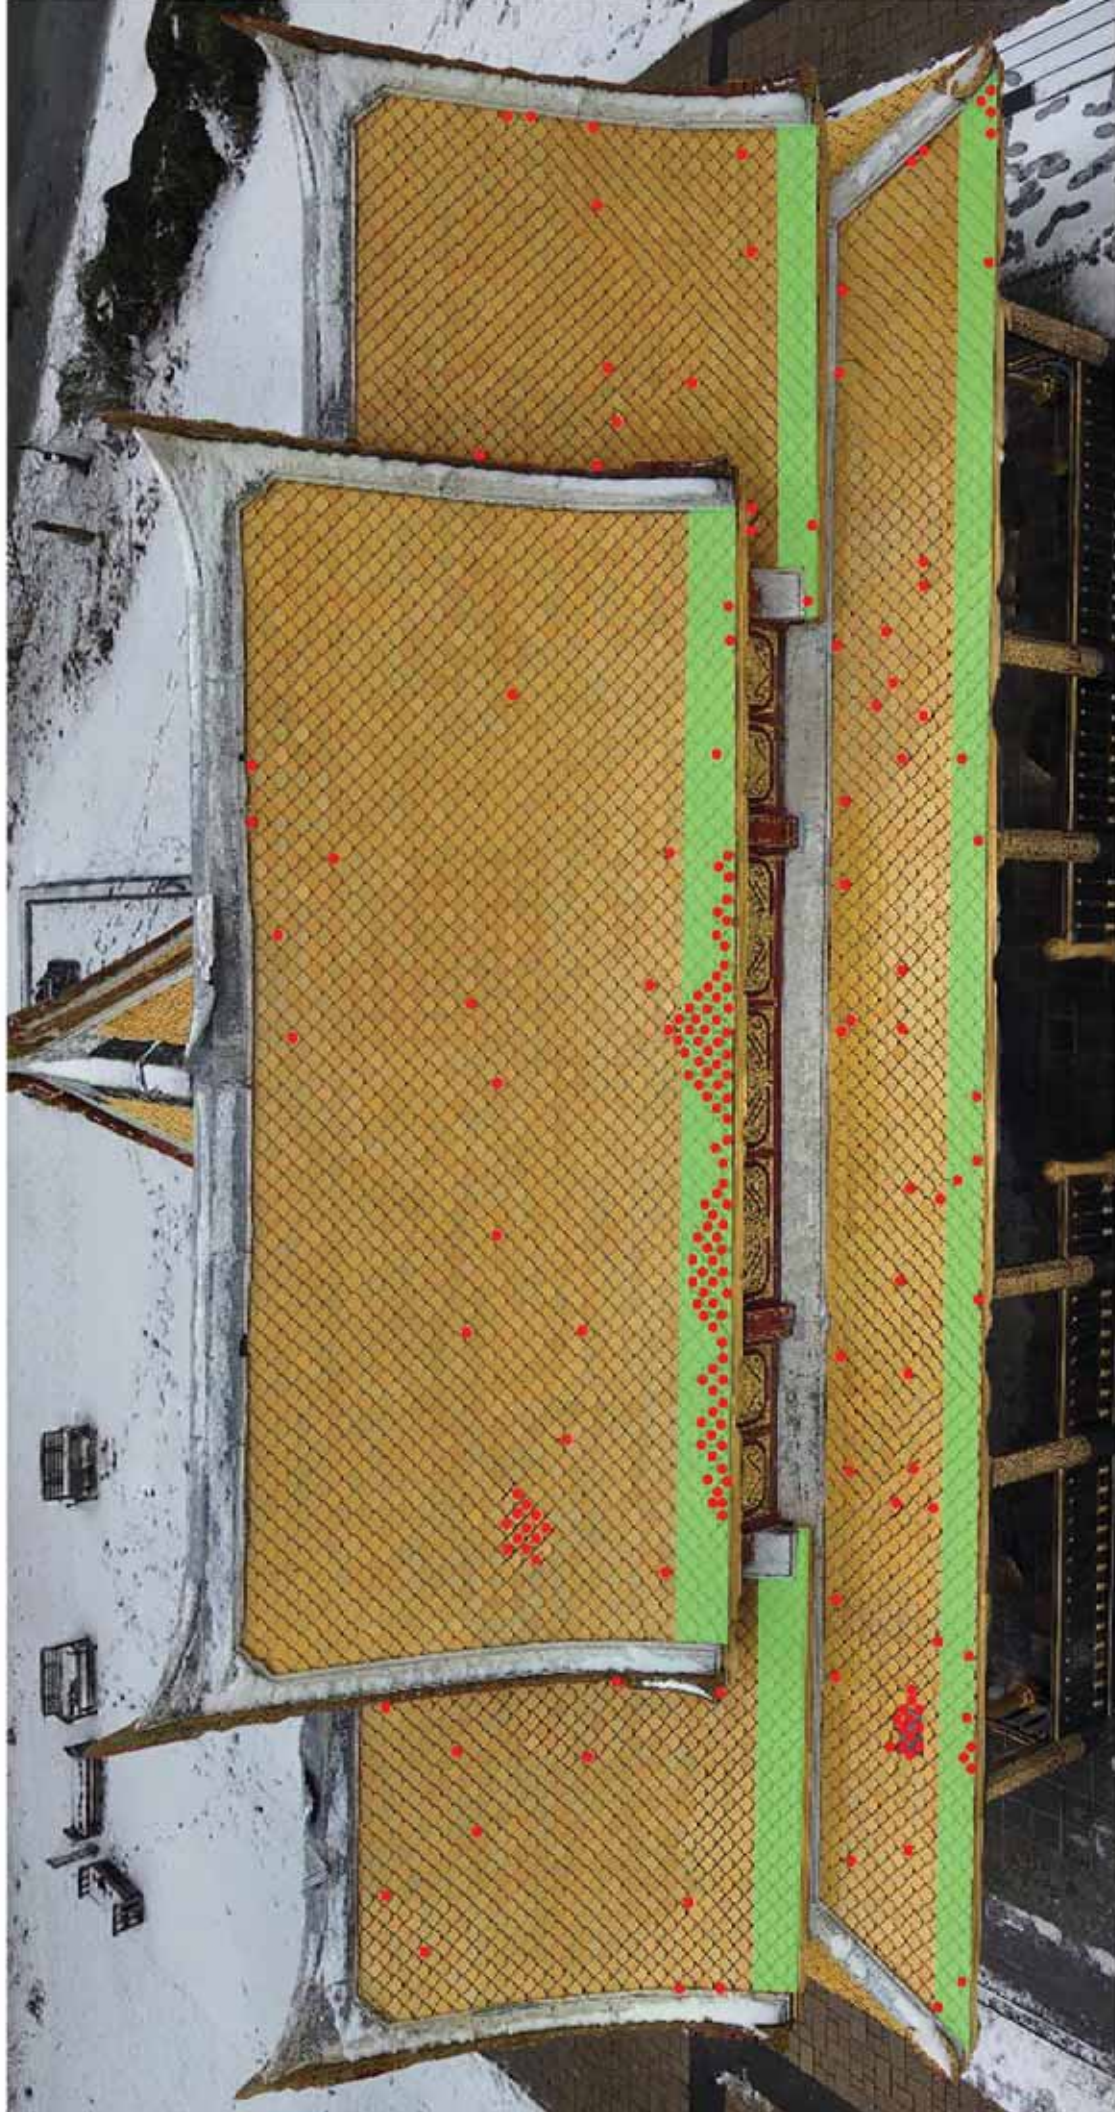
1. East Roof - Initial observed damaged tiles from aerial view (not accounting for shear cracking) - Priority 1

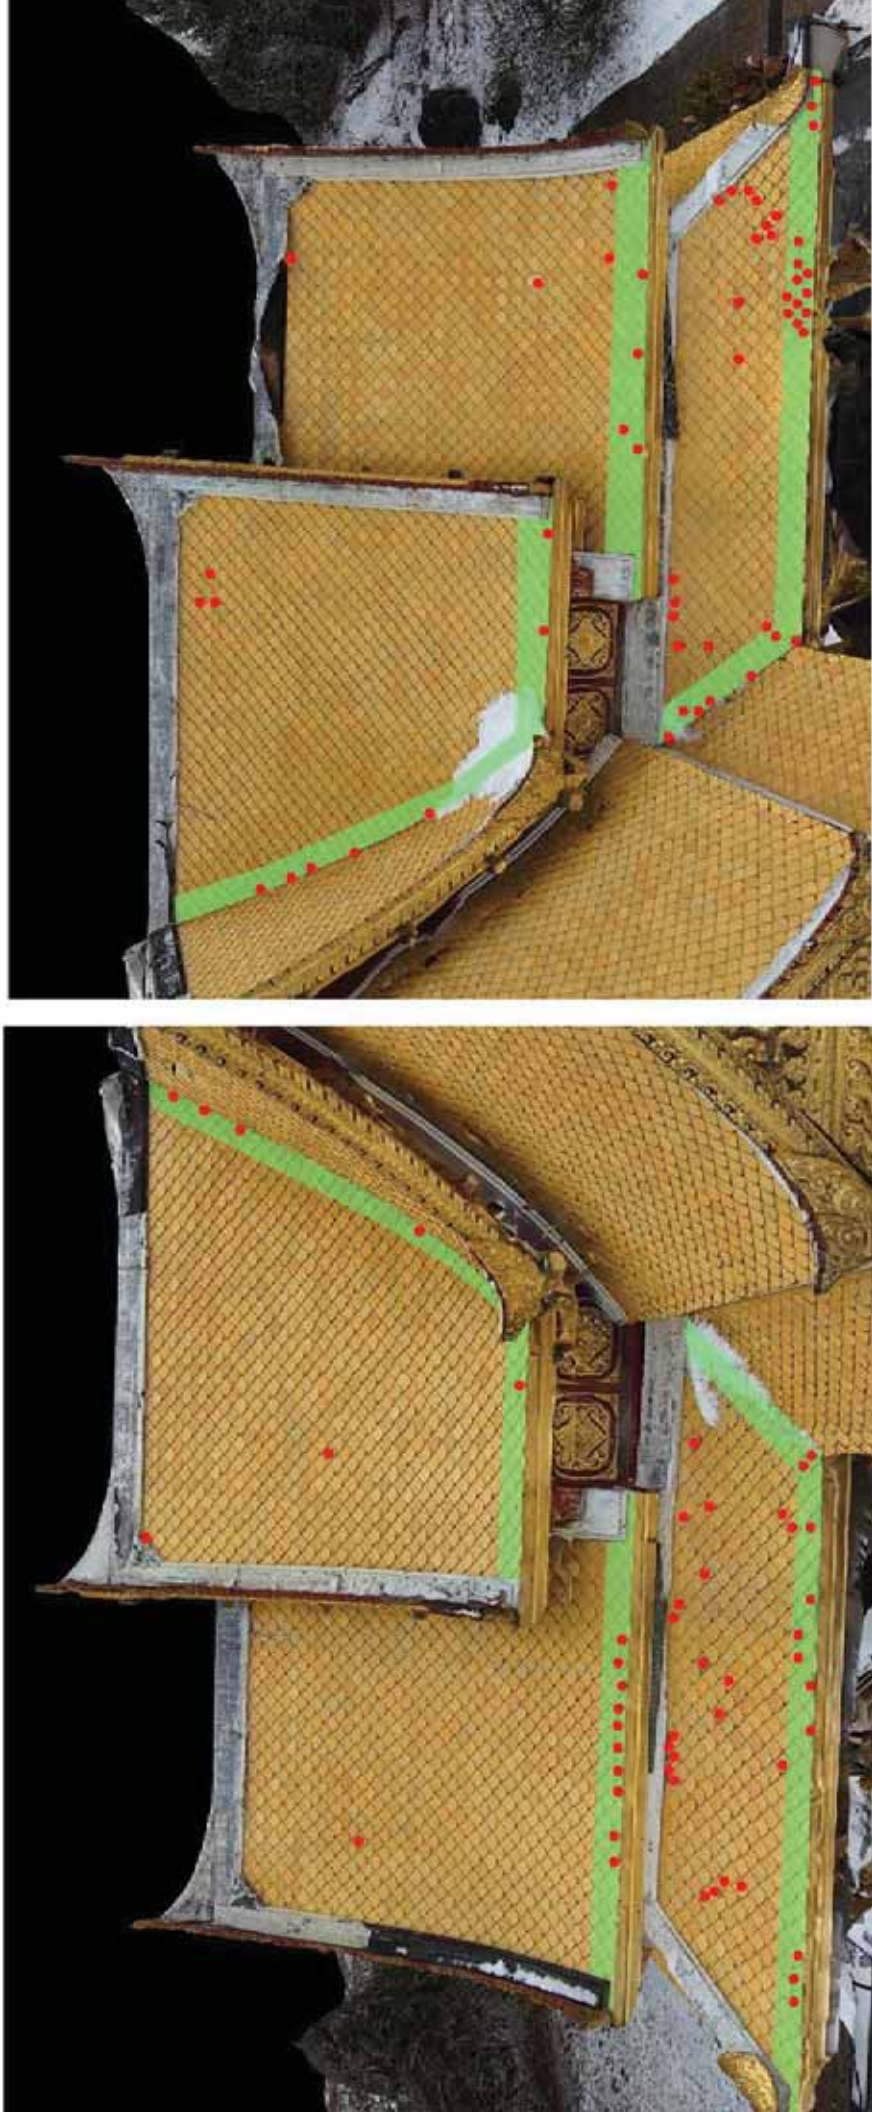
2. West Roofs - Initial observed damaged tiles from aerial view (not accounting for shear cracking) - Priority 1

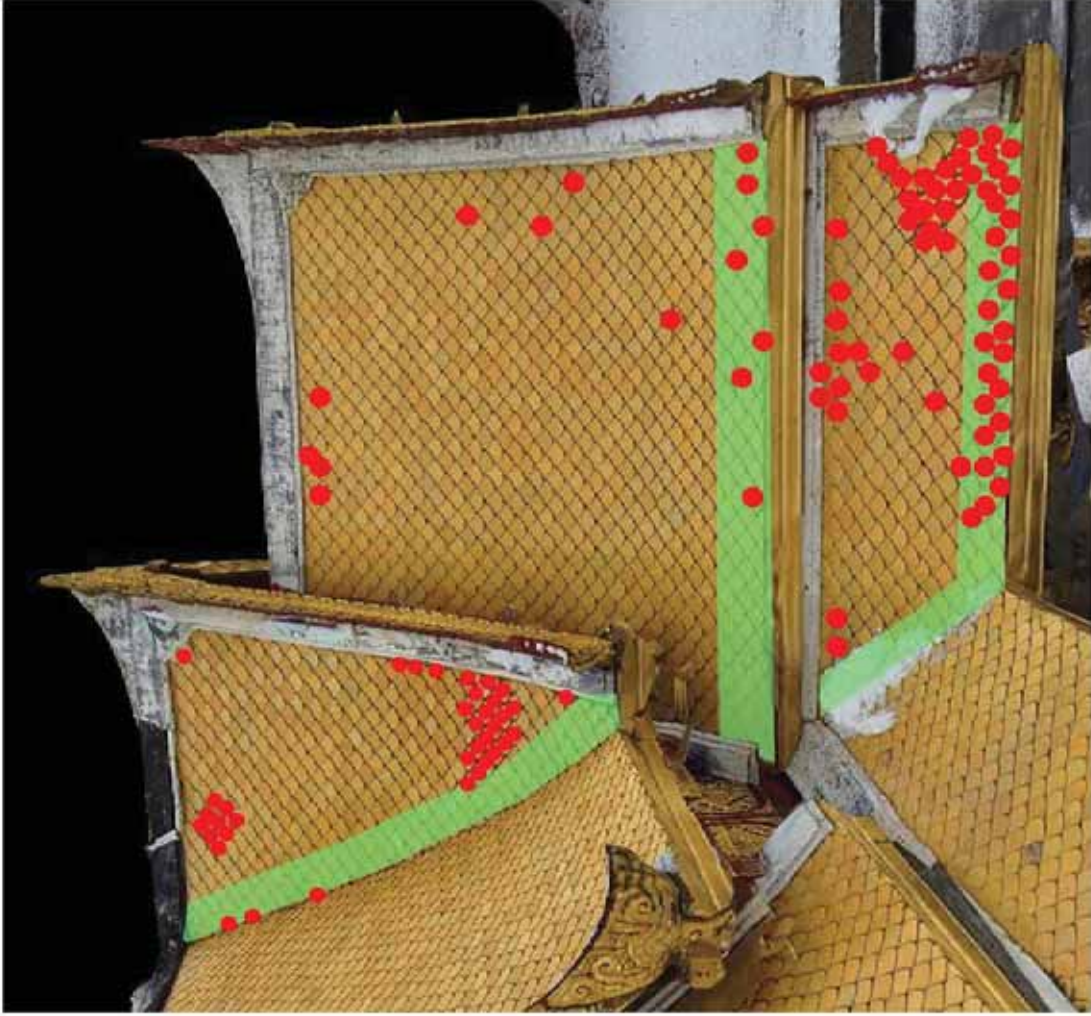
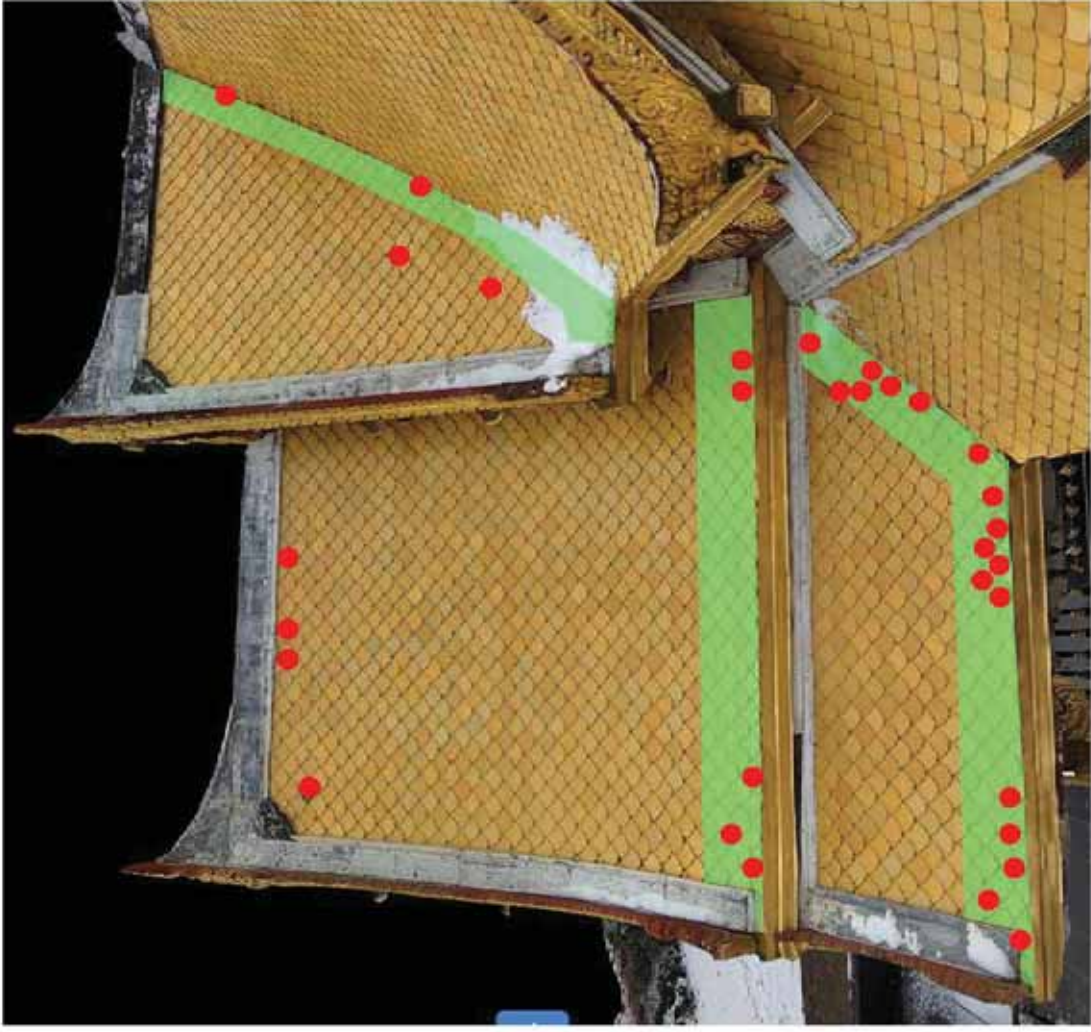
3. North & South Roofs of West Gable - Initial observed damaged tiles (not accounting for shear cracking) - Priority 1

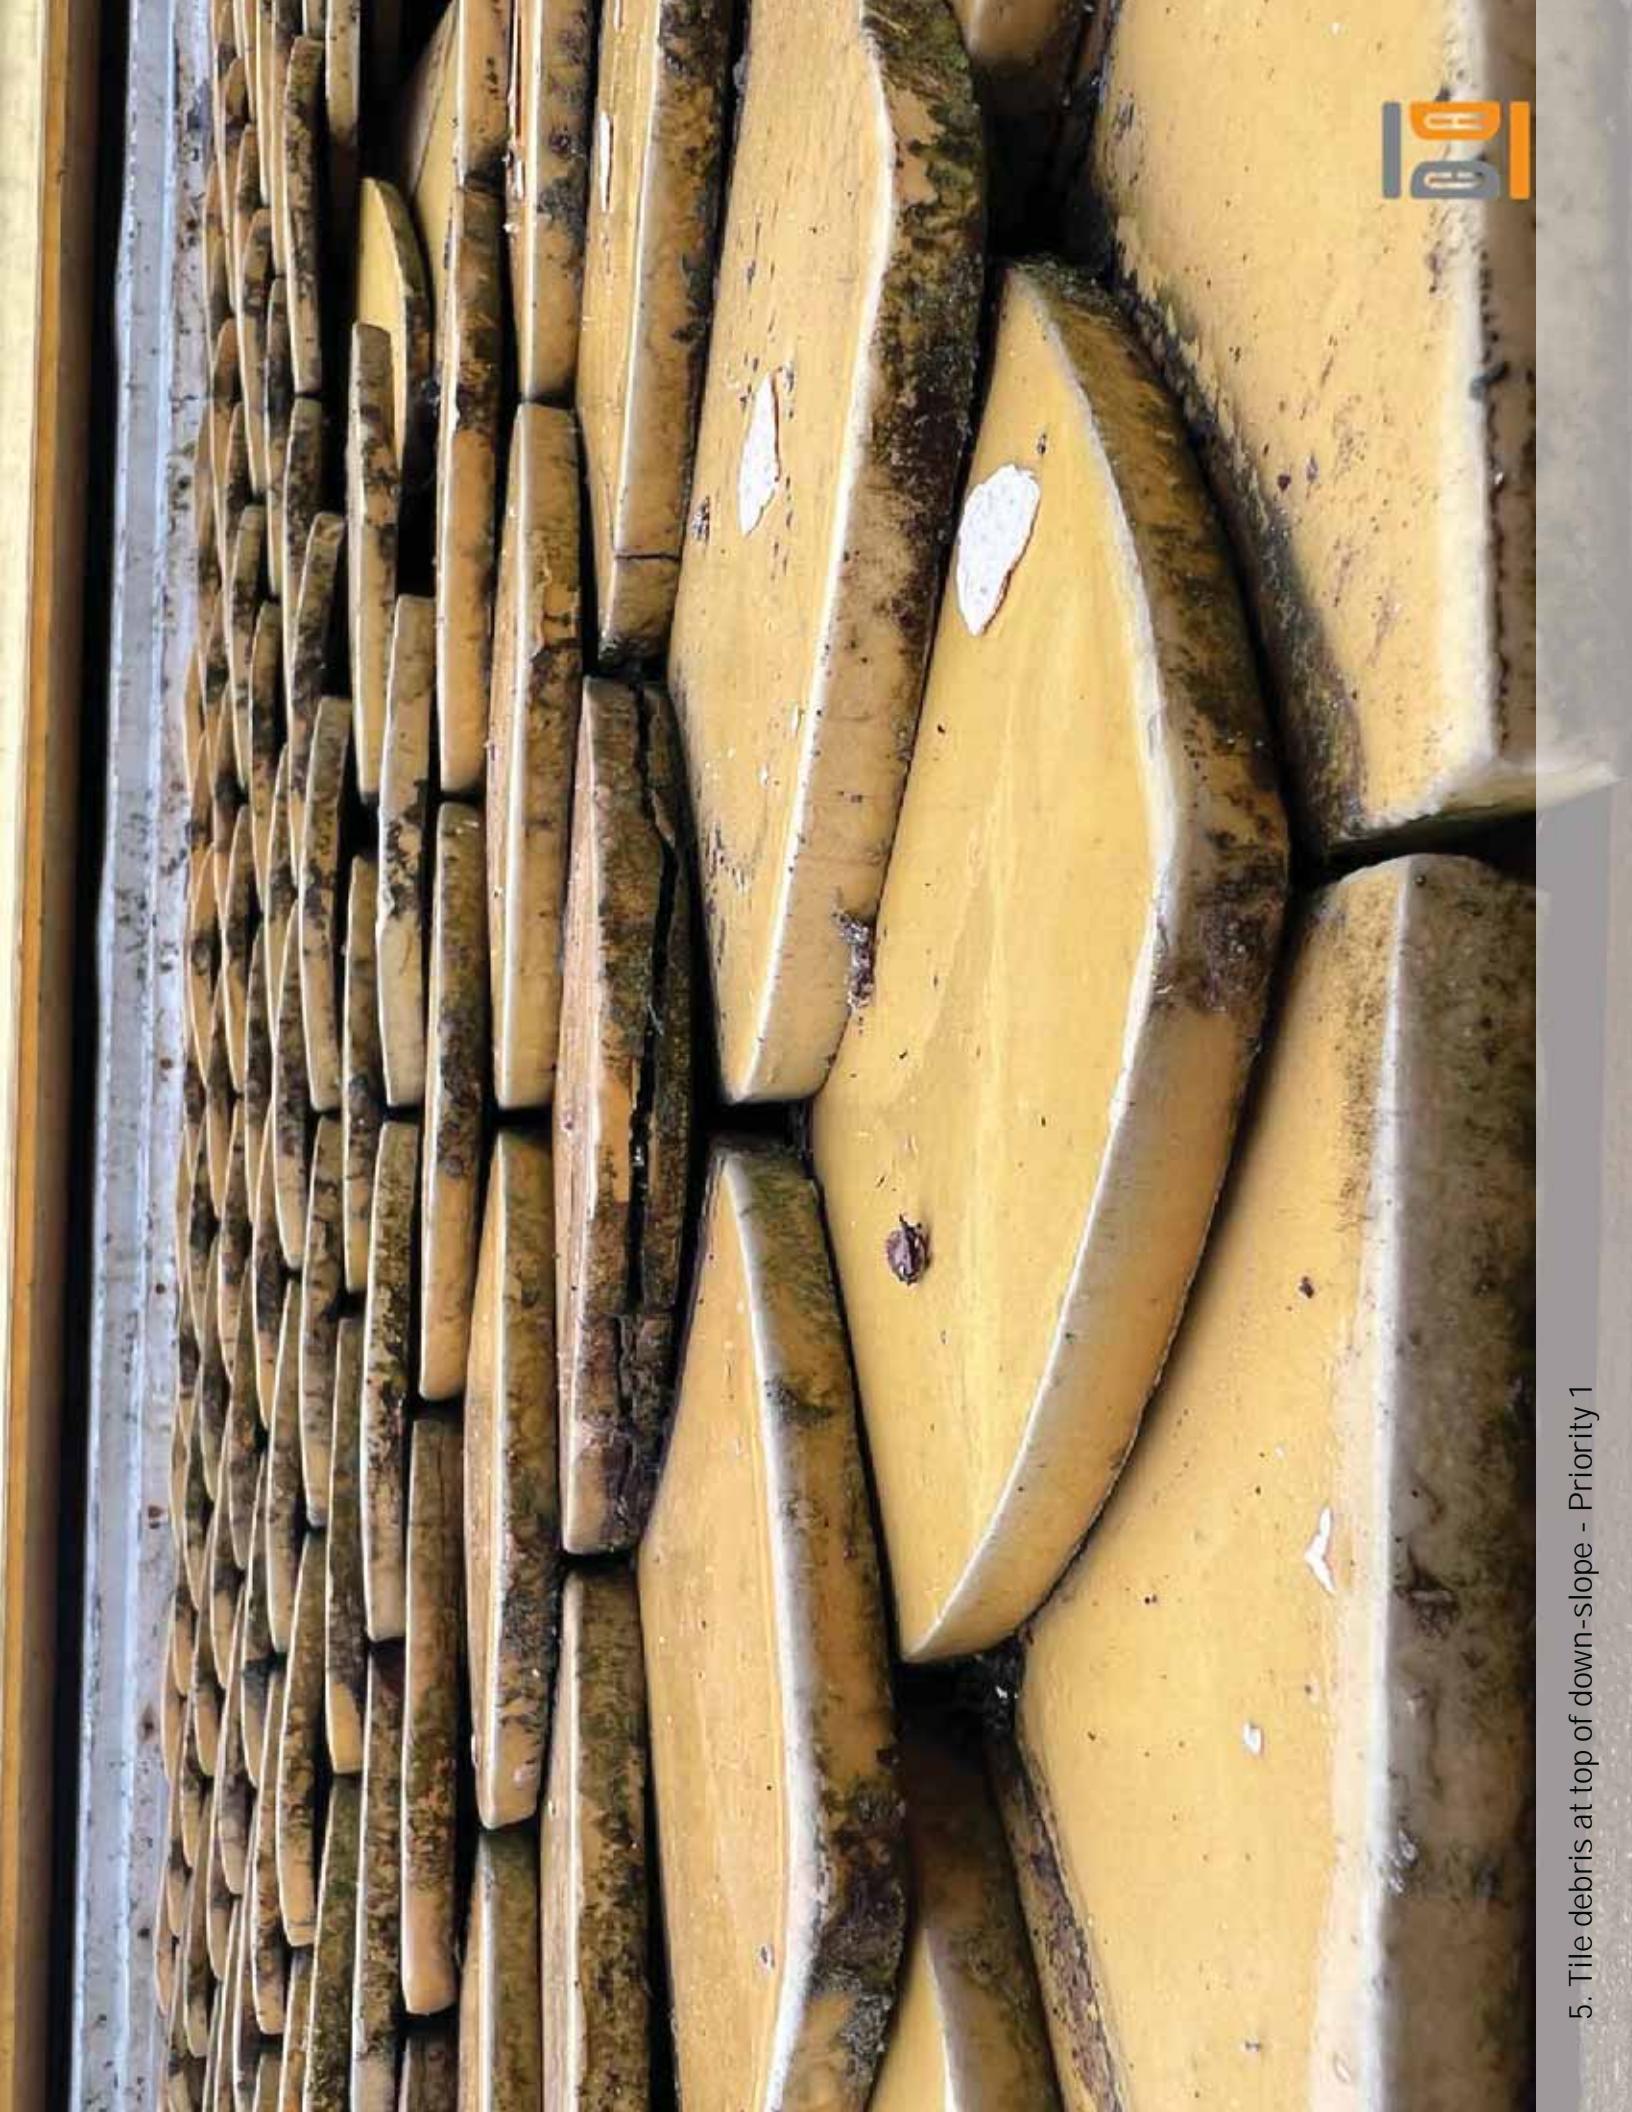
5. Tile debris at top of down-slope - Priority 1

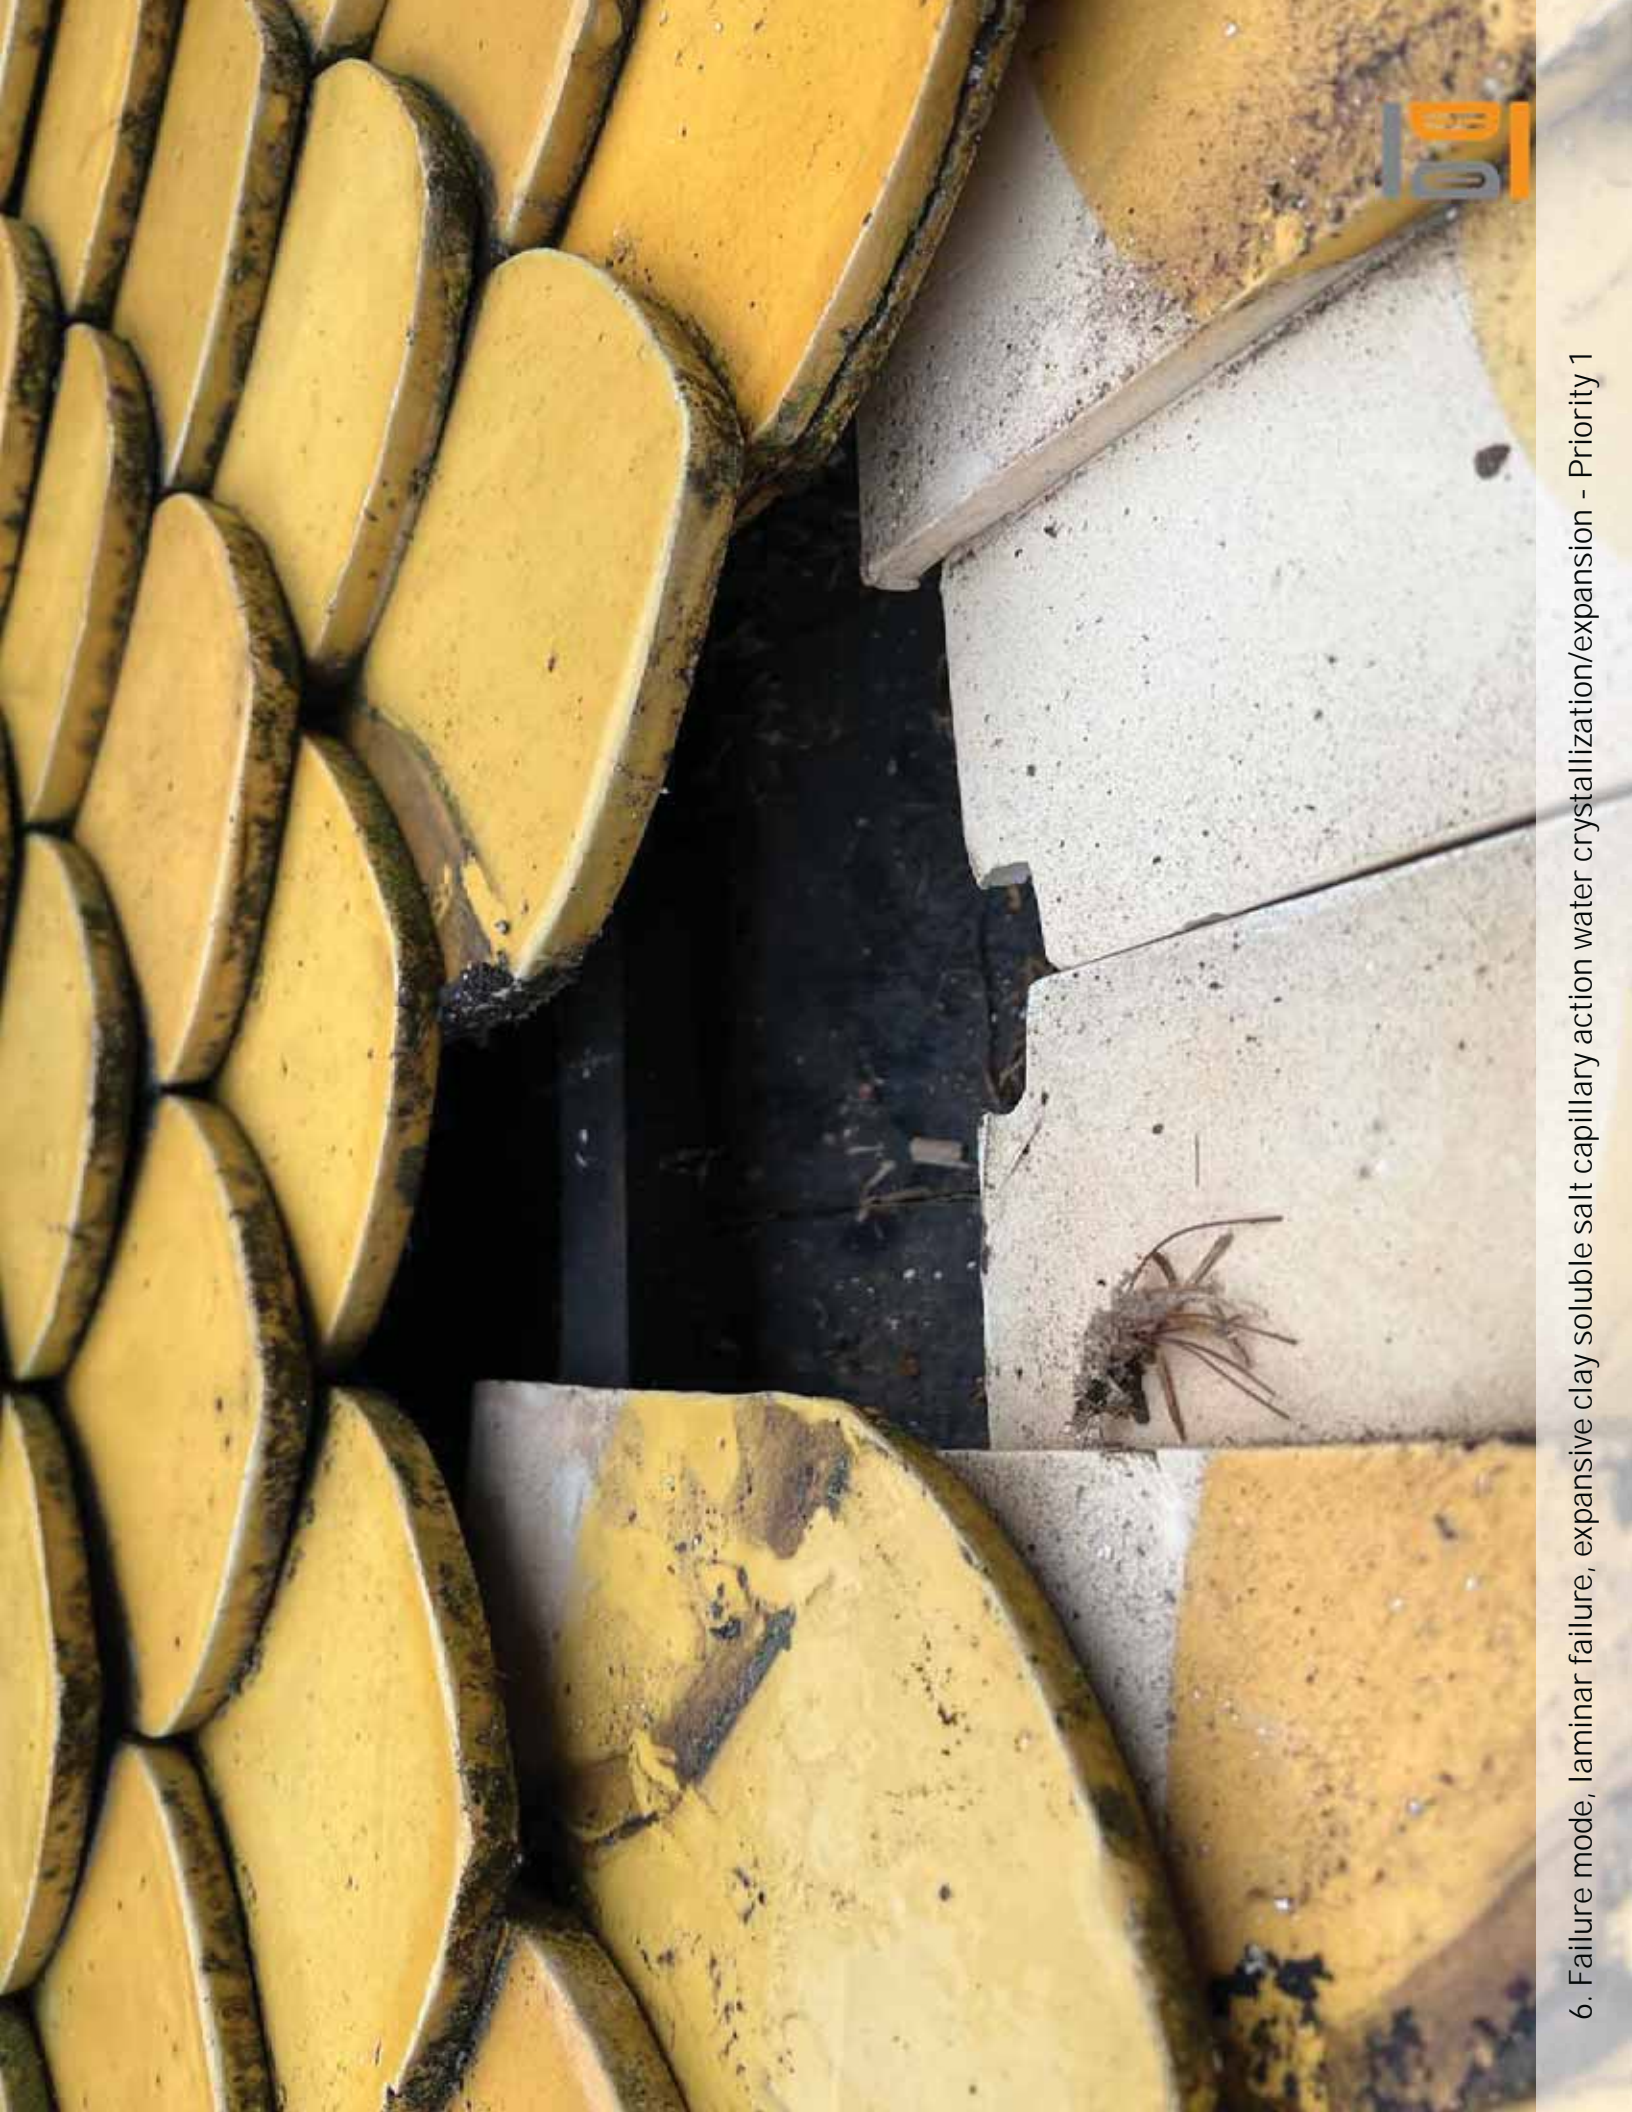
6. Failure mode, lamellar failure, expansive clay soluble salt capillary action water crystallization/expansion - Priority 1

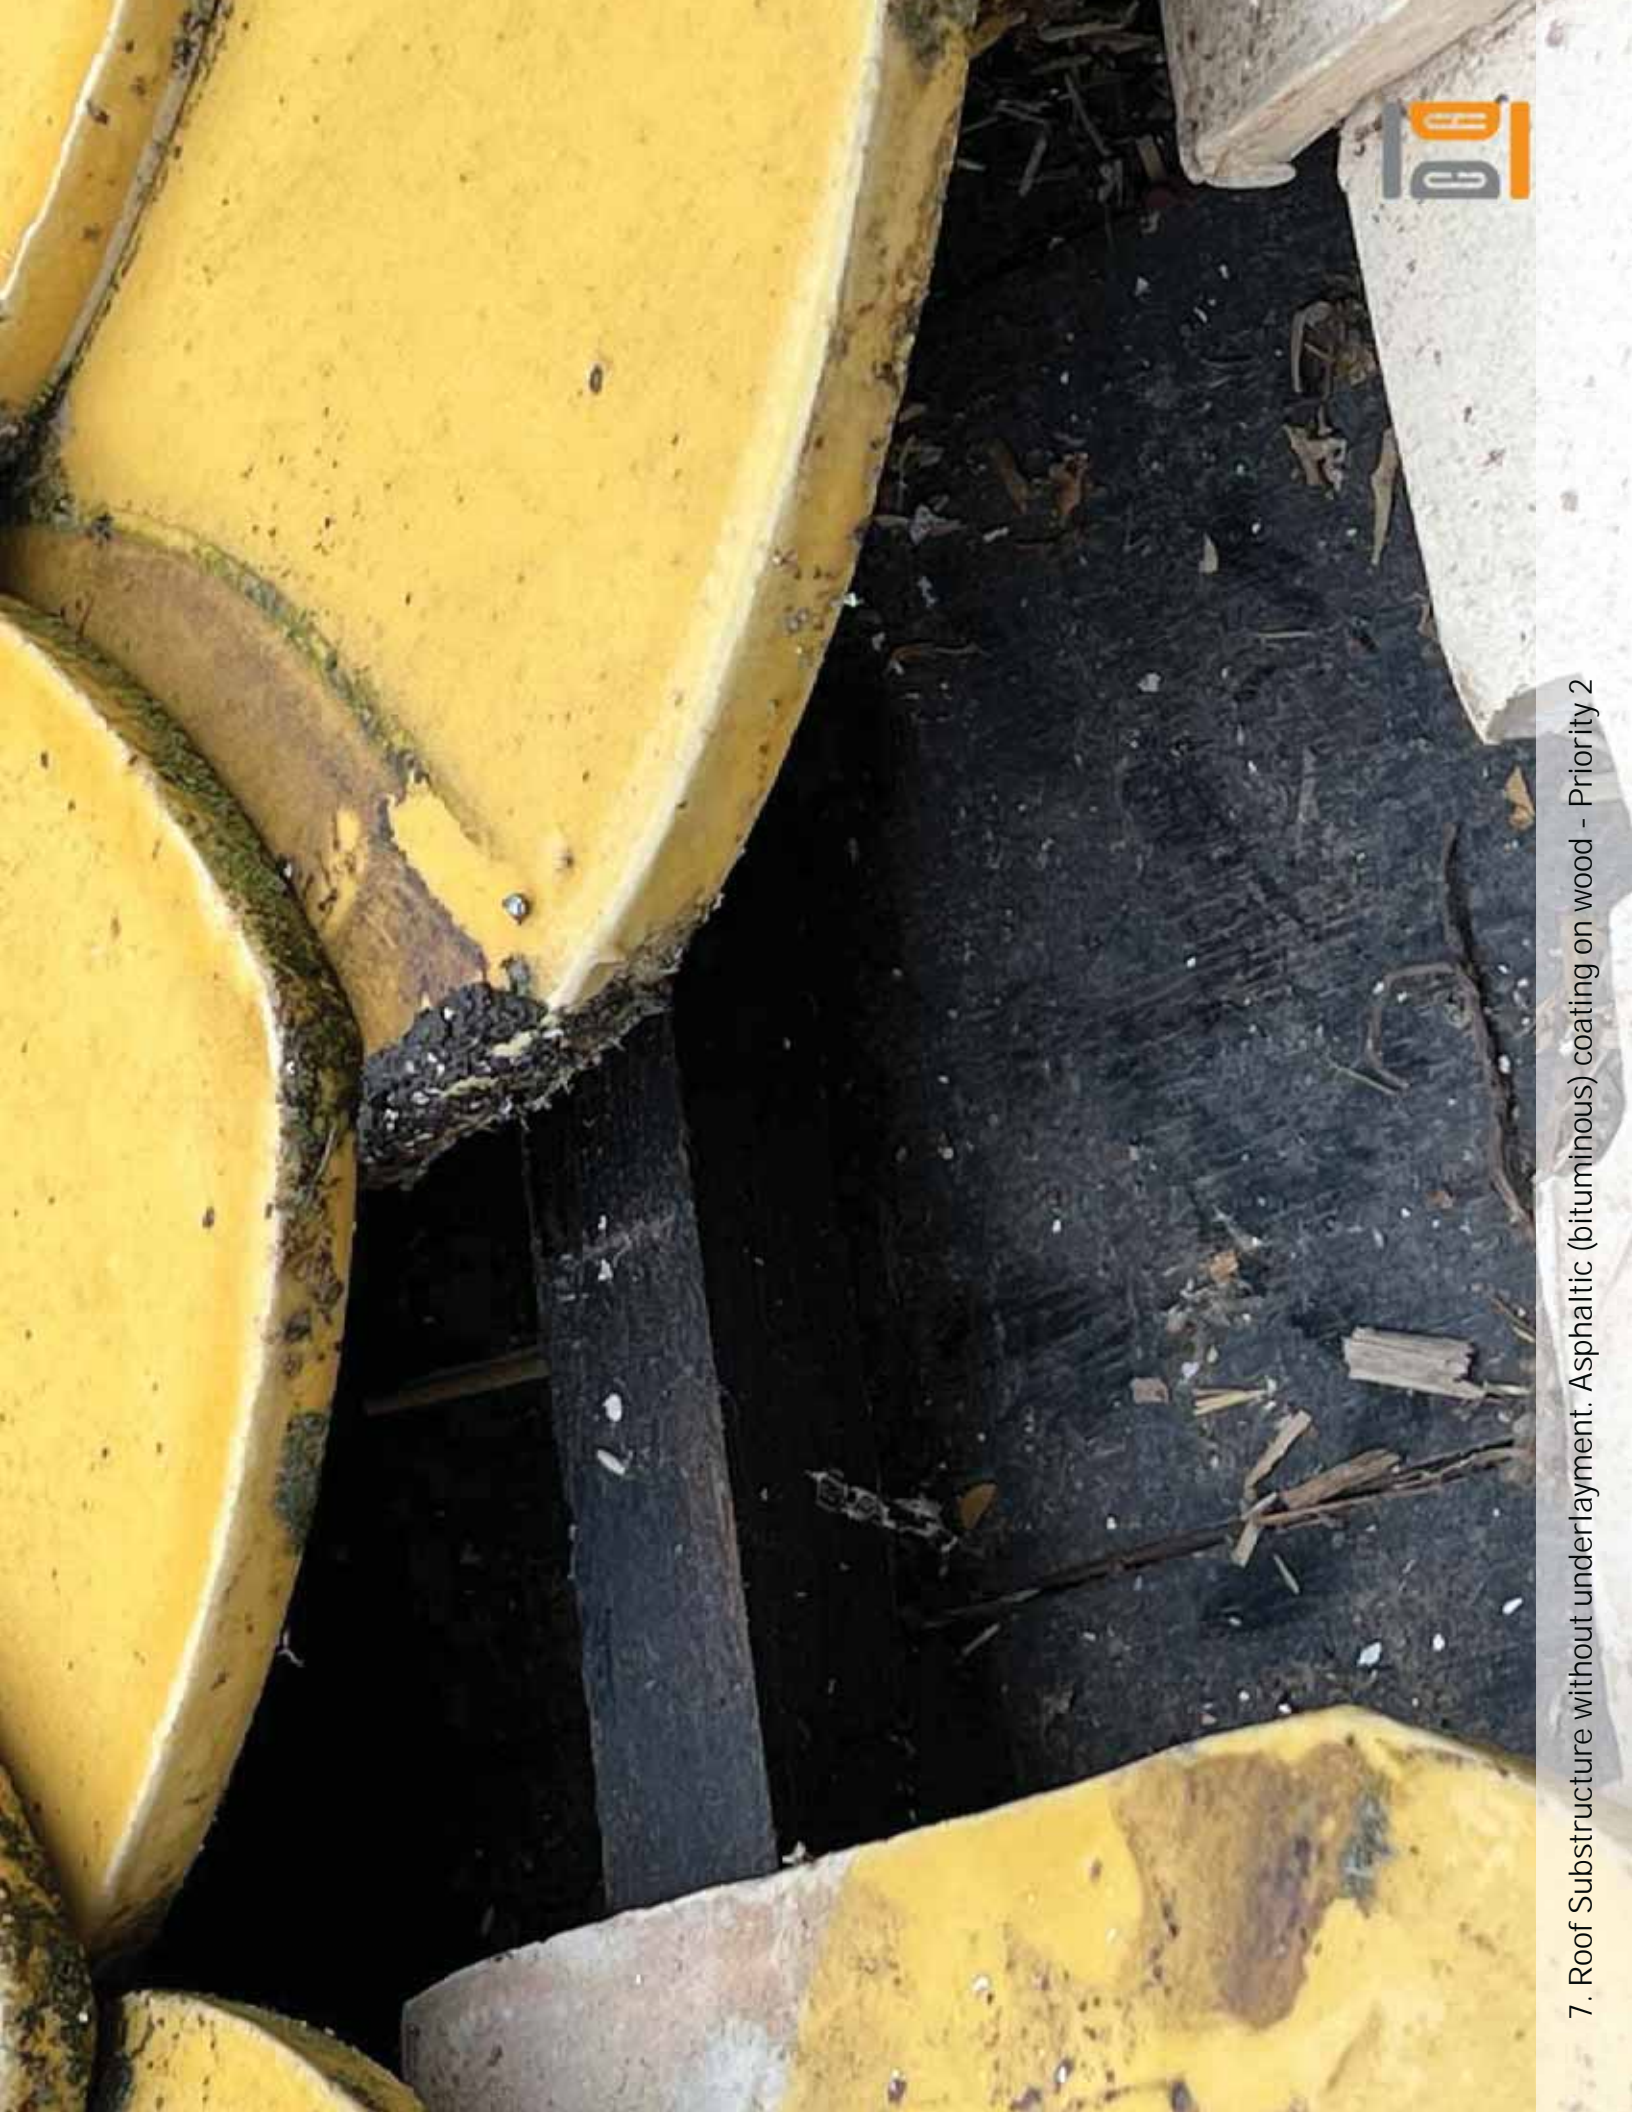
7. Roof Substructure without underlayment. Asphaltic (bituminous) coating on wood - Priority 2
