OLBRICH BOTOANICAL GARDENS ROYAL THAI PAVILION CONDITION ASSESSMENT REPORT

MAY 20, 2022

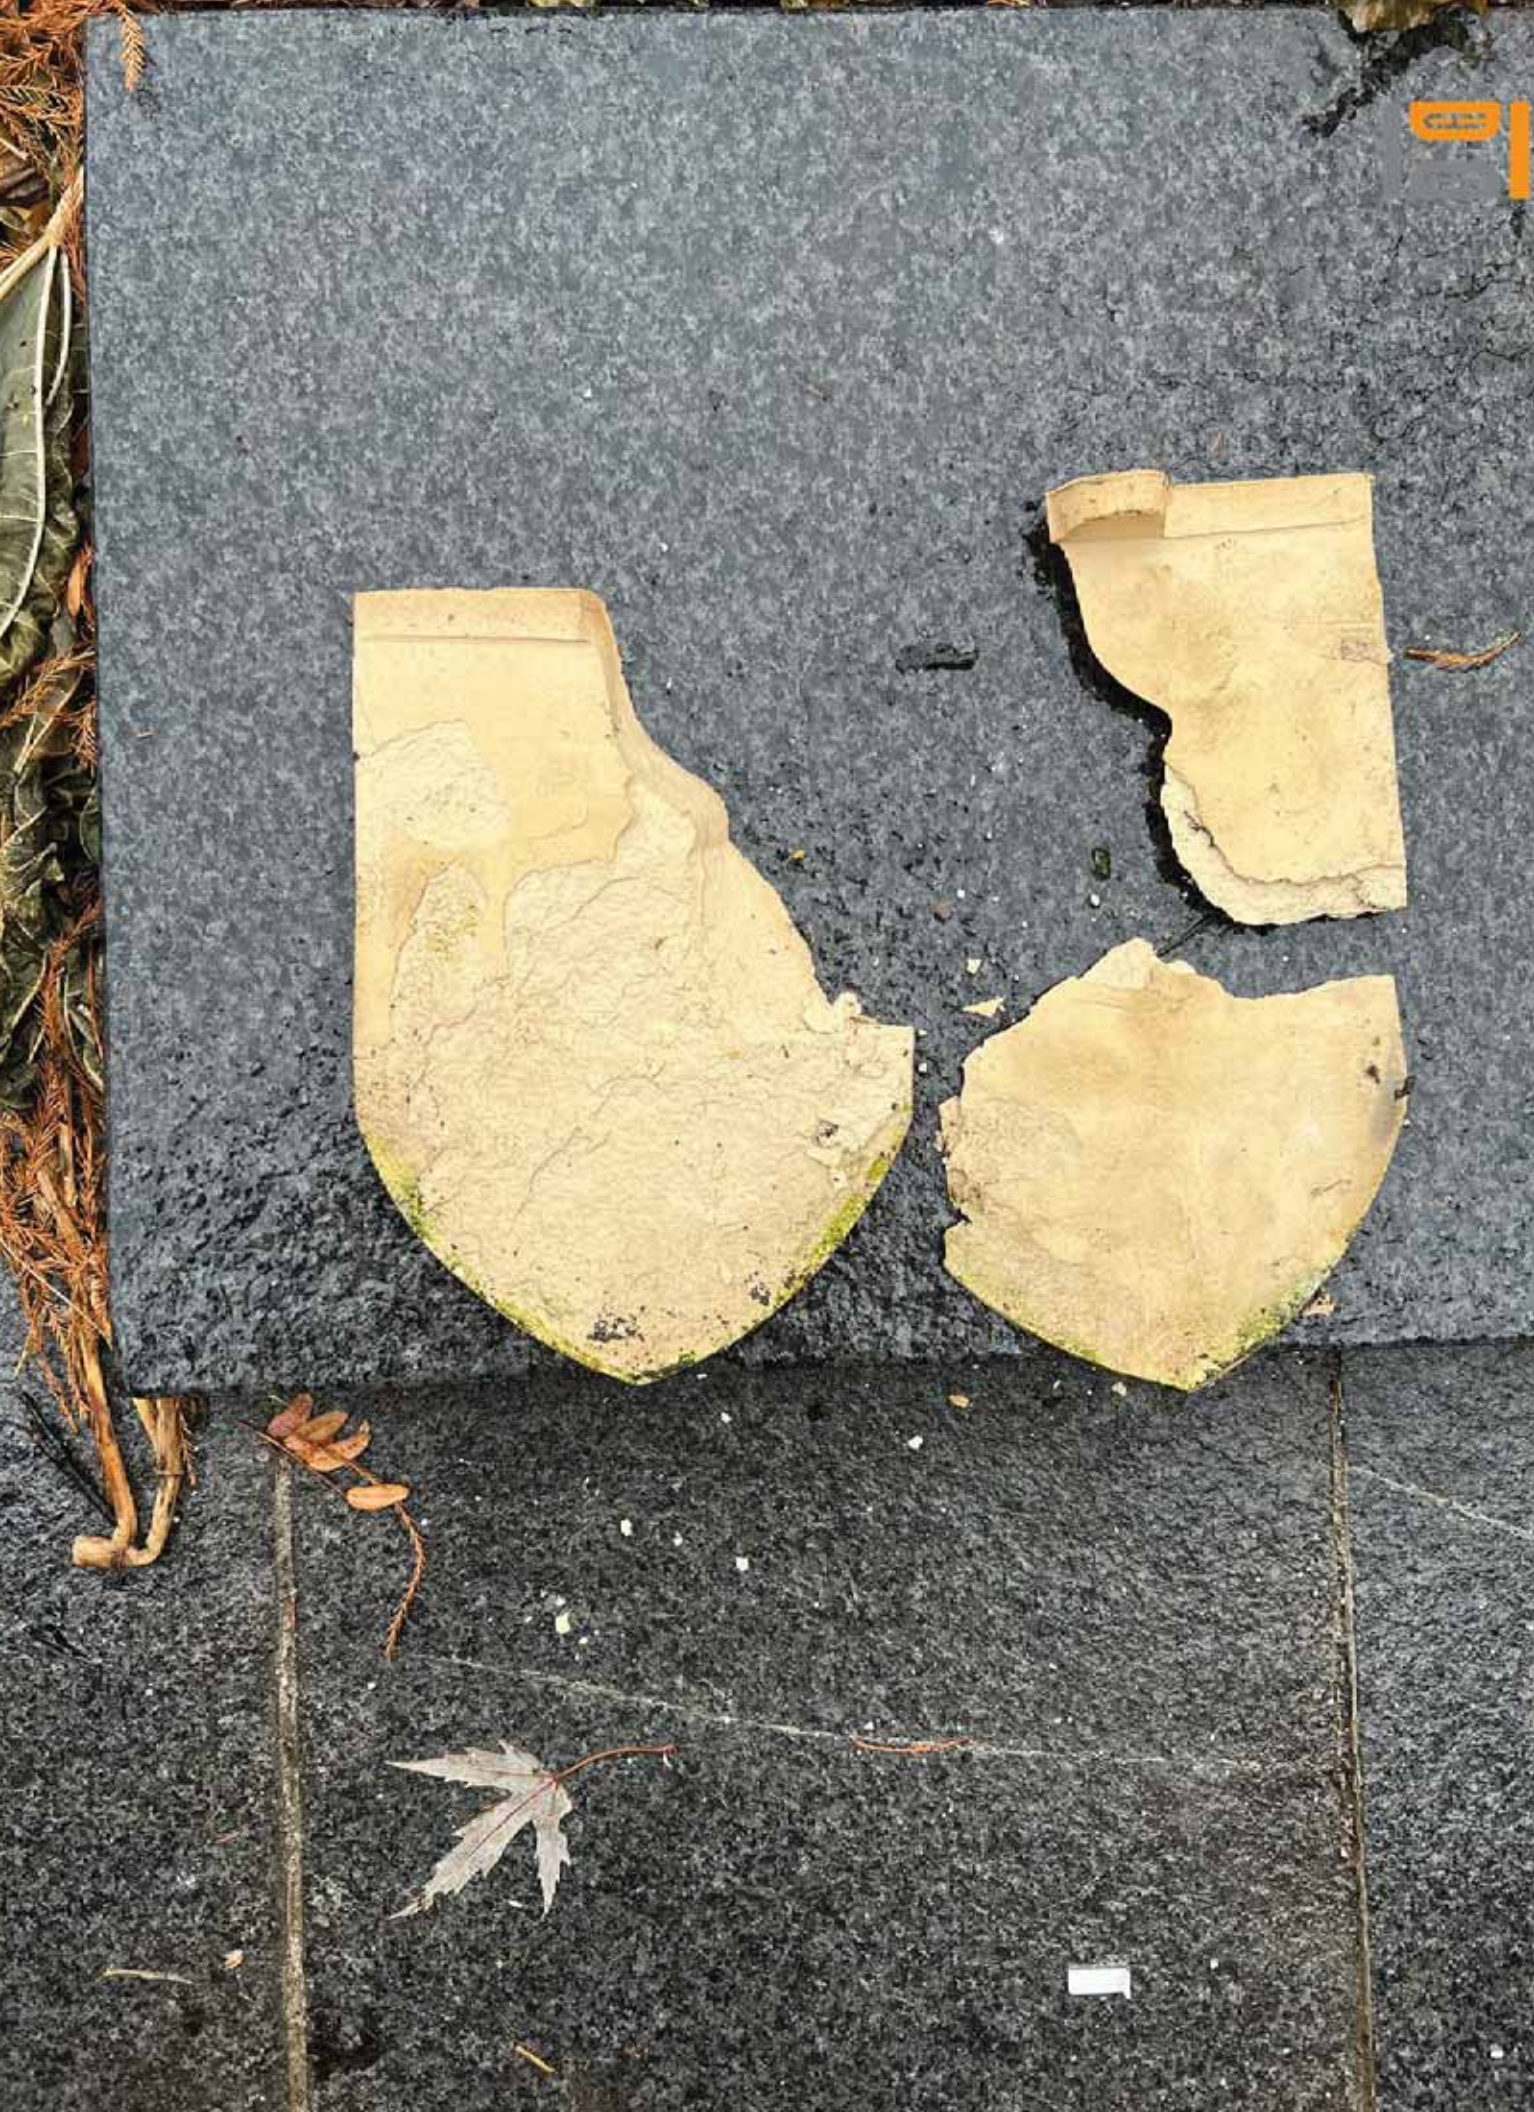
8. Exploded tile - Typical condition of water-infiltration damage - Priority 1

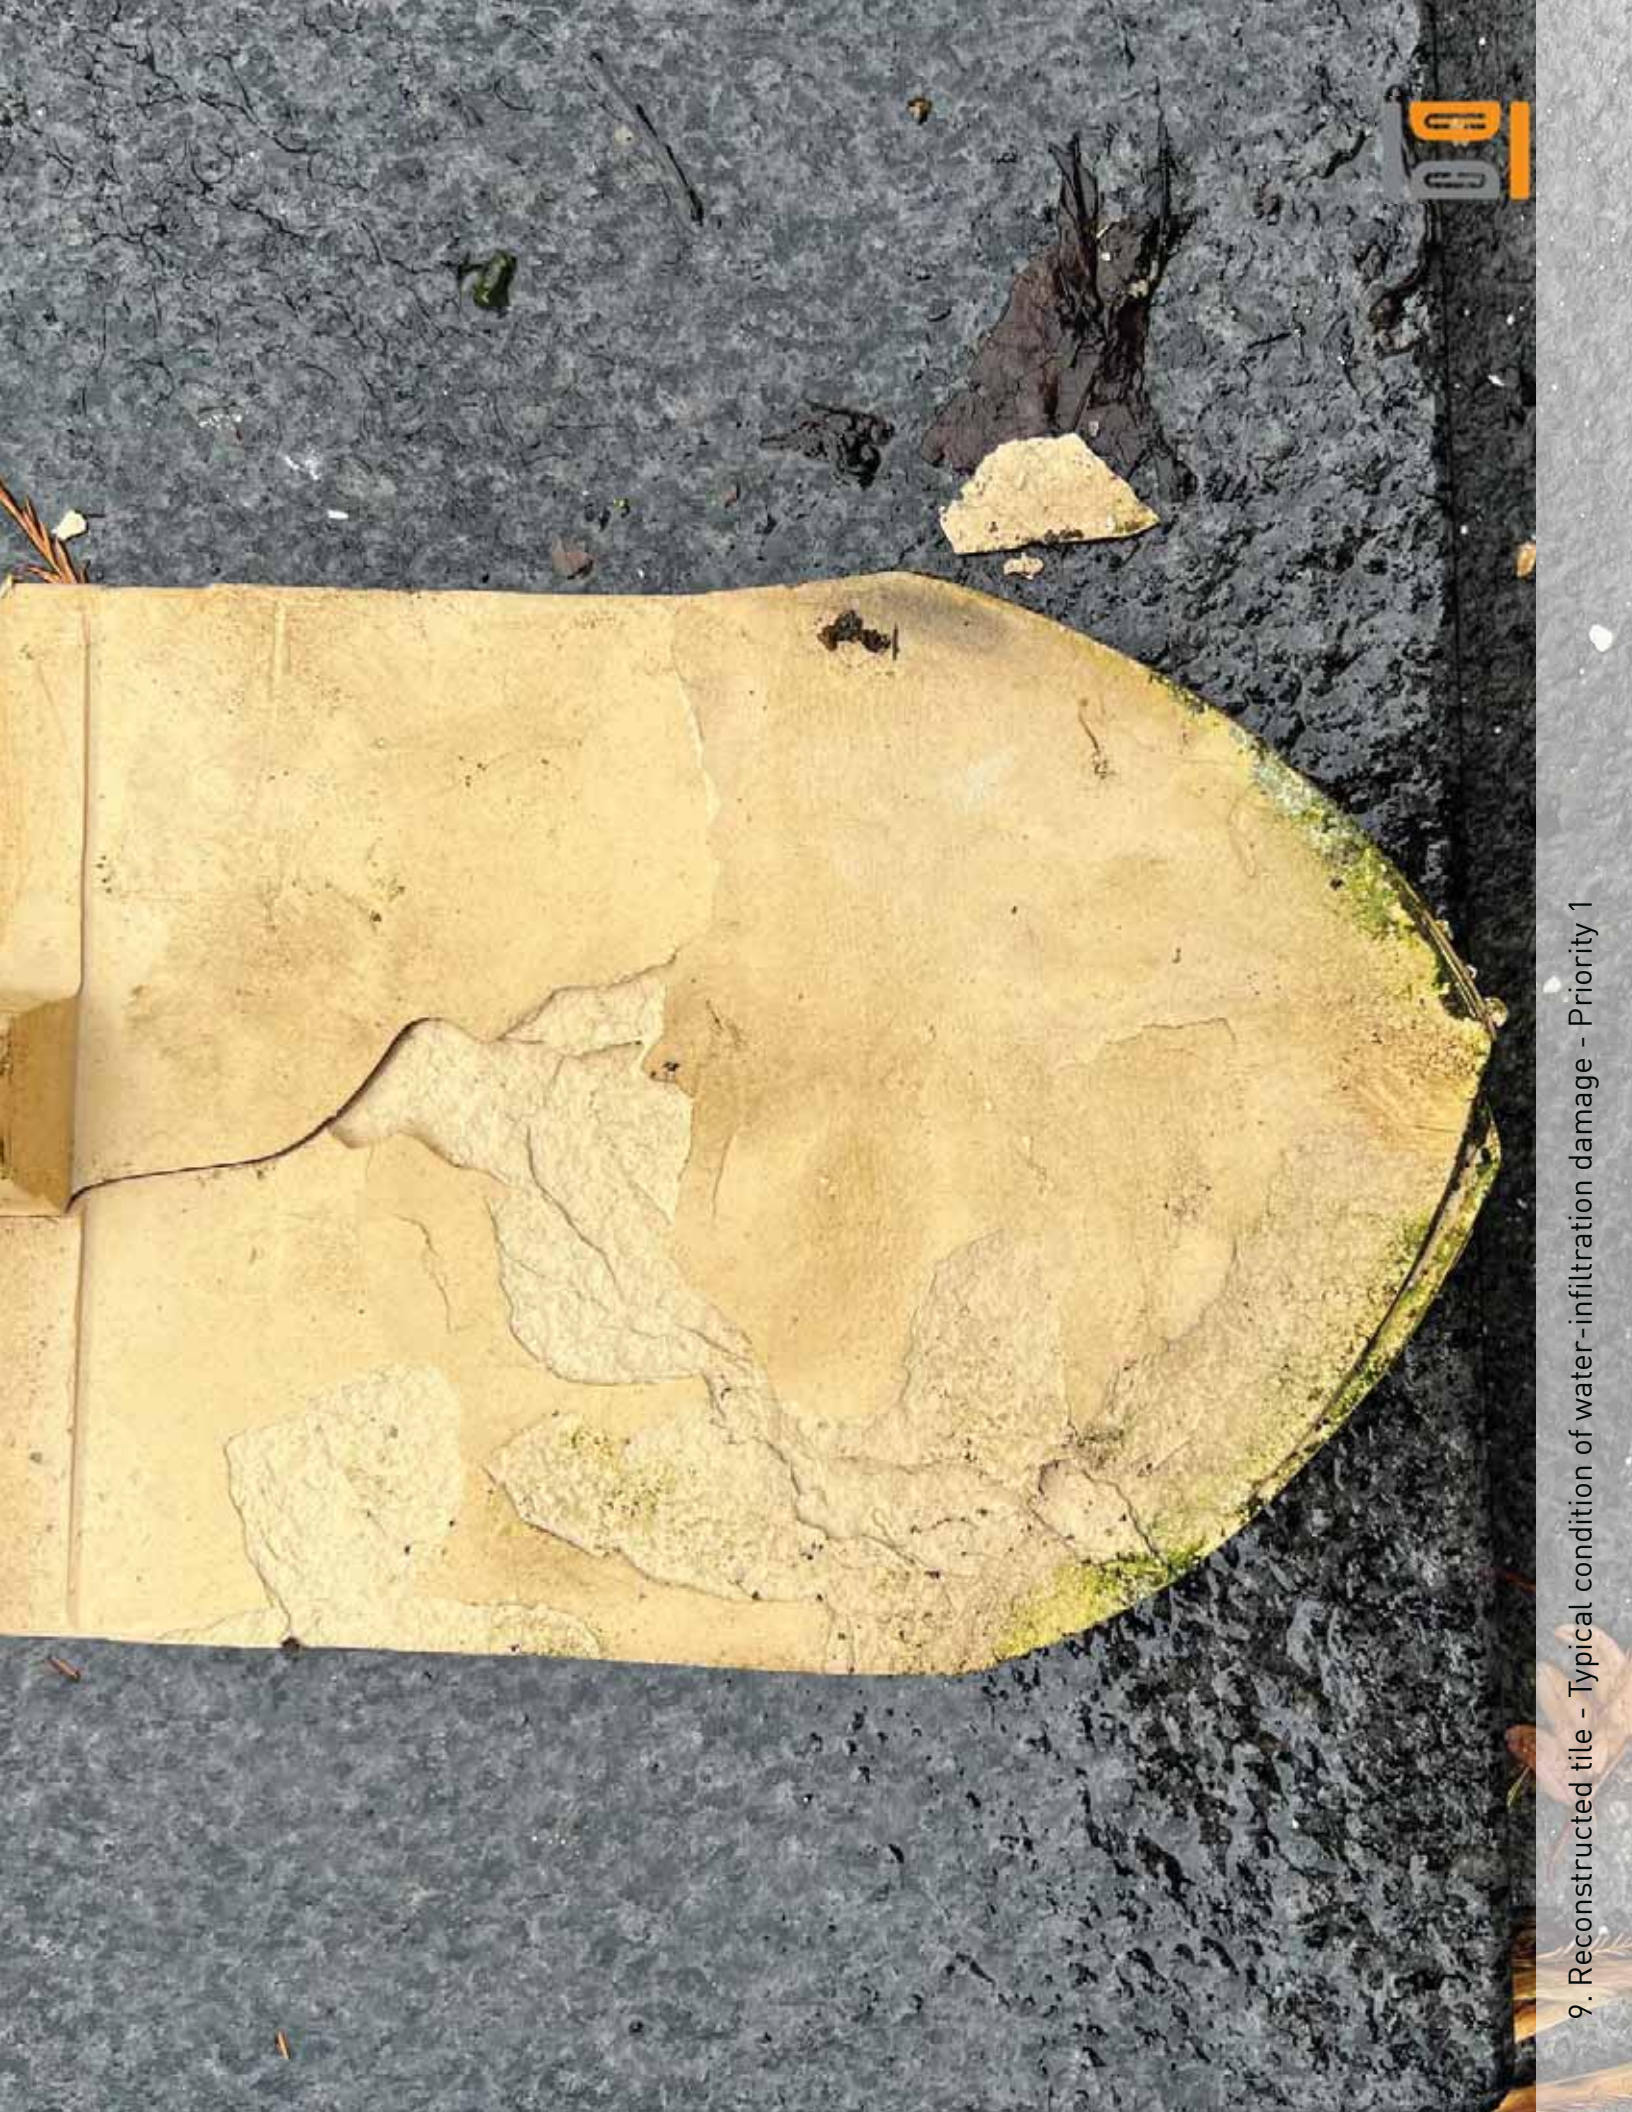
9. Reconstructed tile - Typical condition of water-infiltration damage - Priority 1

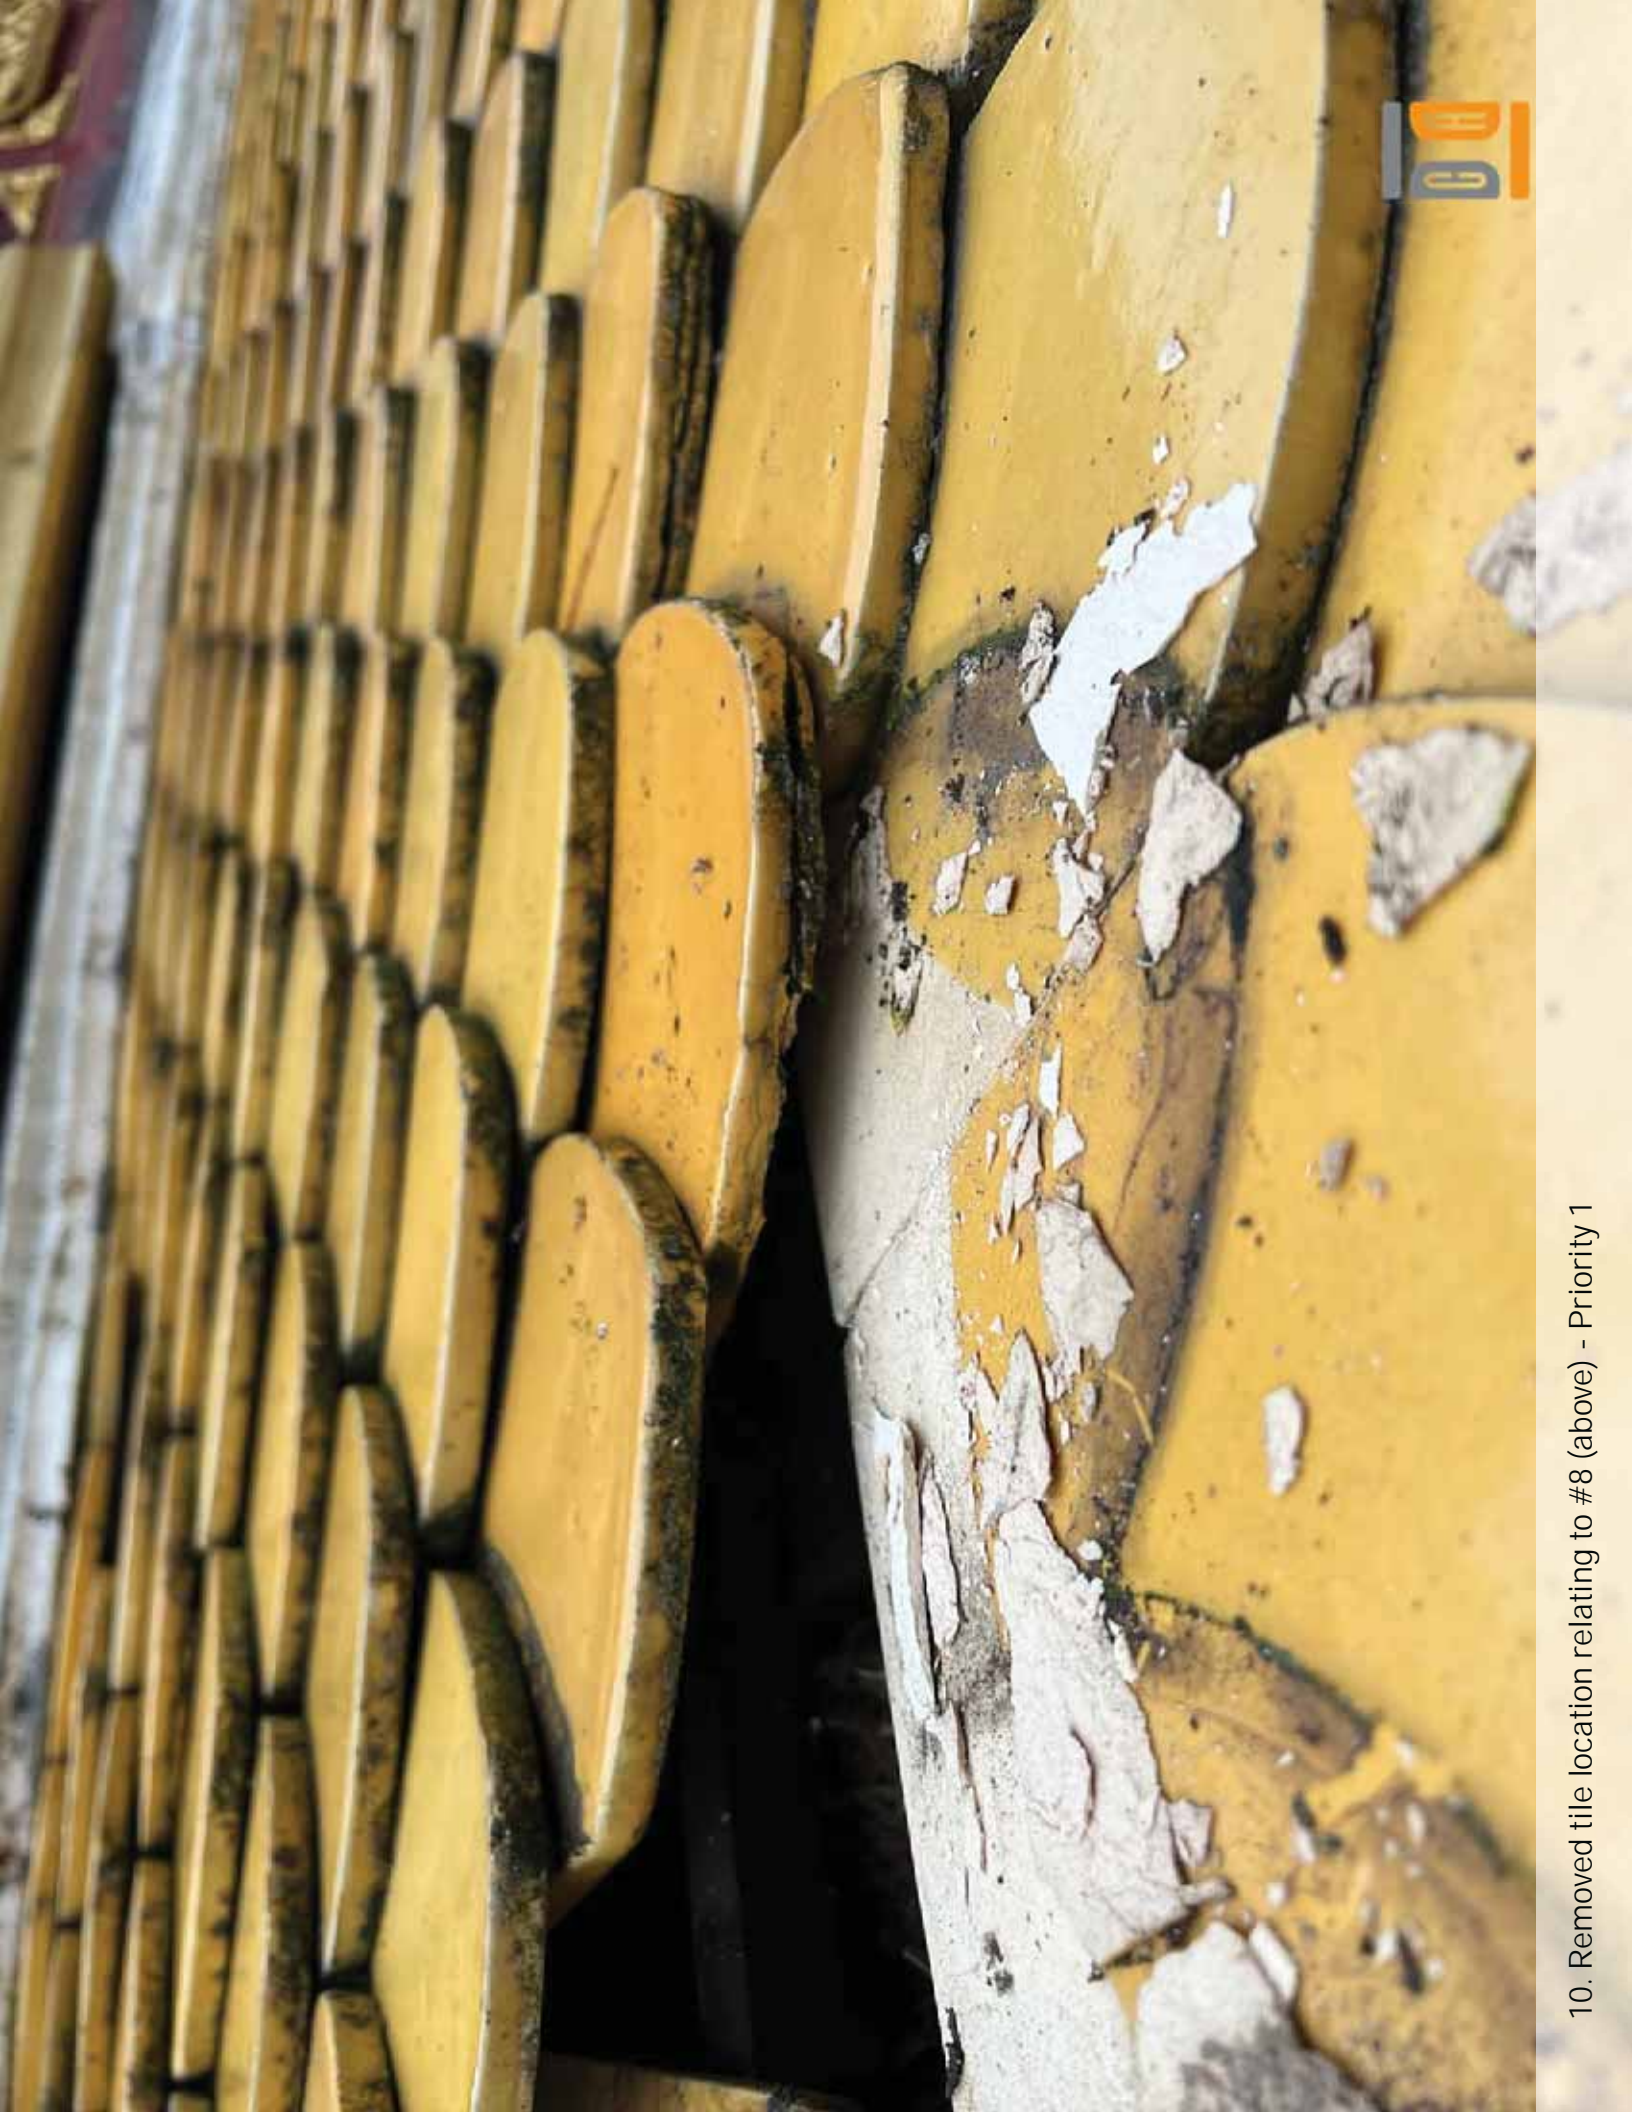
10. Removed tile location relating to #8 (above) - Priority 1

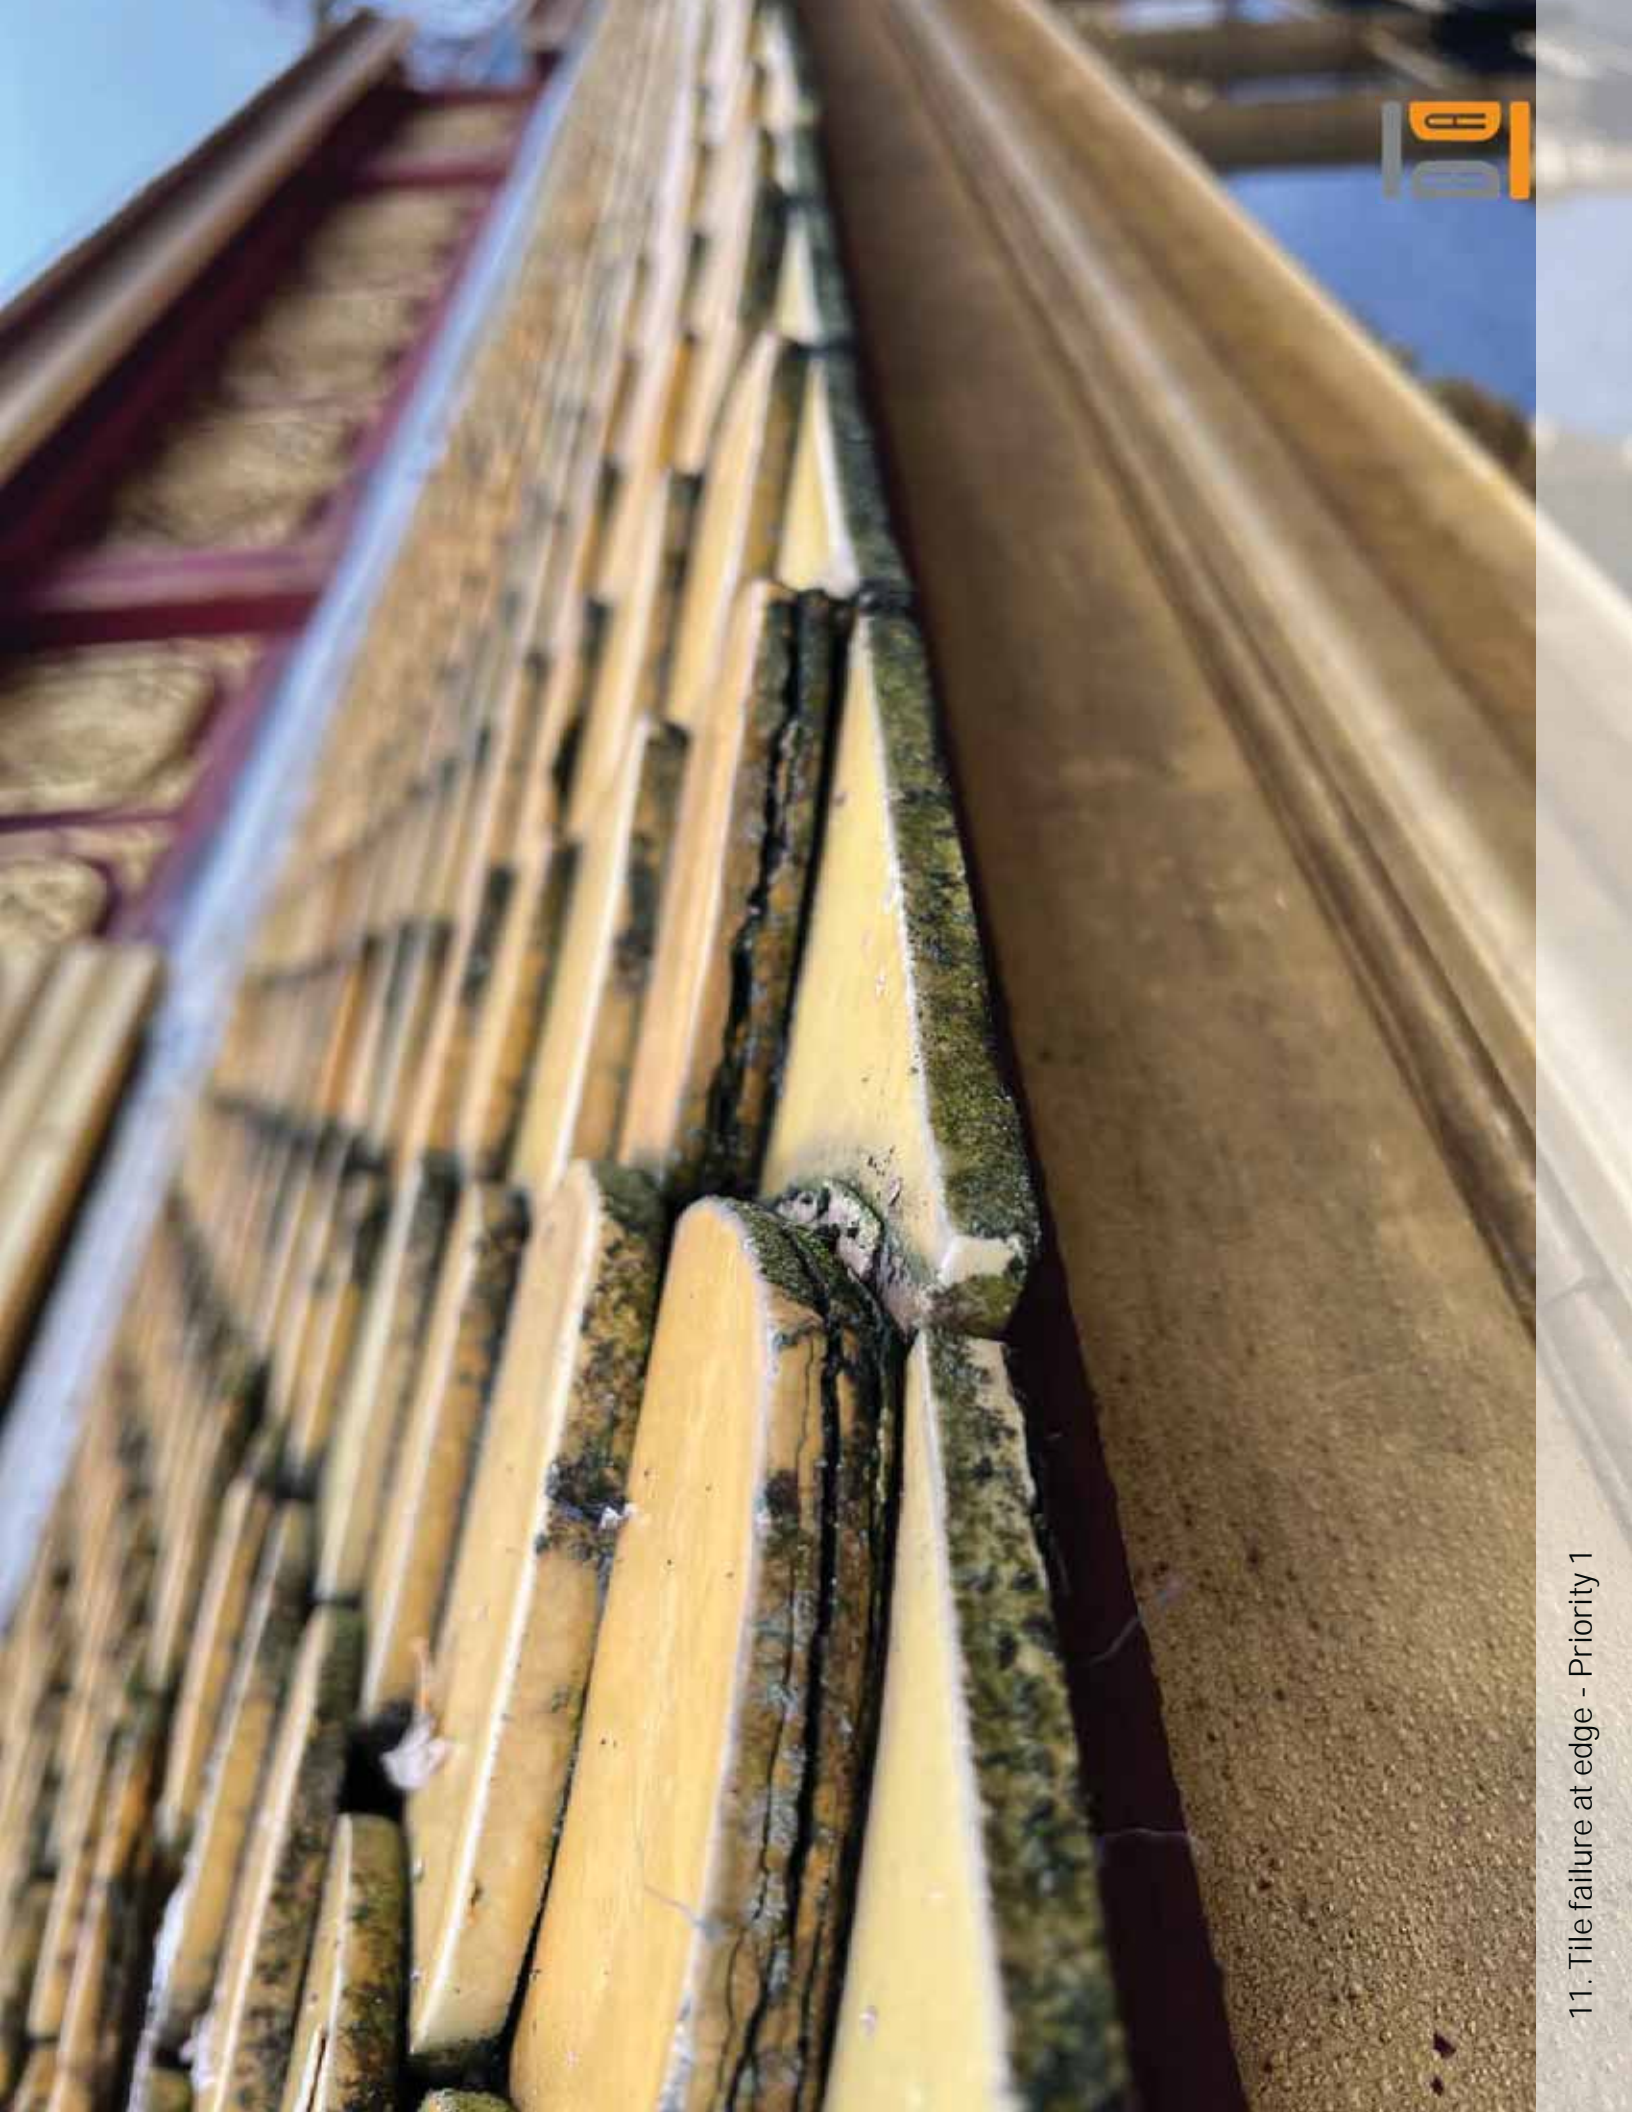
11. Tile failure at edge - Priority 1

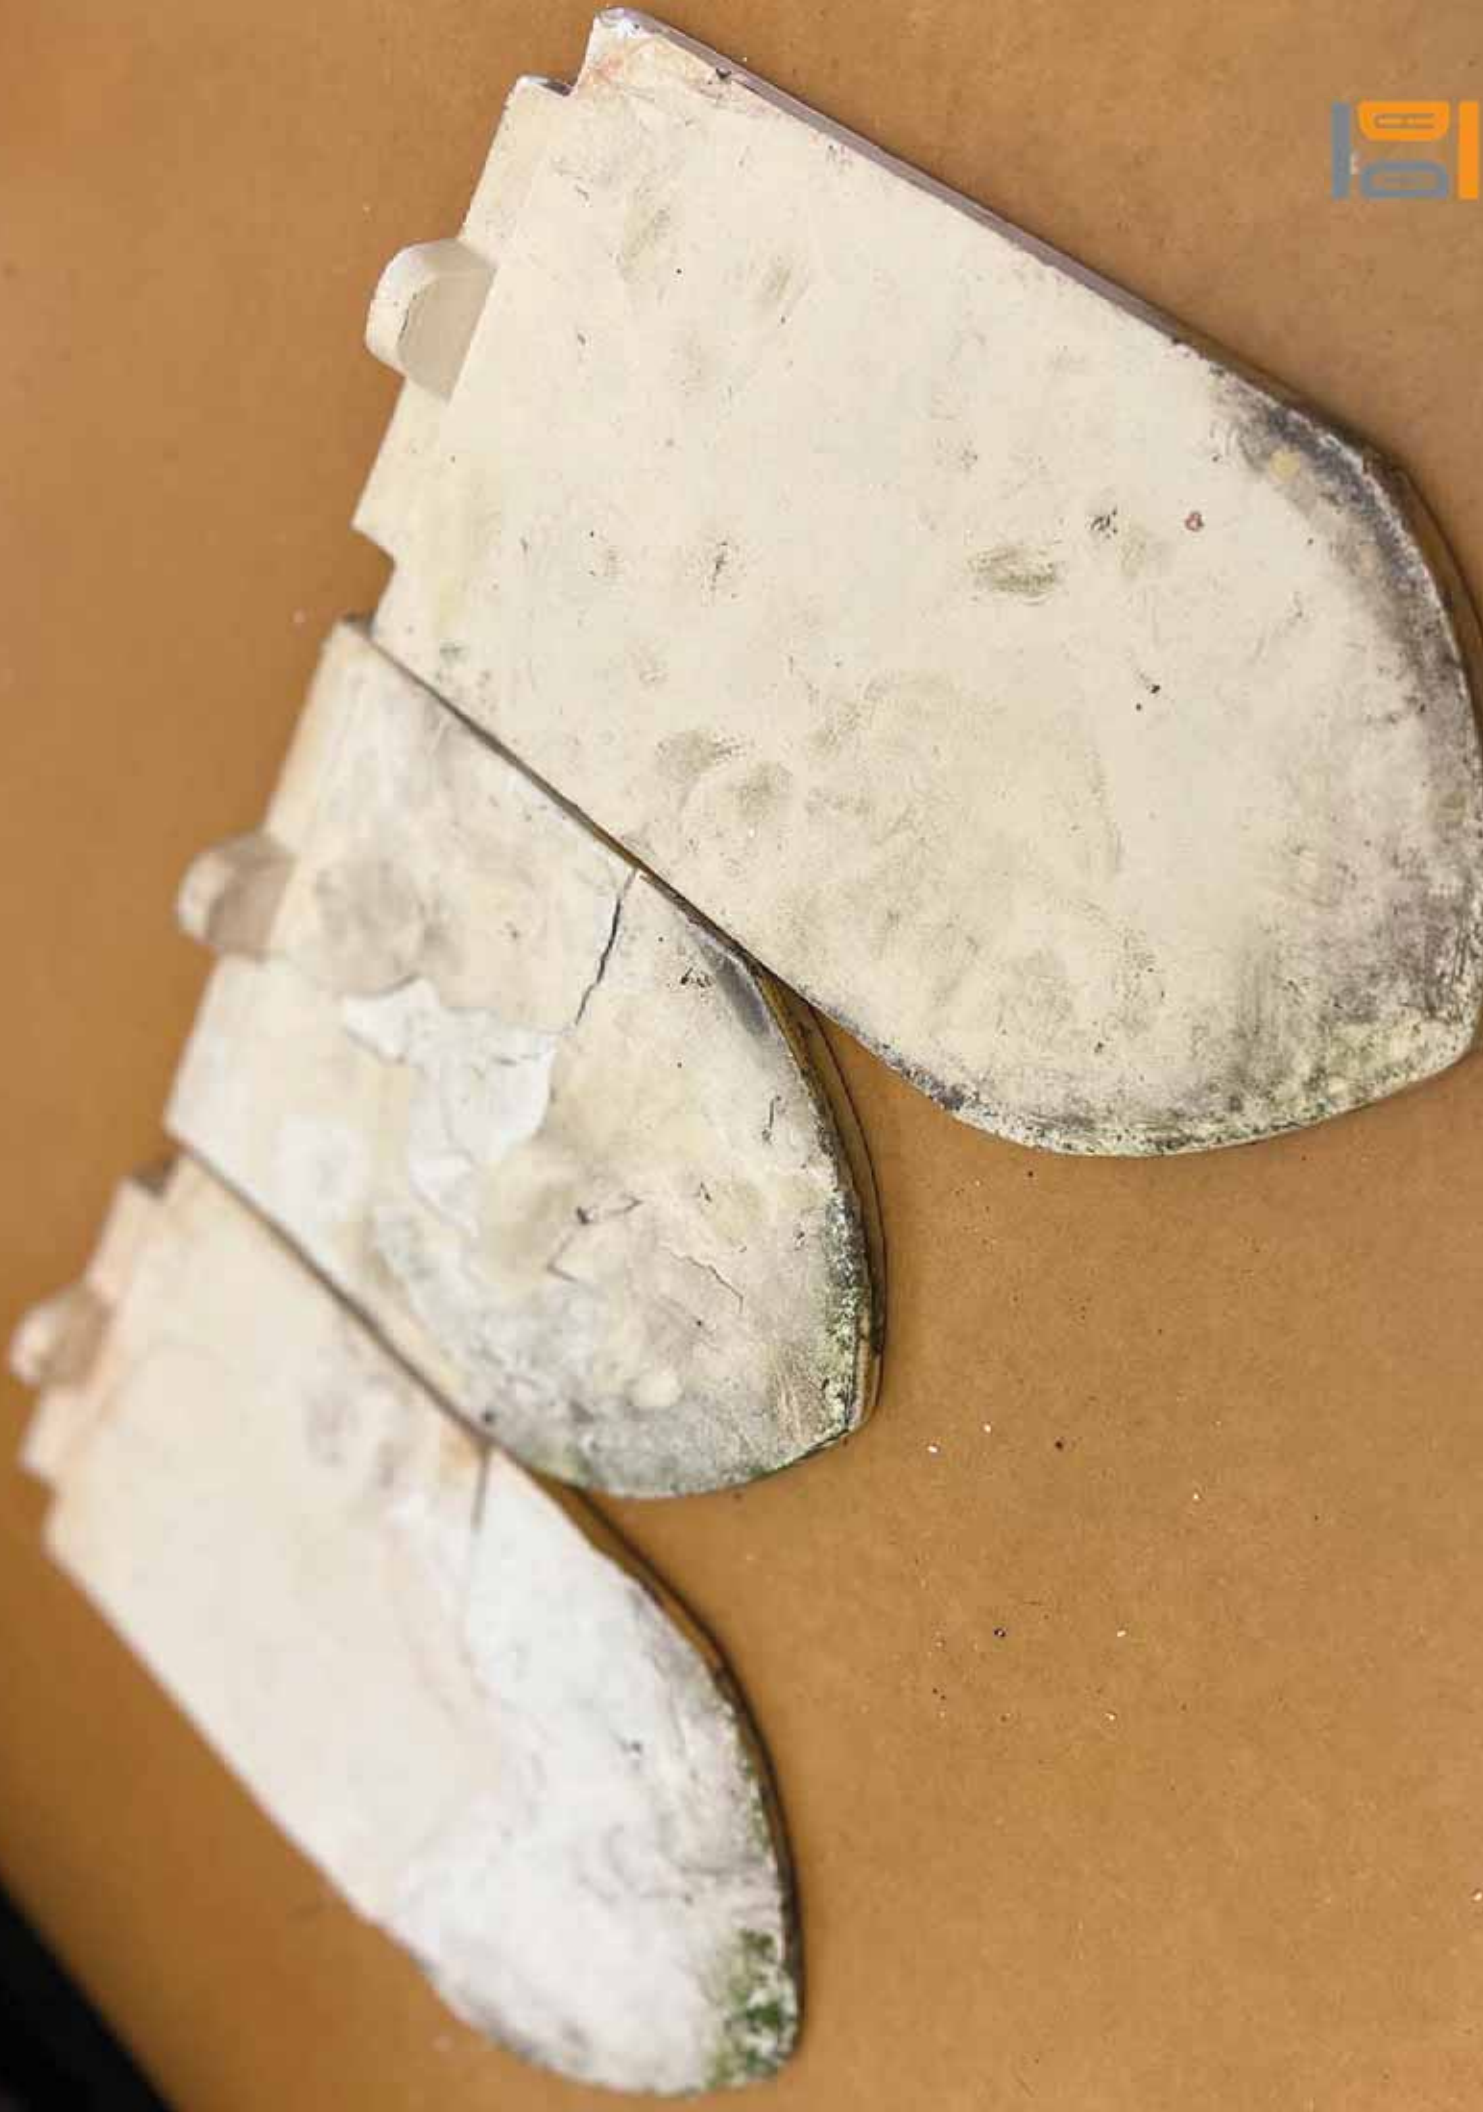
12. Grouping of three tiles removed for further study - Priority 1

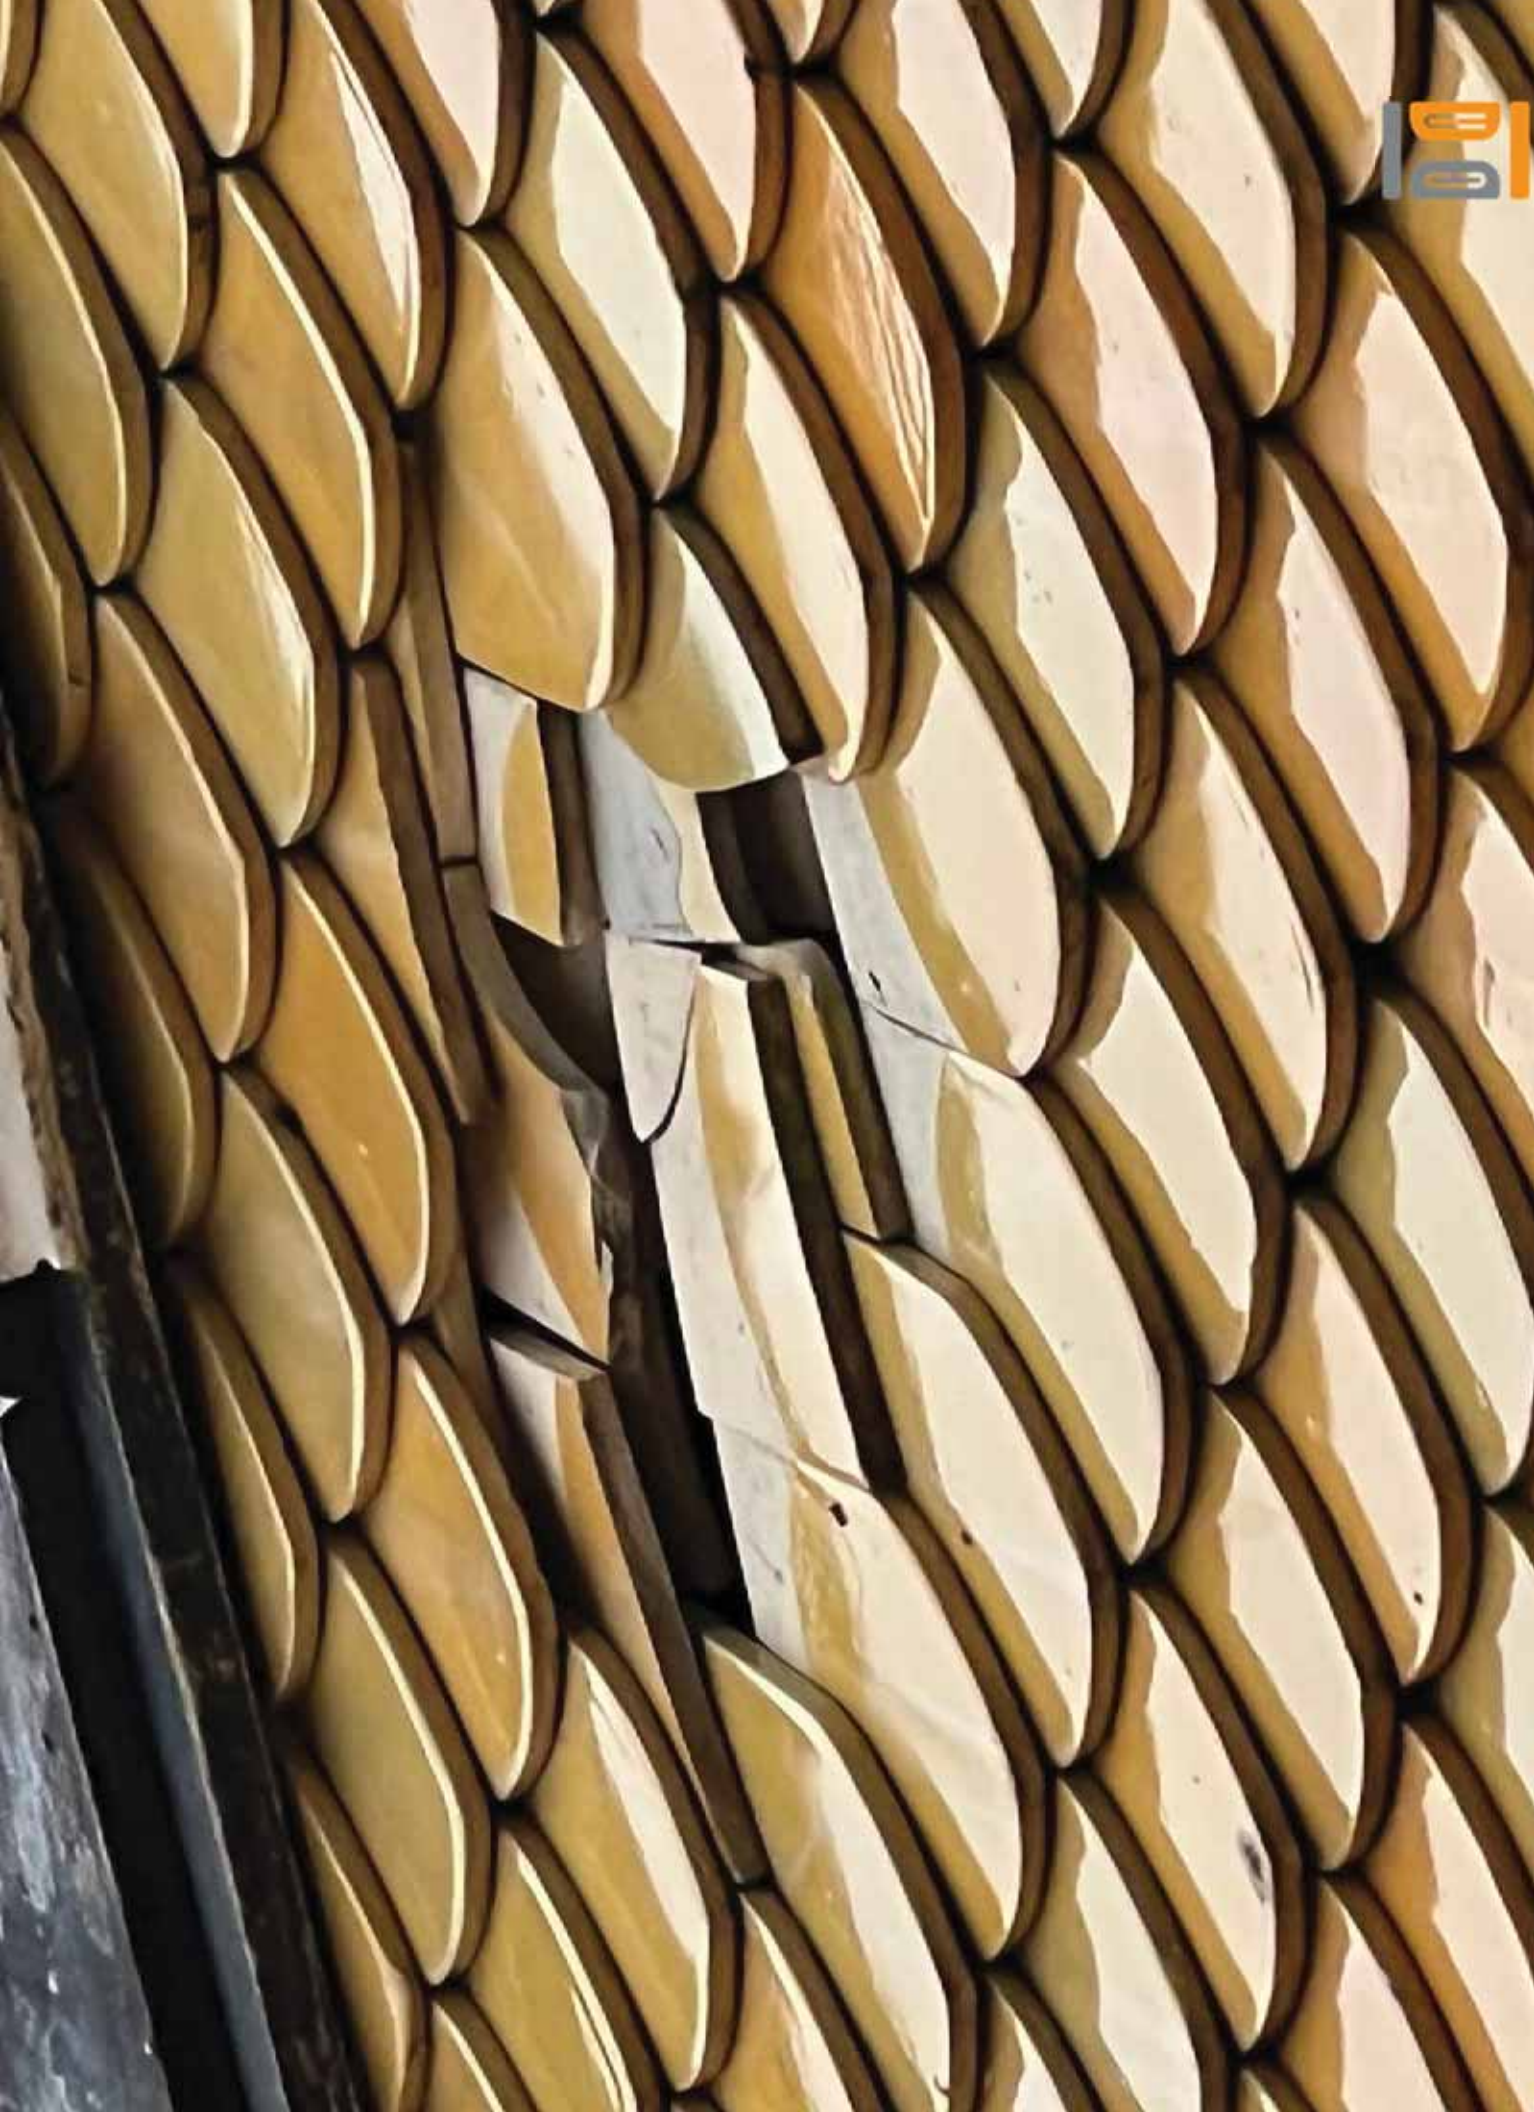
14. View of fractured tile – from impact or concentrated point load (assumed) - Priority 1

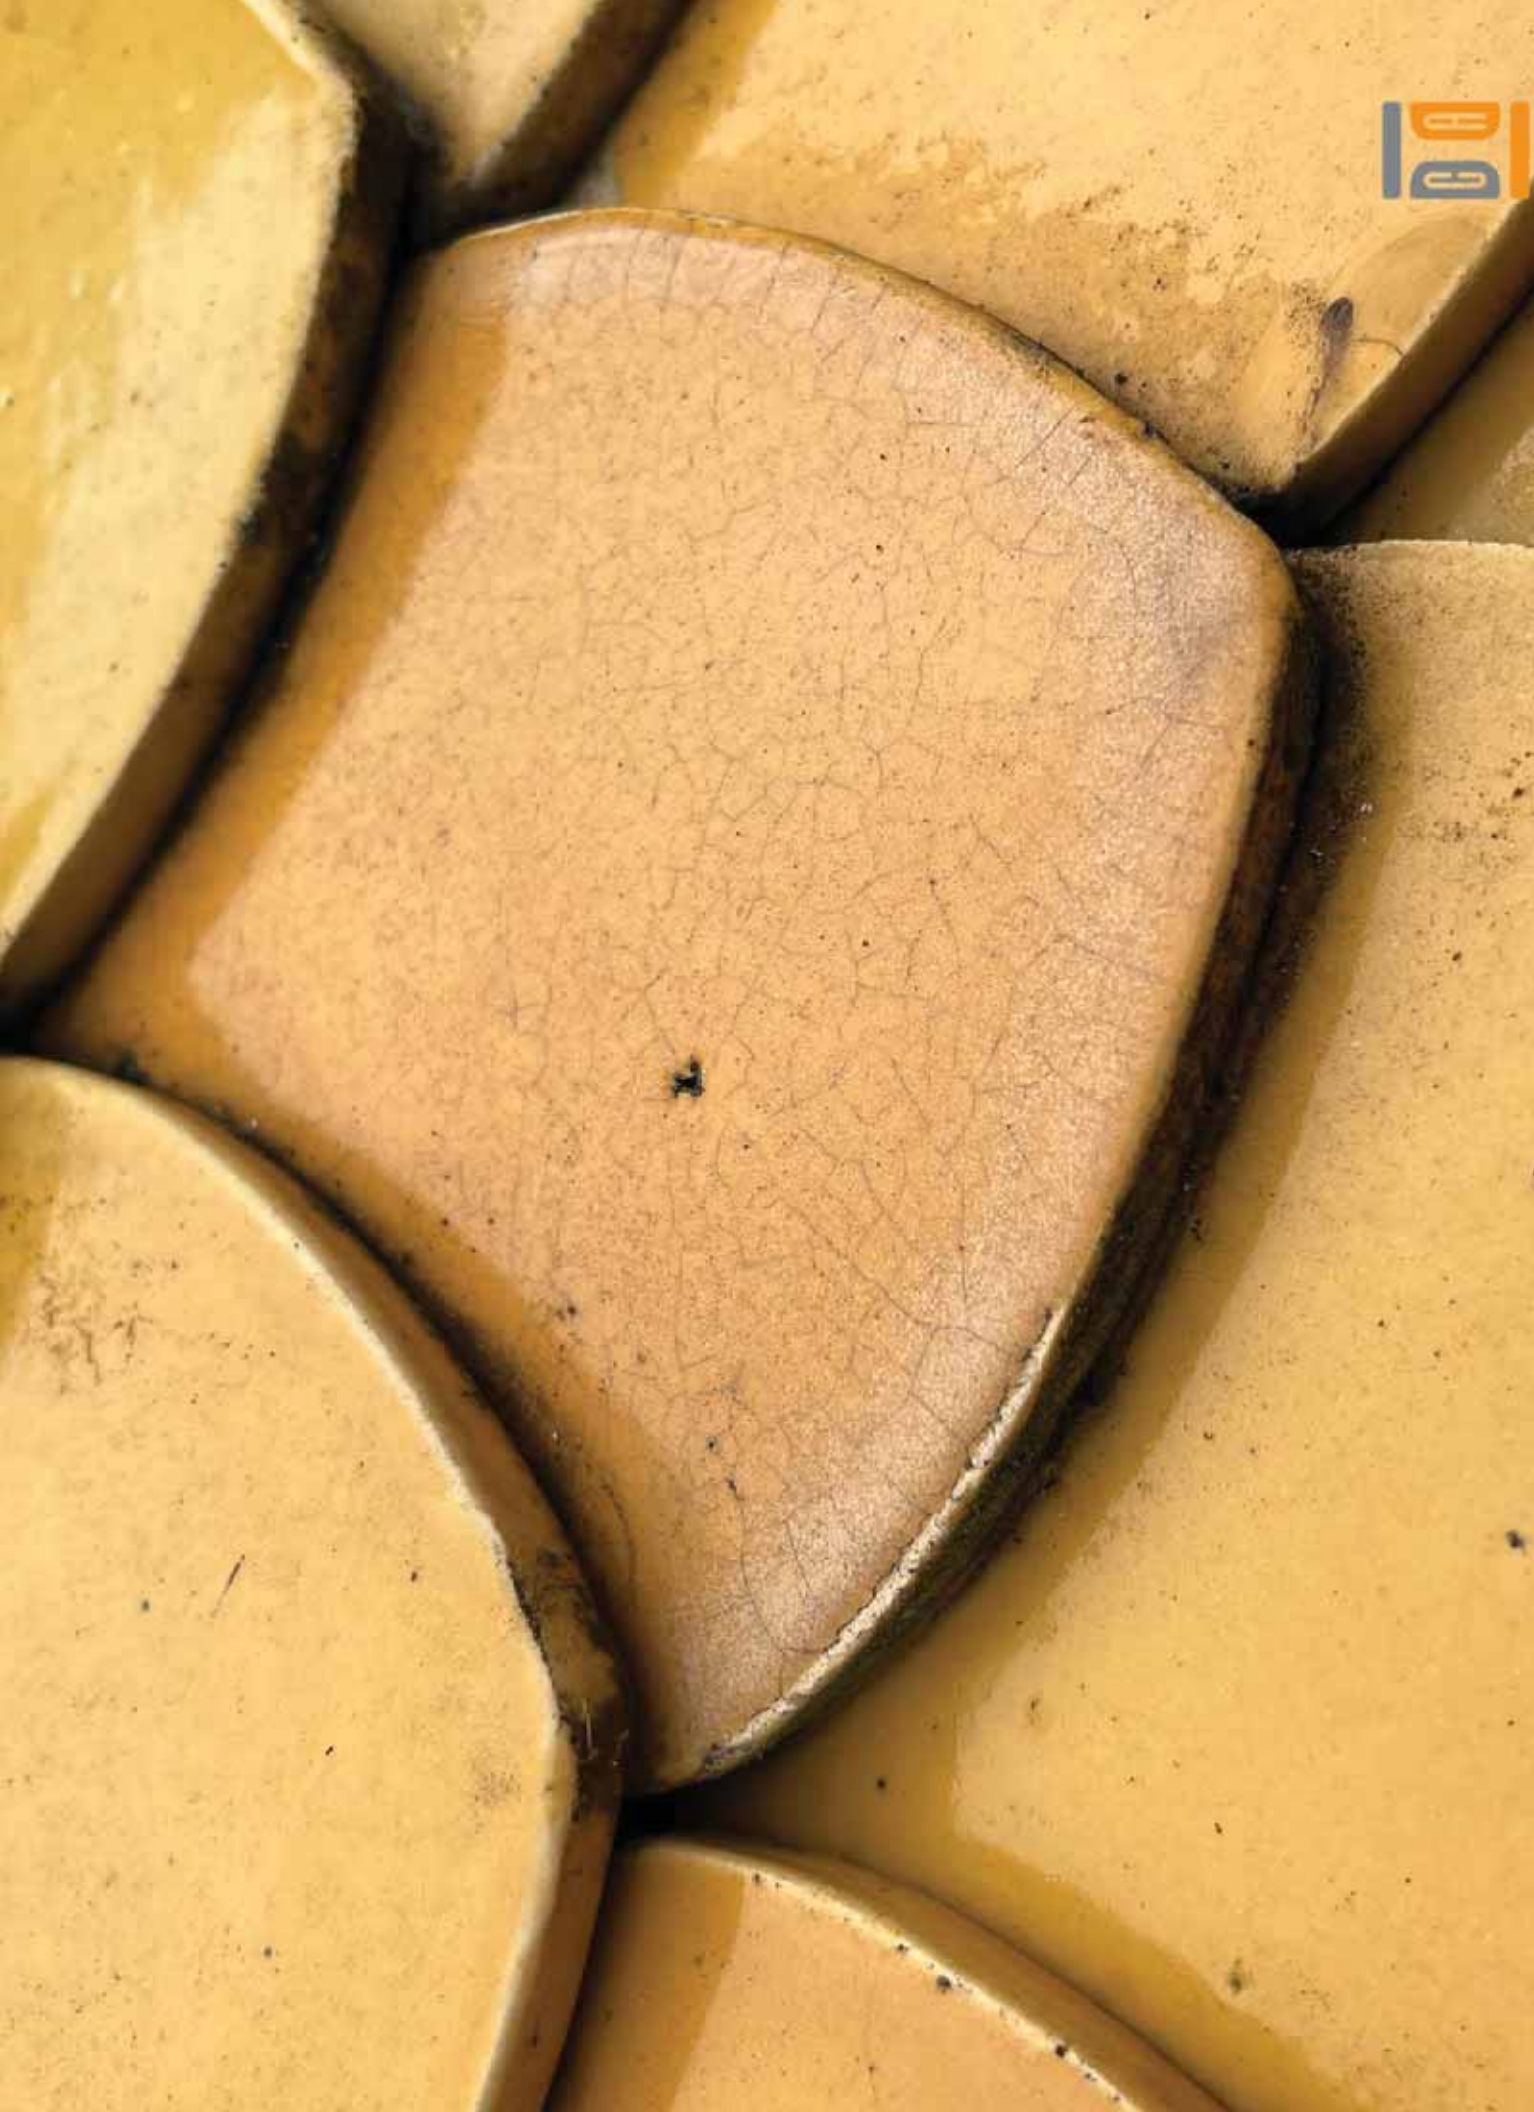
15. Fractured ceramic glaze – eventual water infiltration - Priority 1
