OLBRICH BOTOANICAL GARDENS ROYAL THAI PAVILION CONDITION ASSESSMENT REPORT

MAY 20, 2022

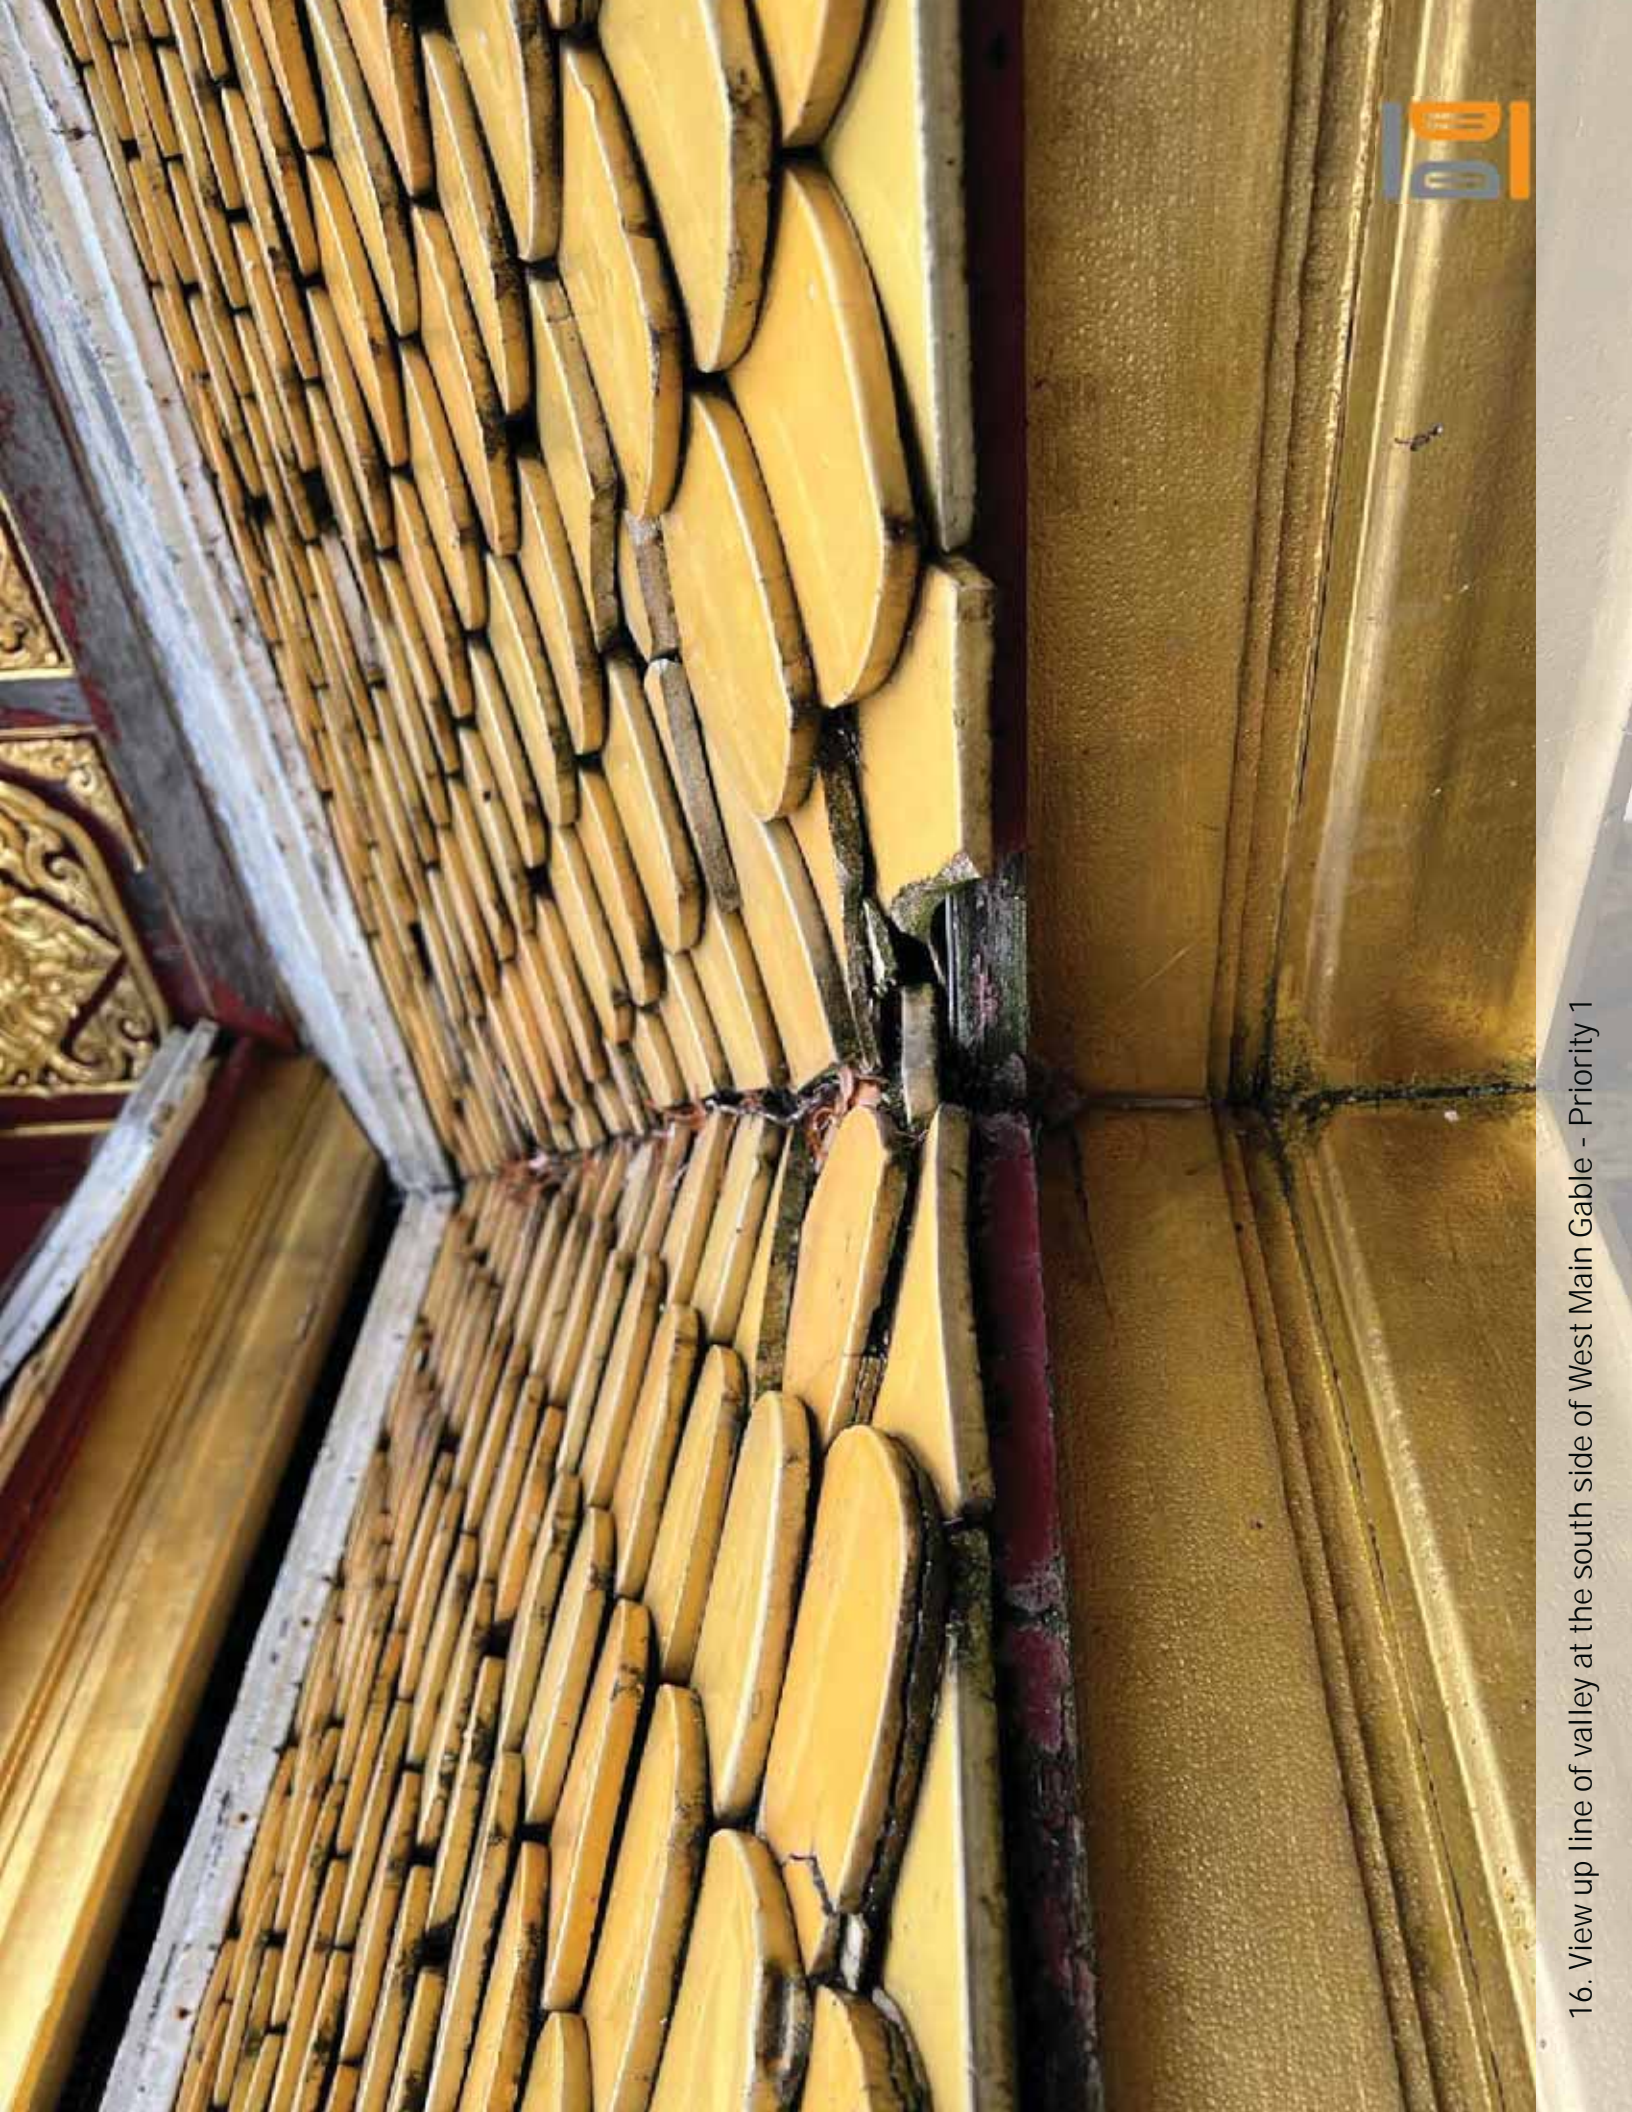
16. View up line of valley at the south side of West Main Gable - Priority 1

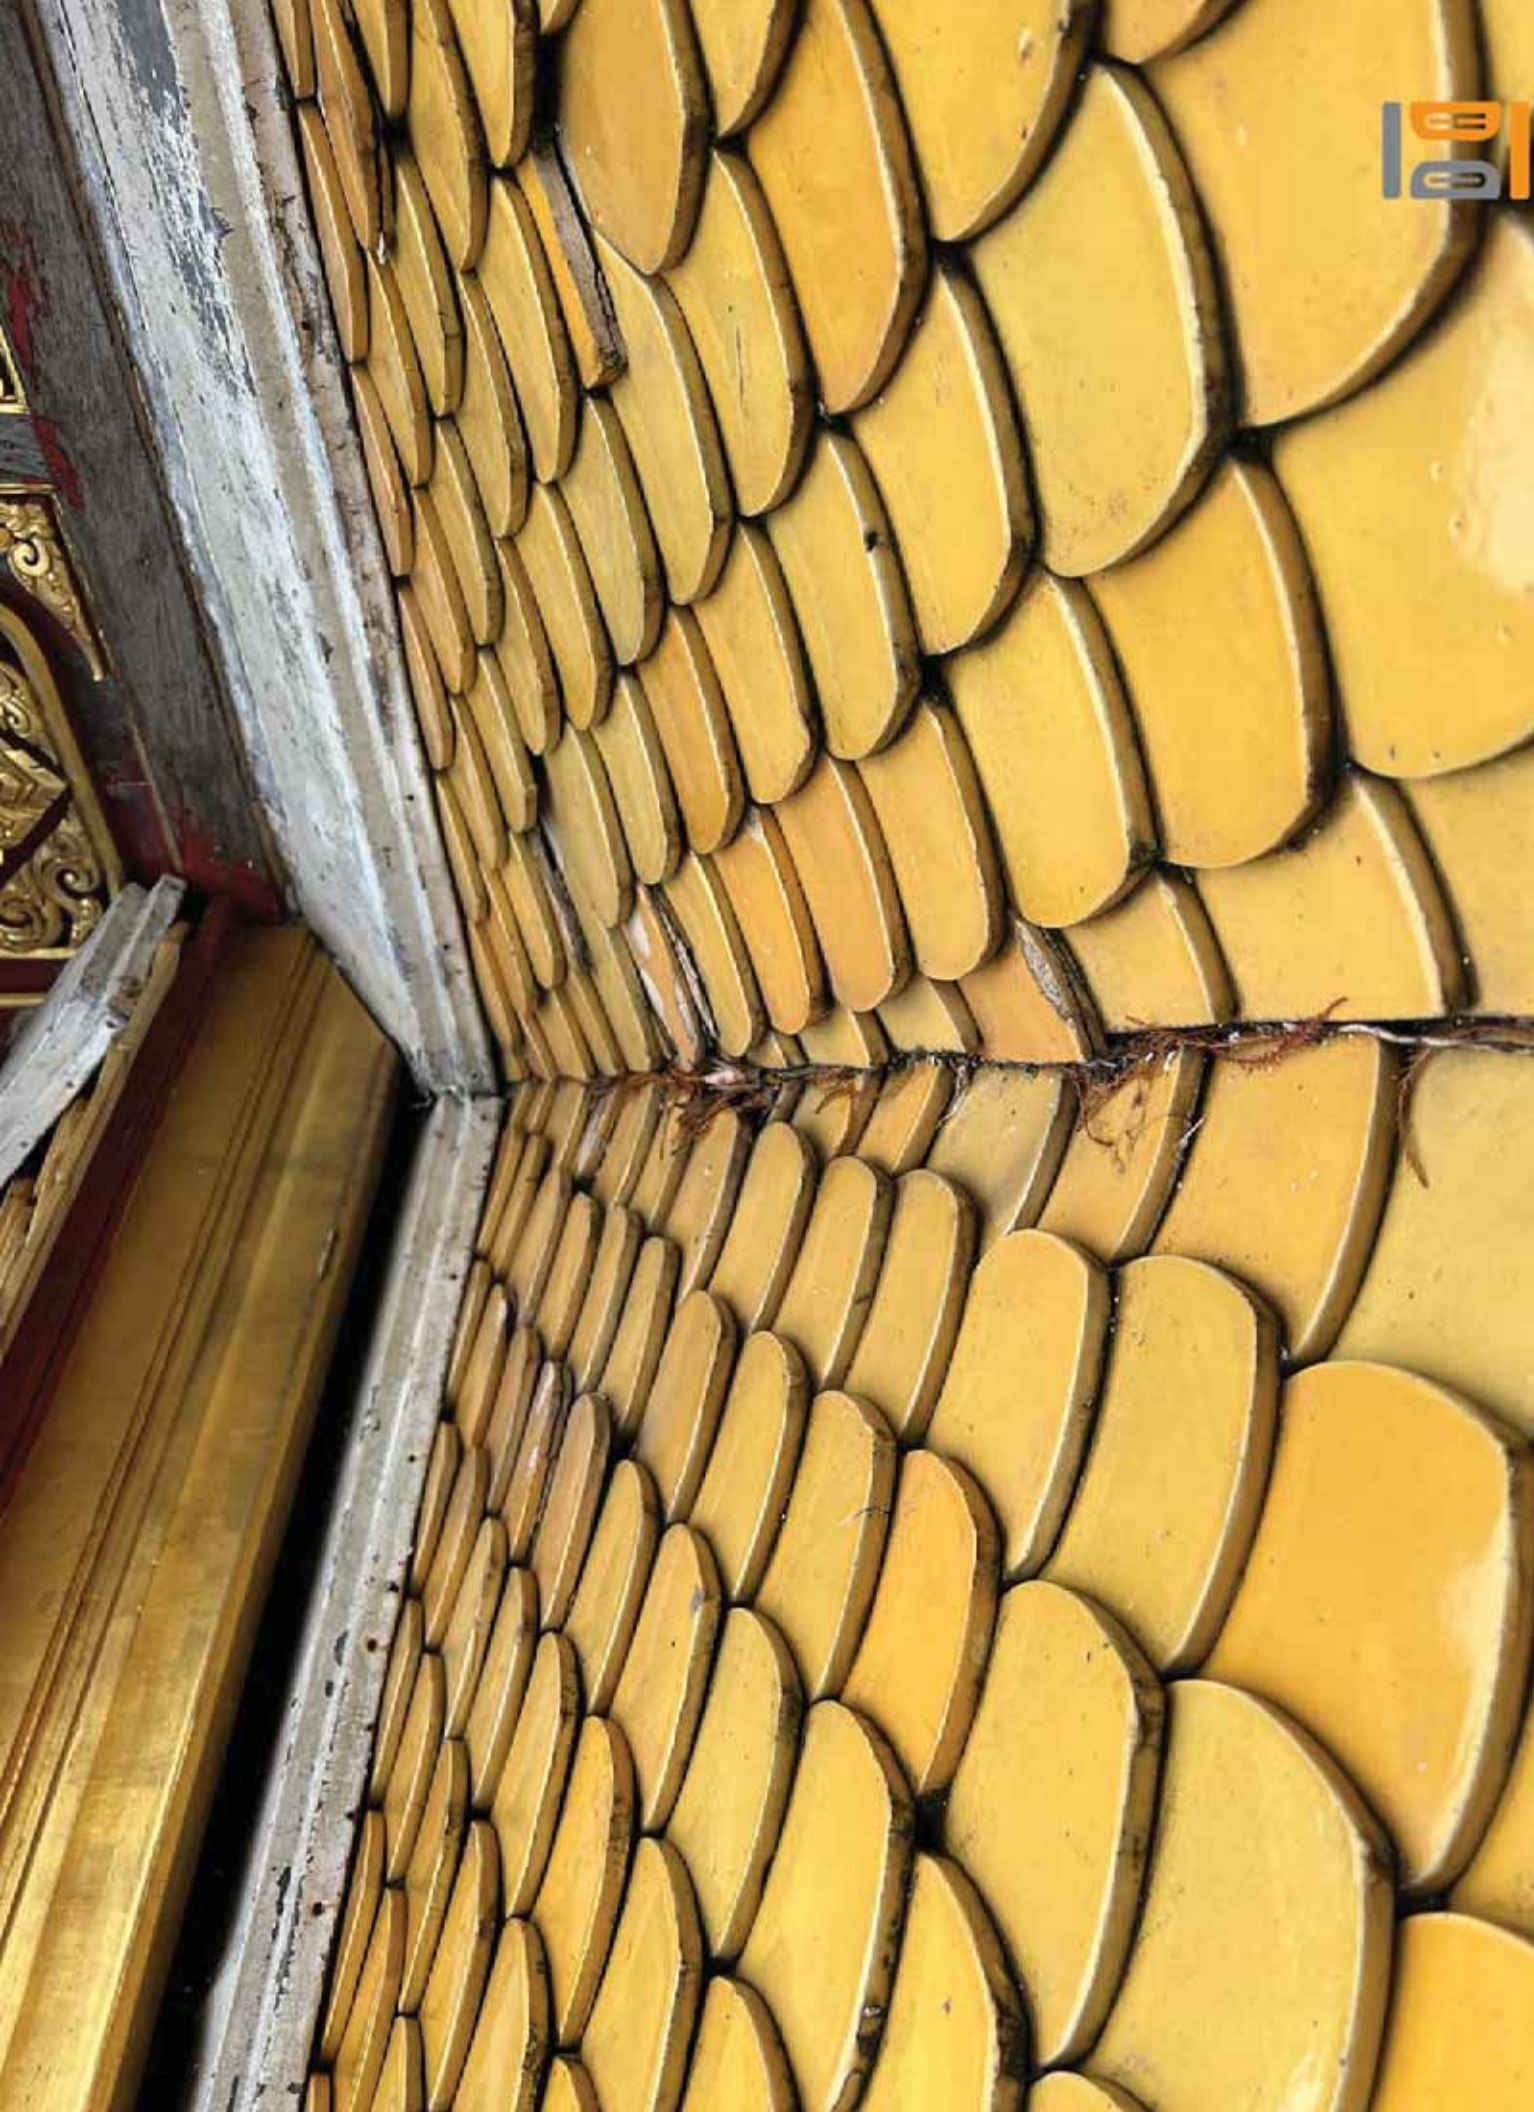
17. Overhead view up line of valley at the south side of West Main Gable - Priority 1

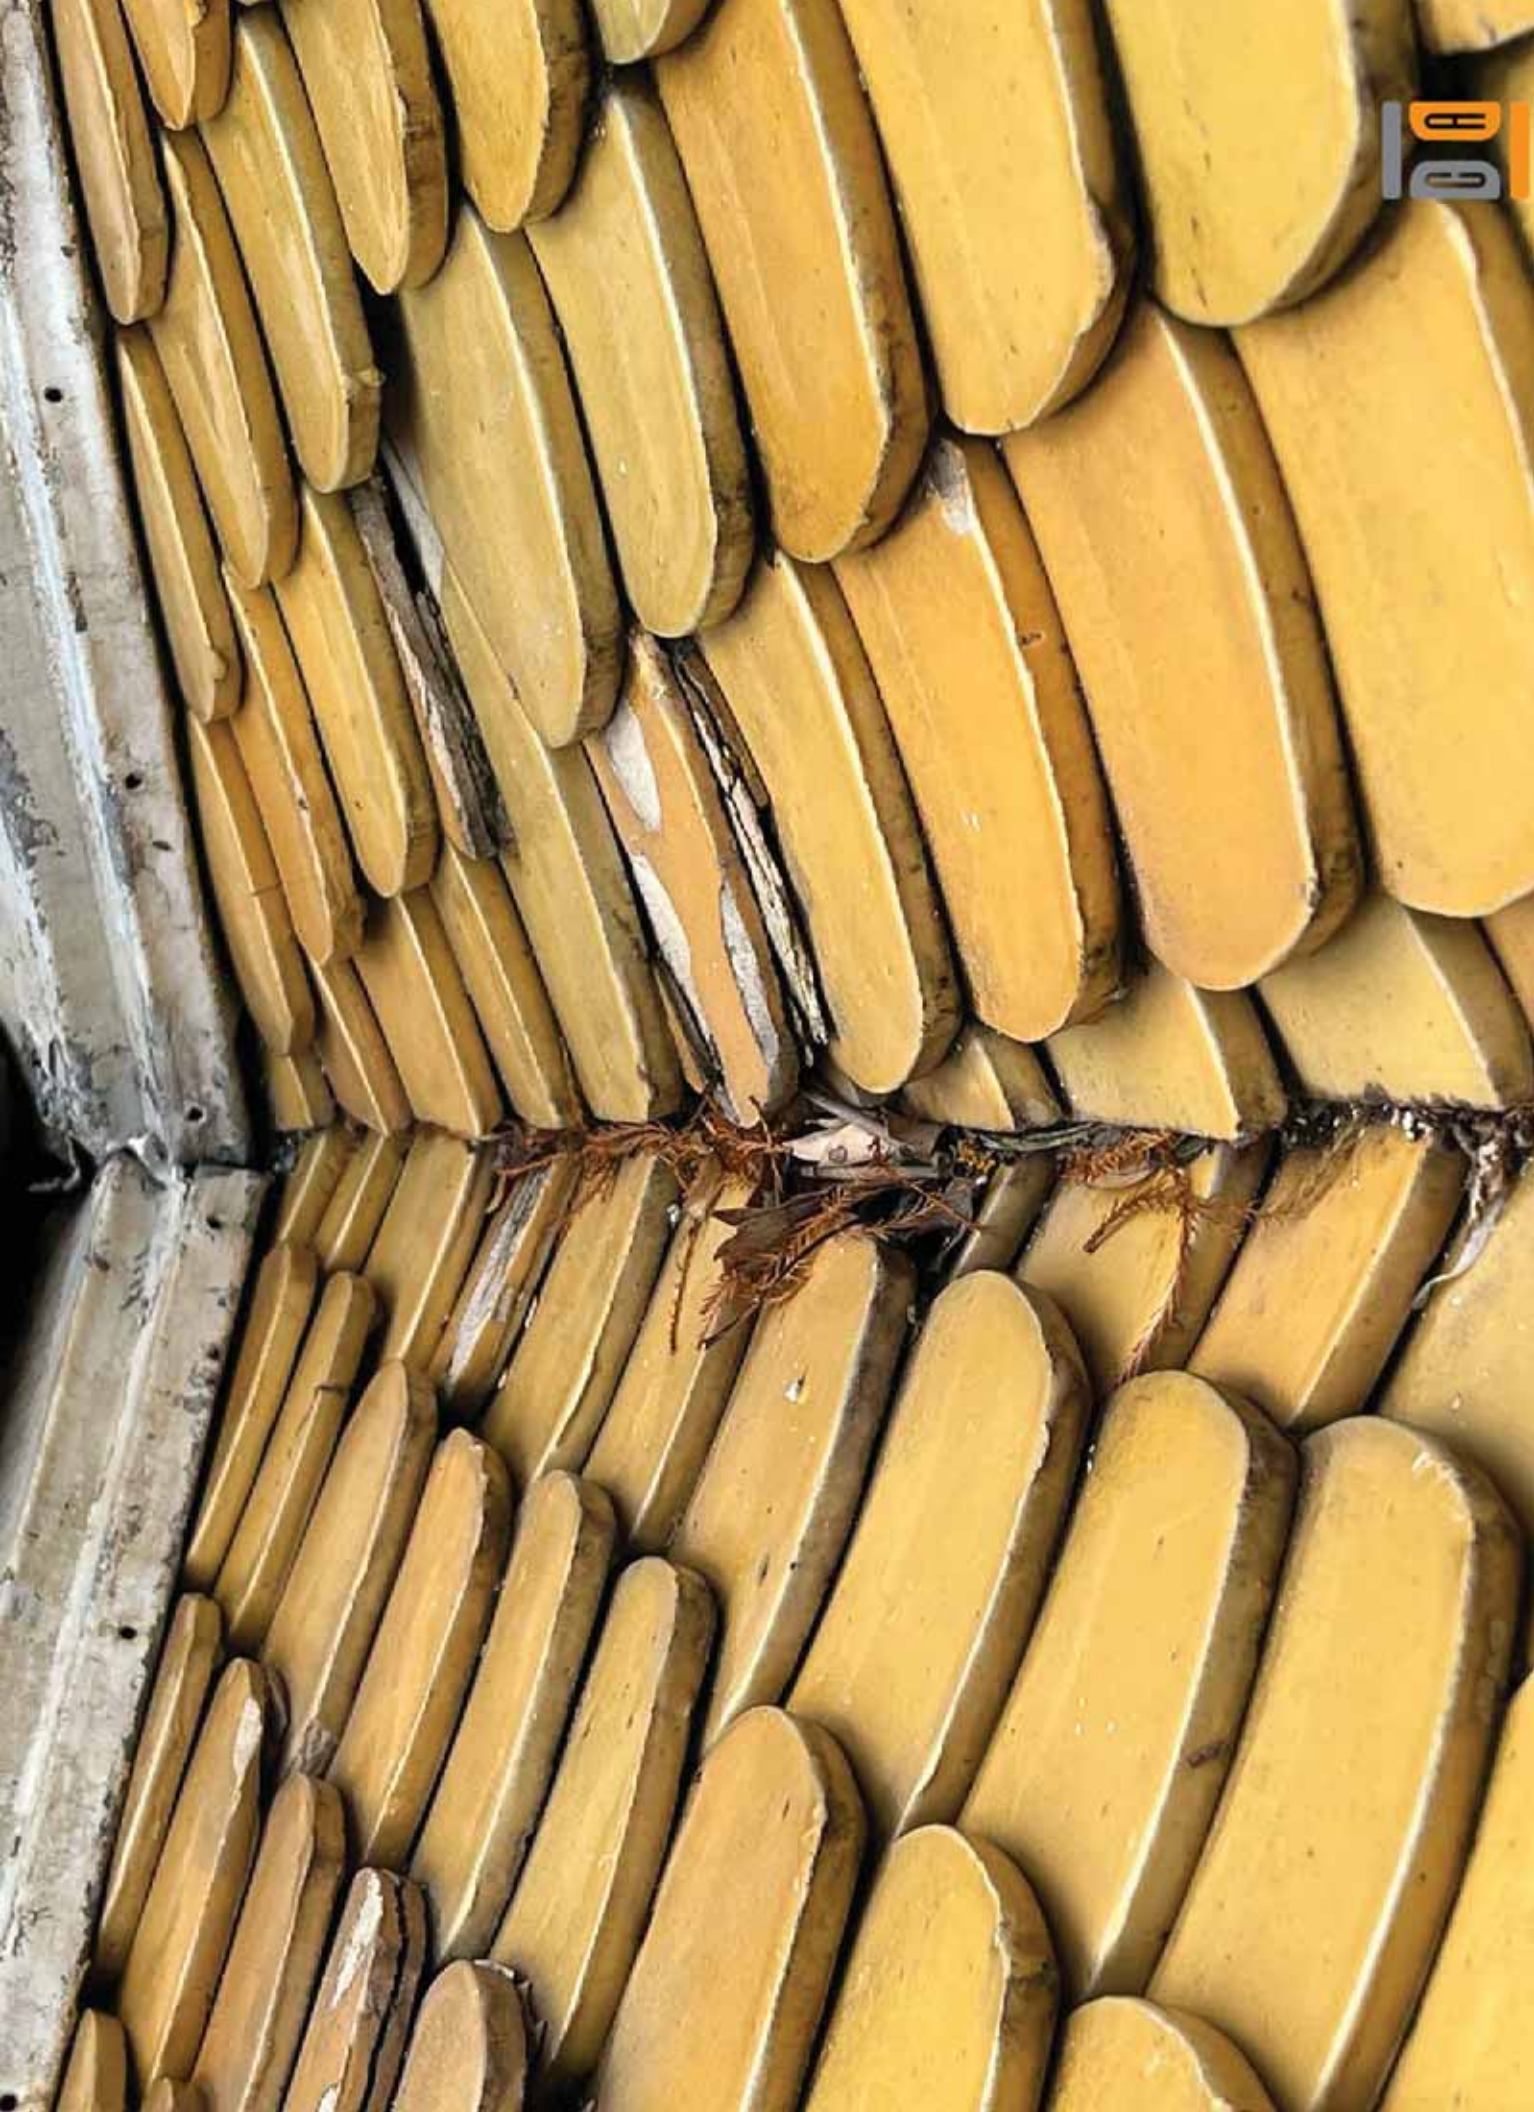
18. Closer view up the valley at the south side of West Main Gable - Priority 1

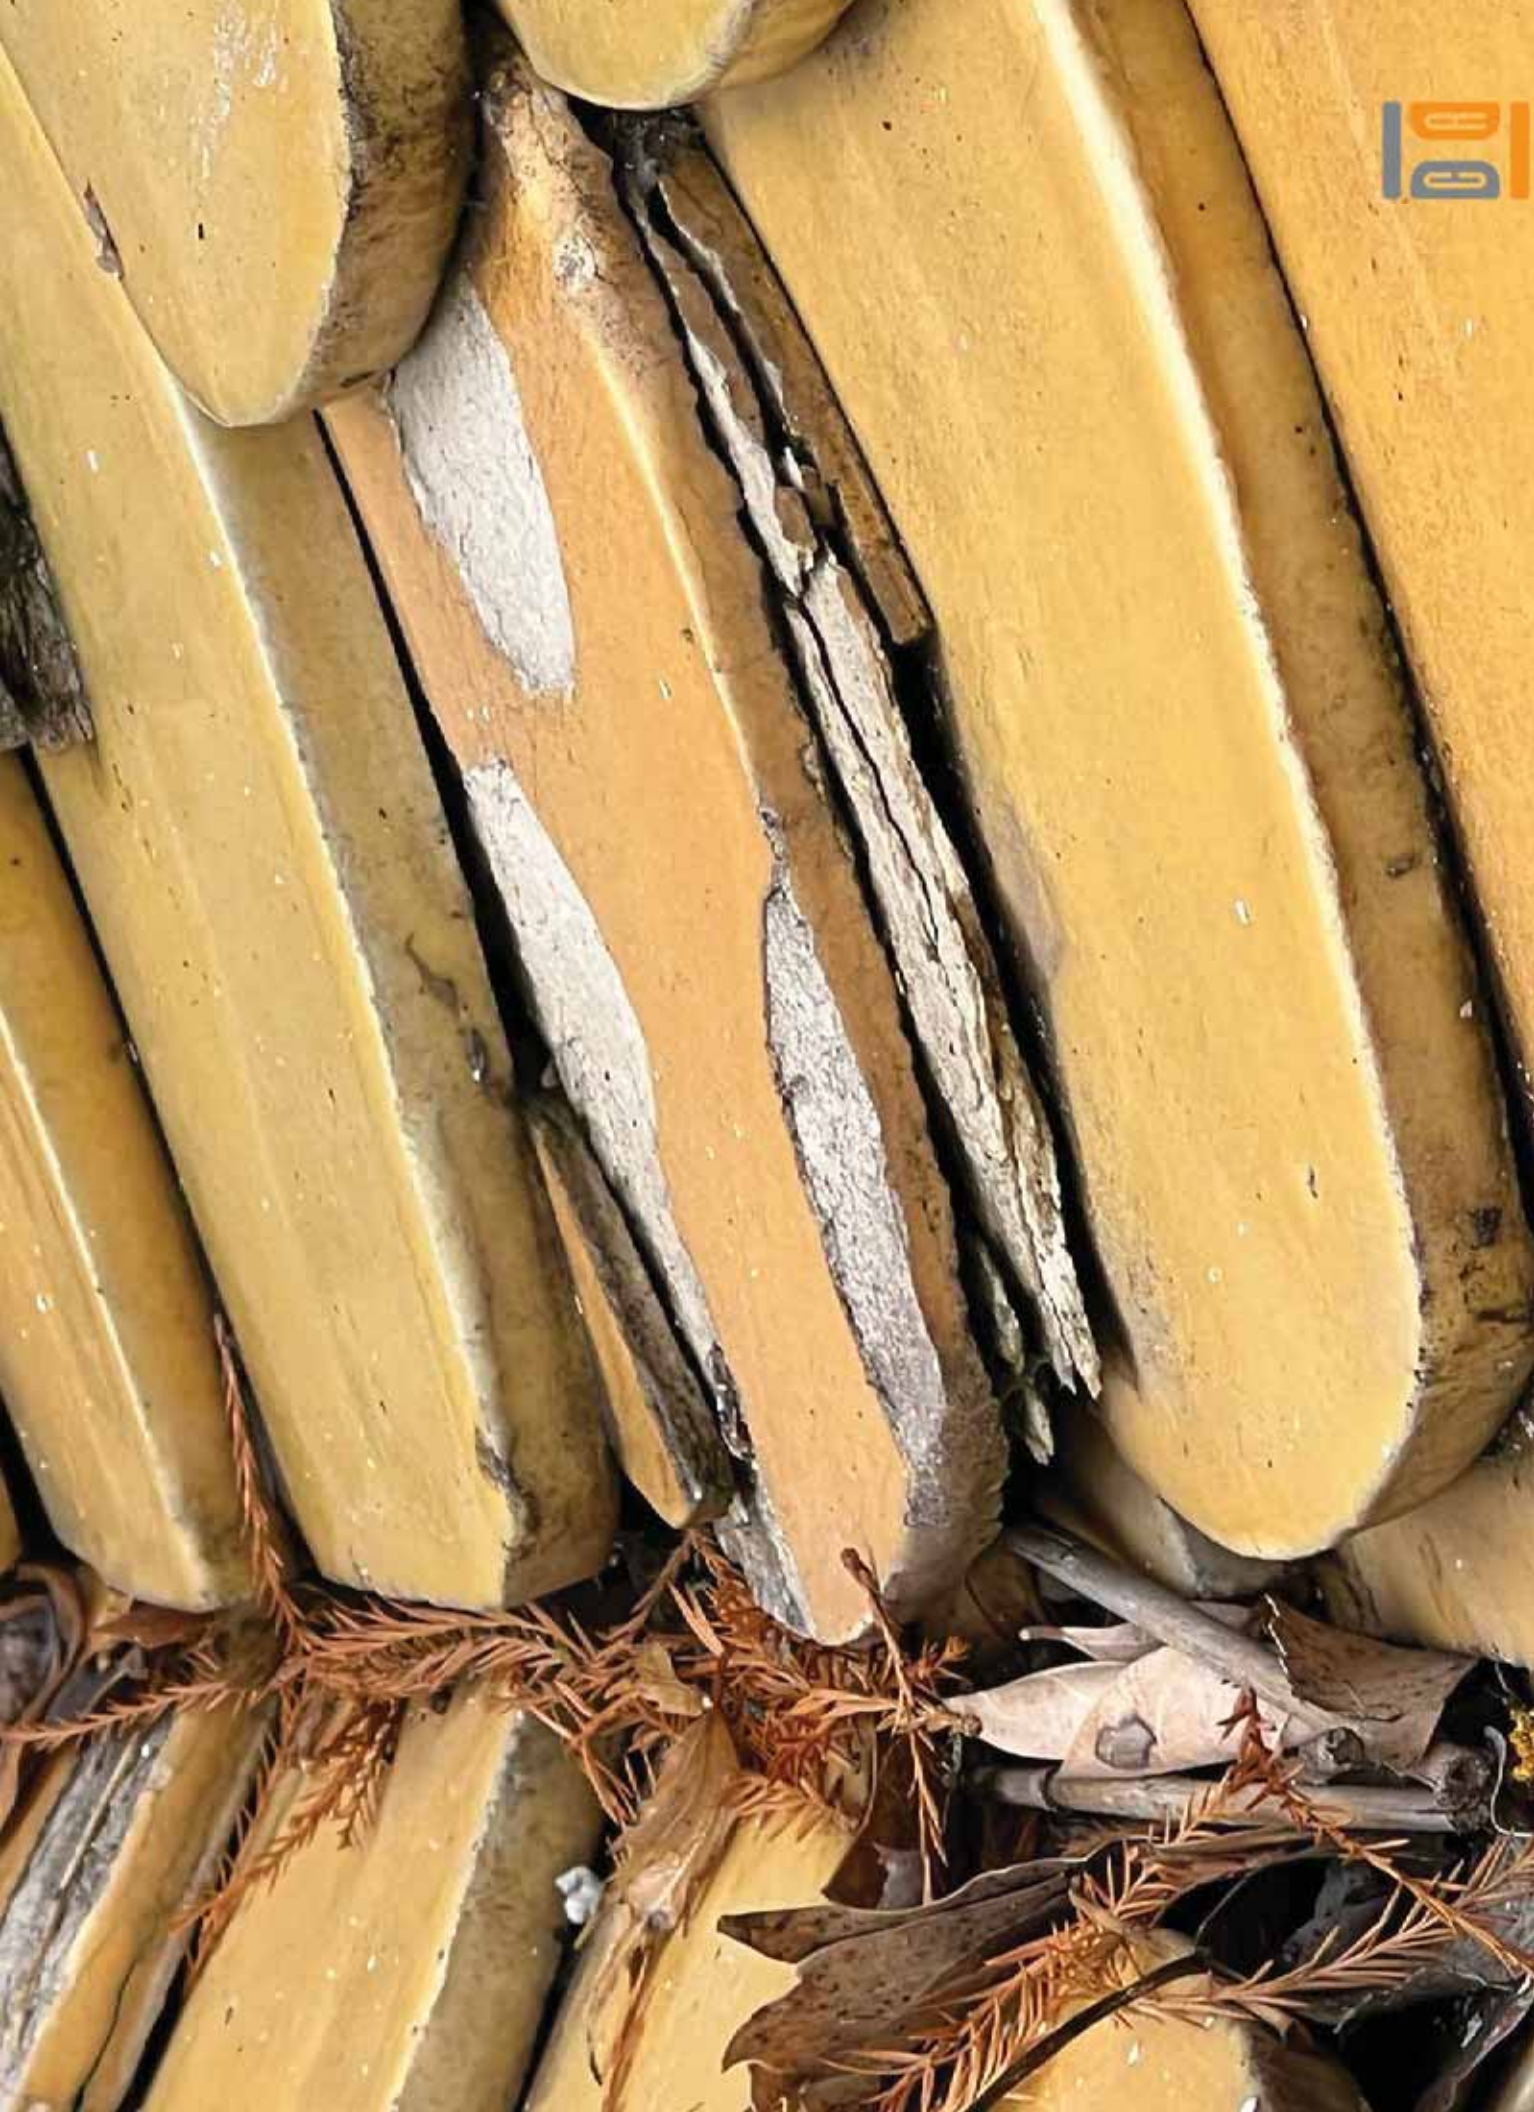
19. Close up of tile degradation at valley identified in images - Priority 1

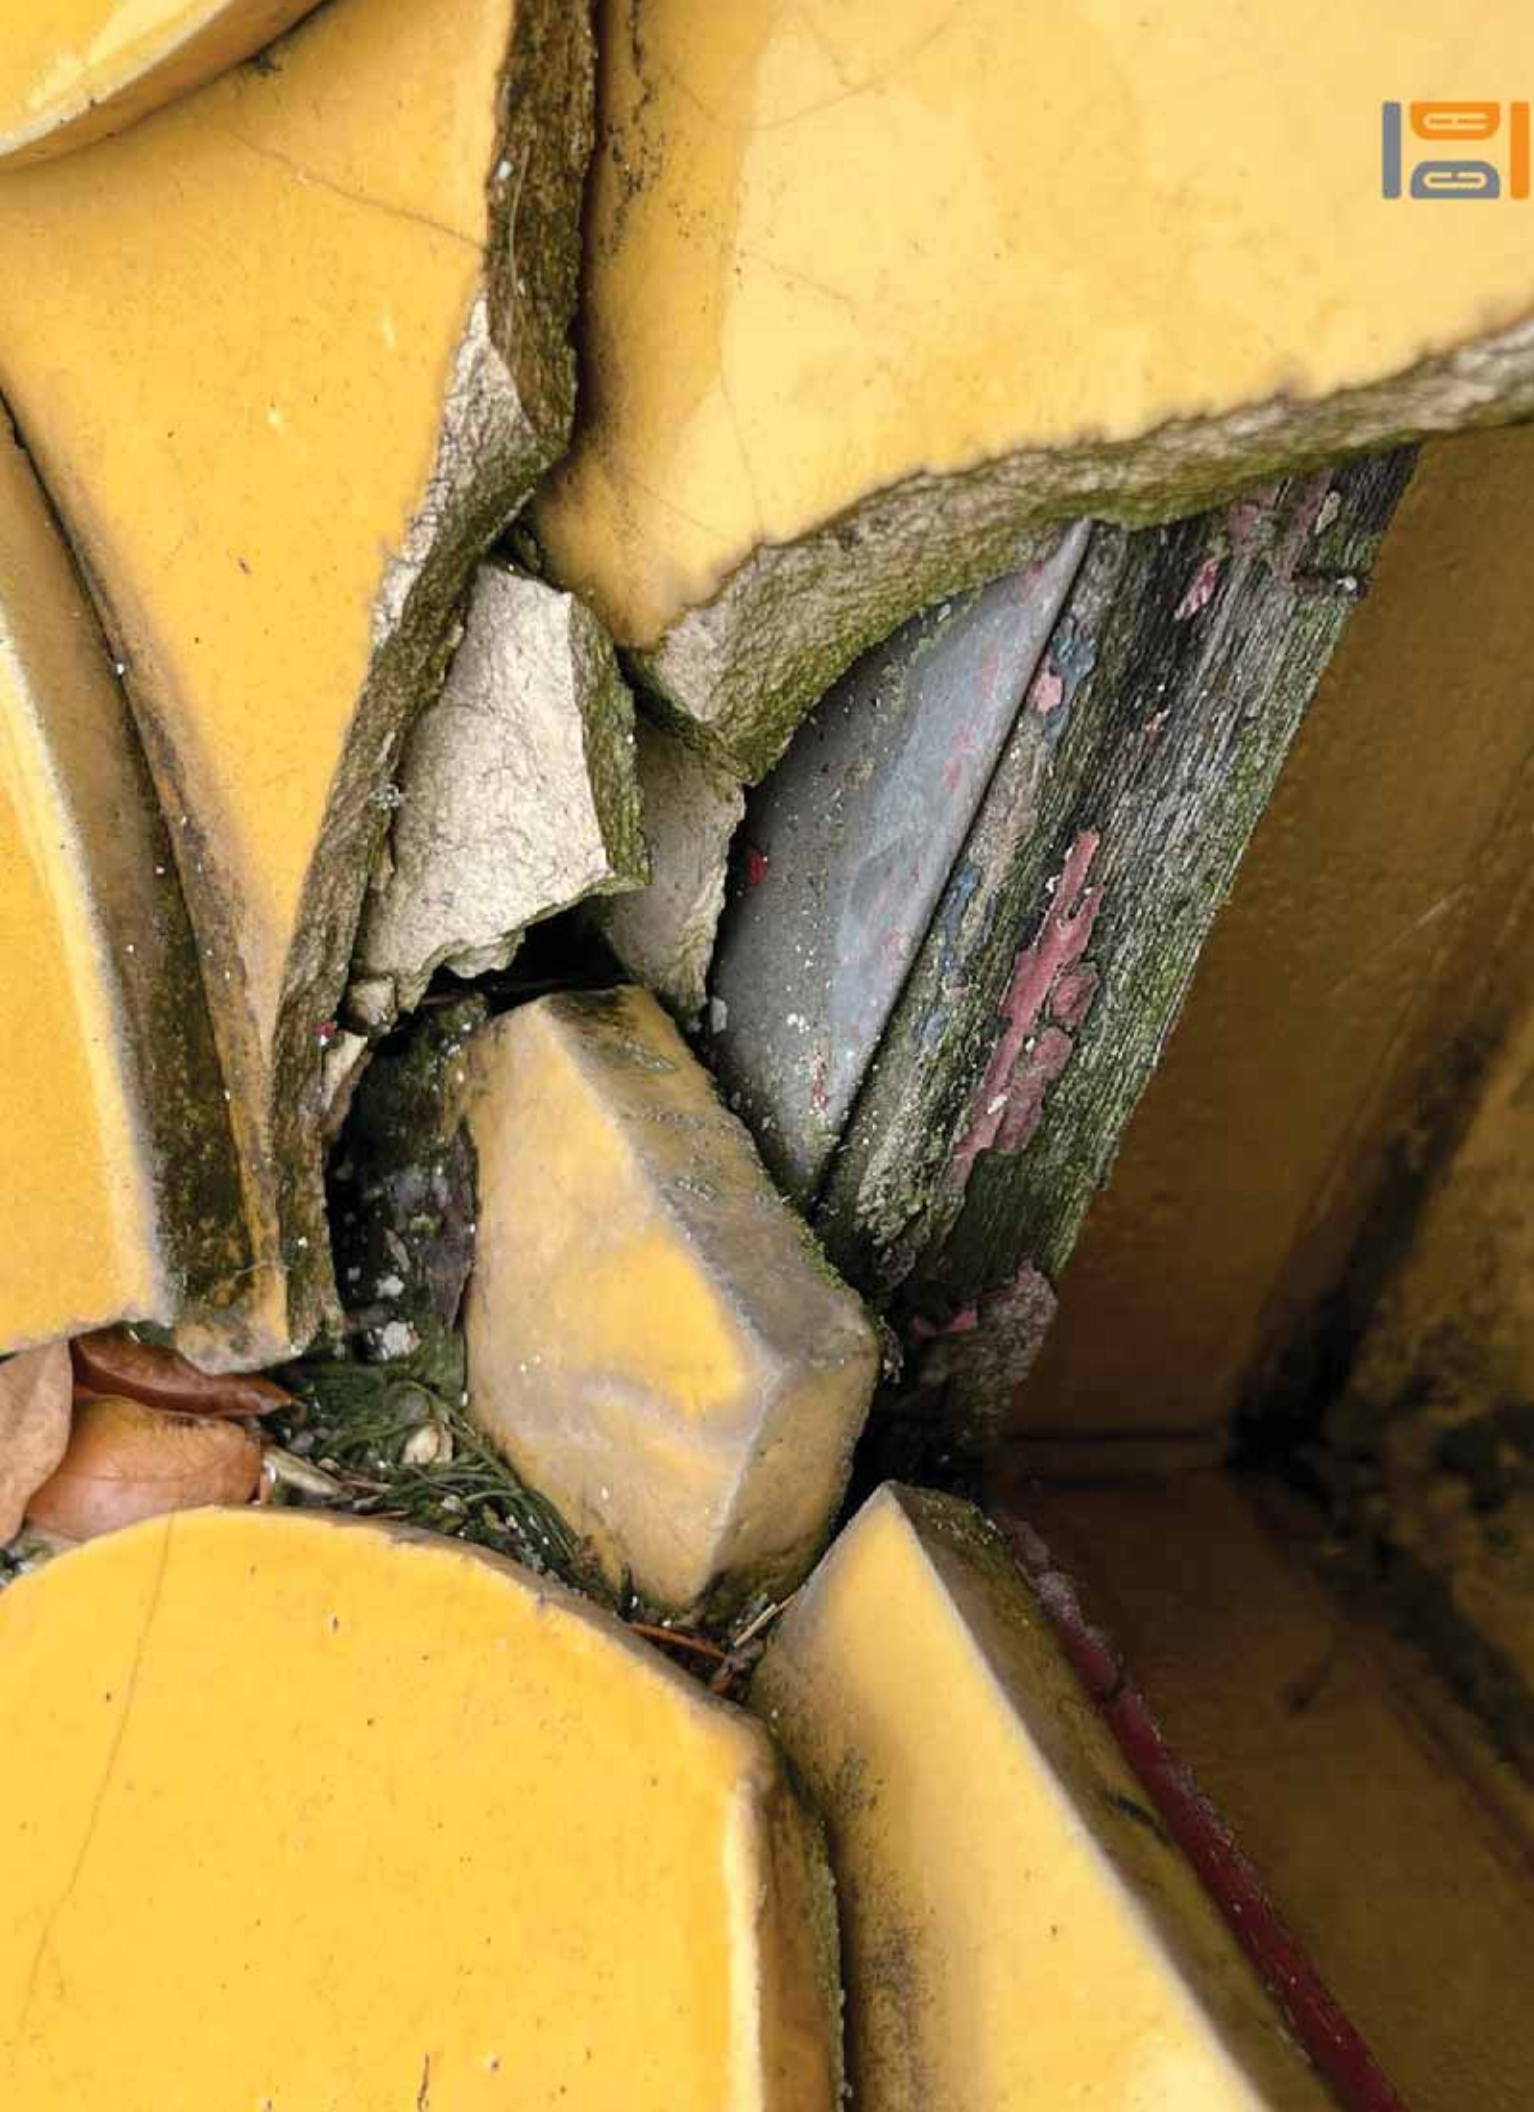
20. Close-up of valley termination at location referenced in images - Priority 1

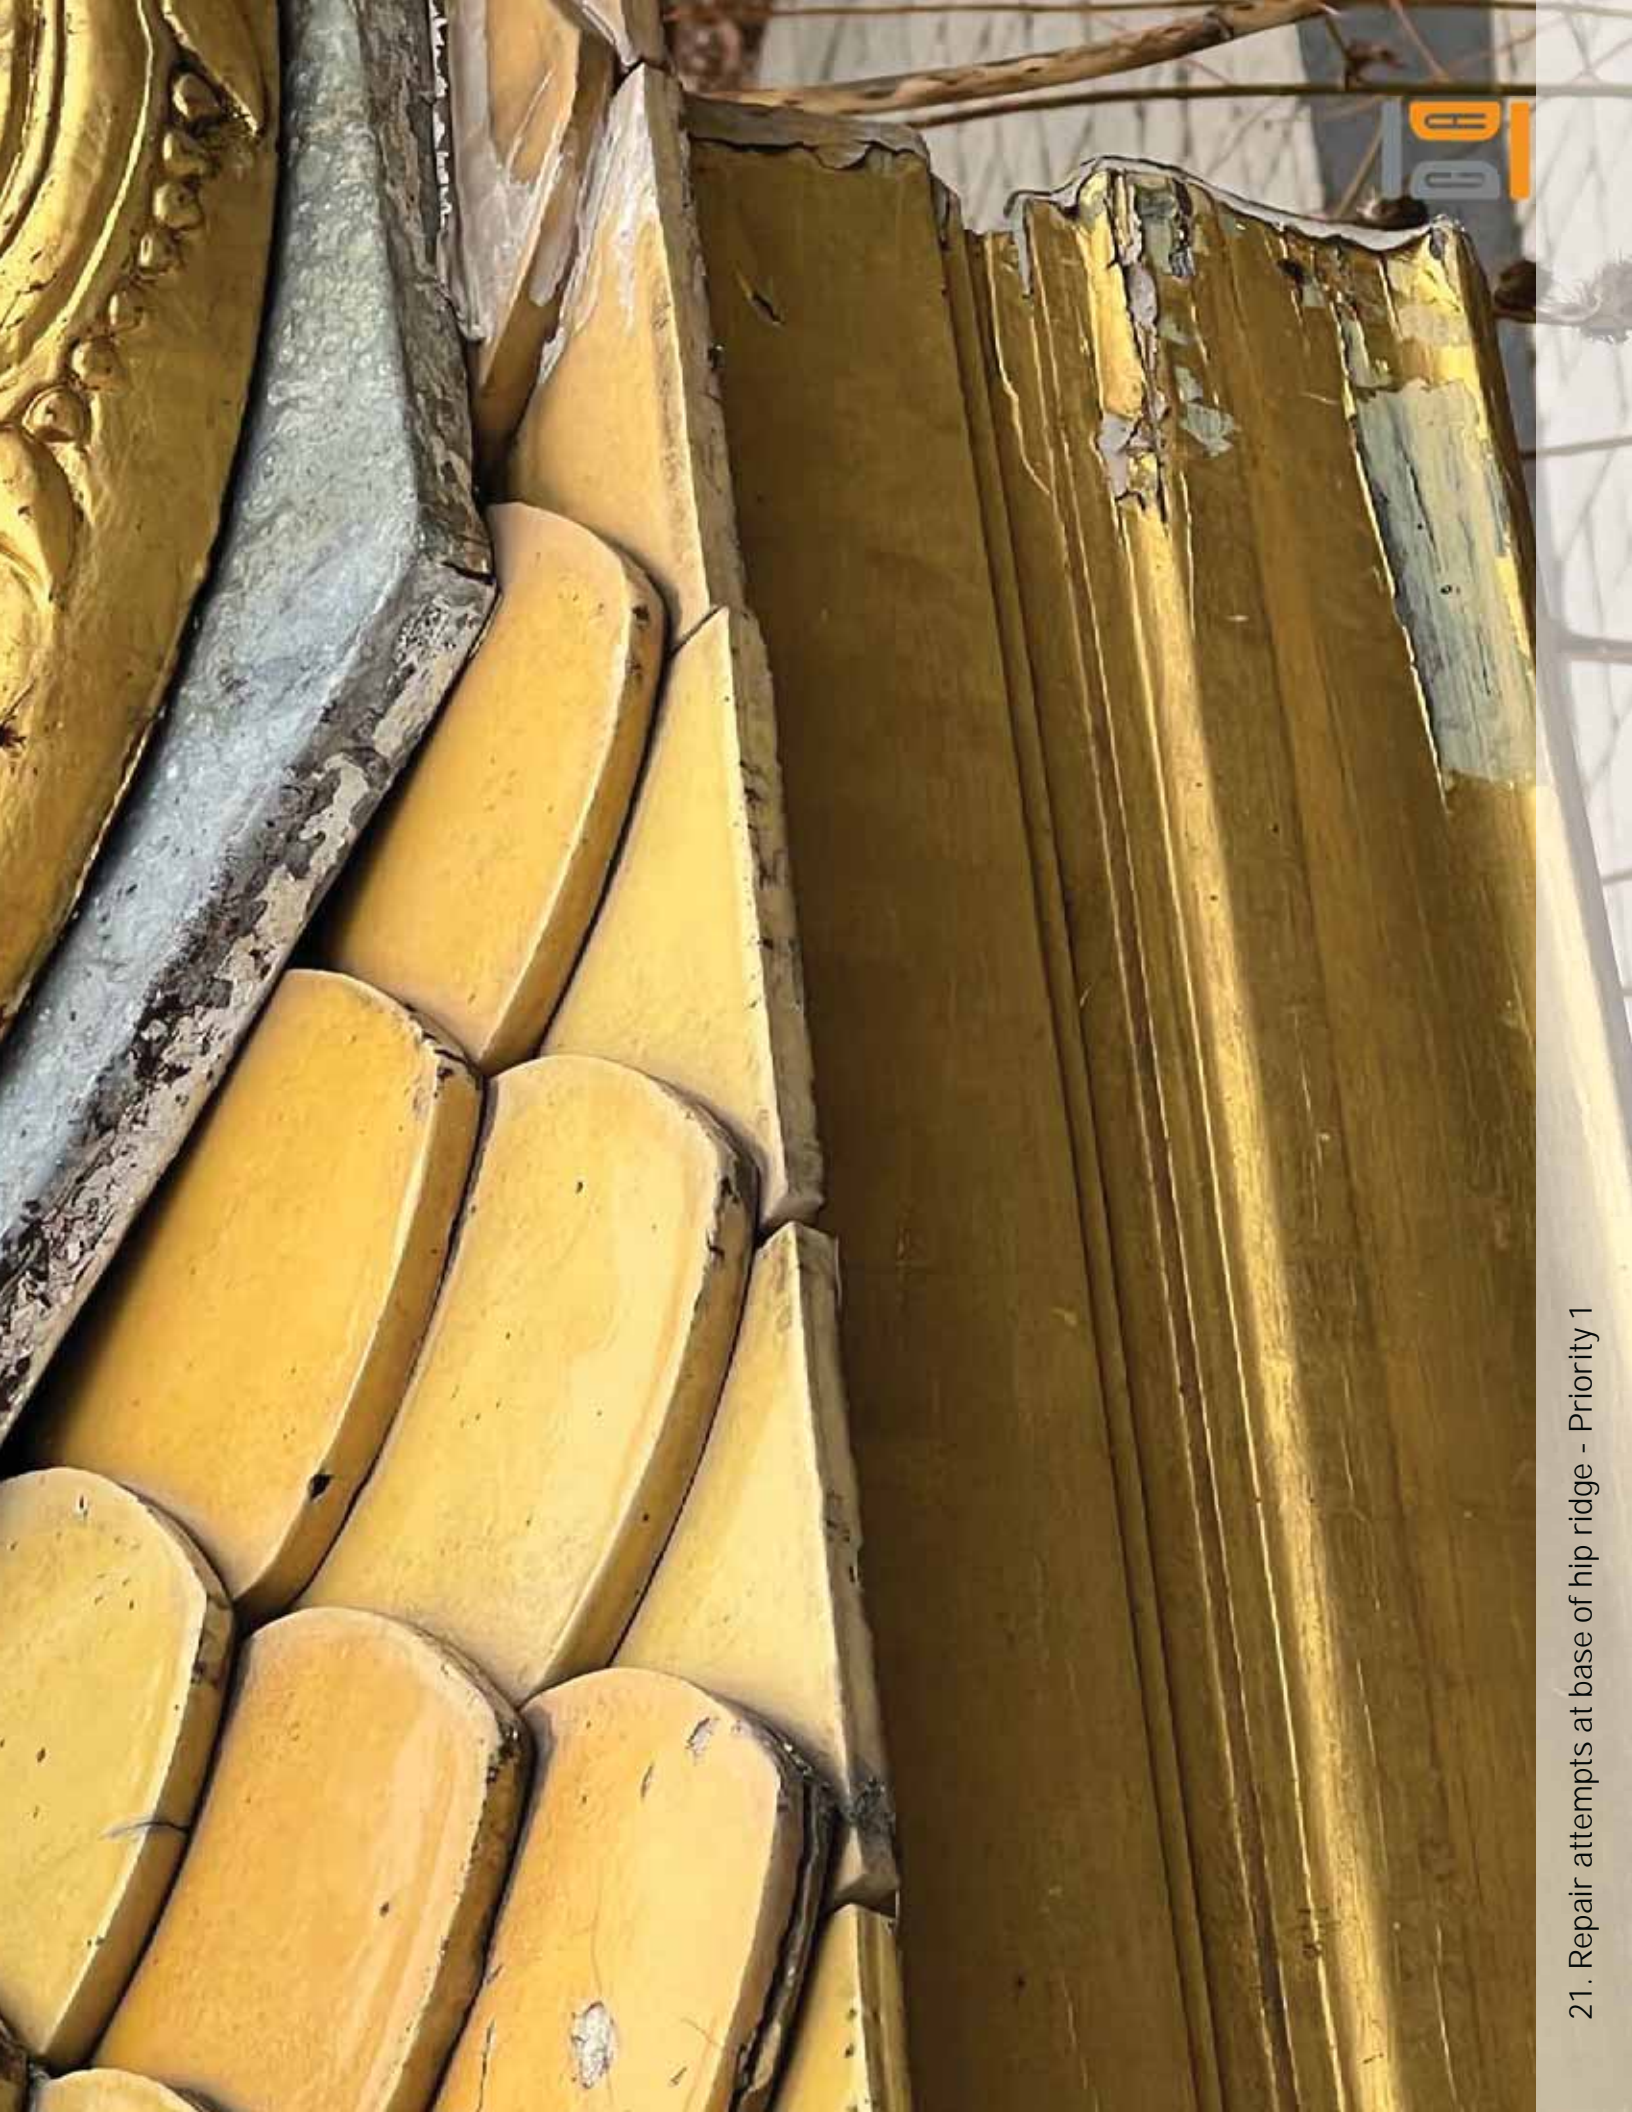
21. Repair attempts at base of hip ridge - Priority 1

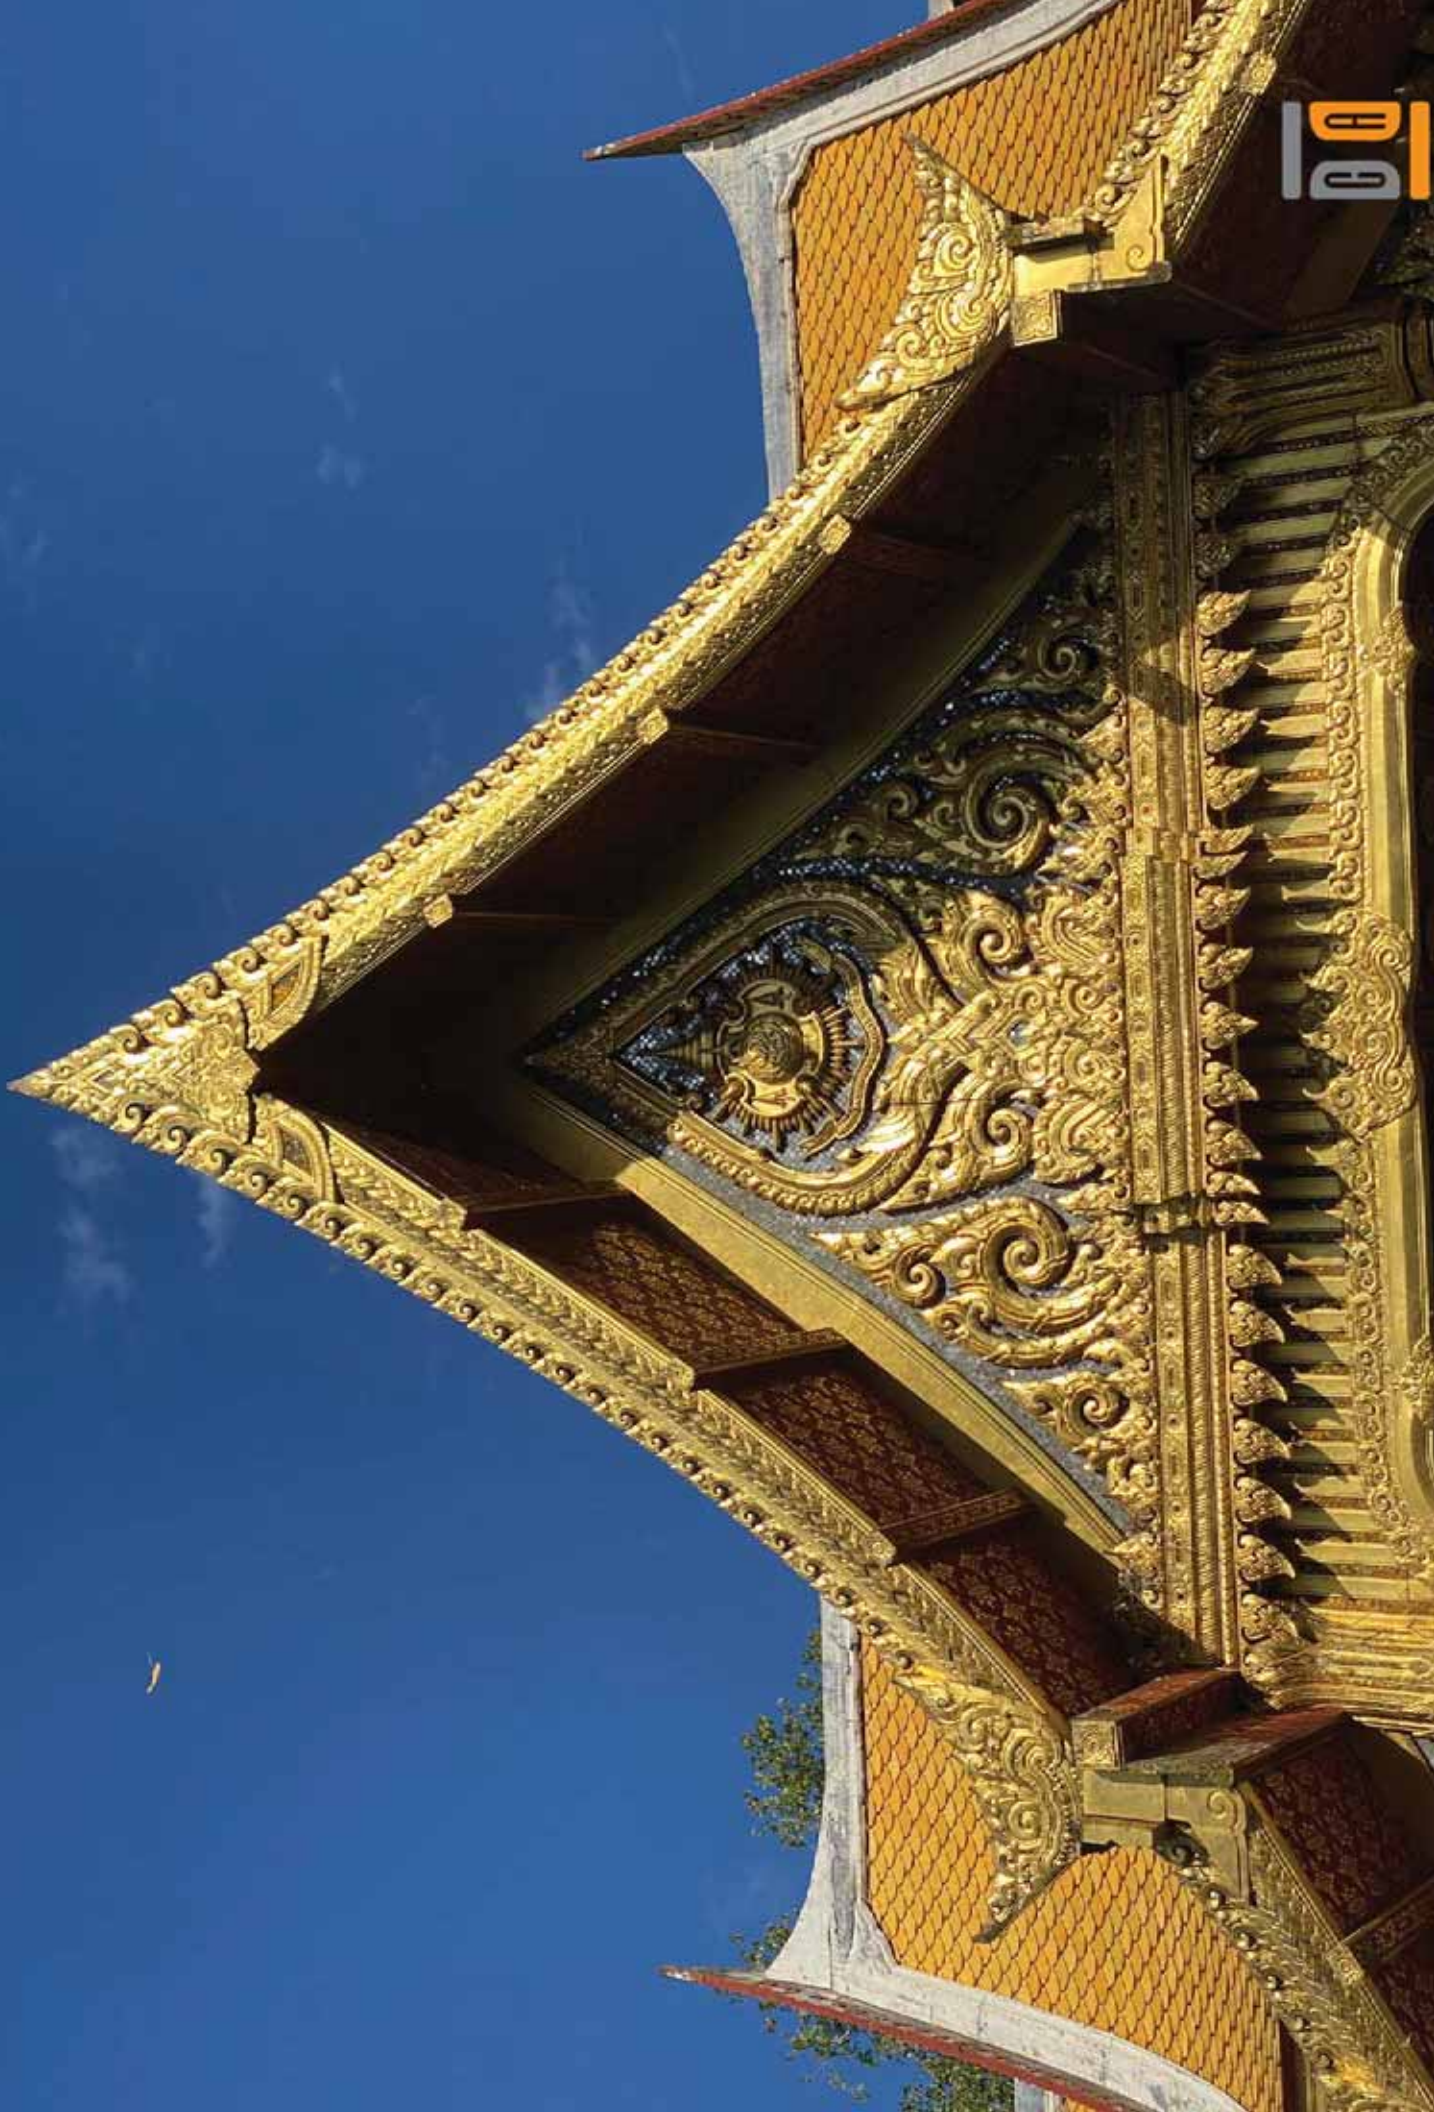
22. View of Western Main Gable decorative treatments – Priority 2
