OLBRICH BOTOANICAL GARDENS ROYAL THAI PAVILION CONDITION ASSESSMENT REPORT

MAY 20, 2022

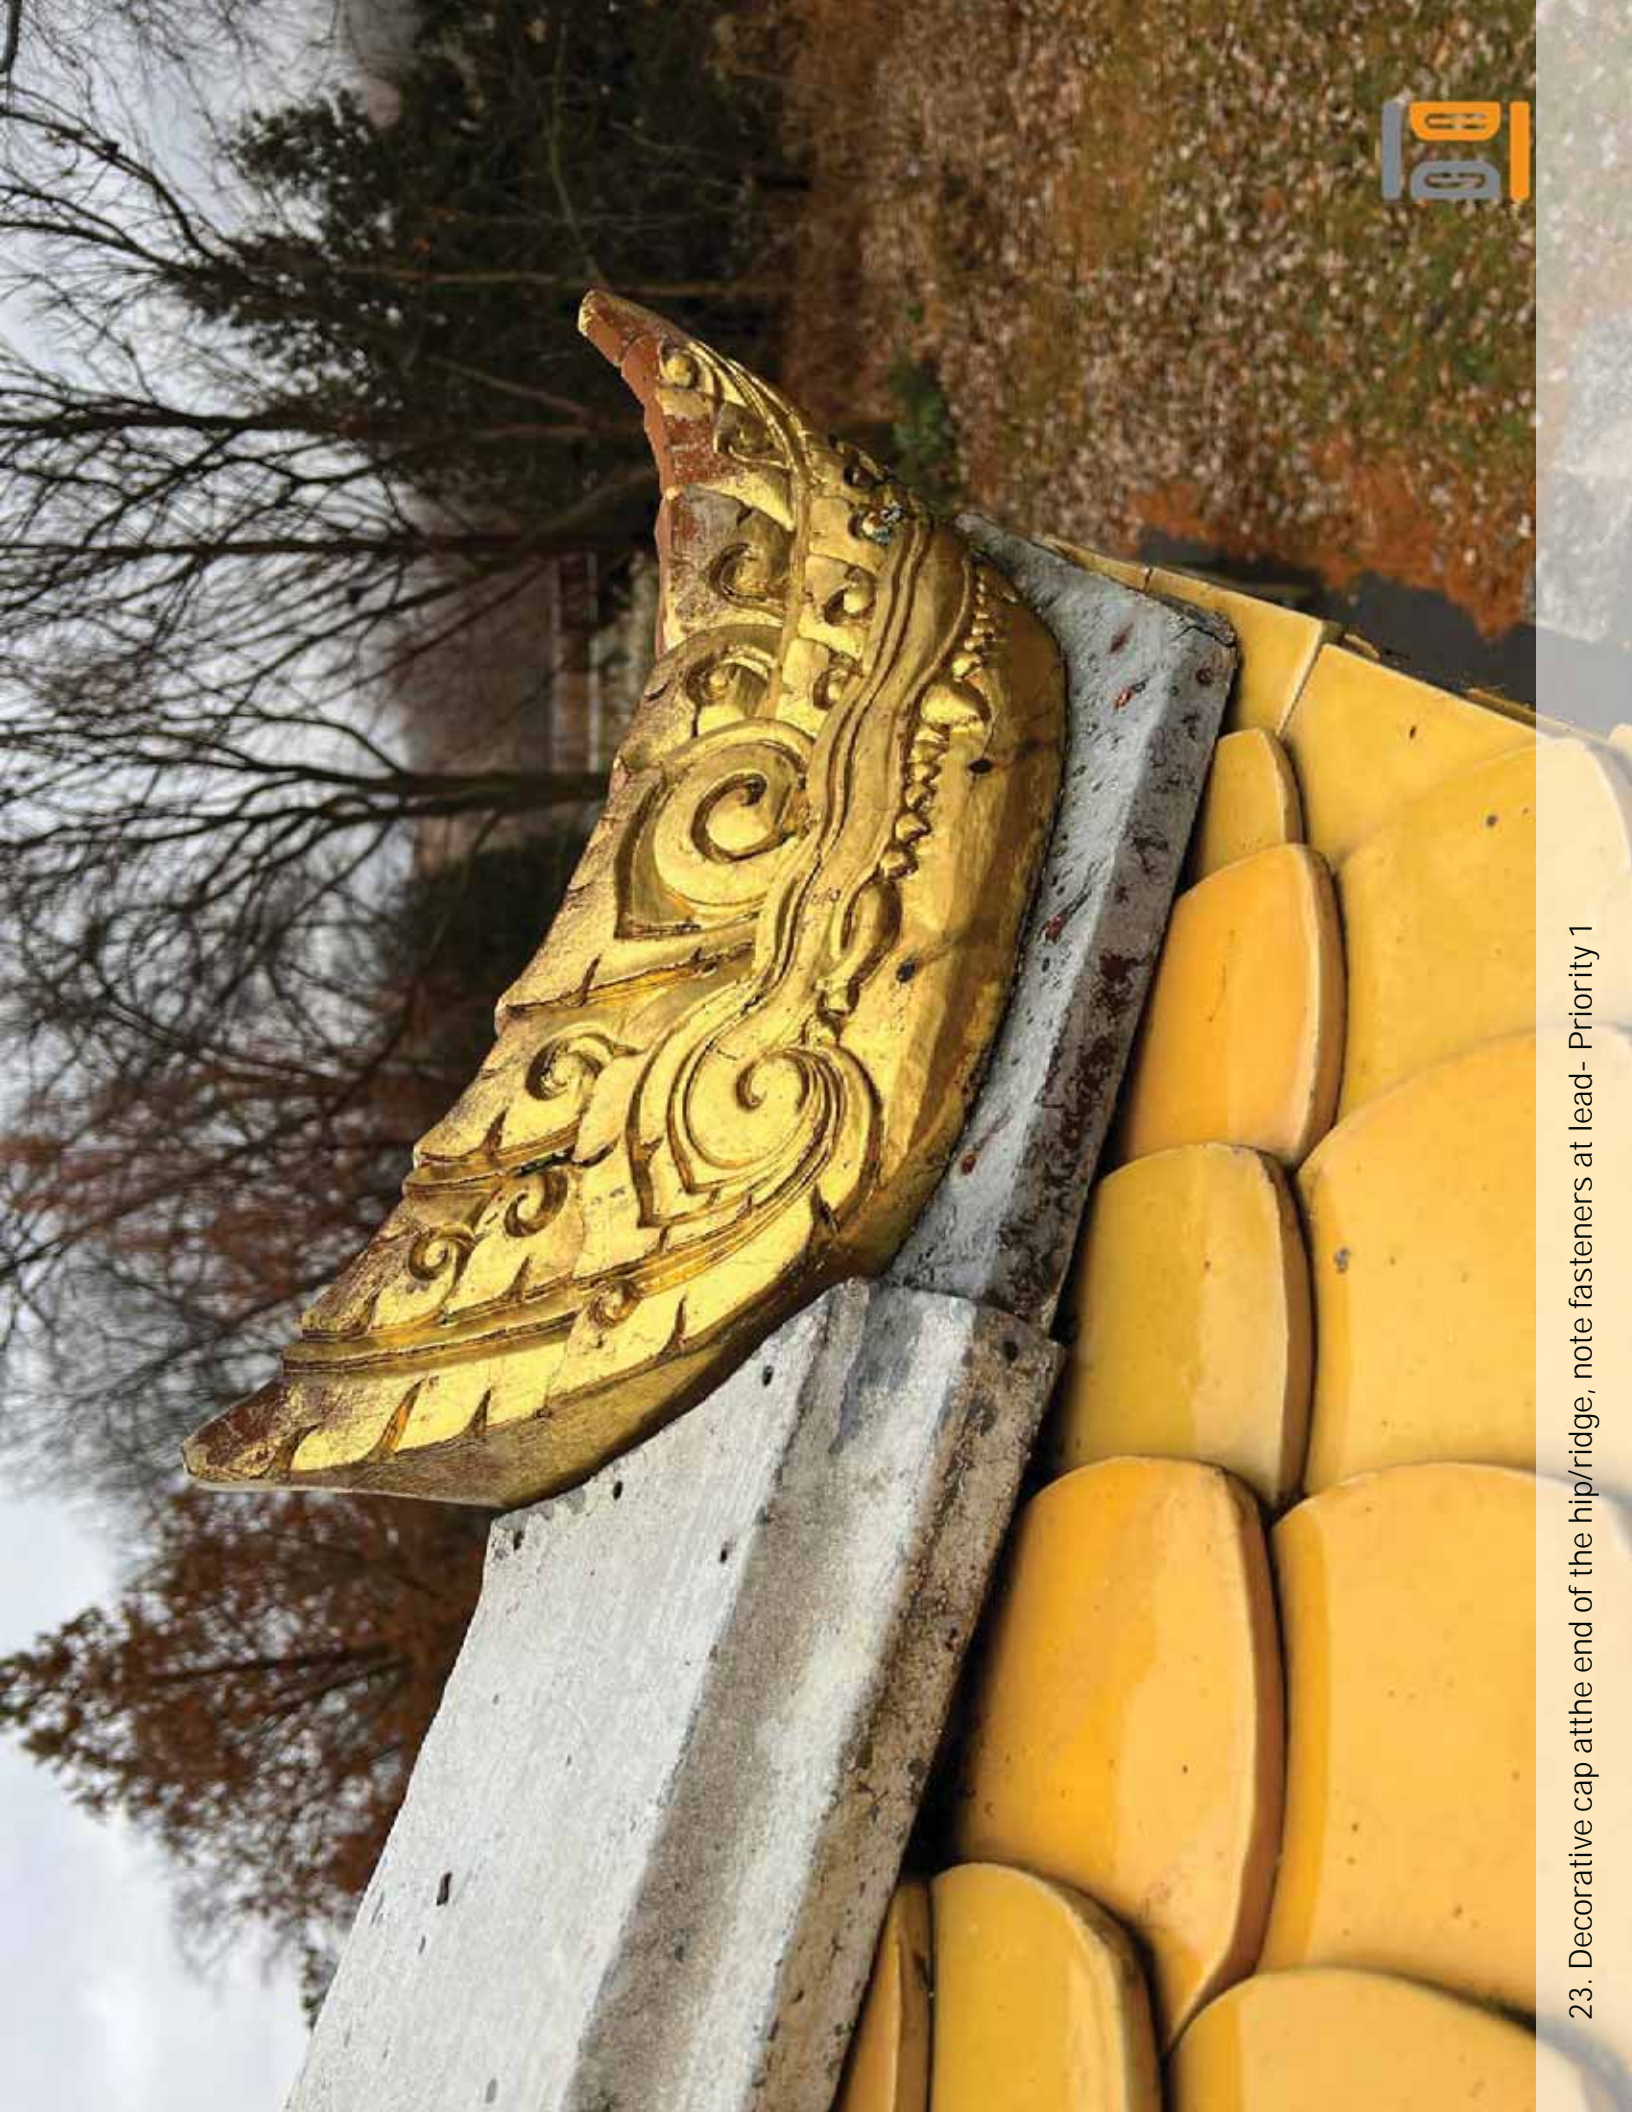
23. Decorative cap at the end of the hip/ridge, note fasteners at lead- Priority 1

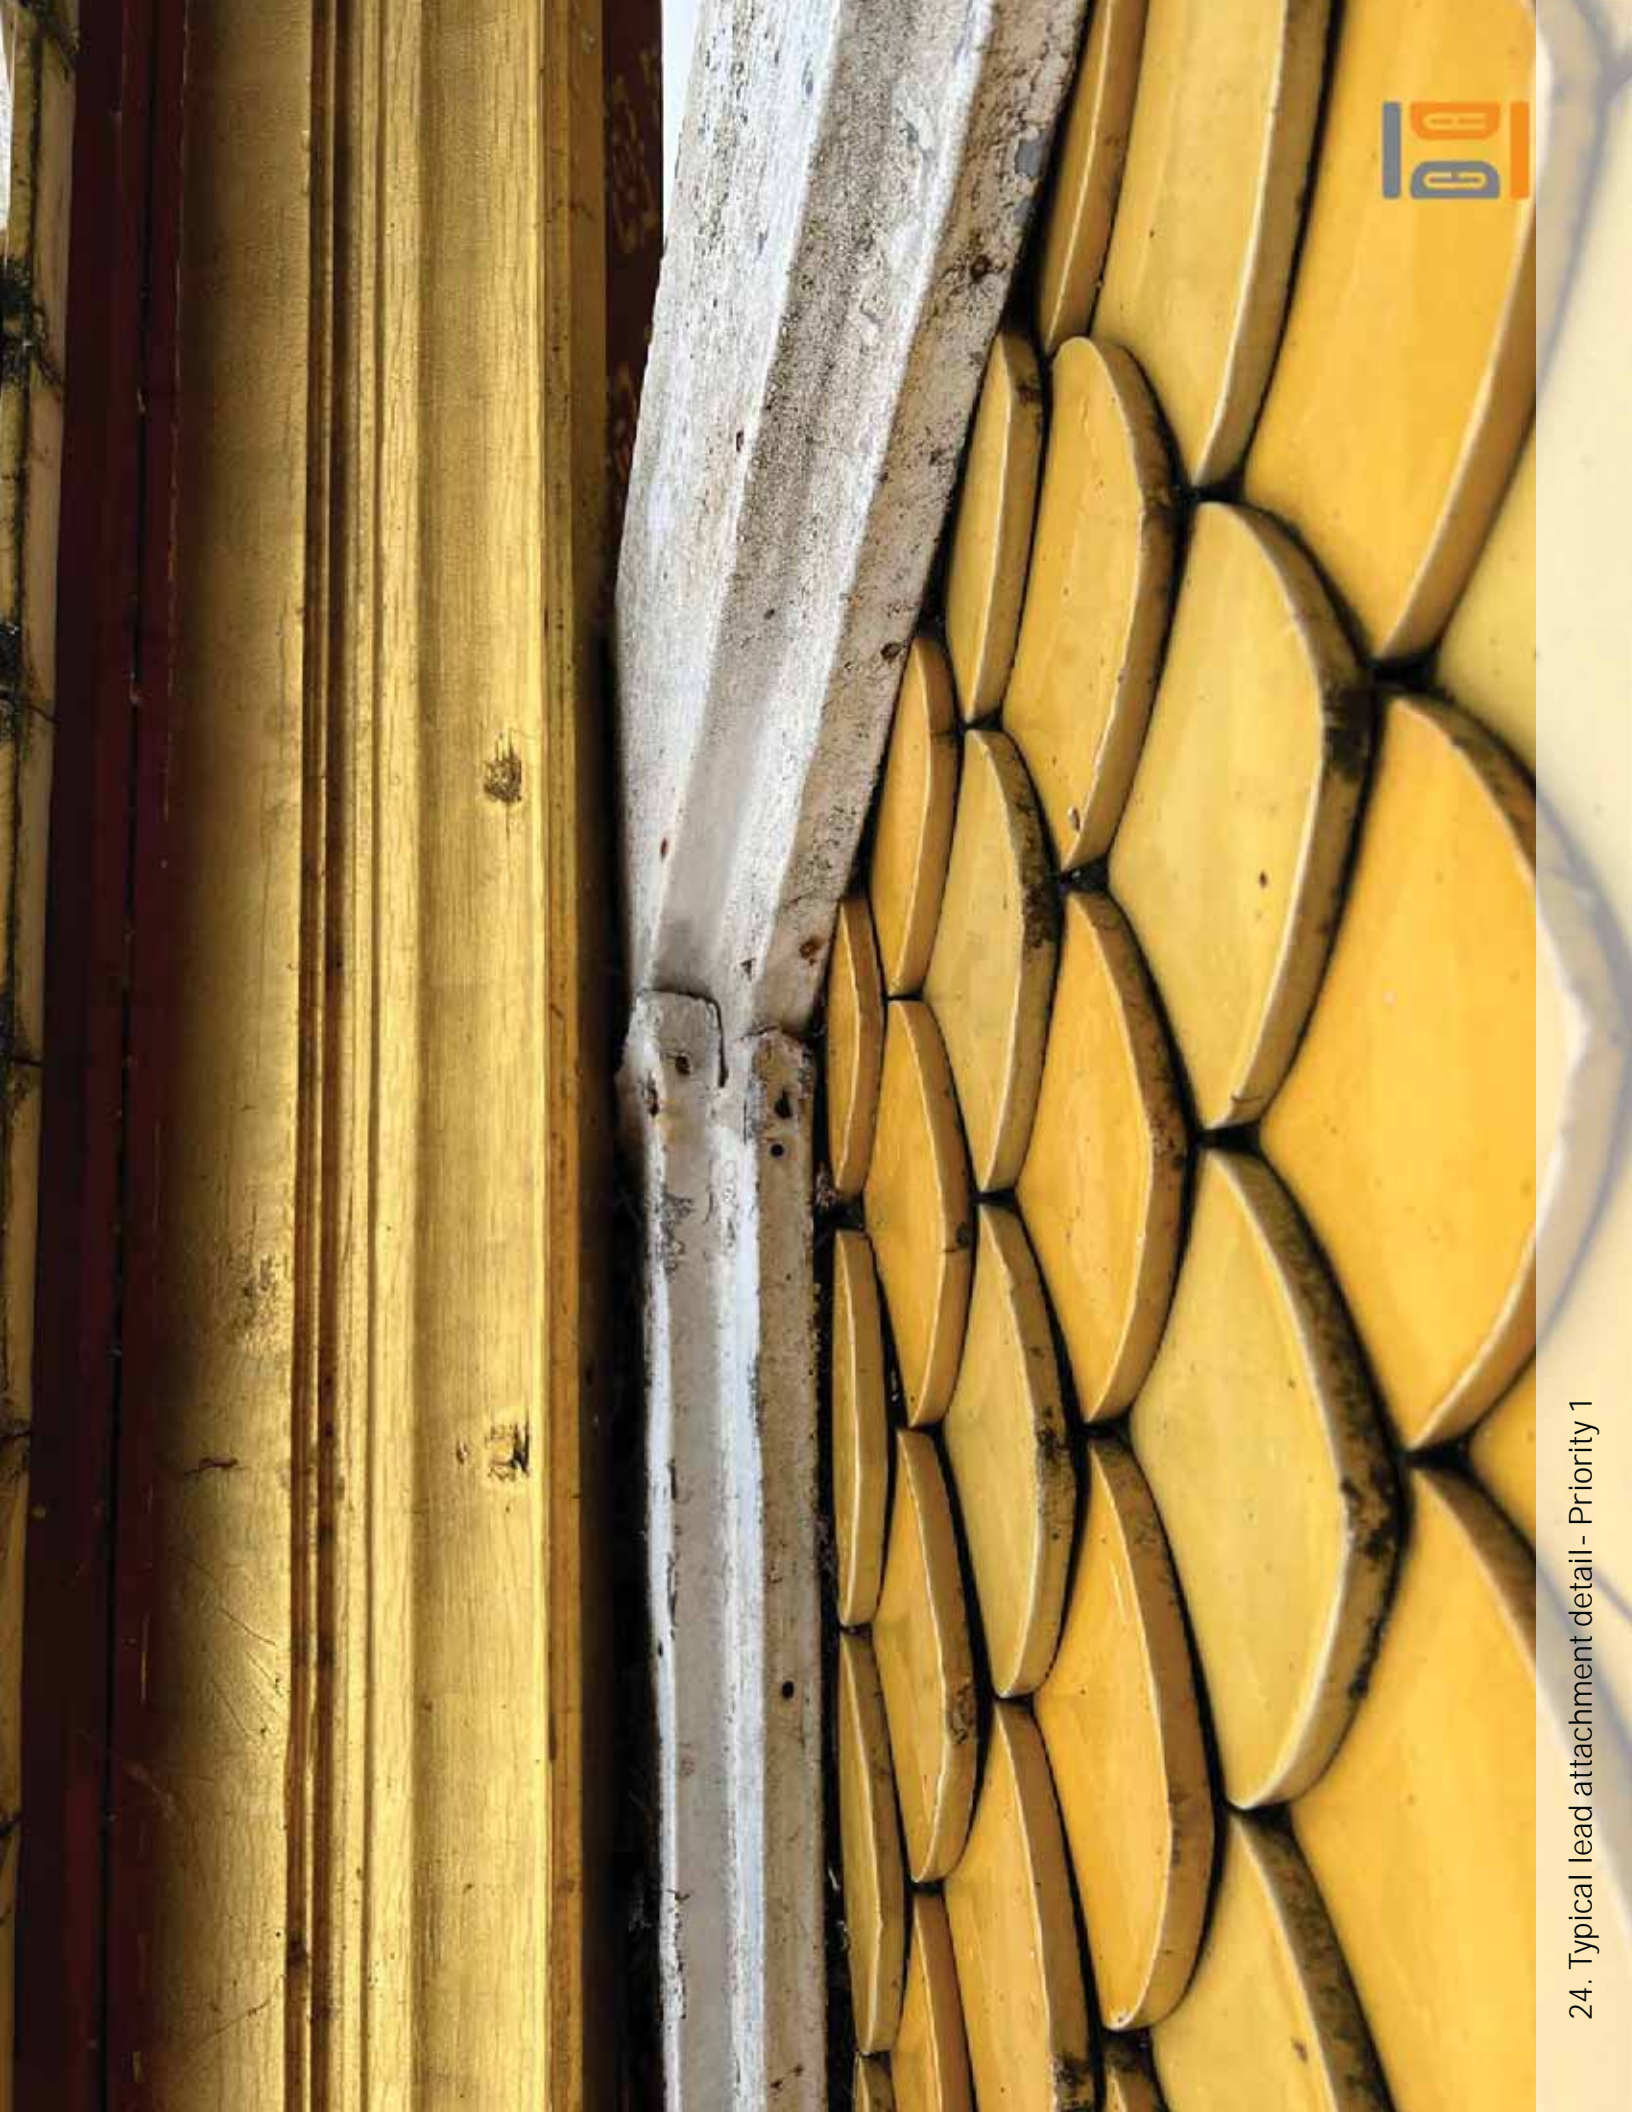
24. Typical lead attachment detail - Priority 1

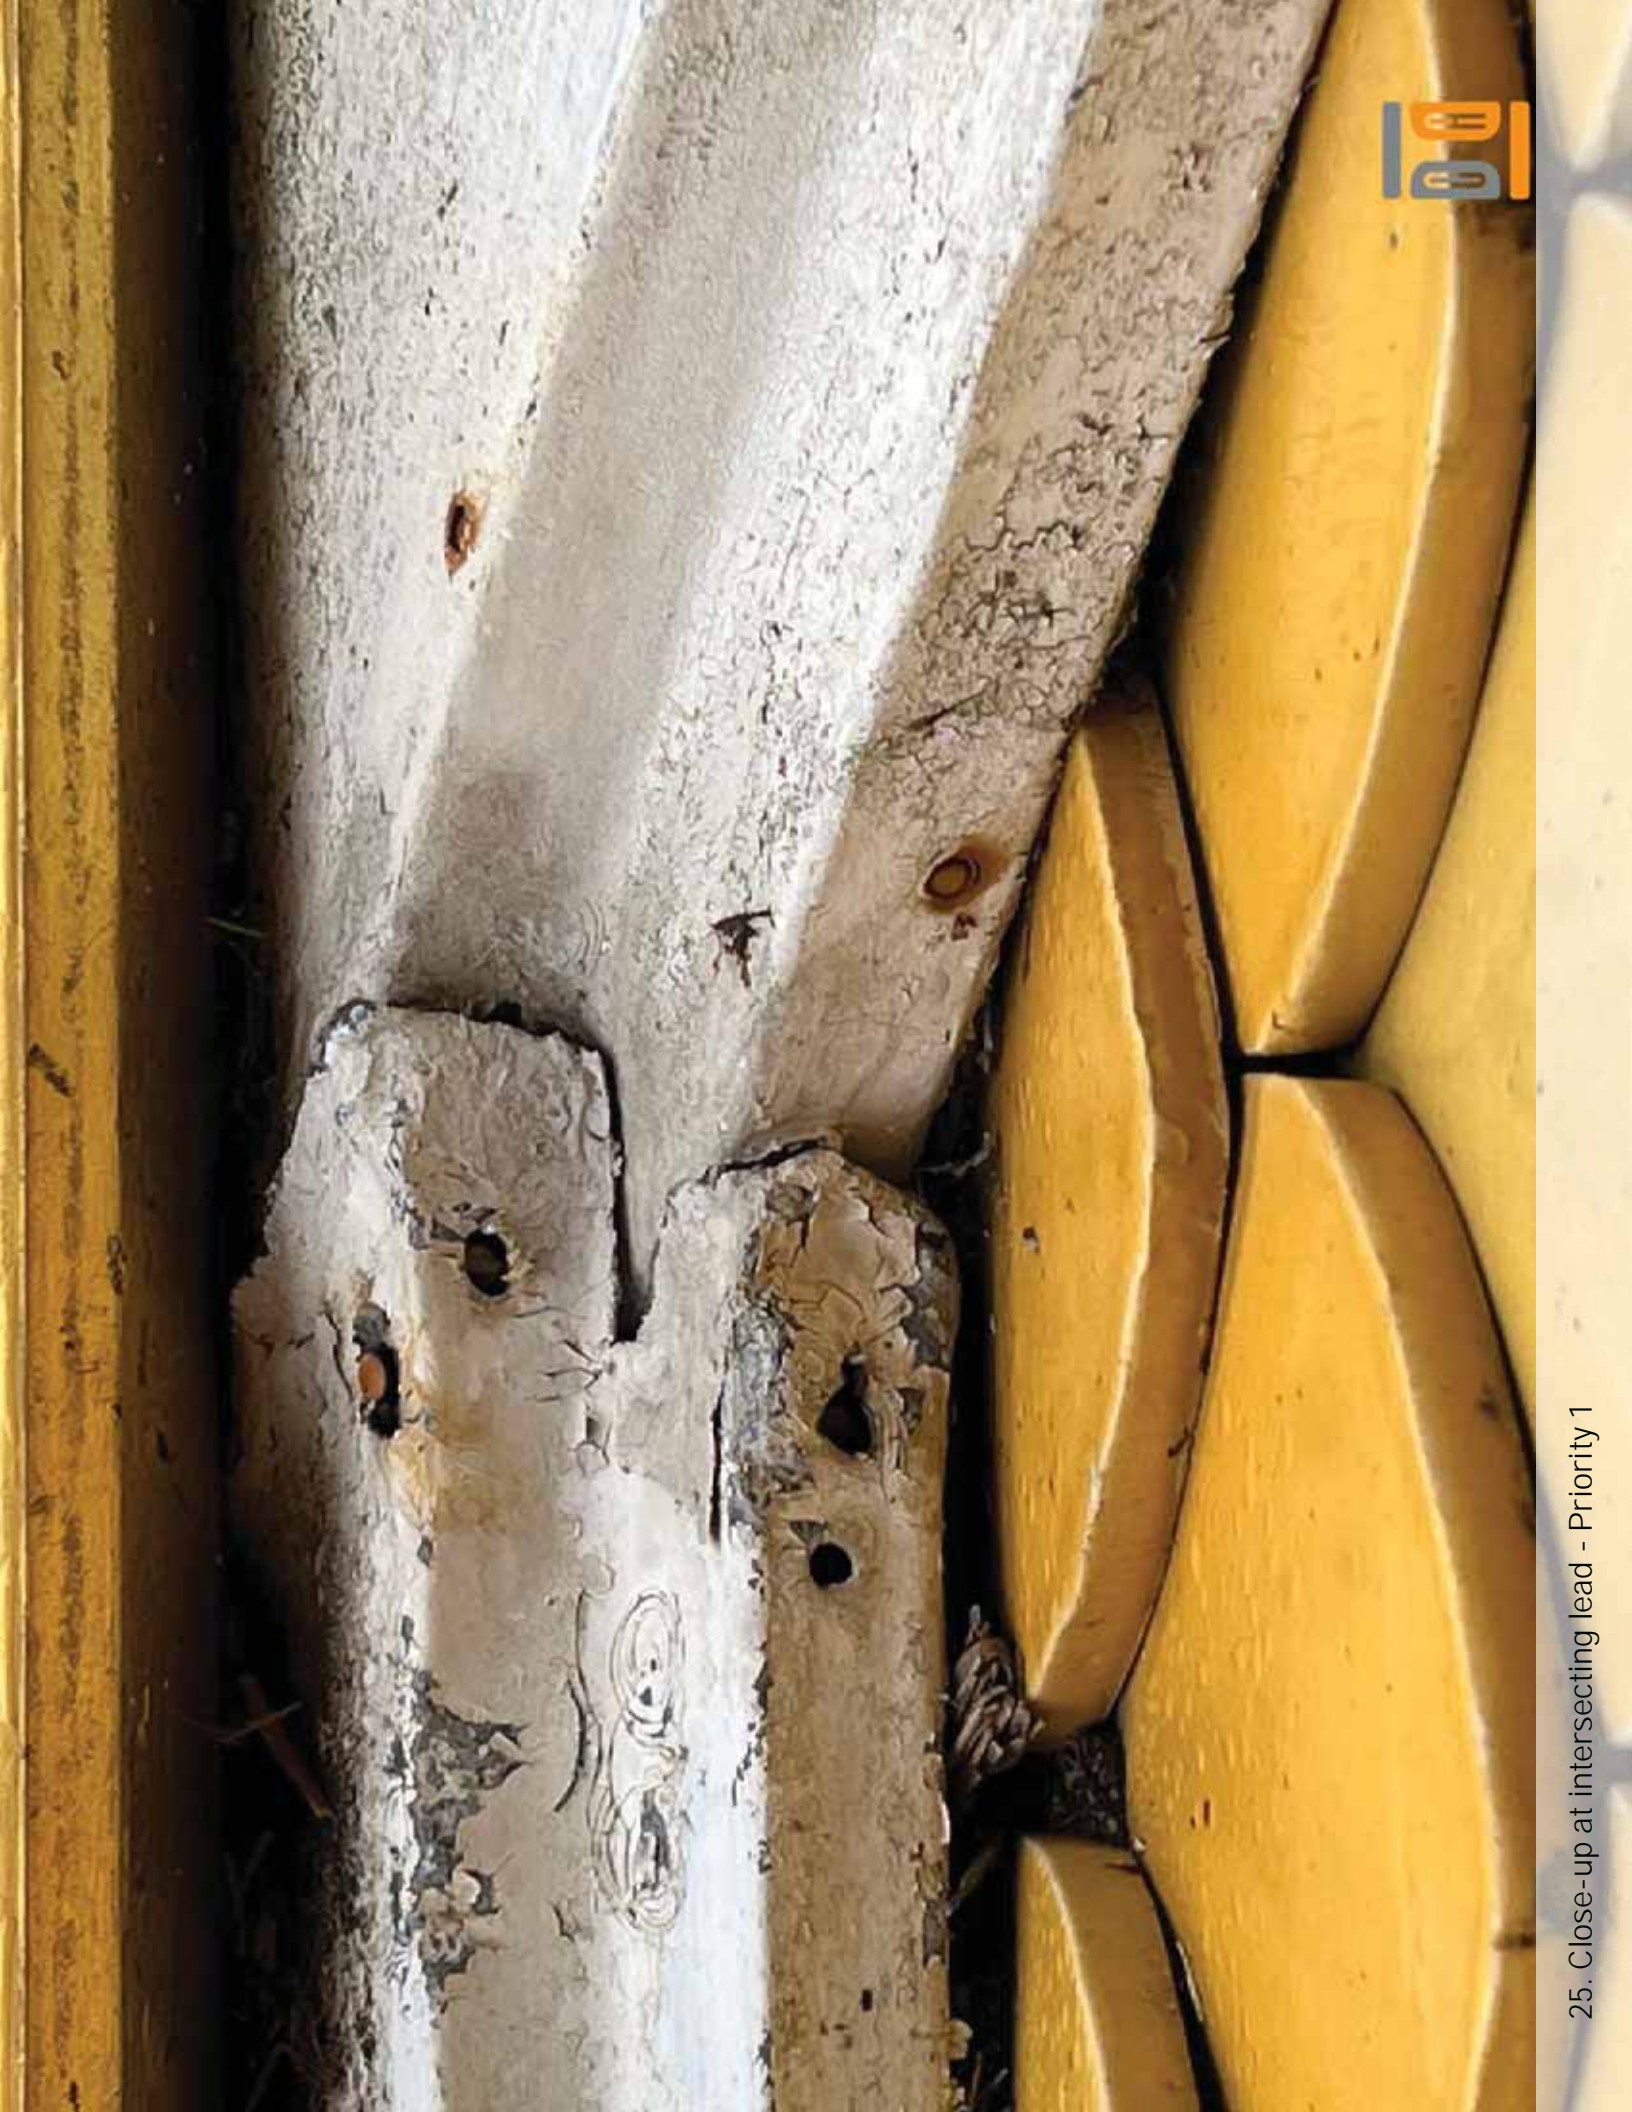
25. Close-up at intersecting lead - Priority 1

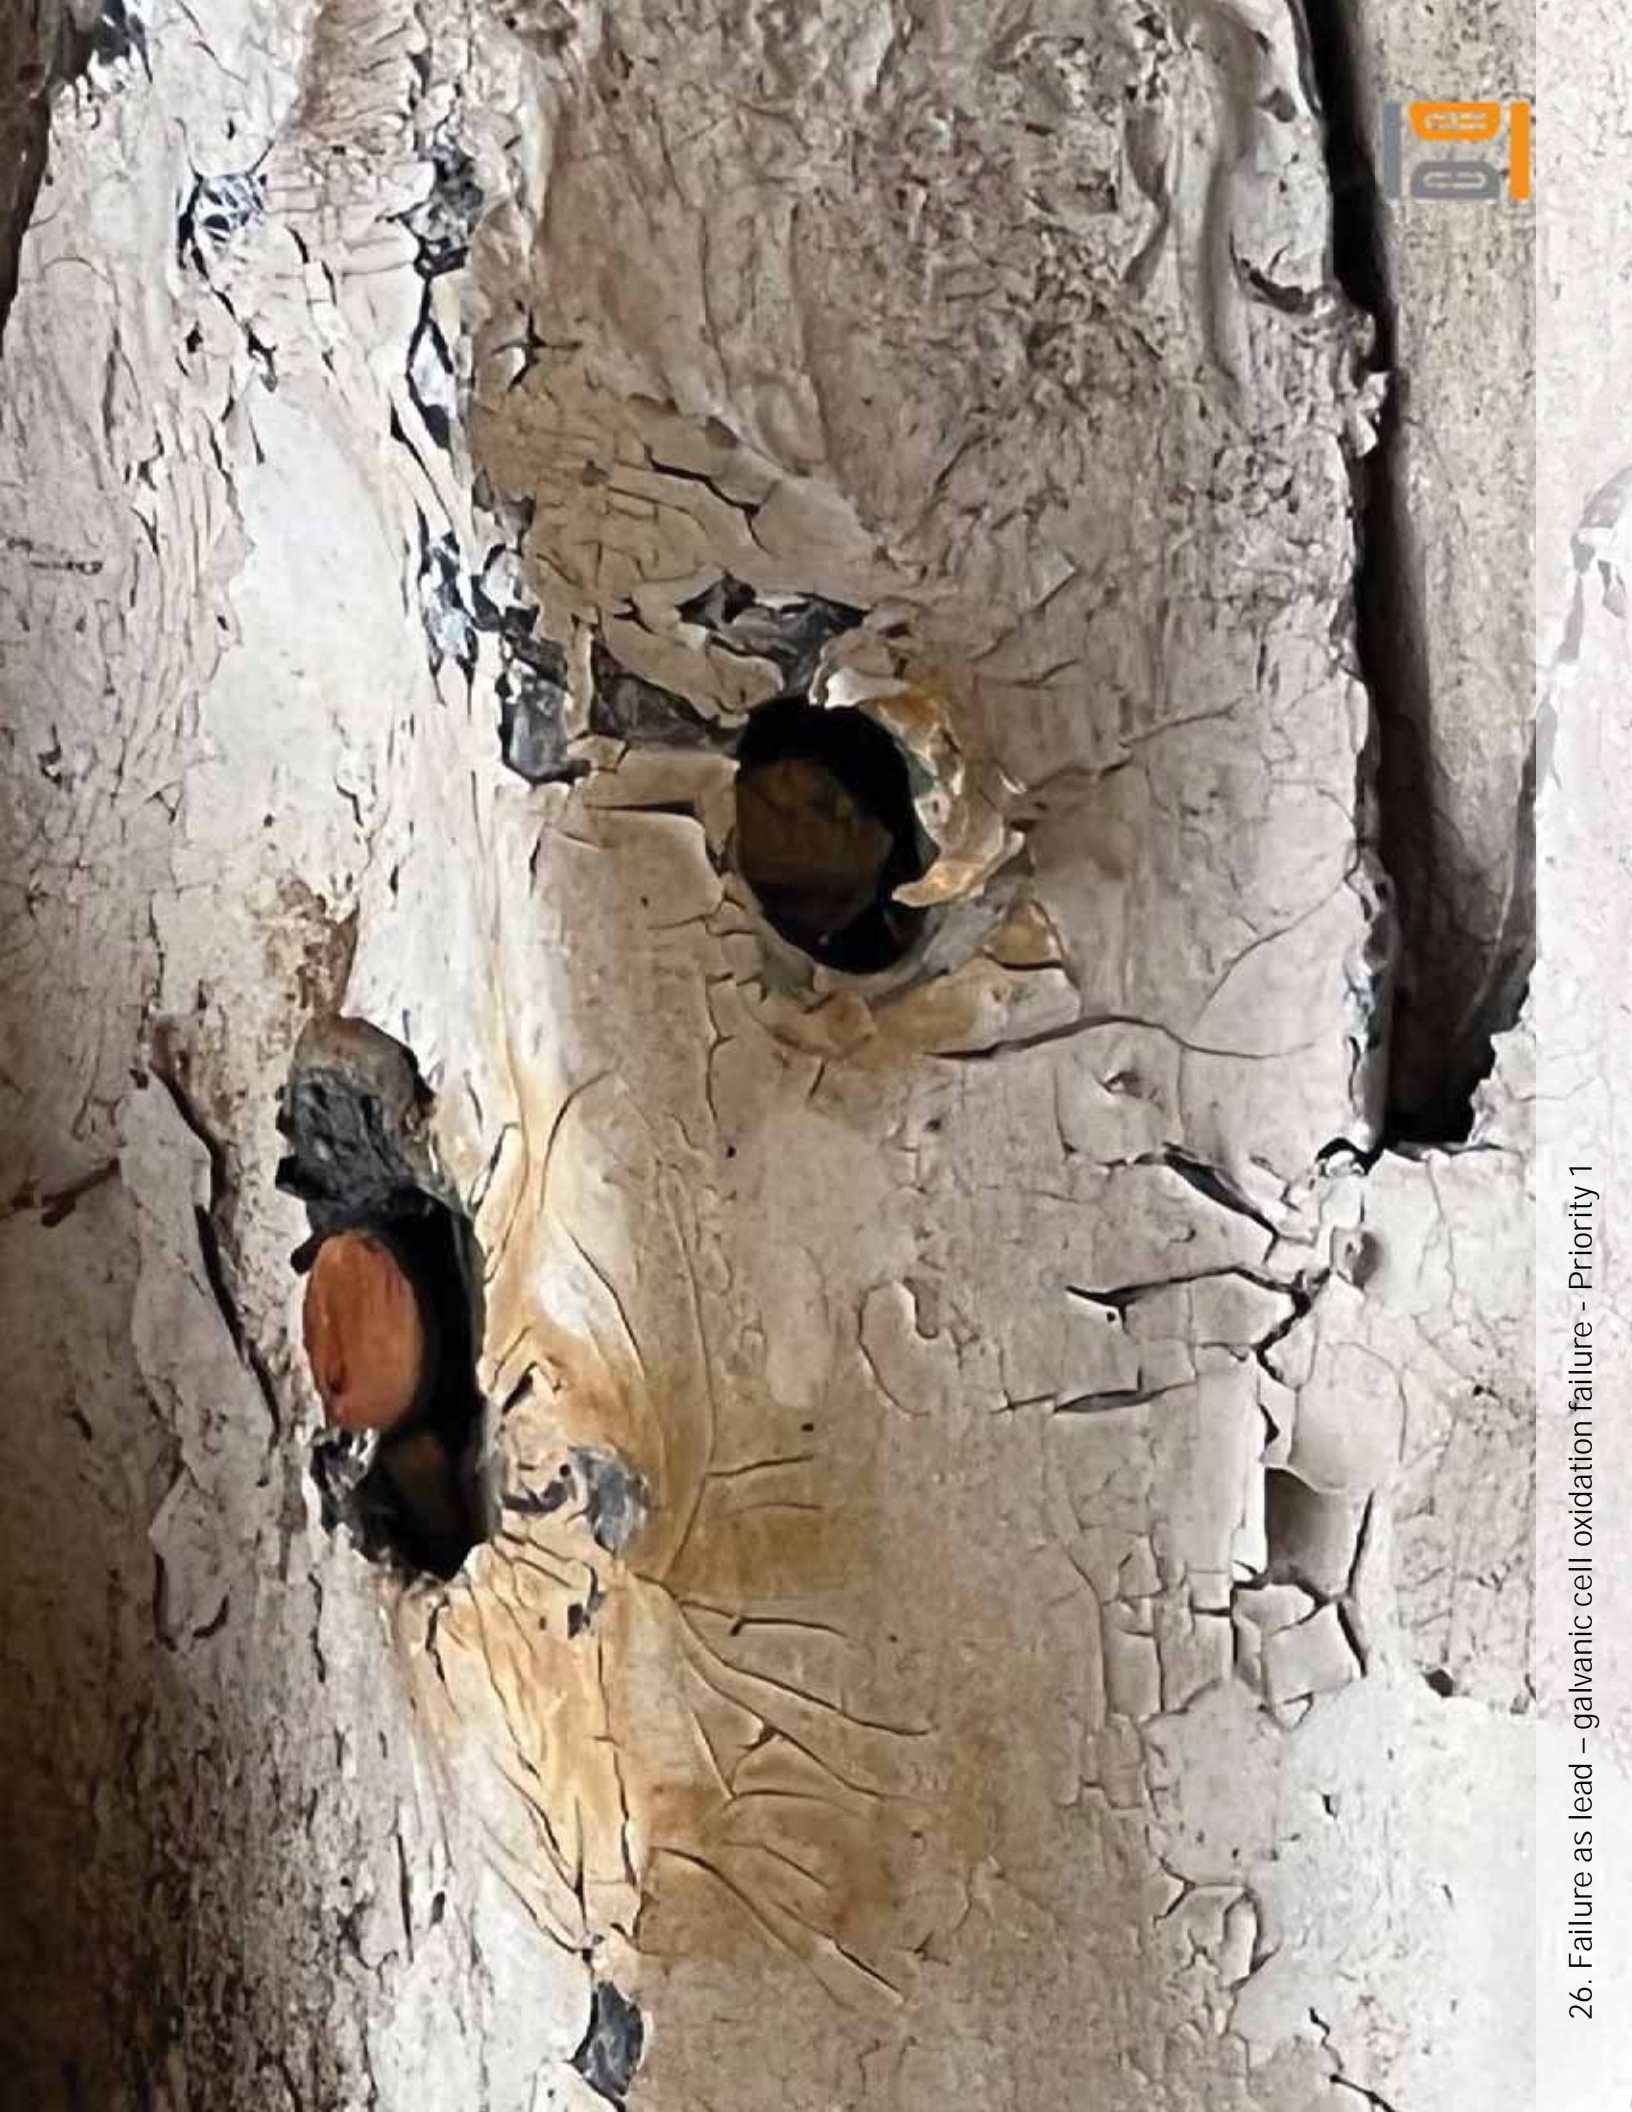
26. Failure as lead - galvanic cell oxidation failure - Priority 1

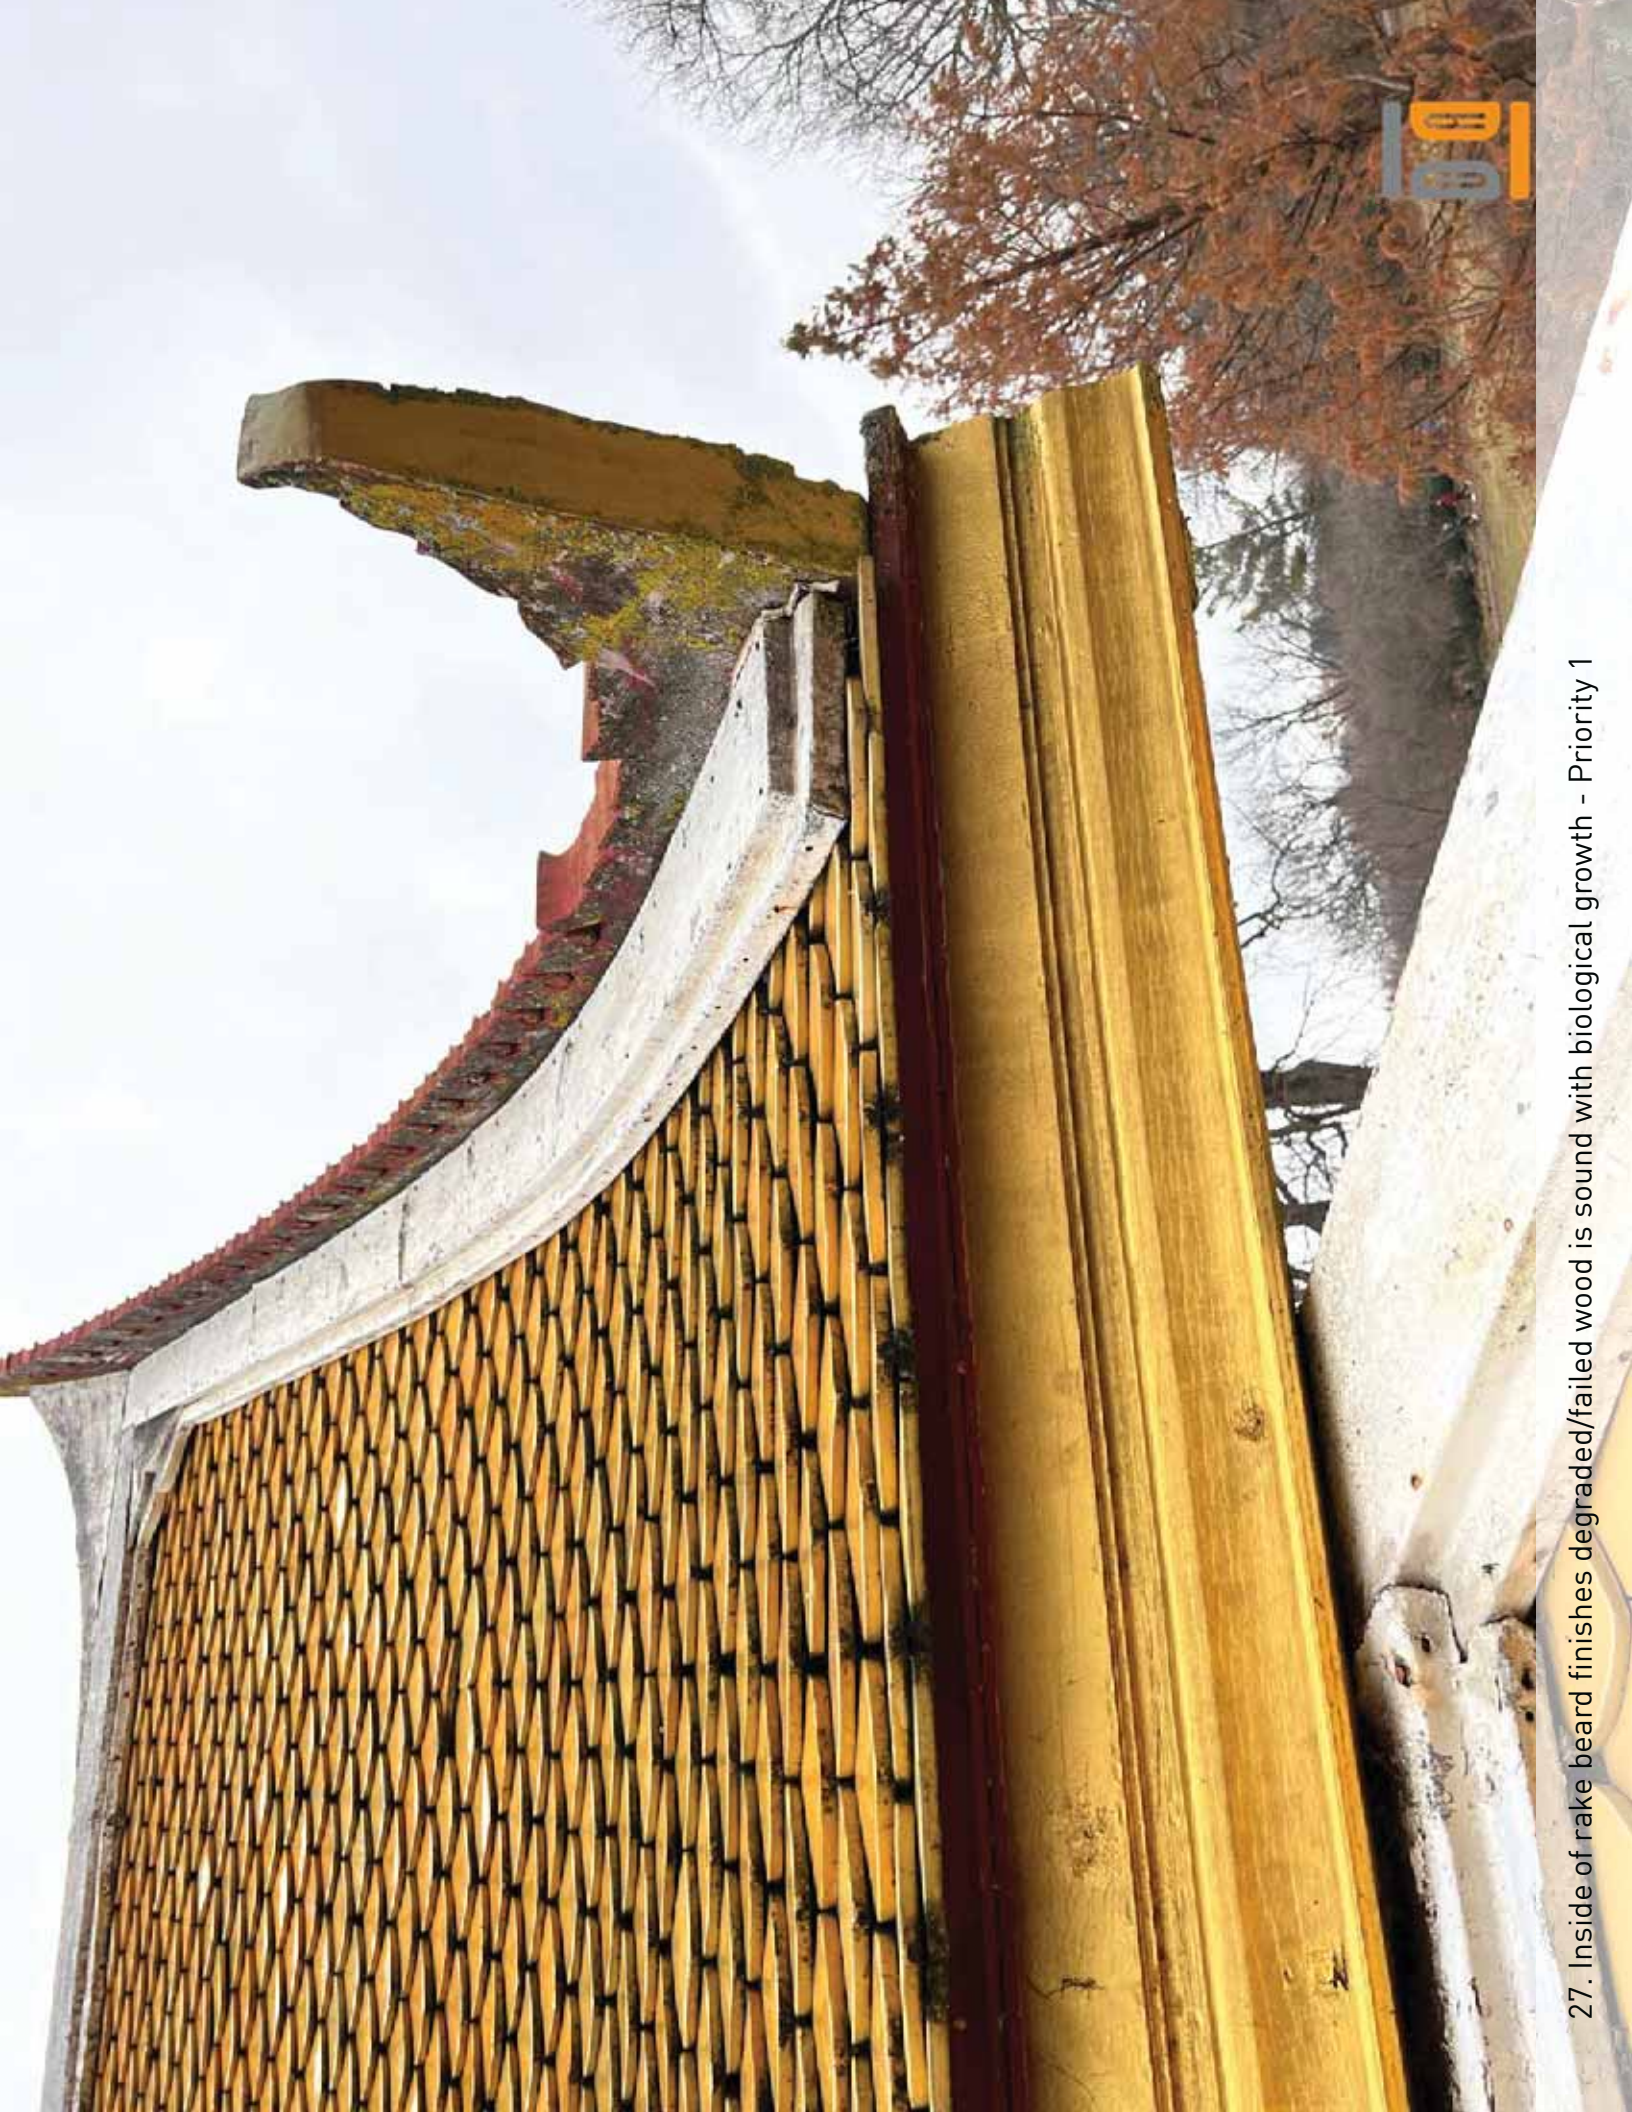
27. Inside of rake beard finishes degraded/failed wood is sound with biological growth - Priority 1

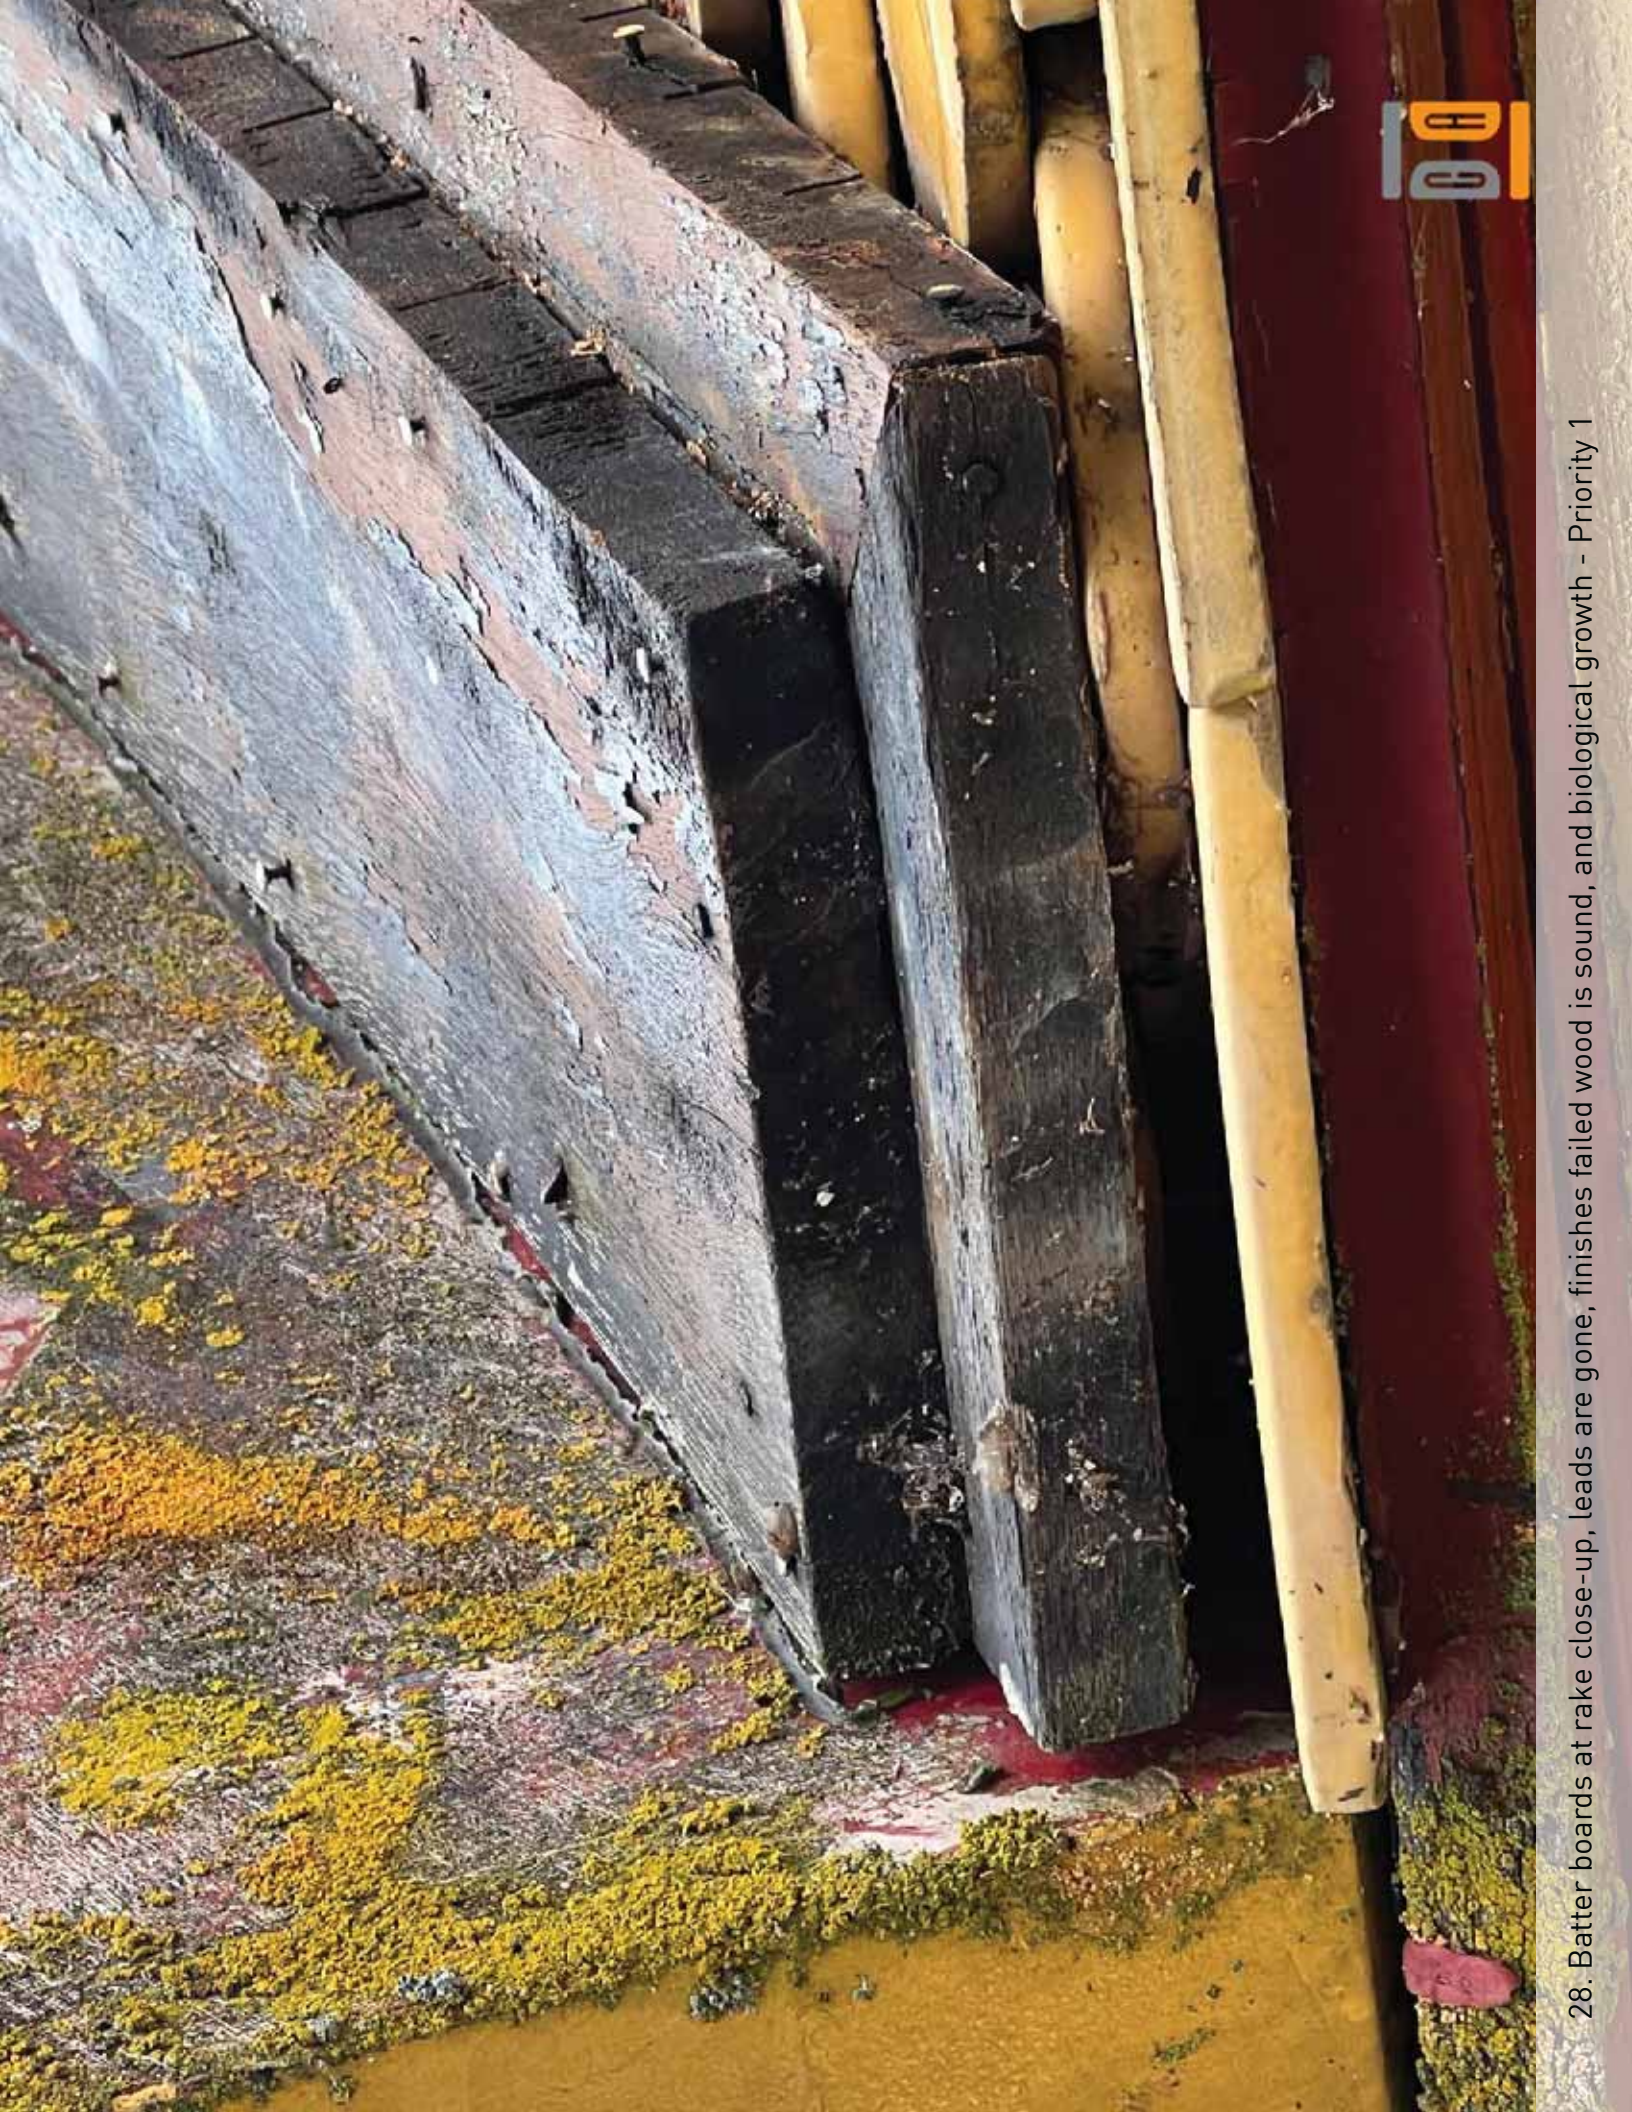
28. Batter boards at rake close-up, leads are gone, finishes failed wood is sound, and biological growth - Priority 1
