OLBRICH BOTOANICAL GARDENS ROYAL THAI PAVILION CONDITION ASSESSMENT REPORT

MAY 20, 2022

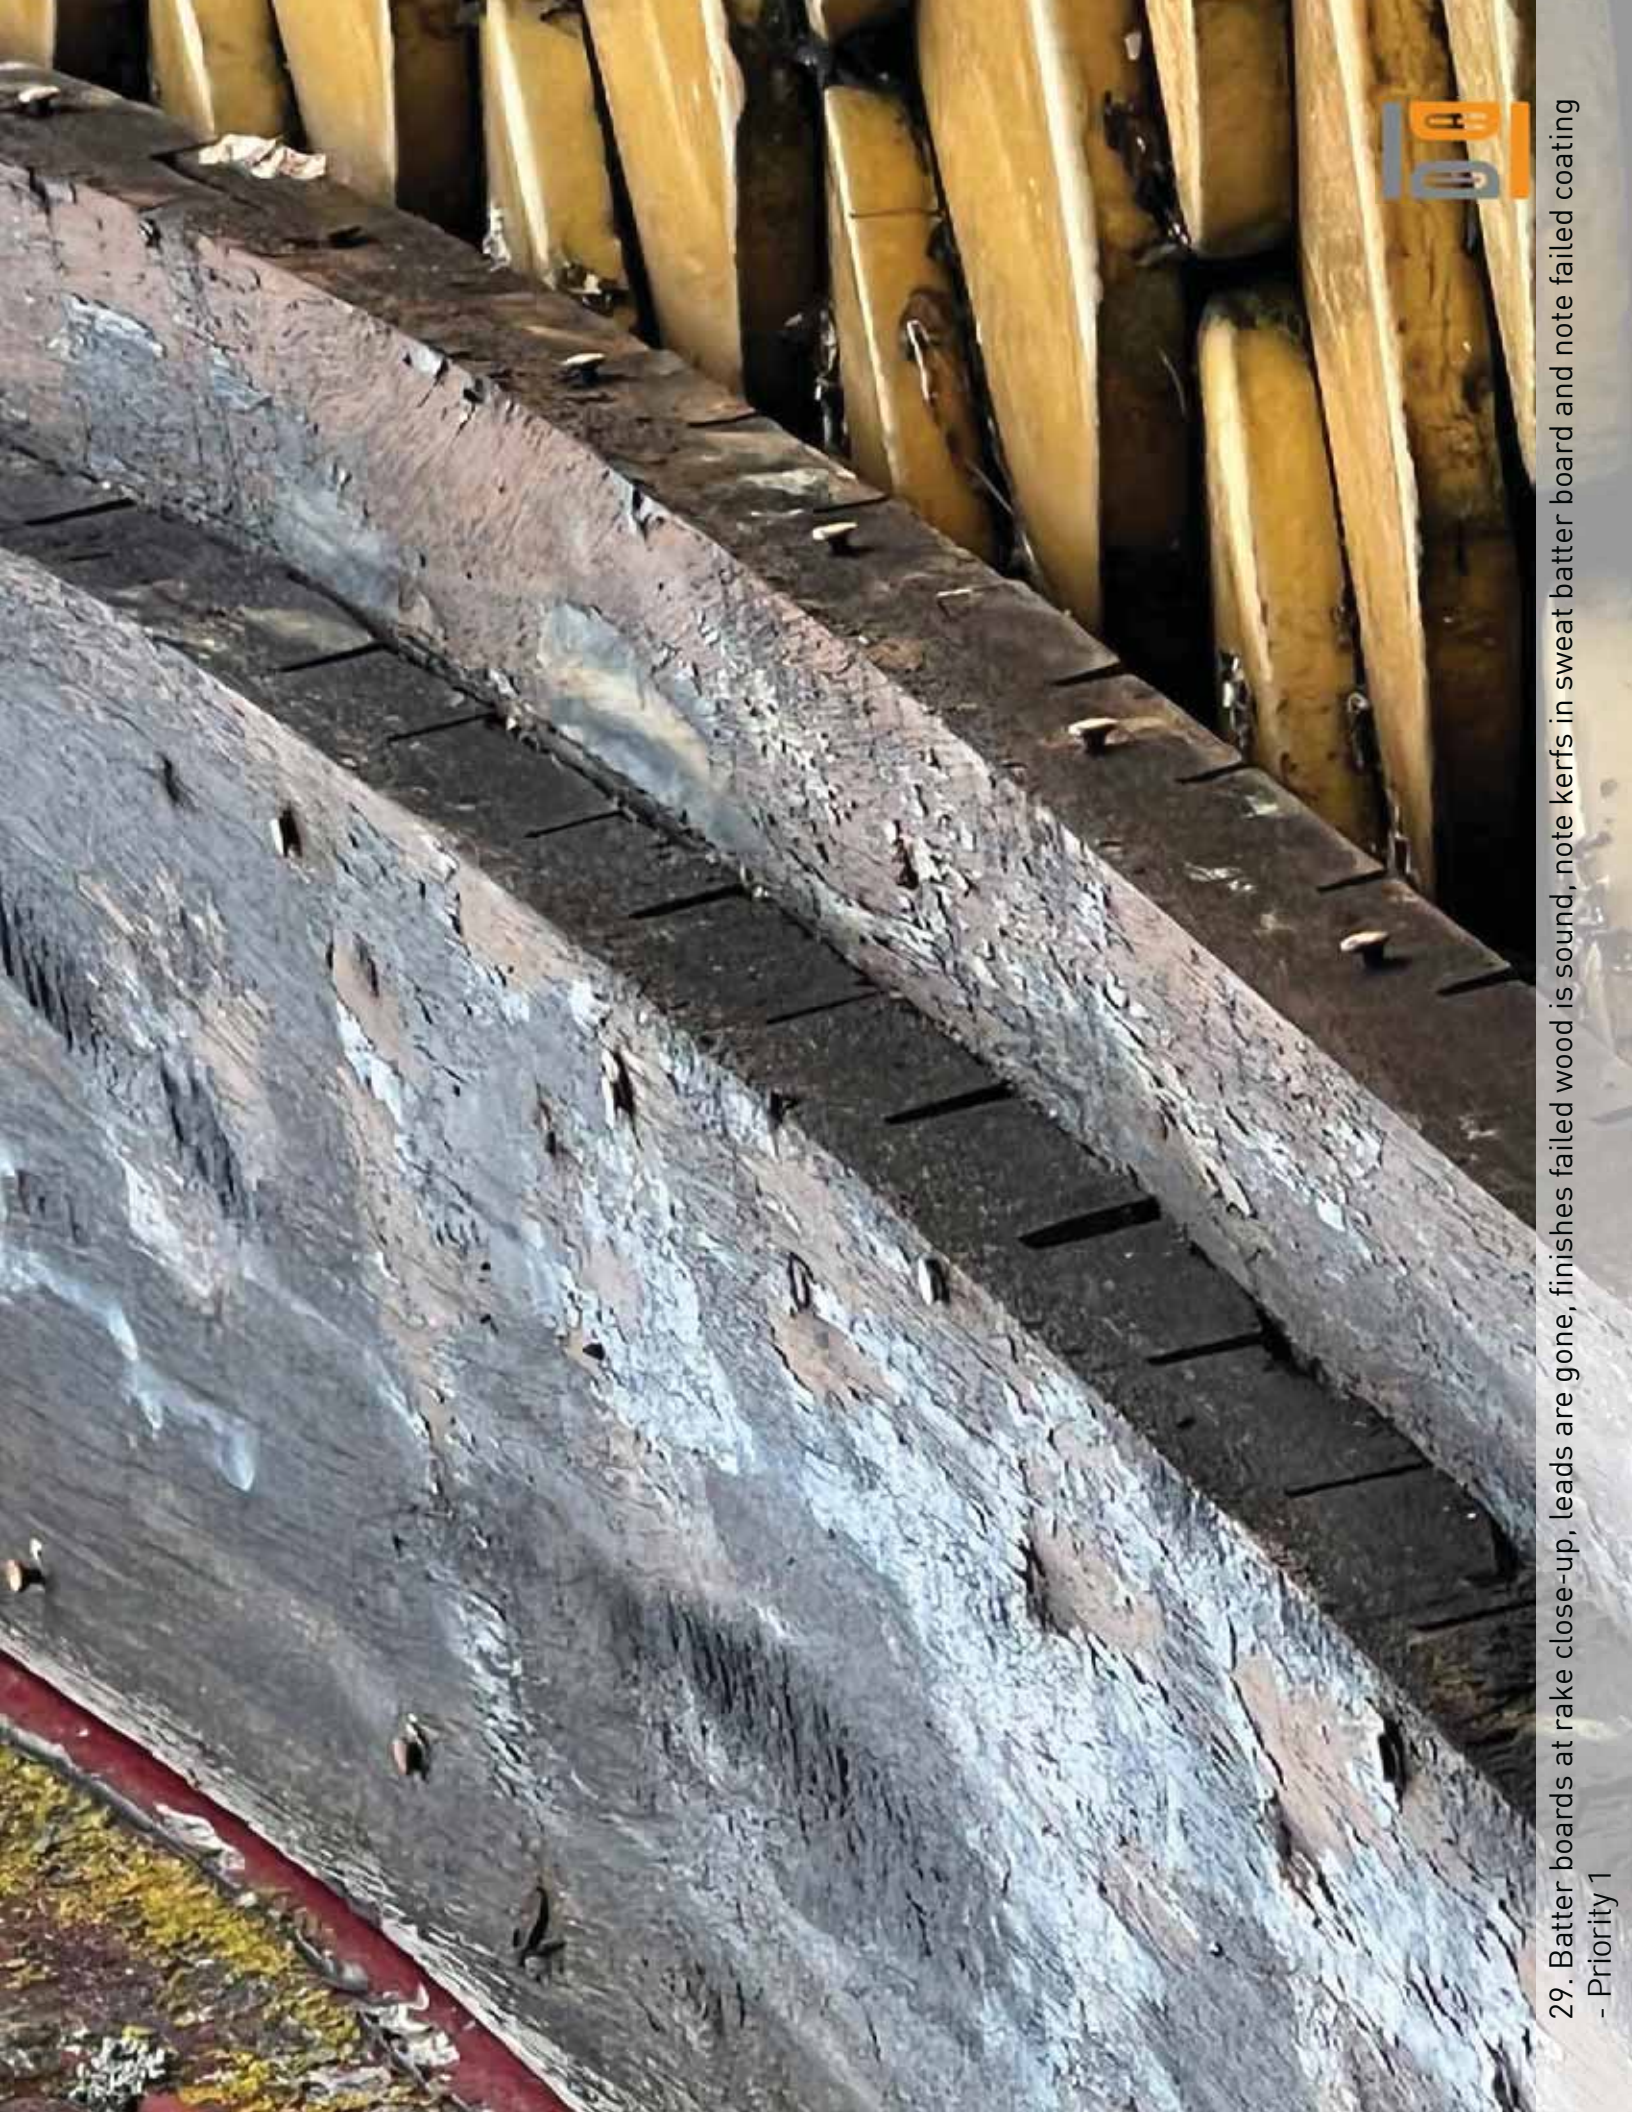
29. Batter boards at rake close-up, leads are gone, finishes failed wood is sound, note kerfs in sweat batter board and note failed coating
- Priority 1

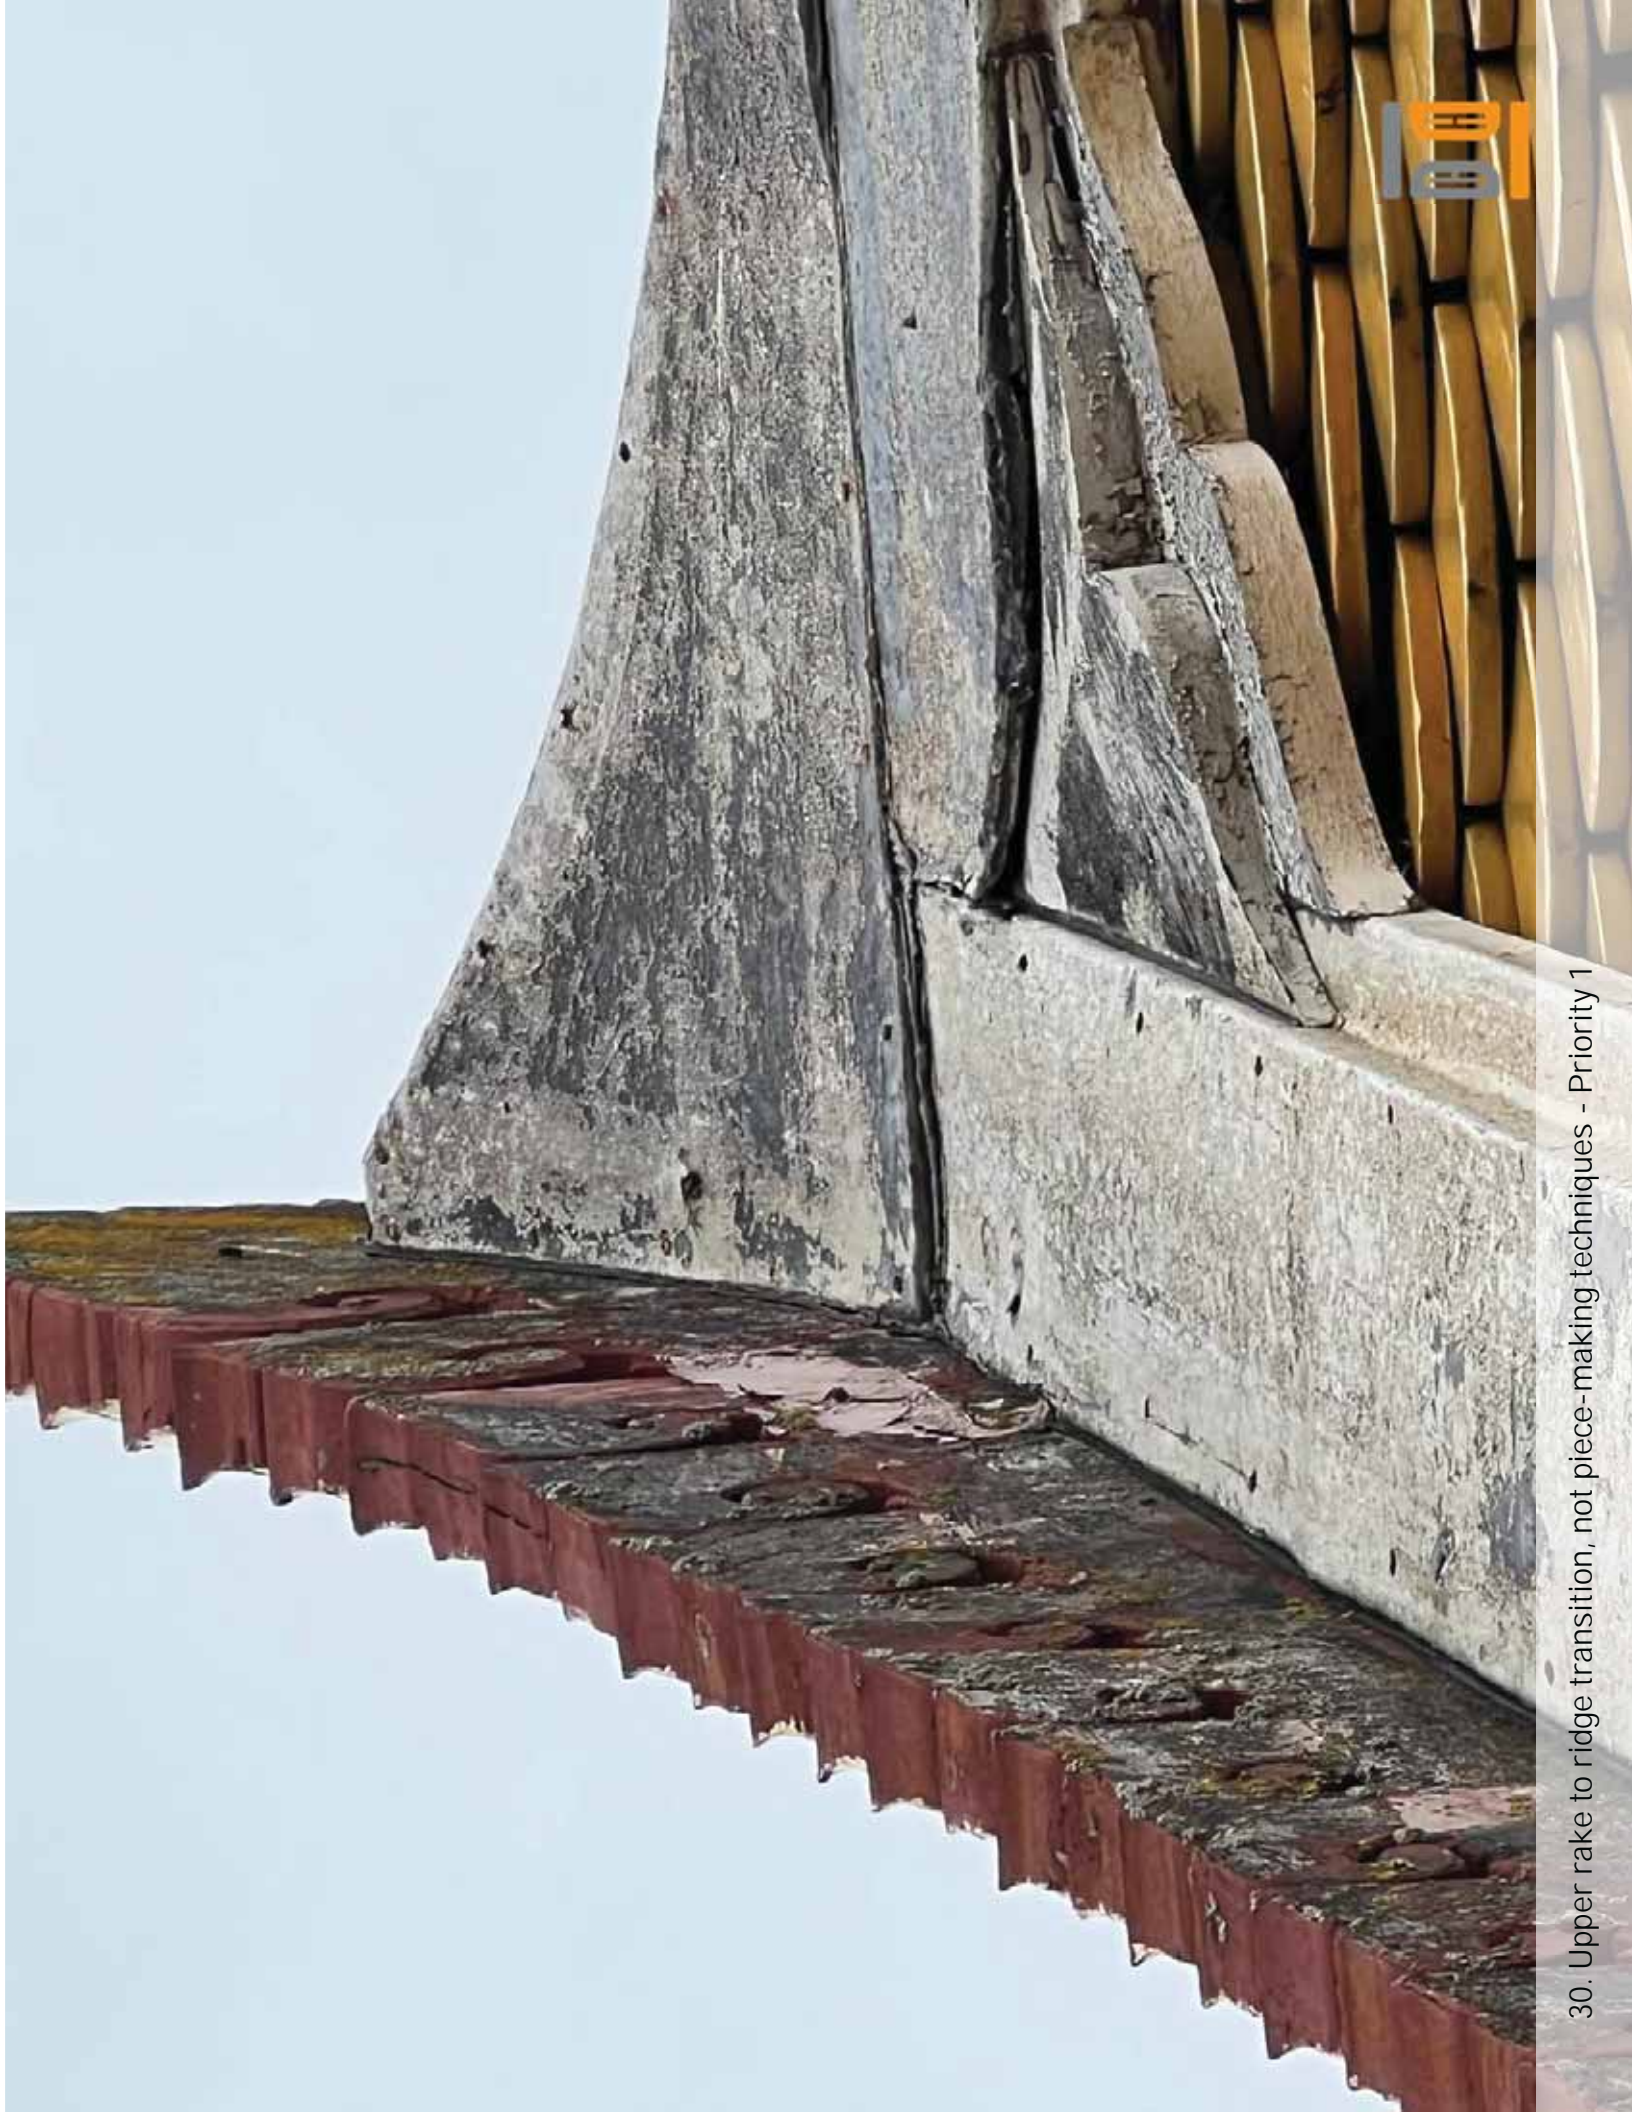
30. Upper rake to ridge transition, not piece-making techniques - Priority 1

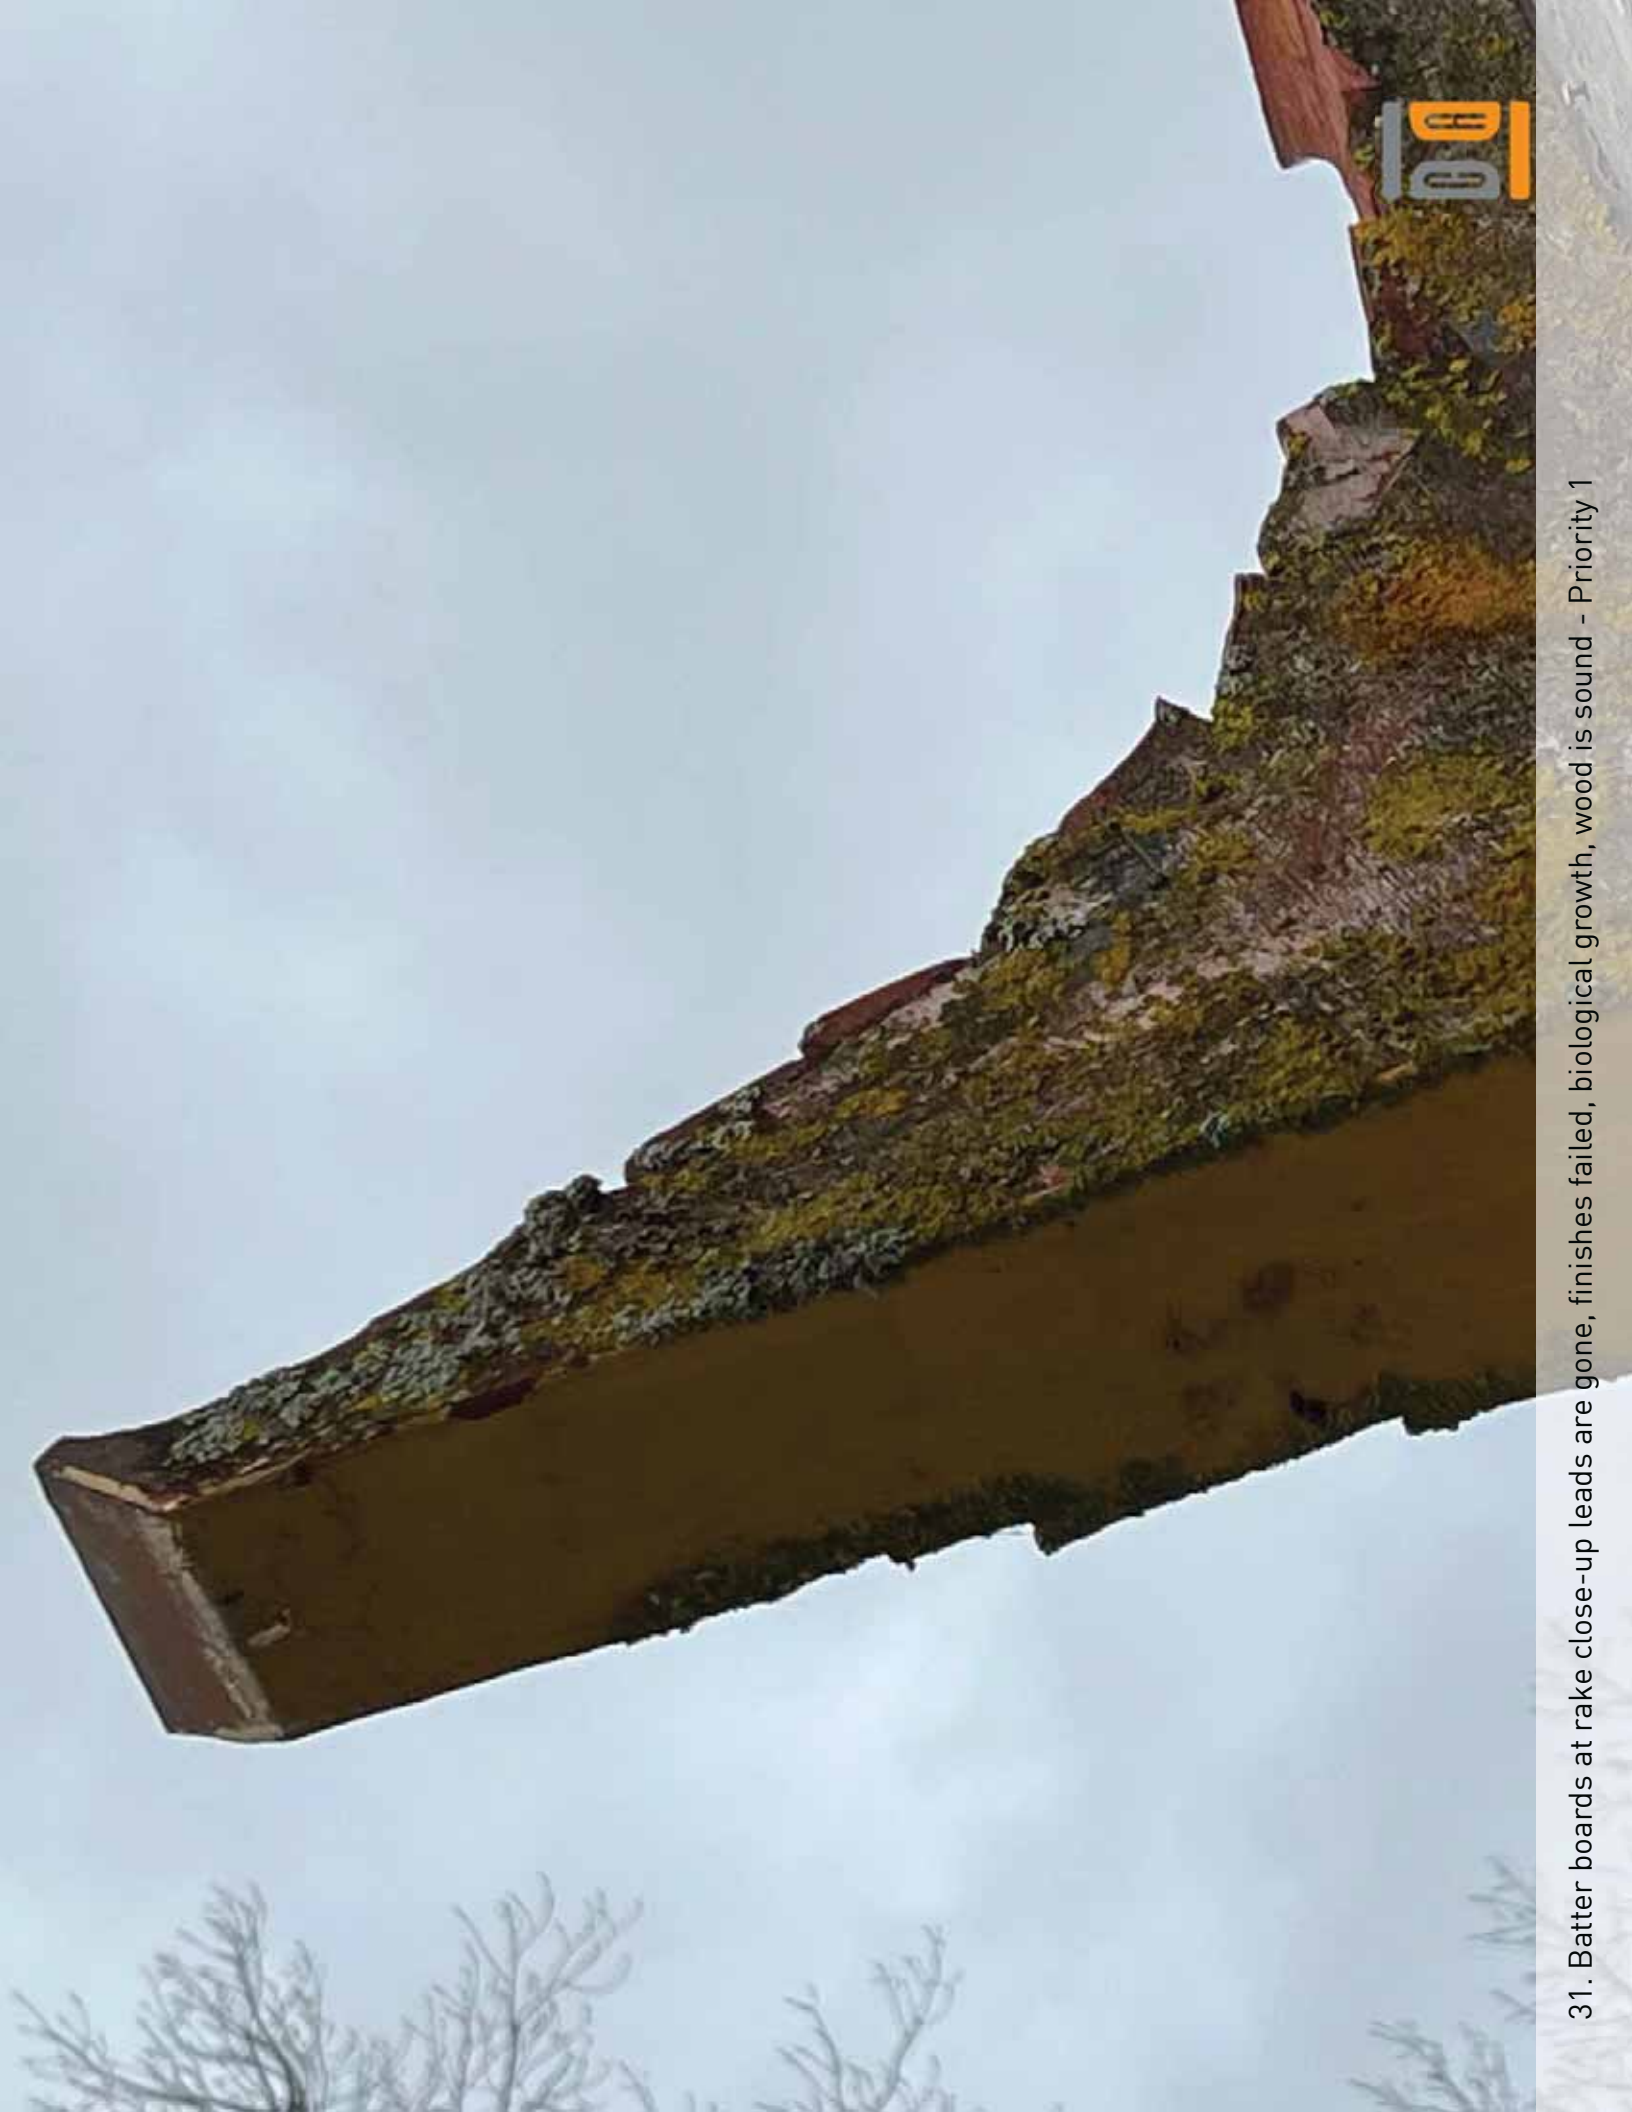
31. Batter boards at rake close-up leads are gone, finishes failed, biological growth, wood is sound - Priority 1

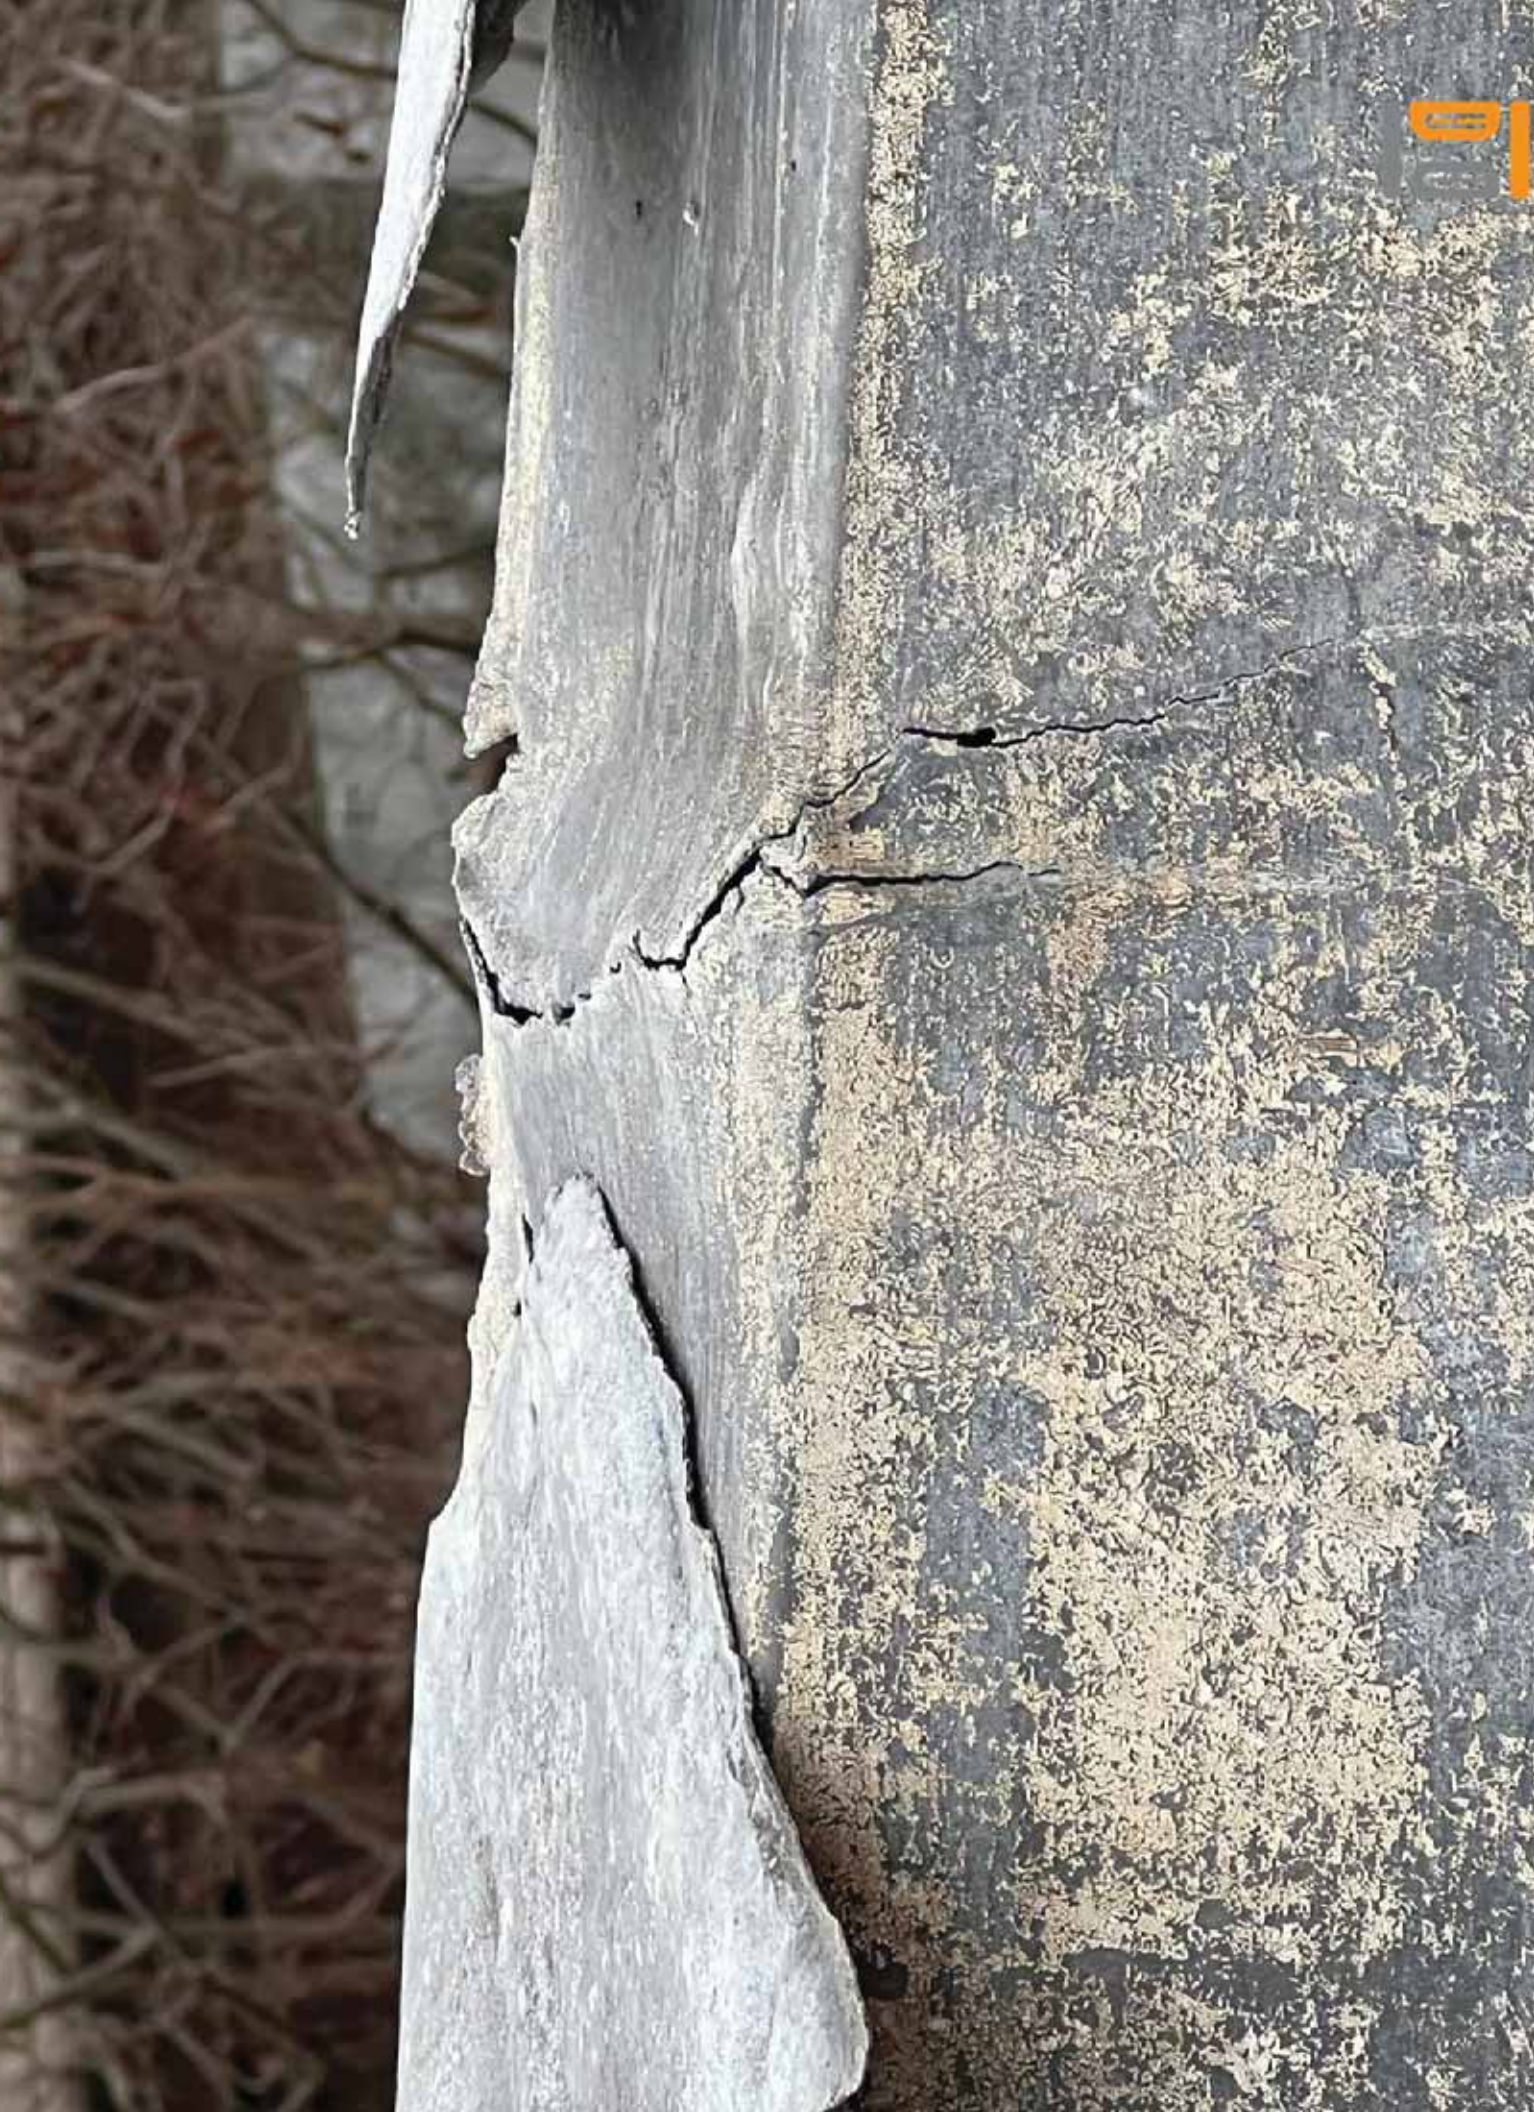
32. Degraded and fractured lead fasteners failure has led to cyclic fatigue and critical failure - Priority 1

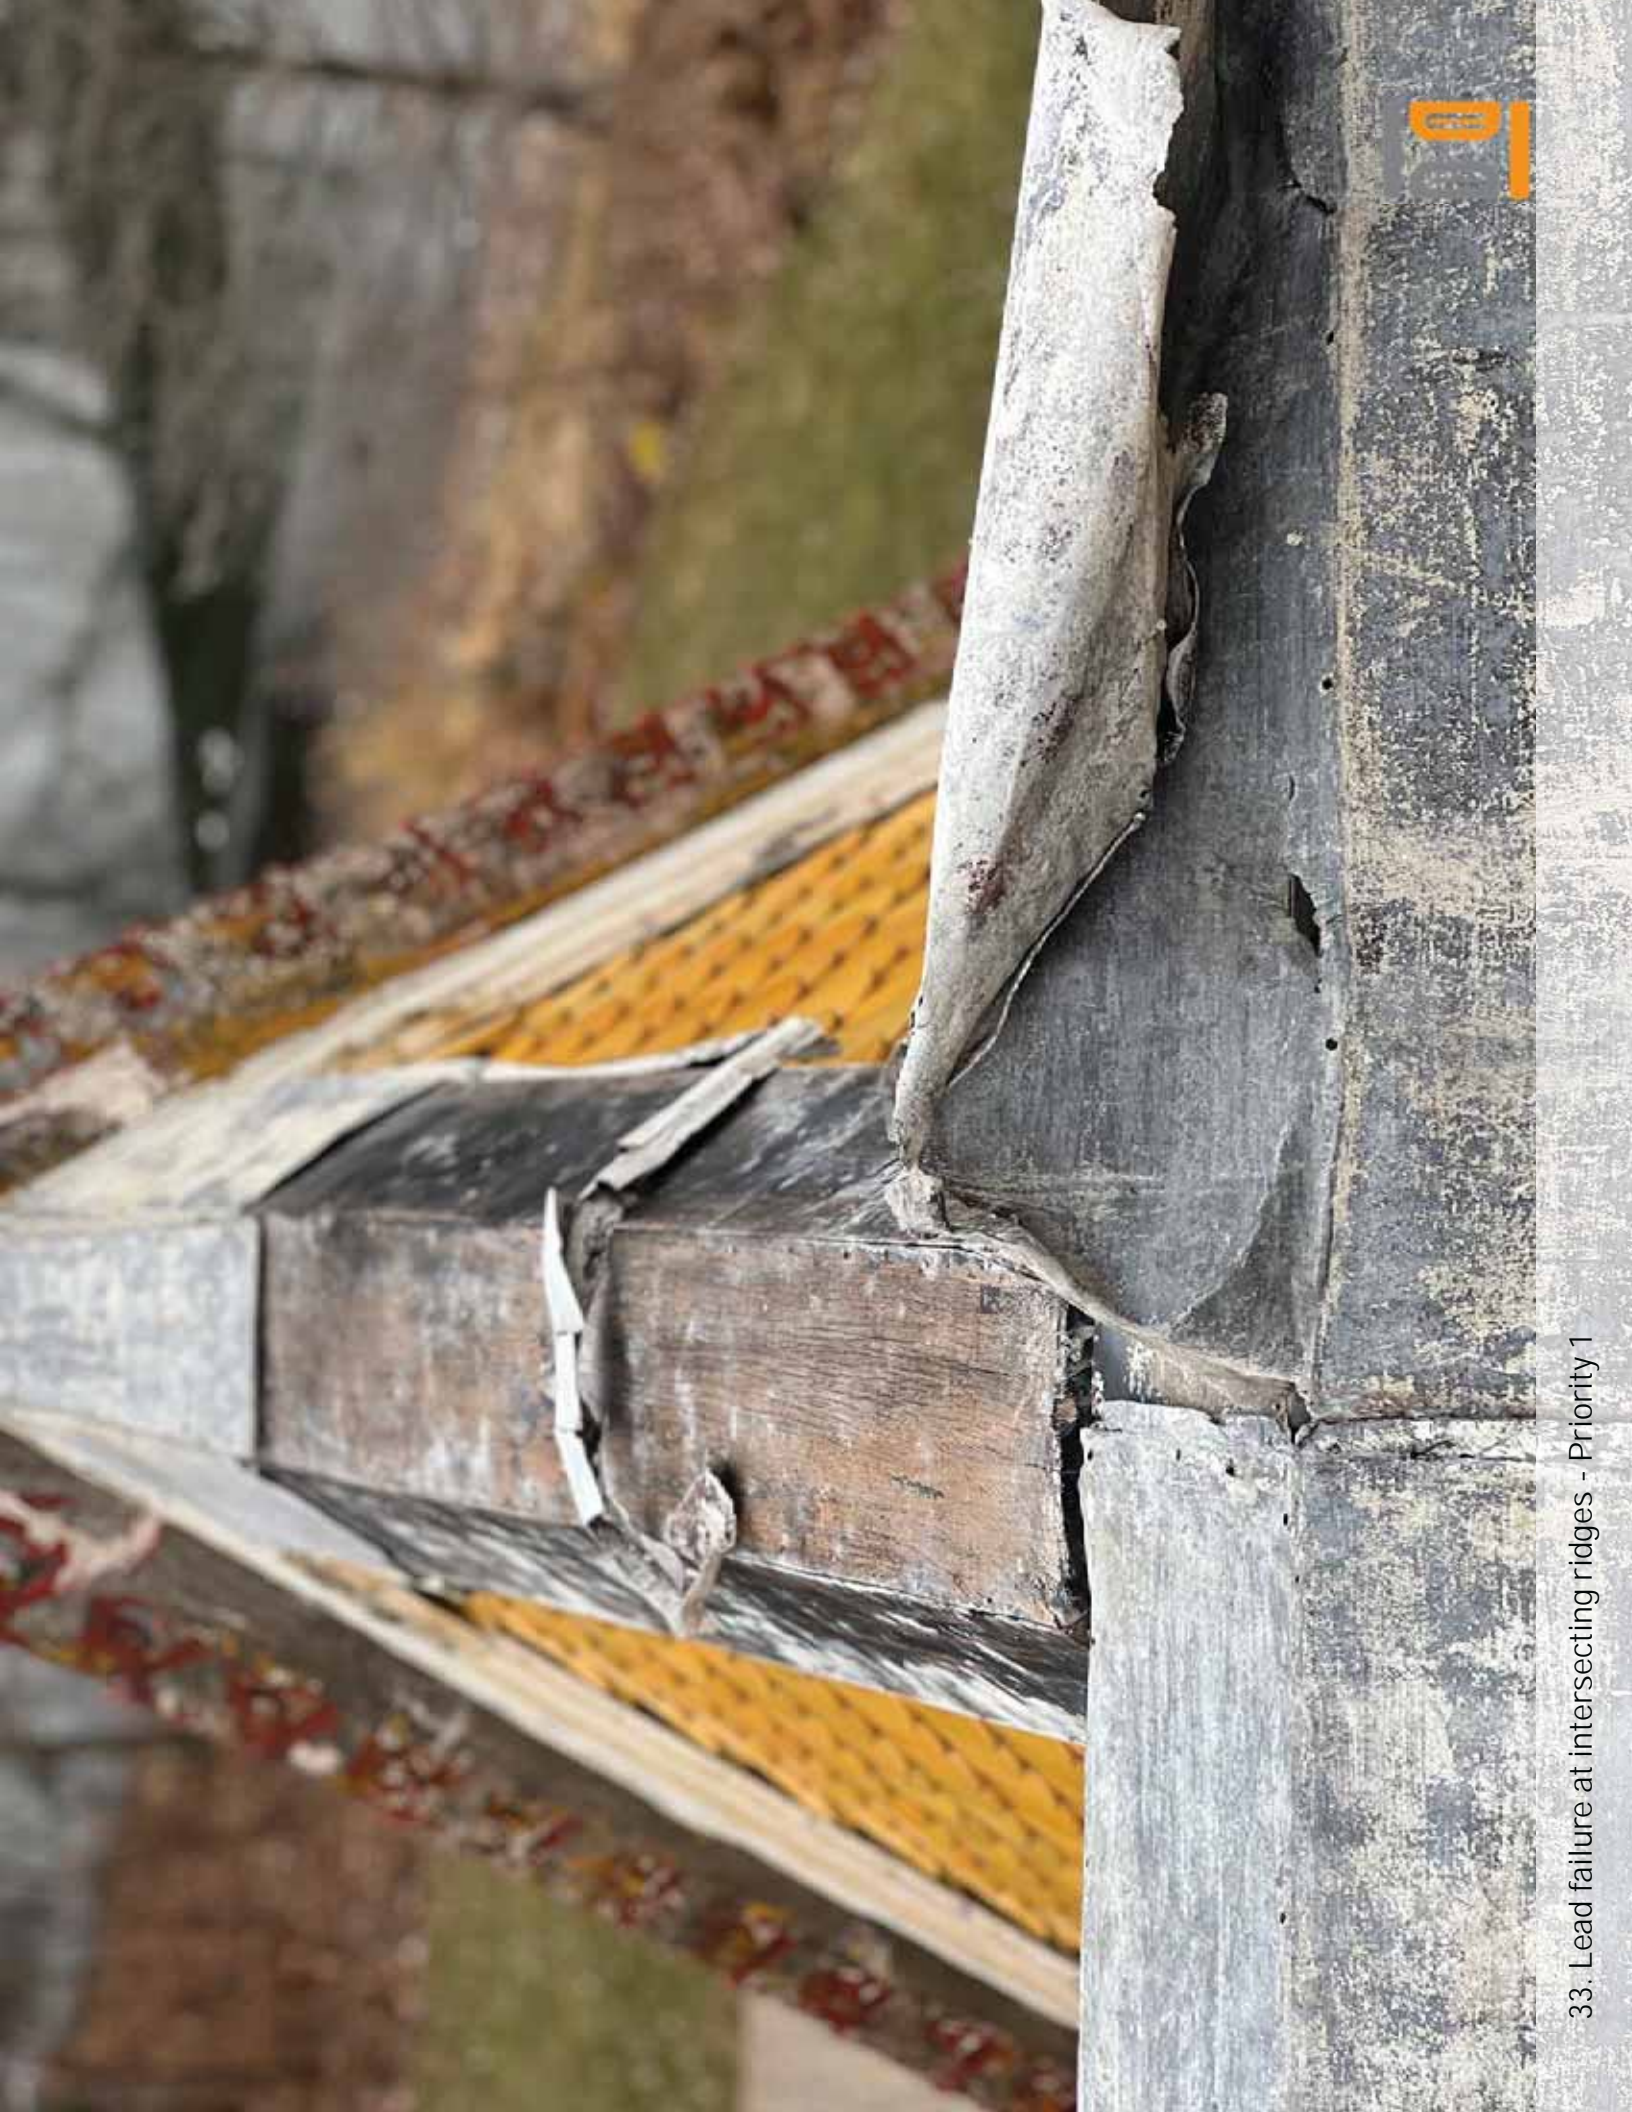
33. Lead failure at intersecting ridges - Priority 1

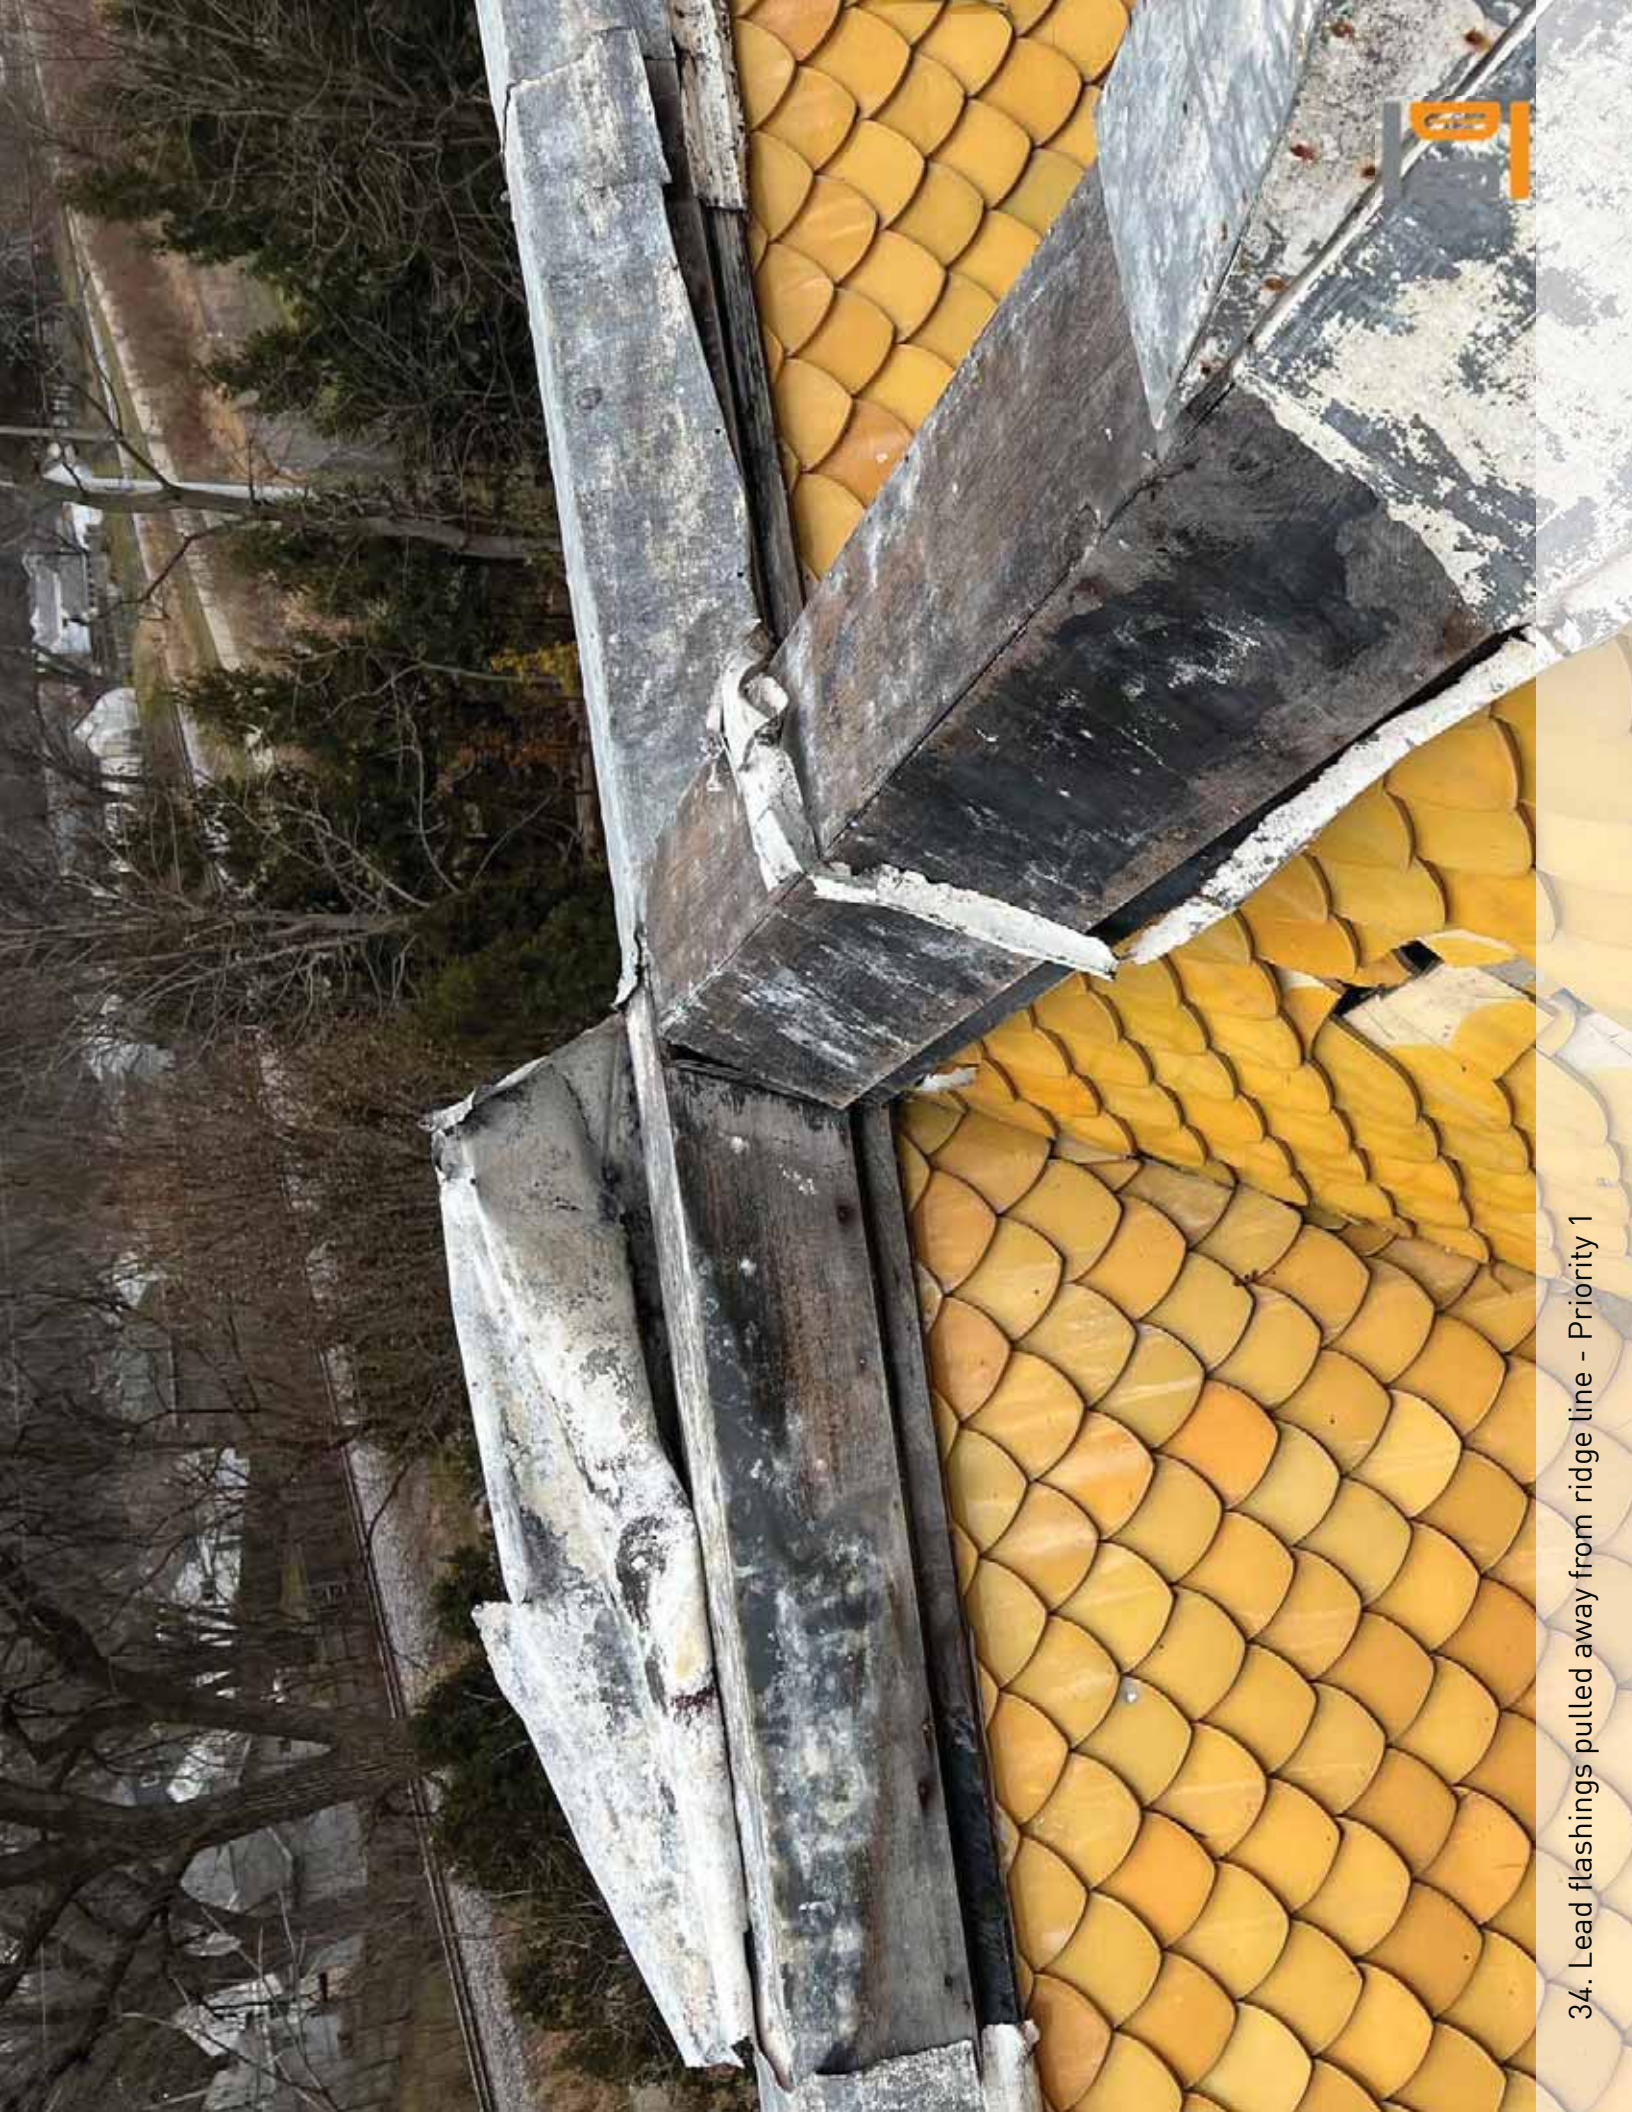
34. Lead flashings pulled away from ridge line - Priority 1
