OLBRICH BOTOANICAL GARDENS ROYAL THAI PAVILION CONDITION ASSESSMENT REPORT

MAY 20, 2022

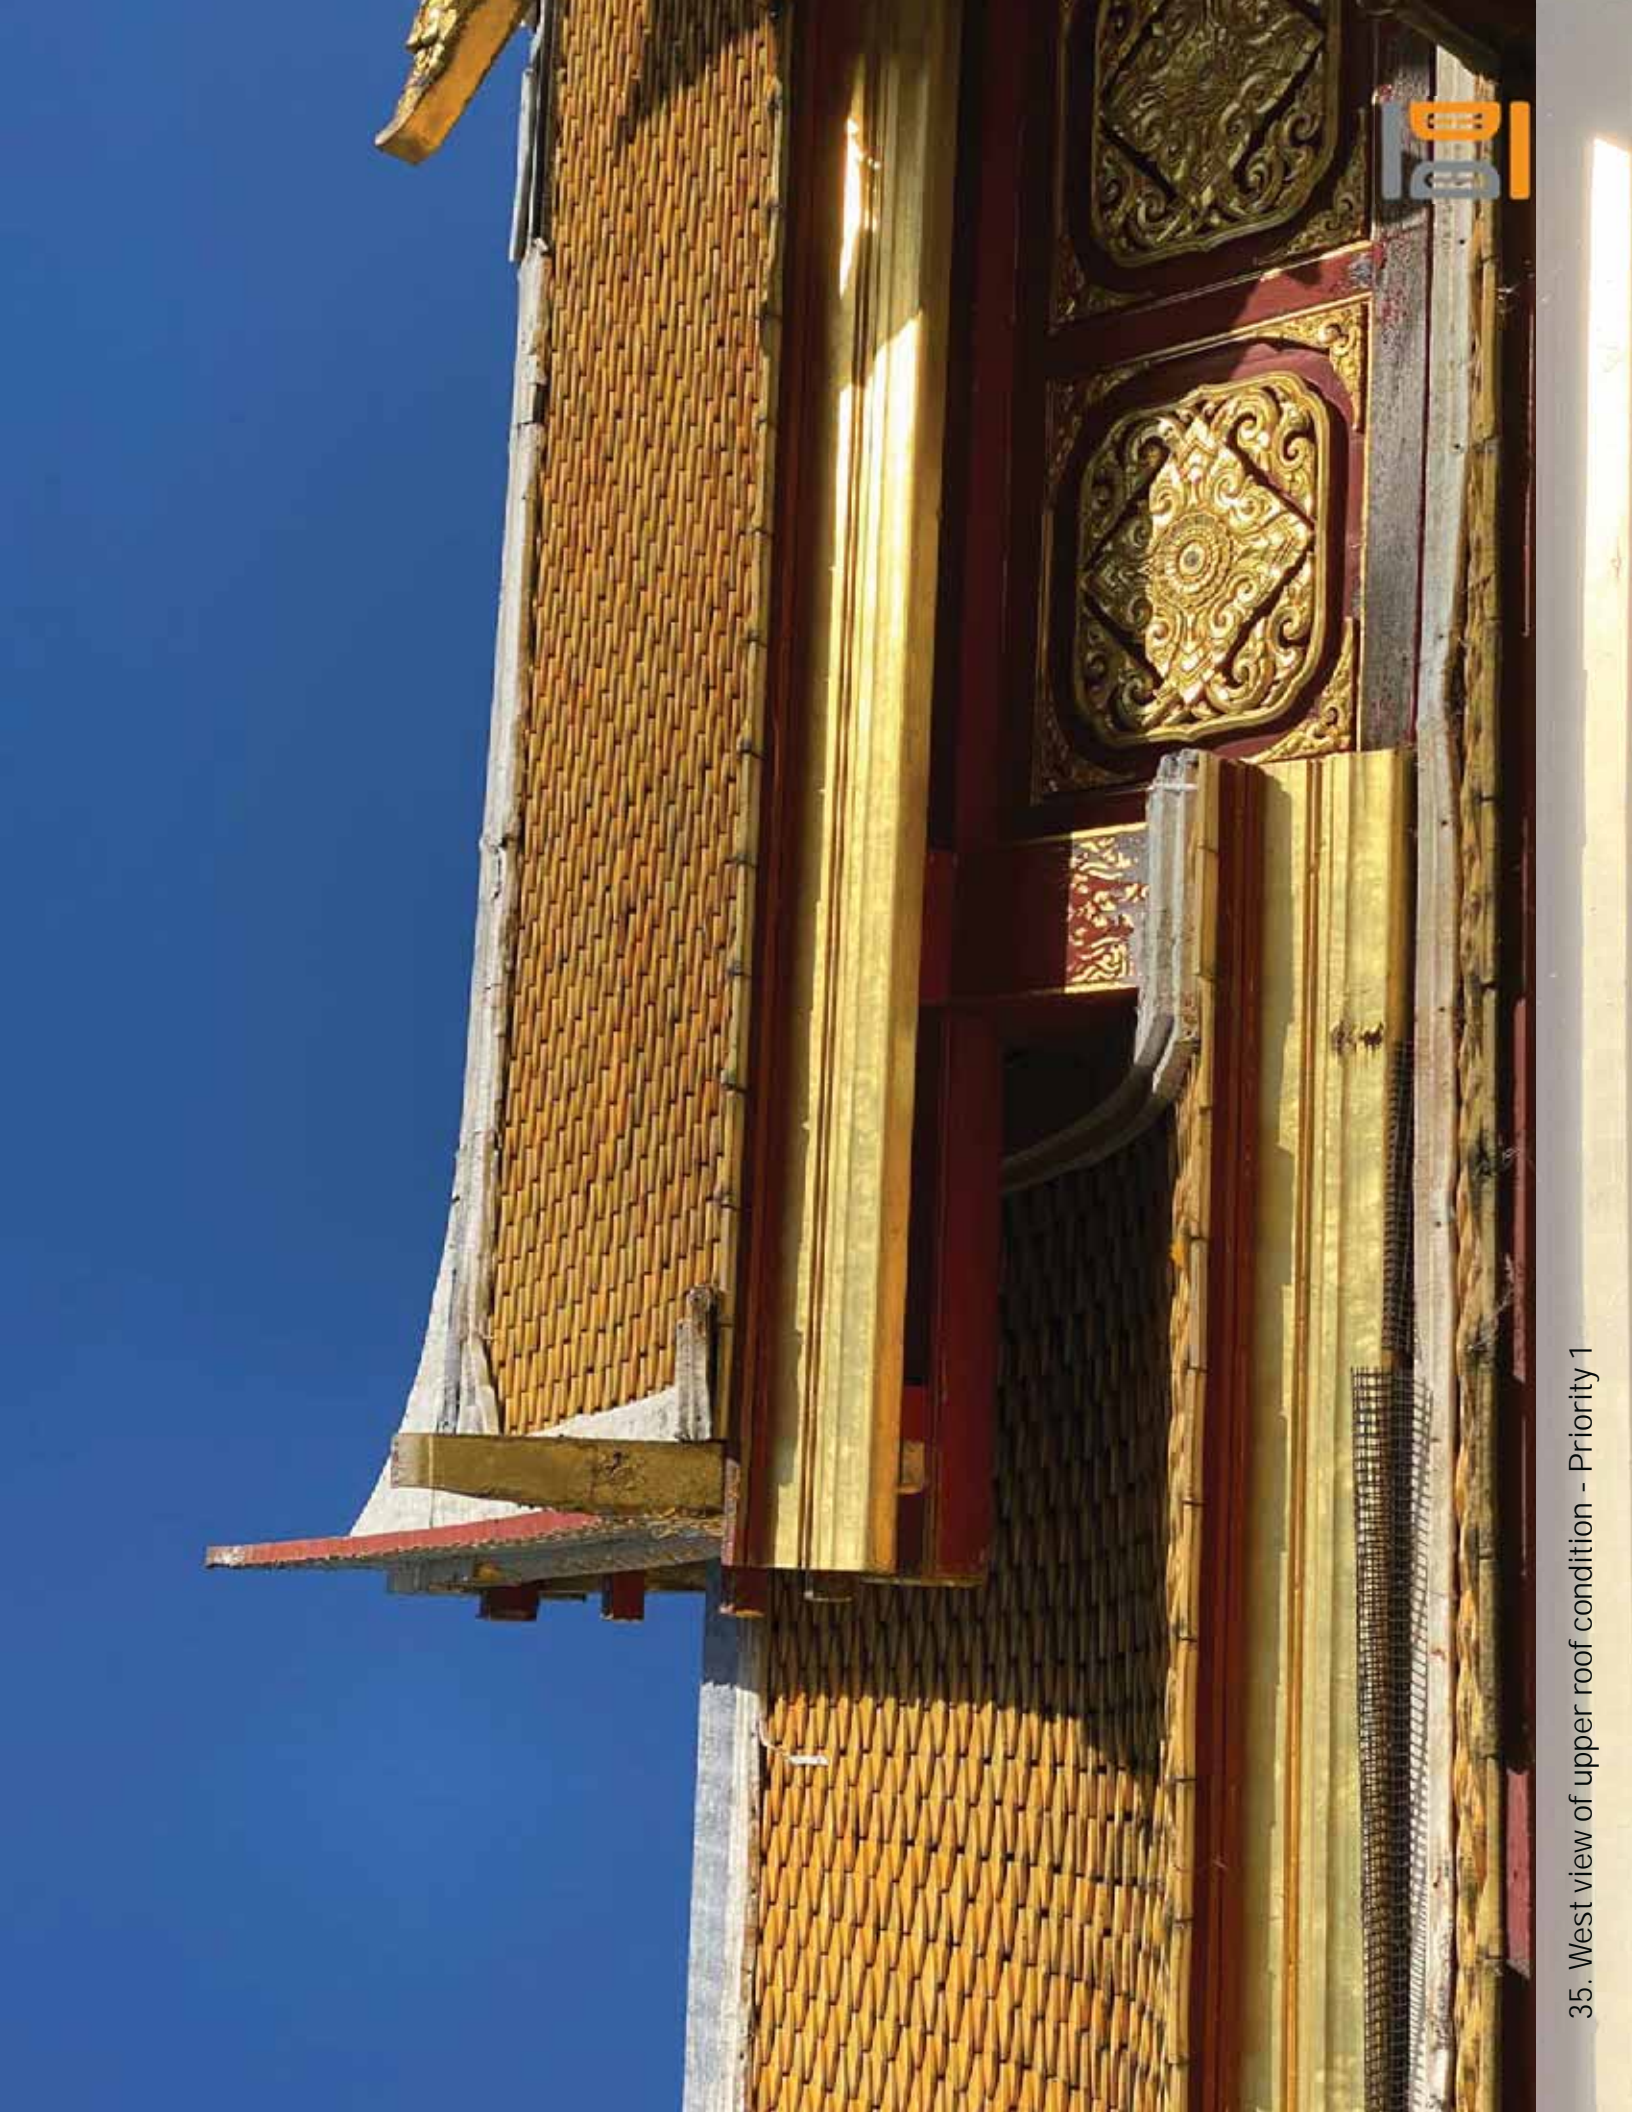
35. West view of upper roof condition - Priority 1

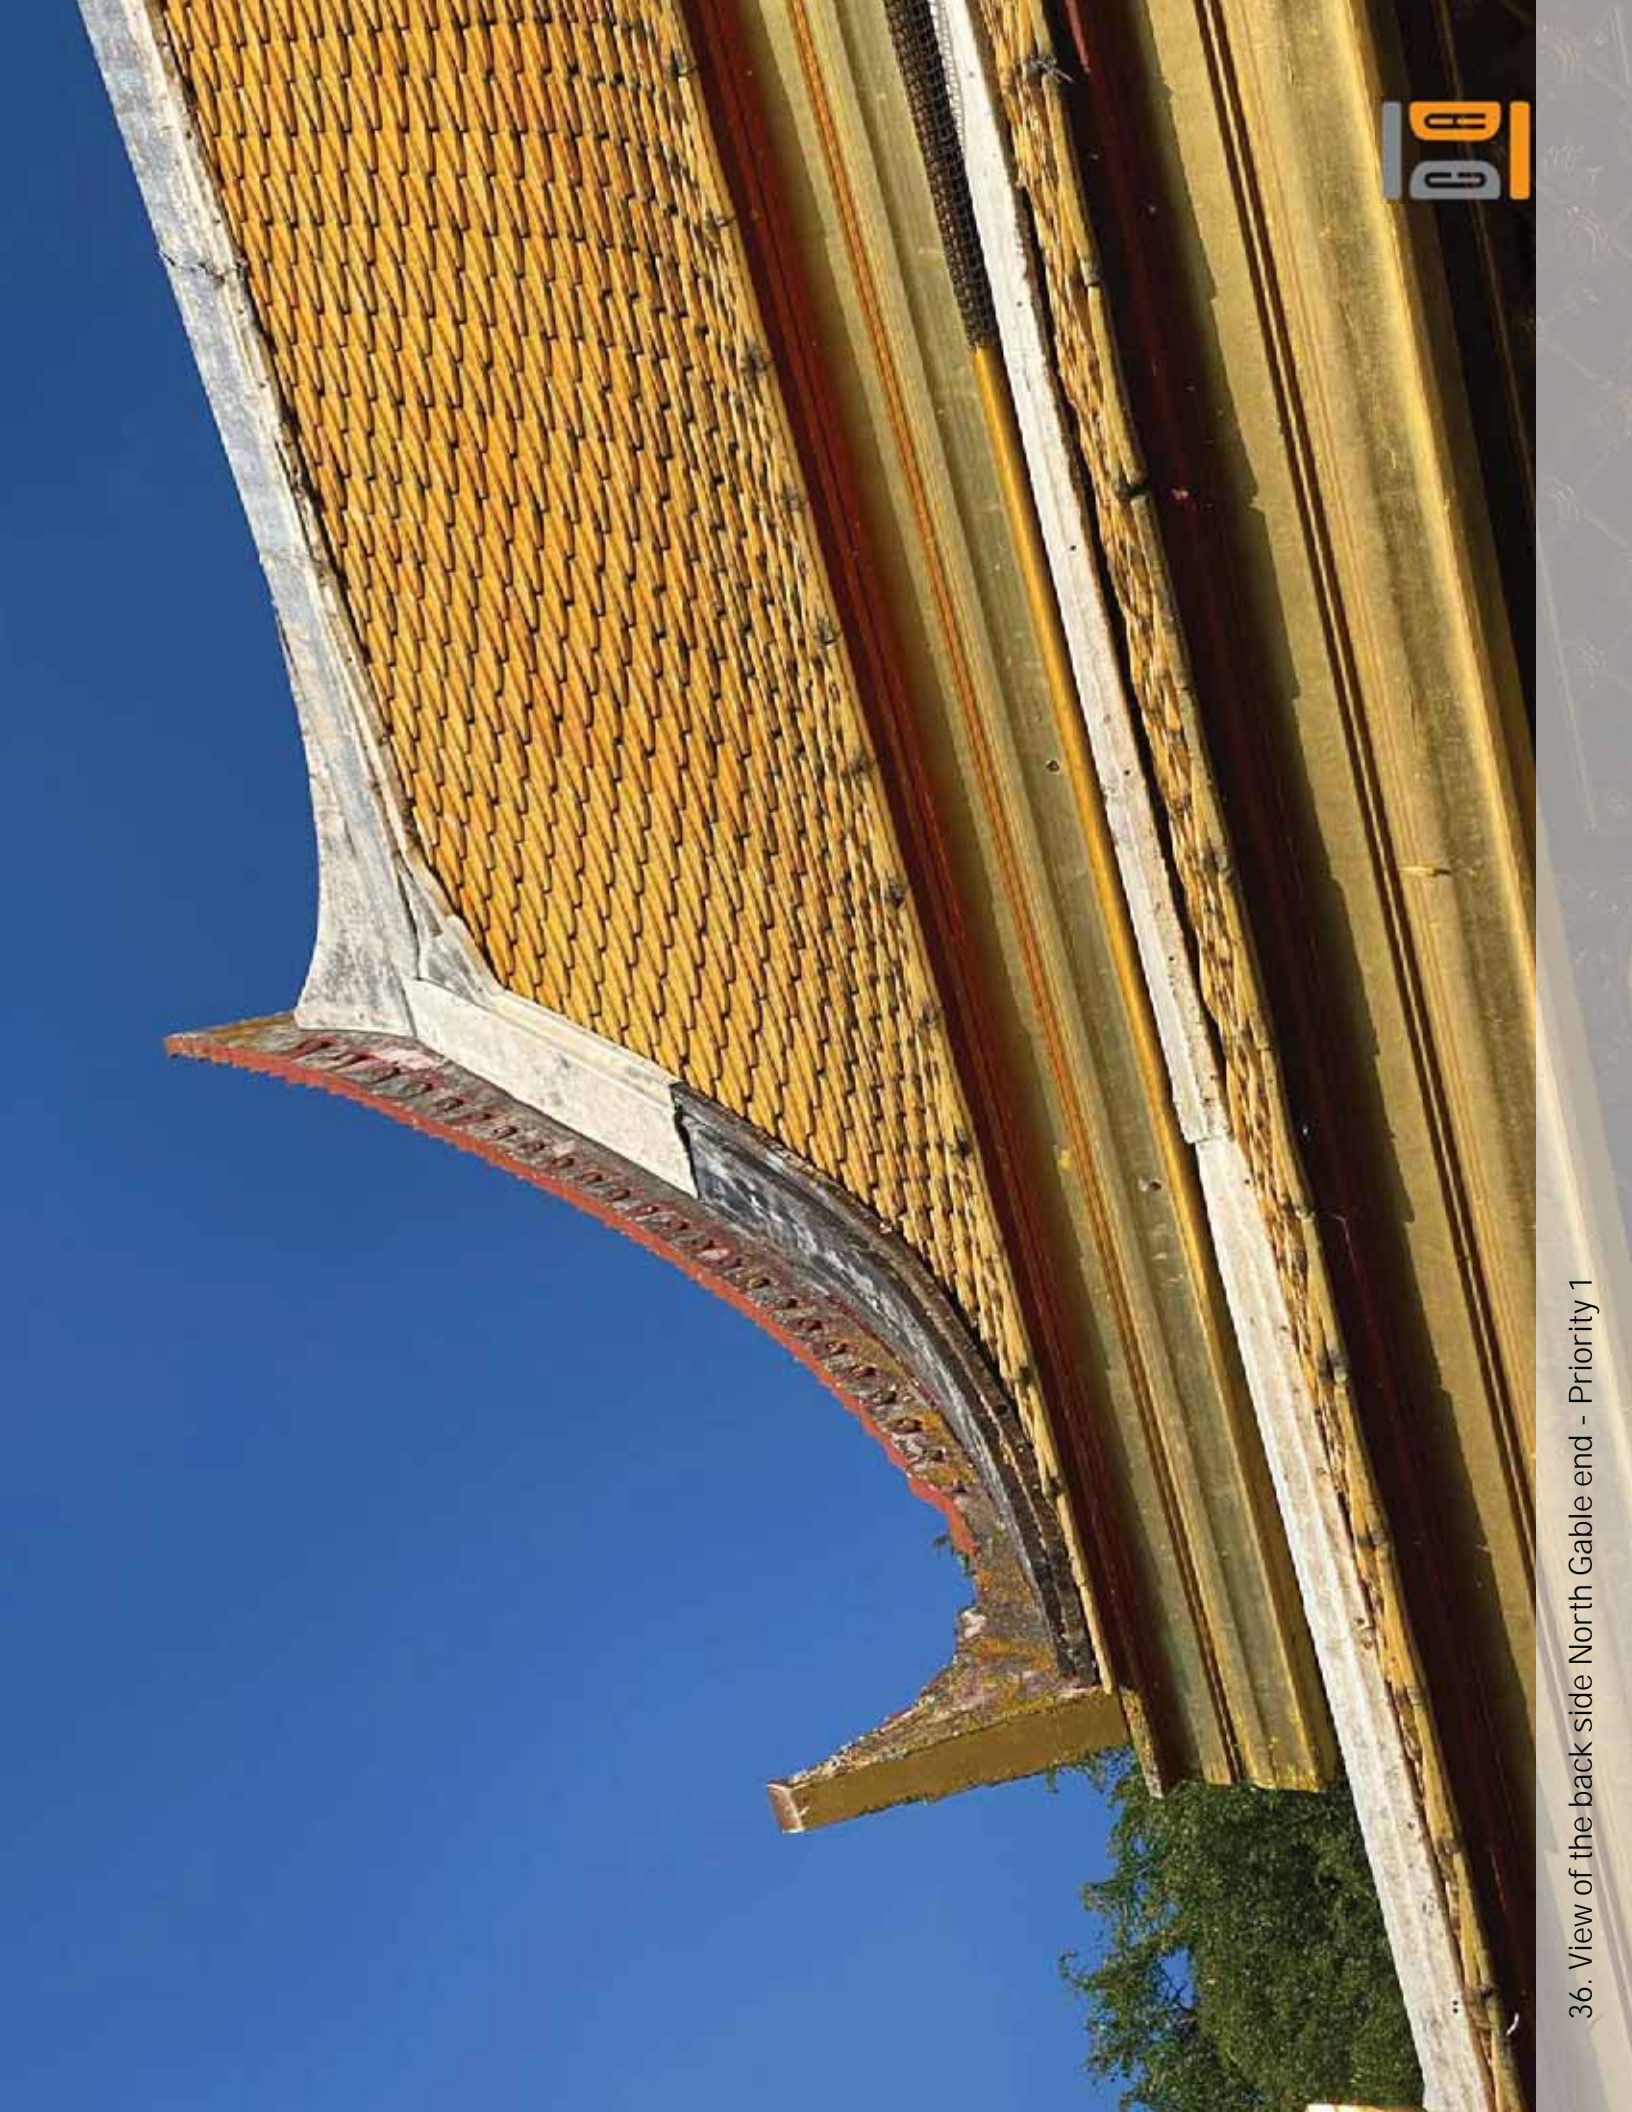
36. View of the back side North Gable end - Priority 1

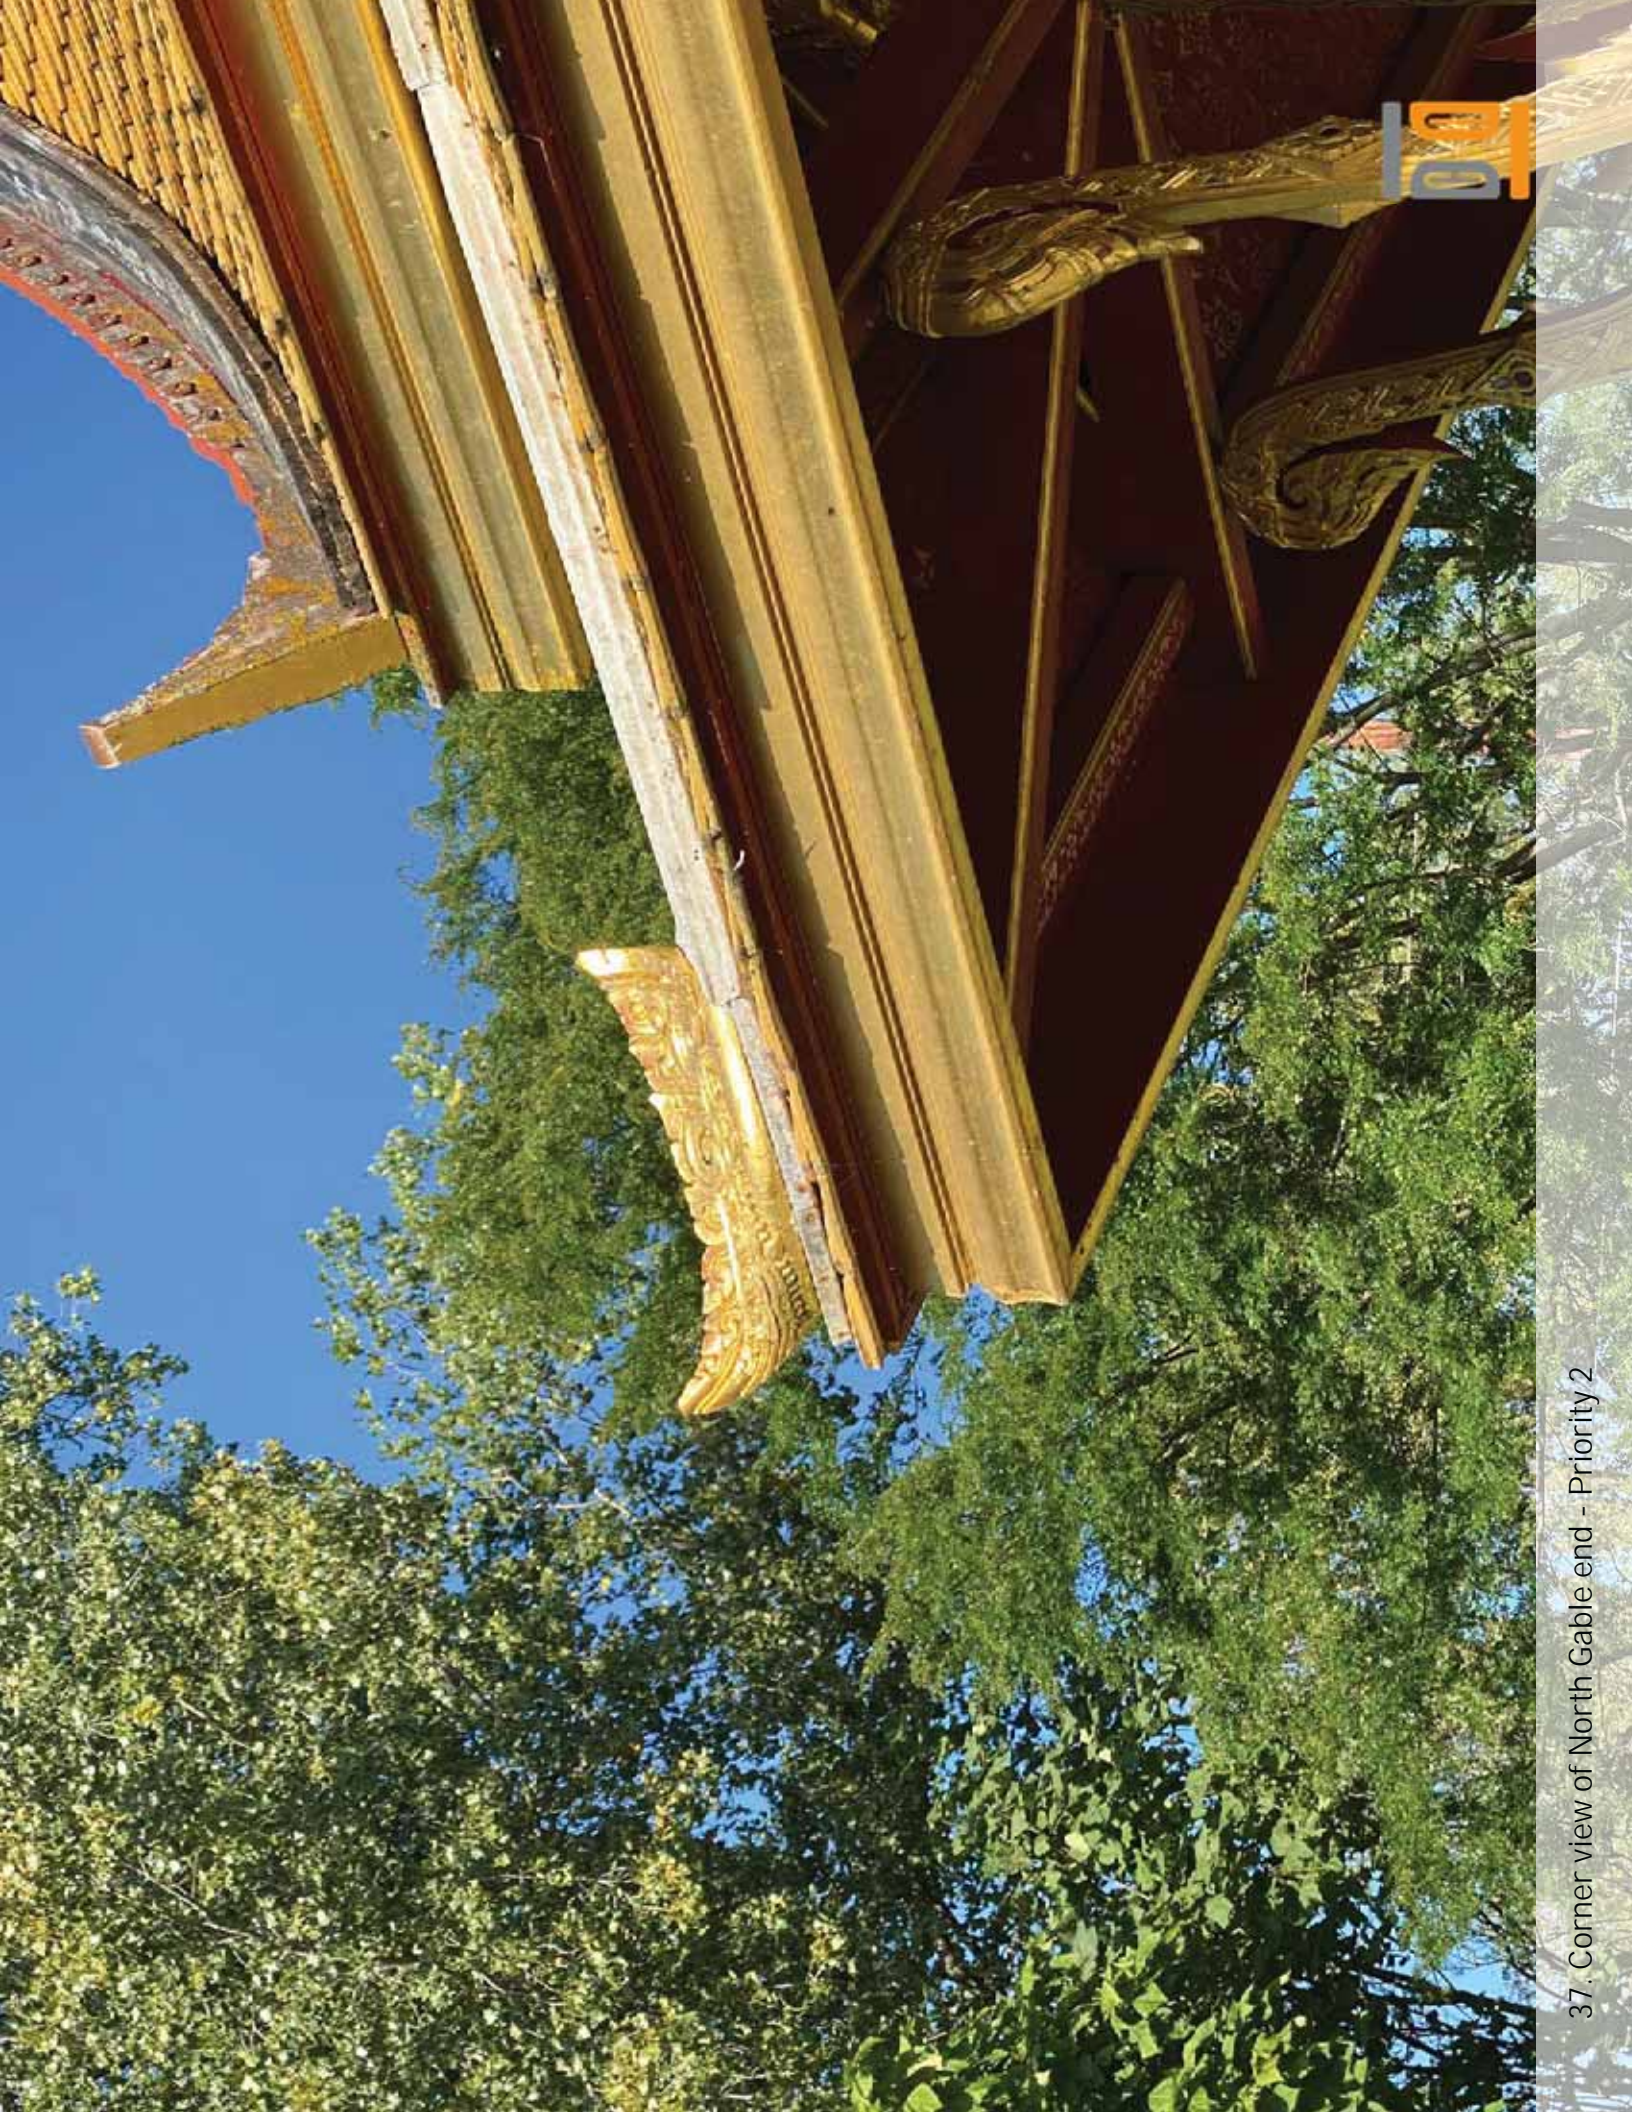
37. Corner view of North Gable end - Priority 2

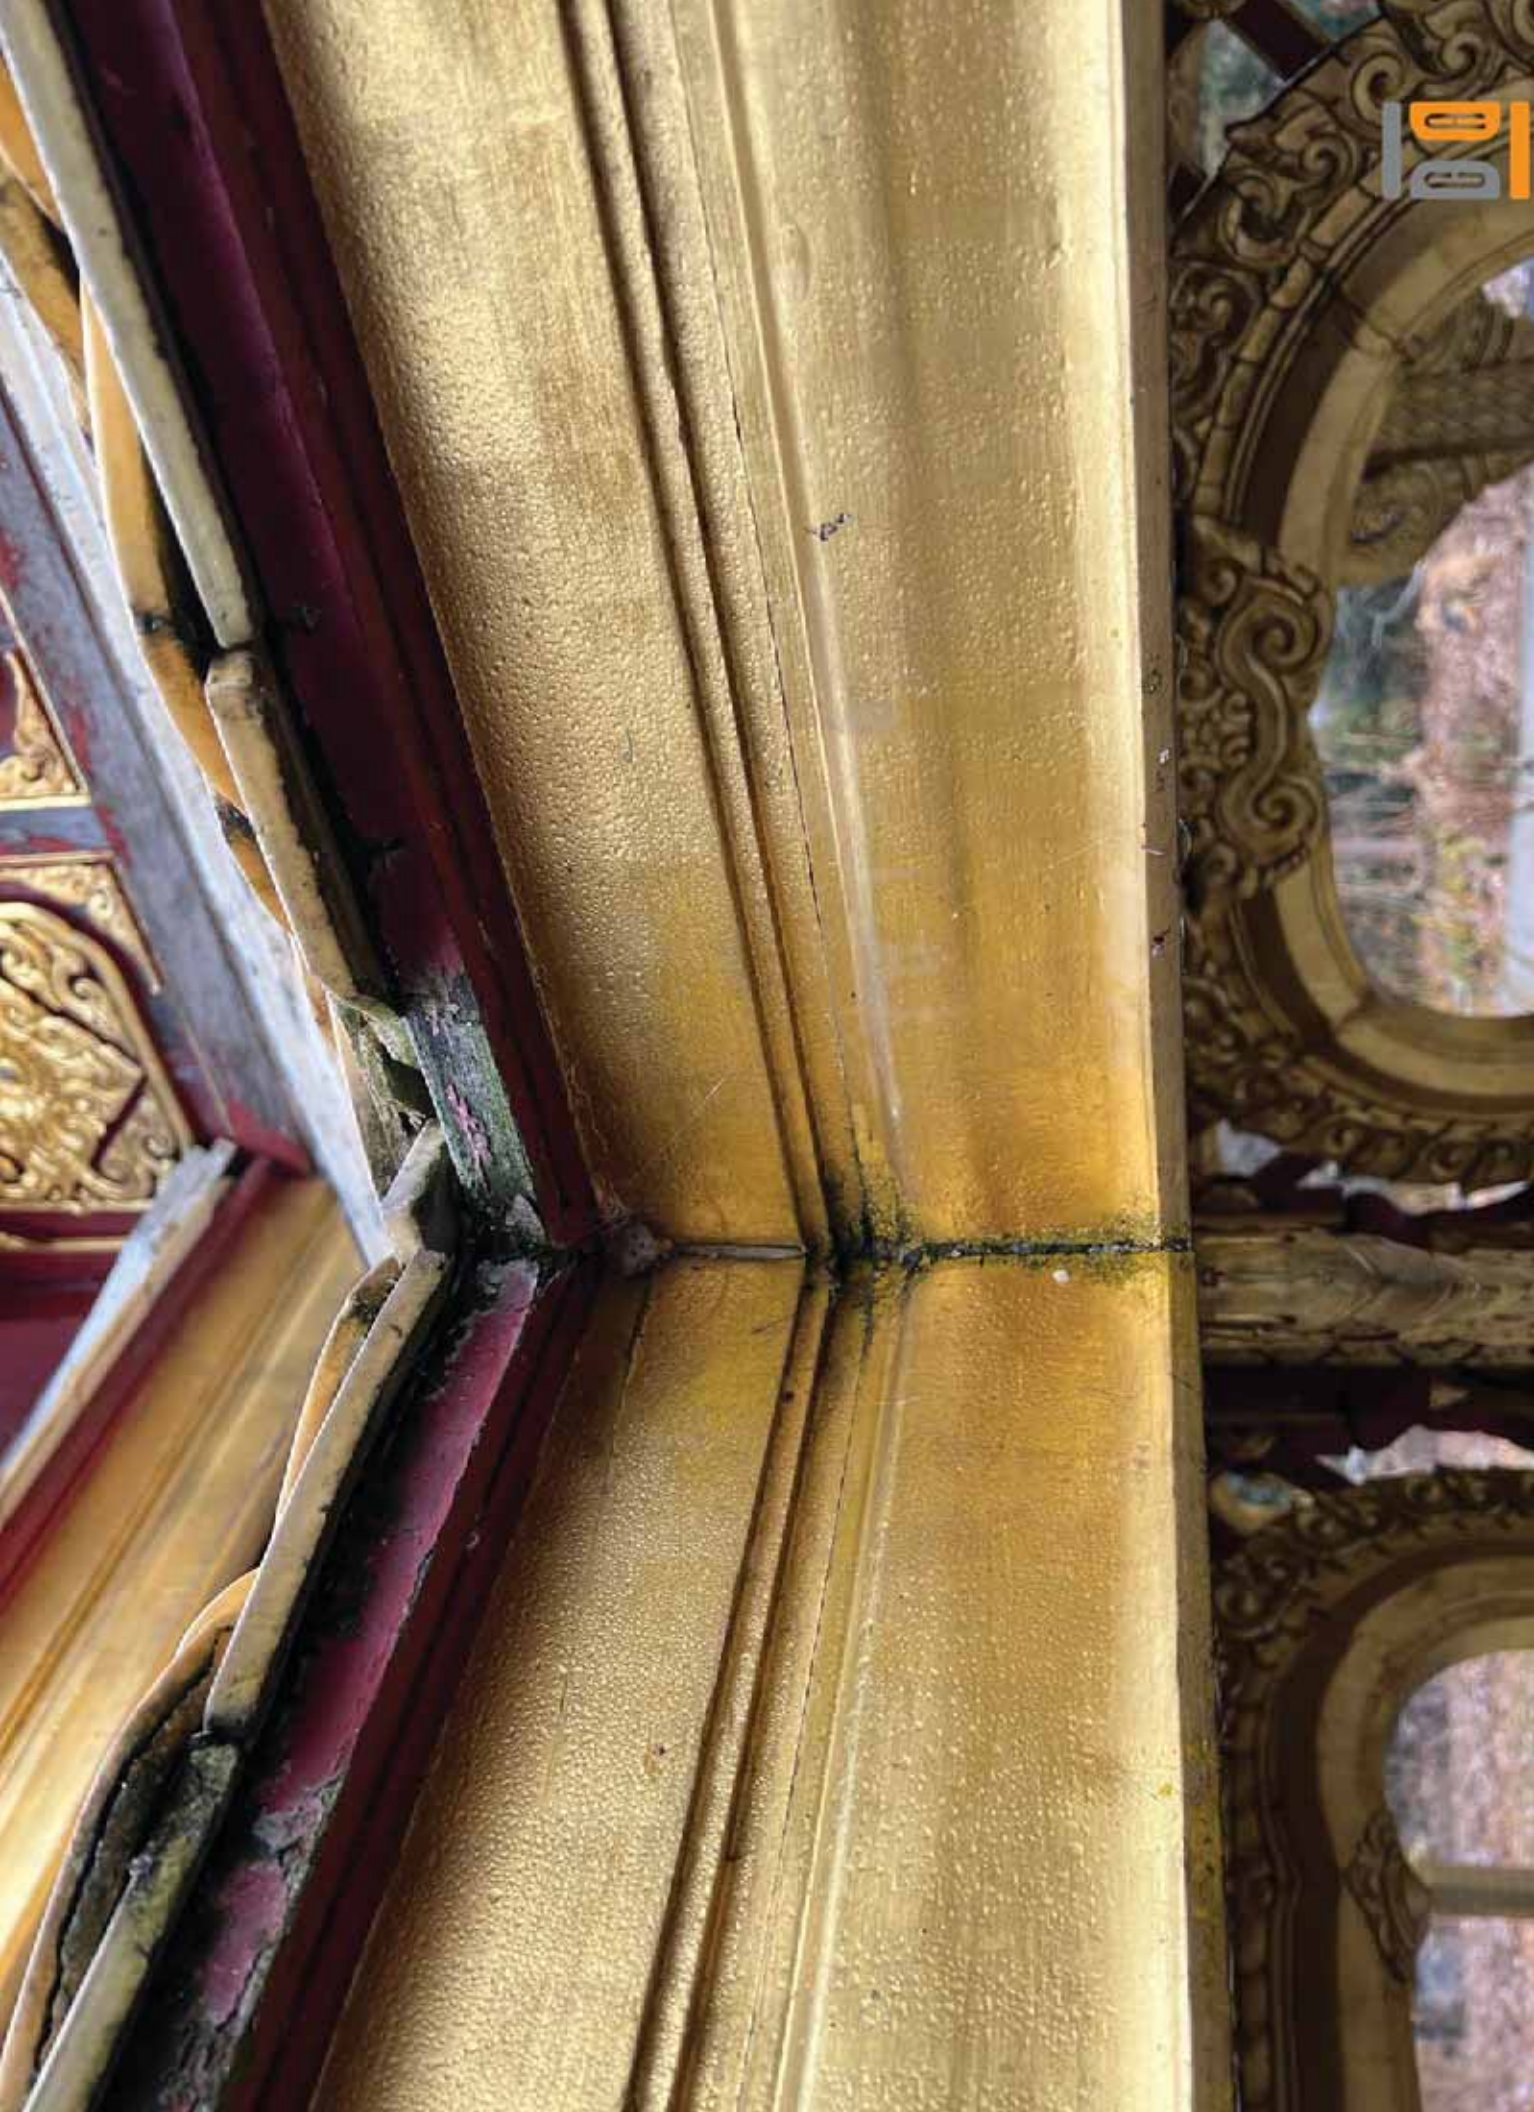
38. Fascia below valley lack of drop has contributed to finish failure and some rot - Priority 2

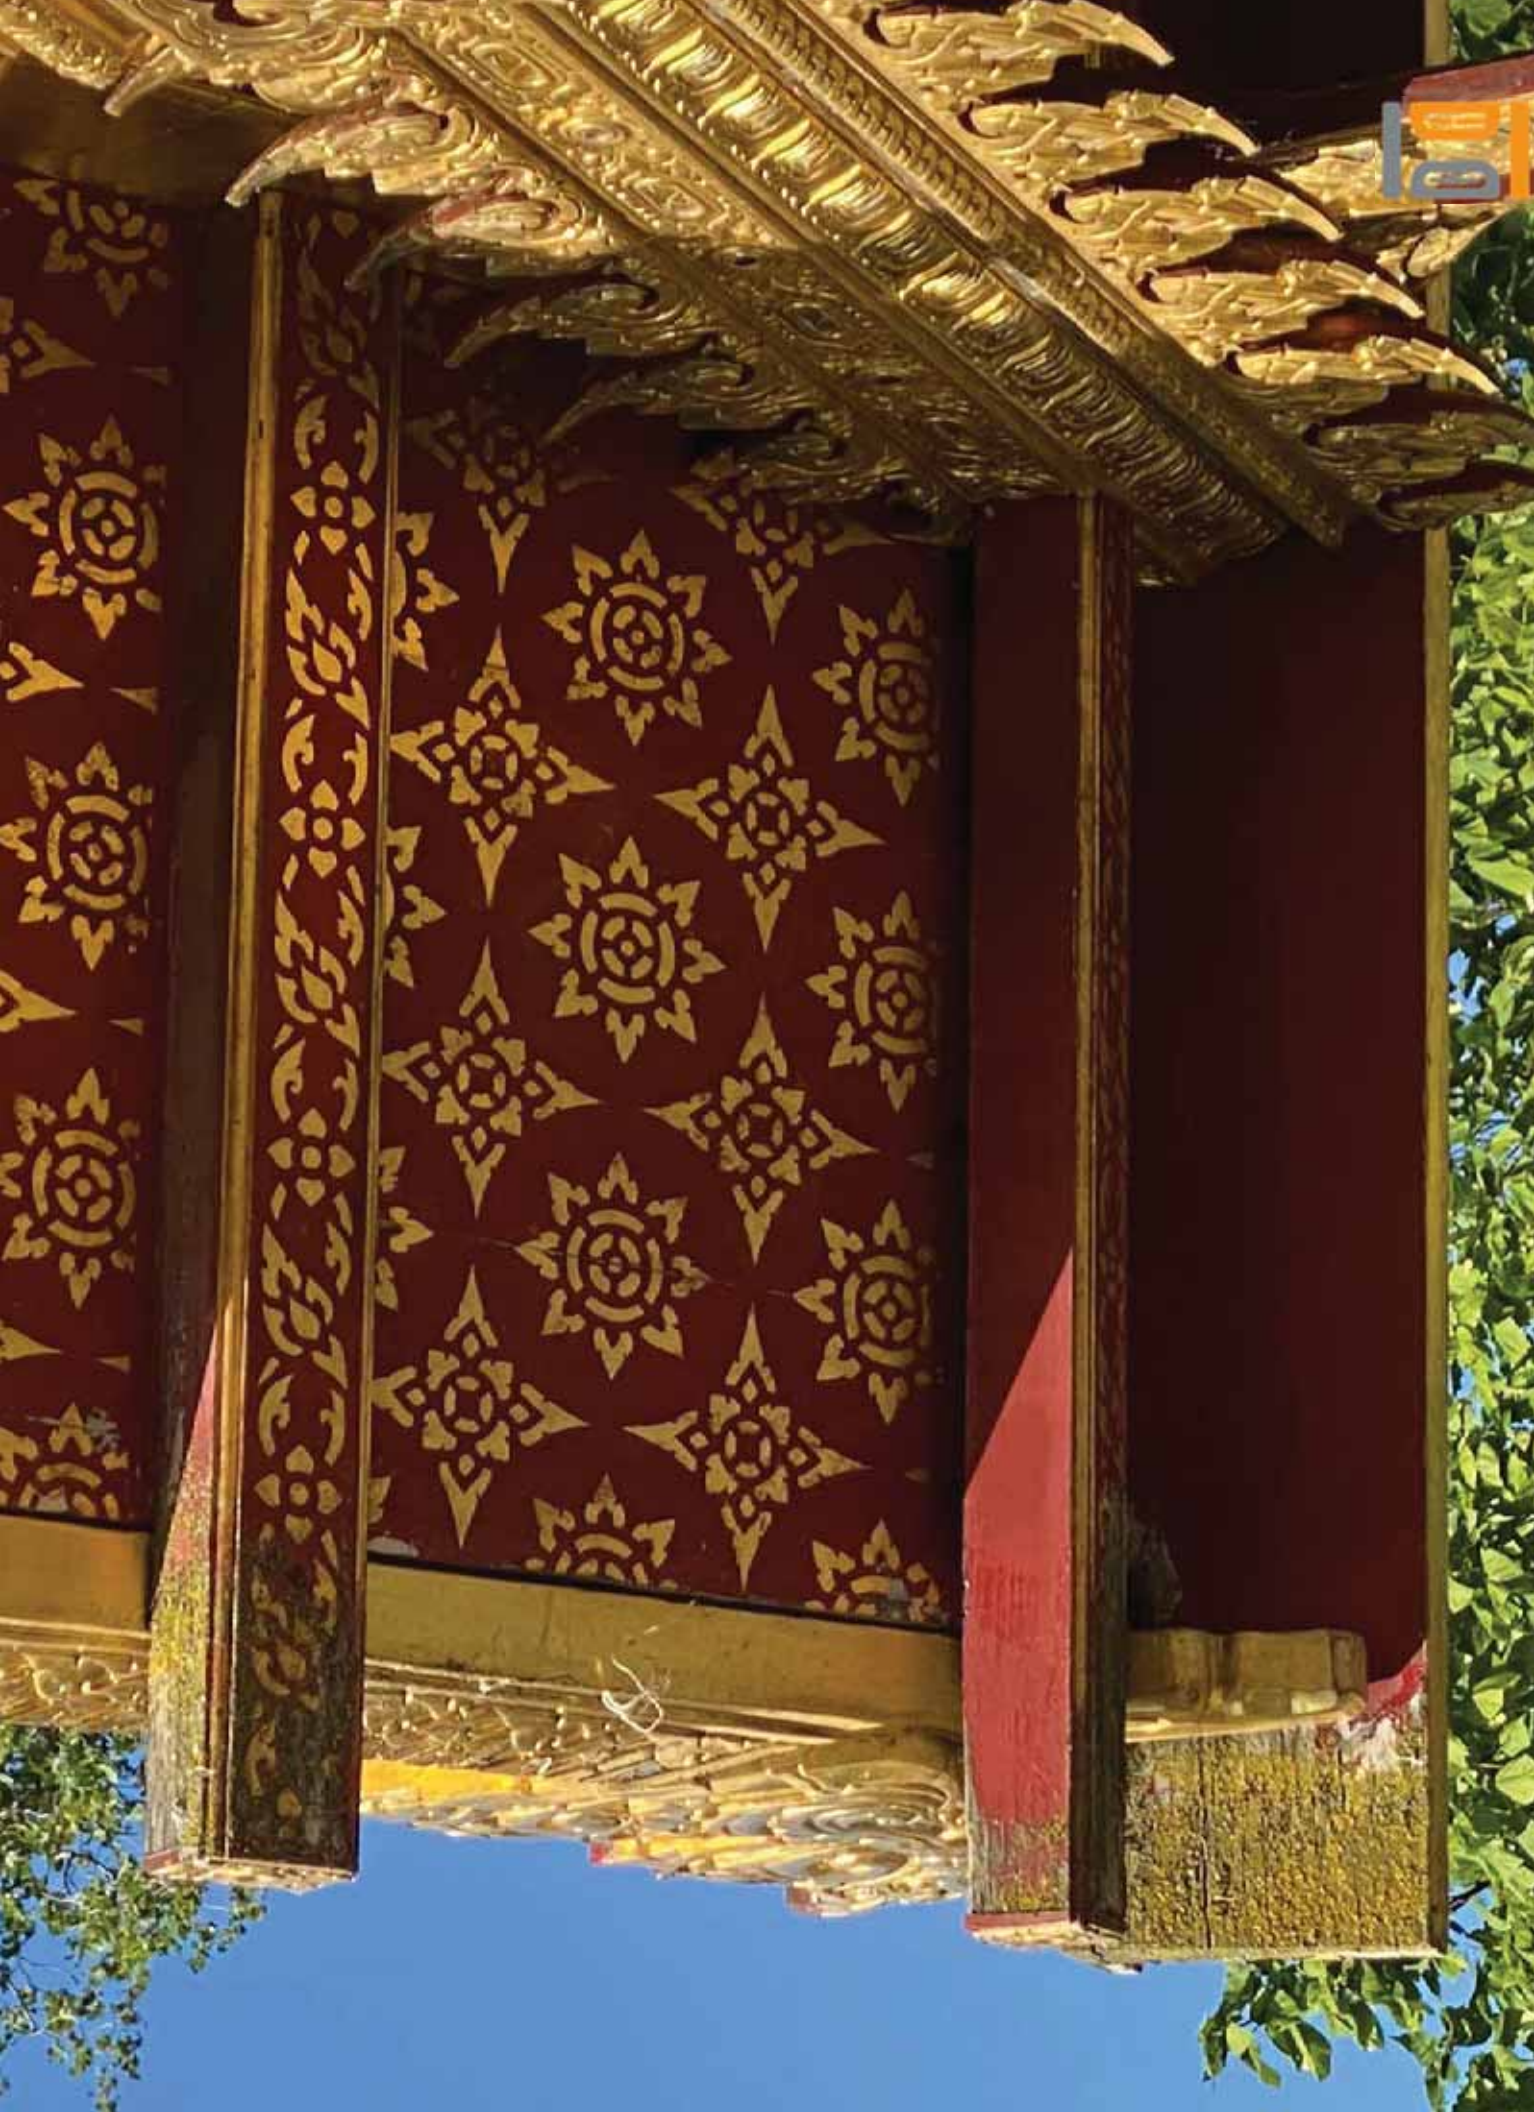
39. View of soffit and wood components showing dry-rotted wood and paint failures - Priority 2

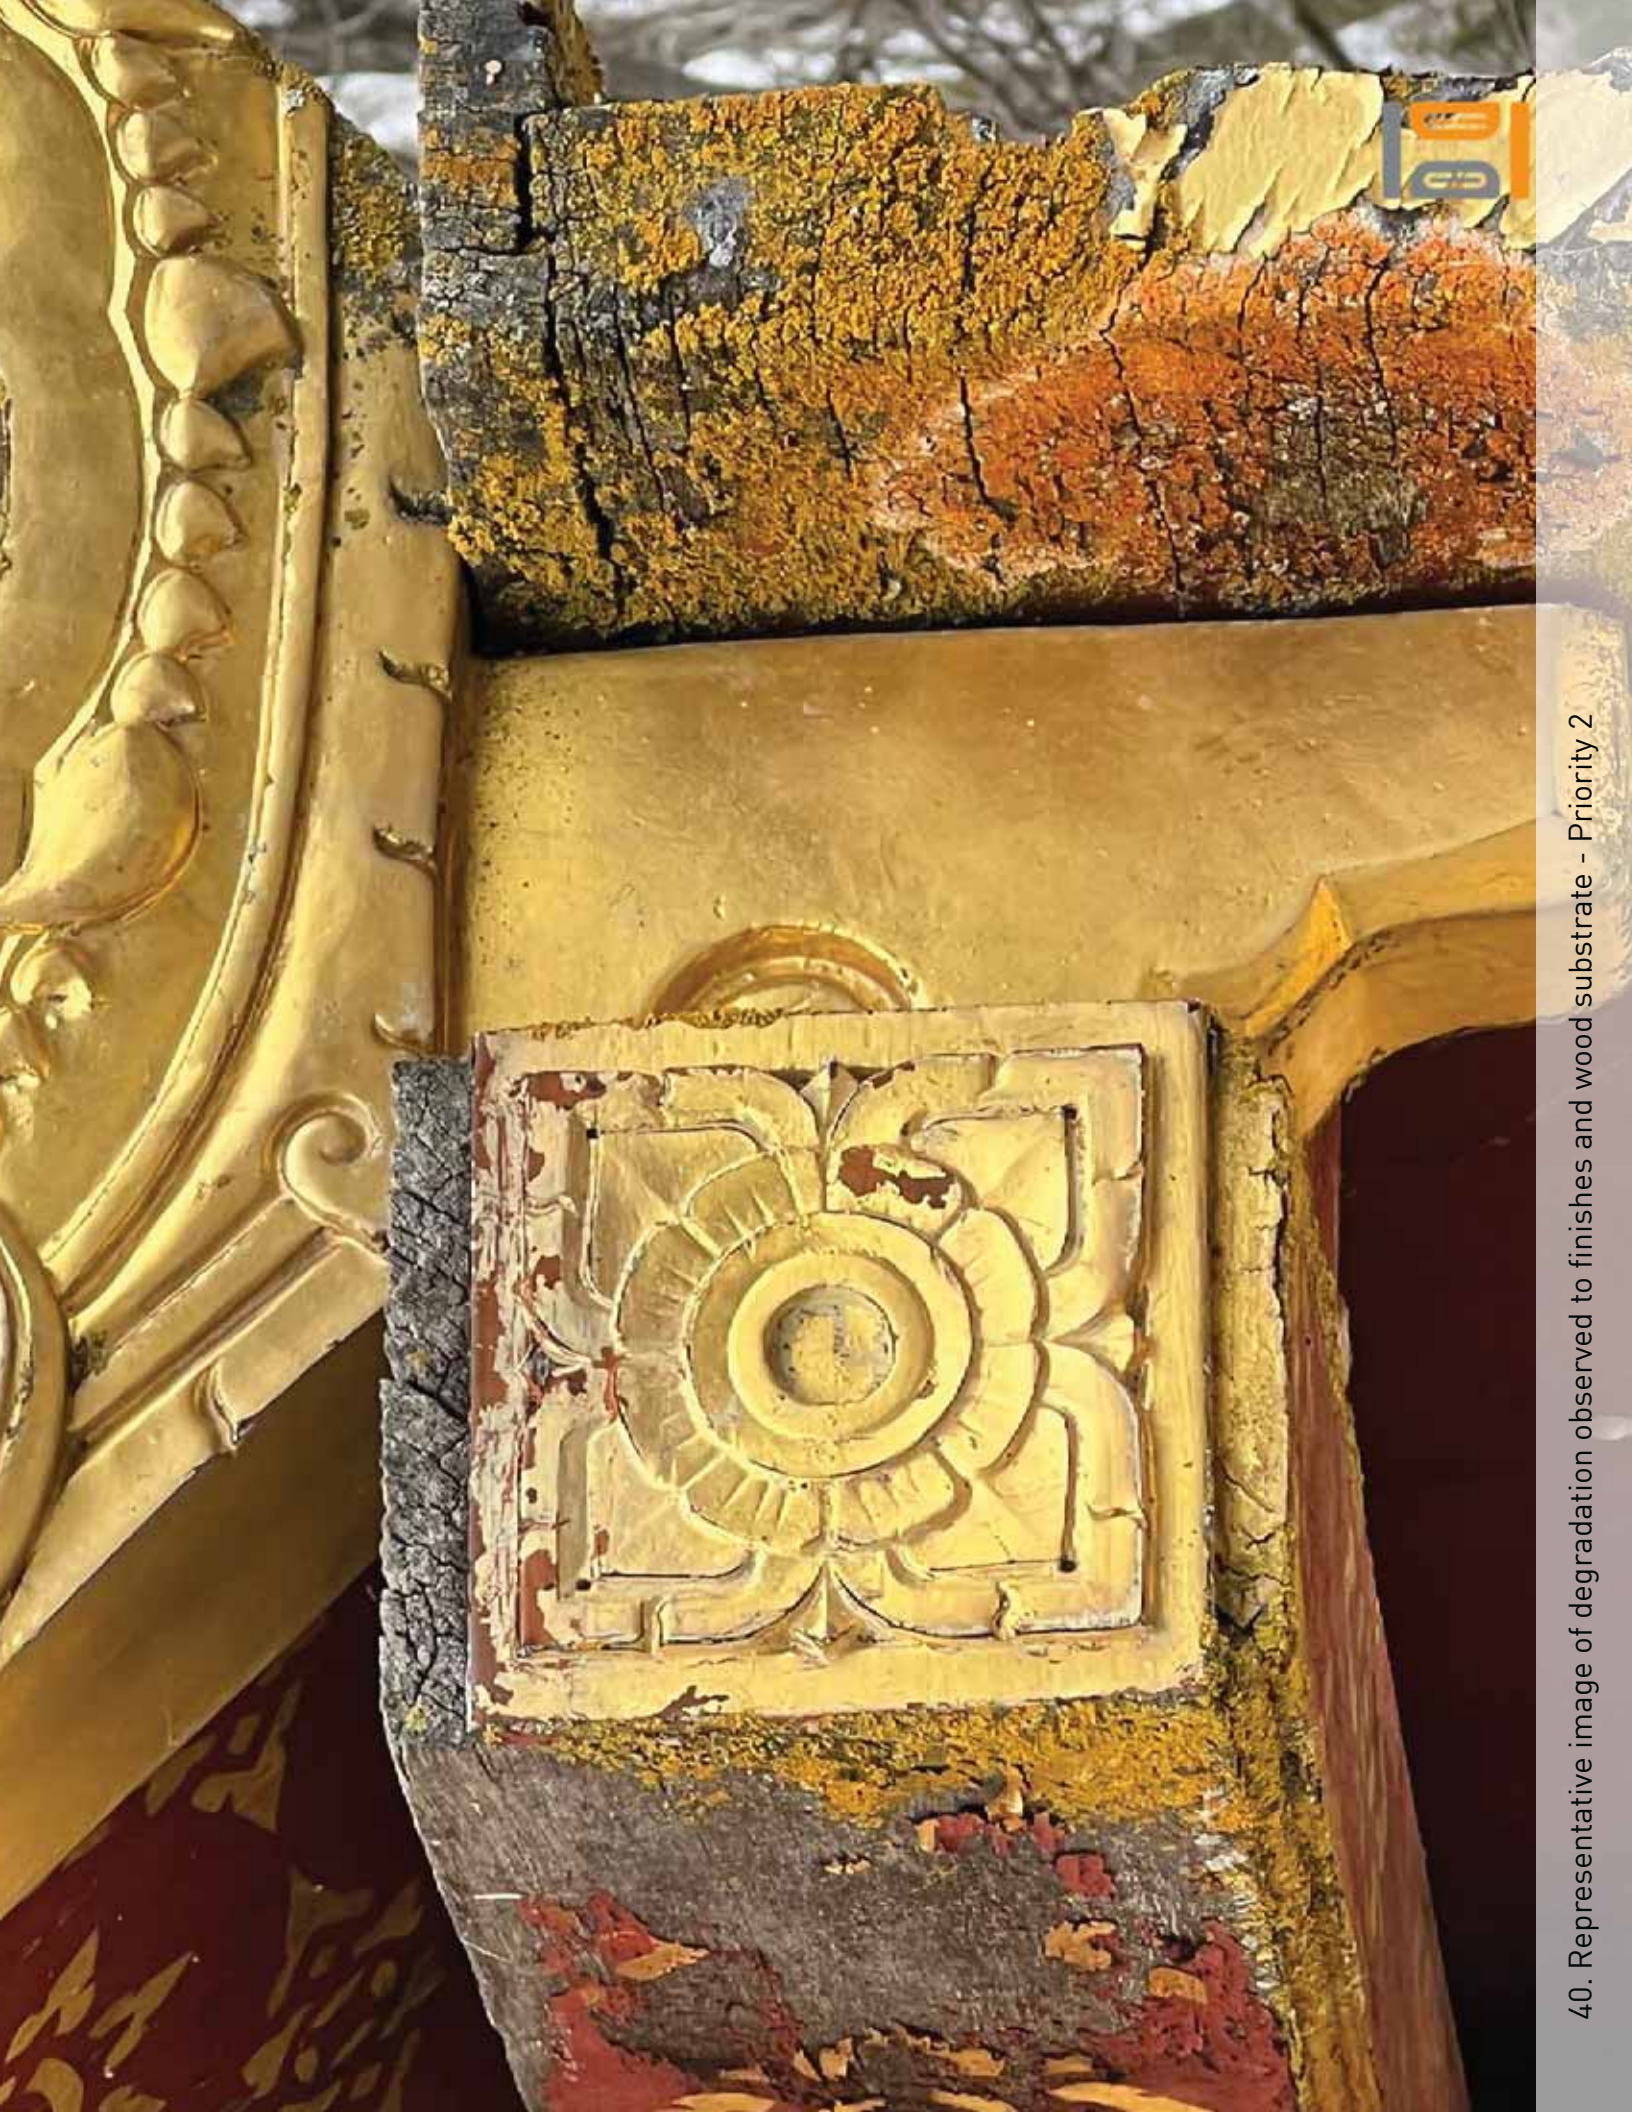
40. Representative image of degradation observed to finishes and wood substrate - Priority 2
