OLBRICH BOTOANICAL GARDENS ROYAL THAI PAVILION CONDITION ASSESSMENT REPORT

MAY 20, 2022

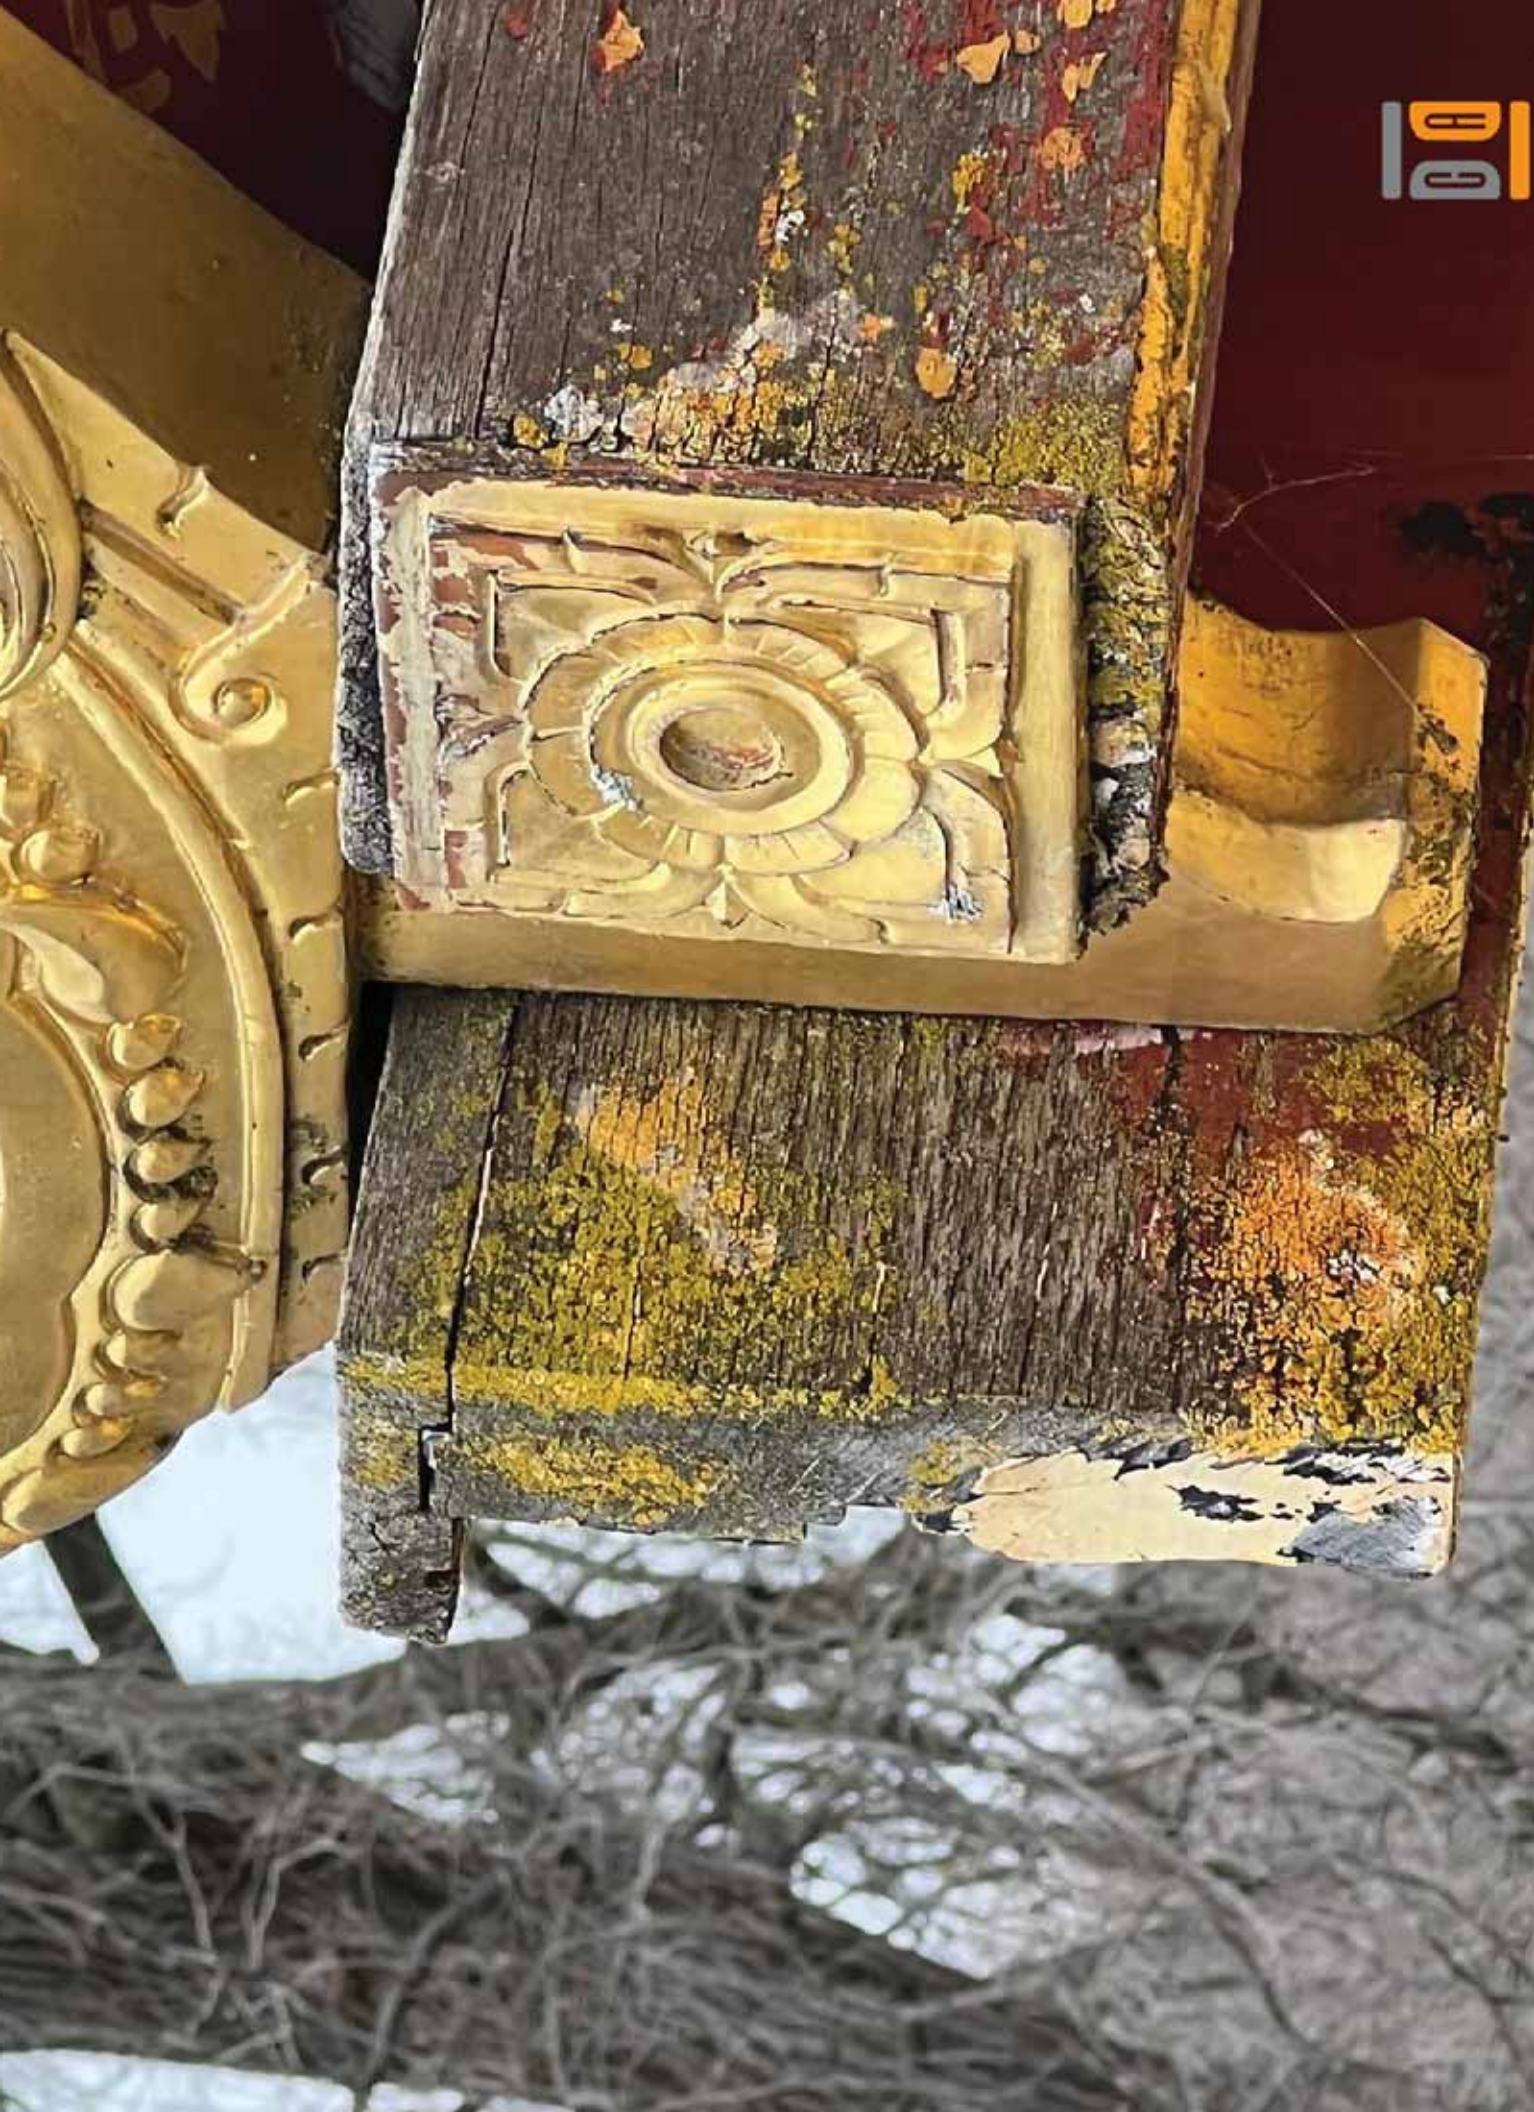
41. Repair attempts at base of hip ridge - Priority 2

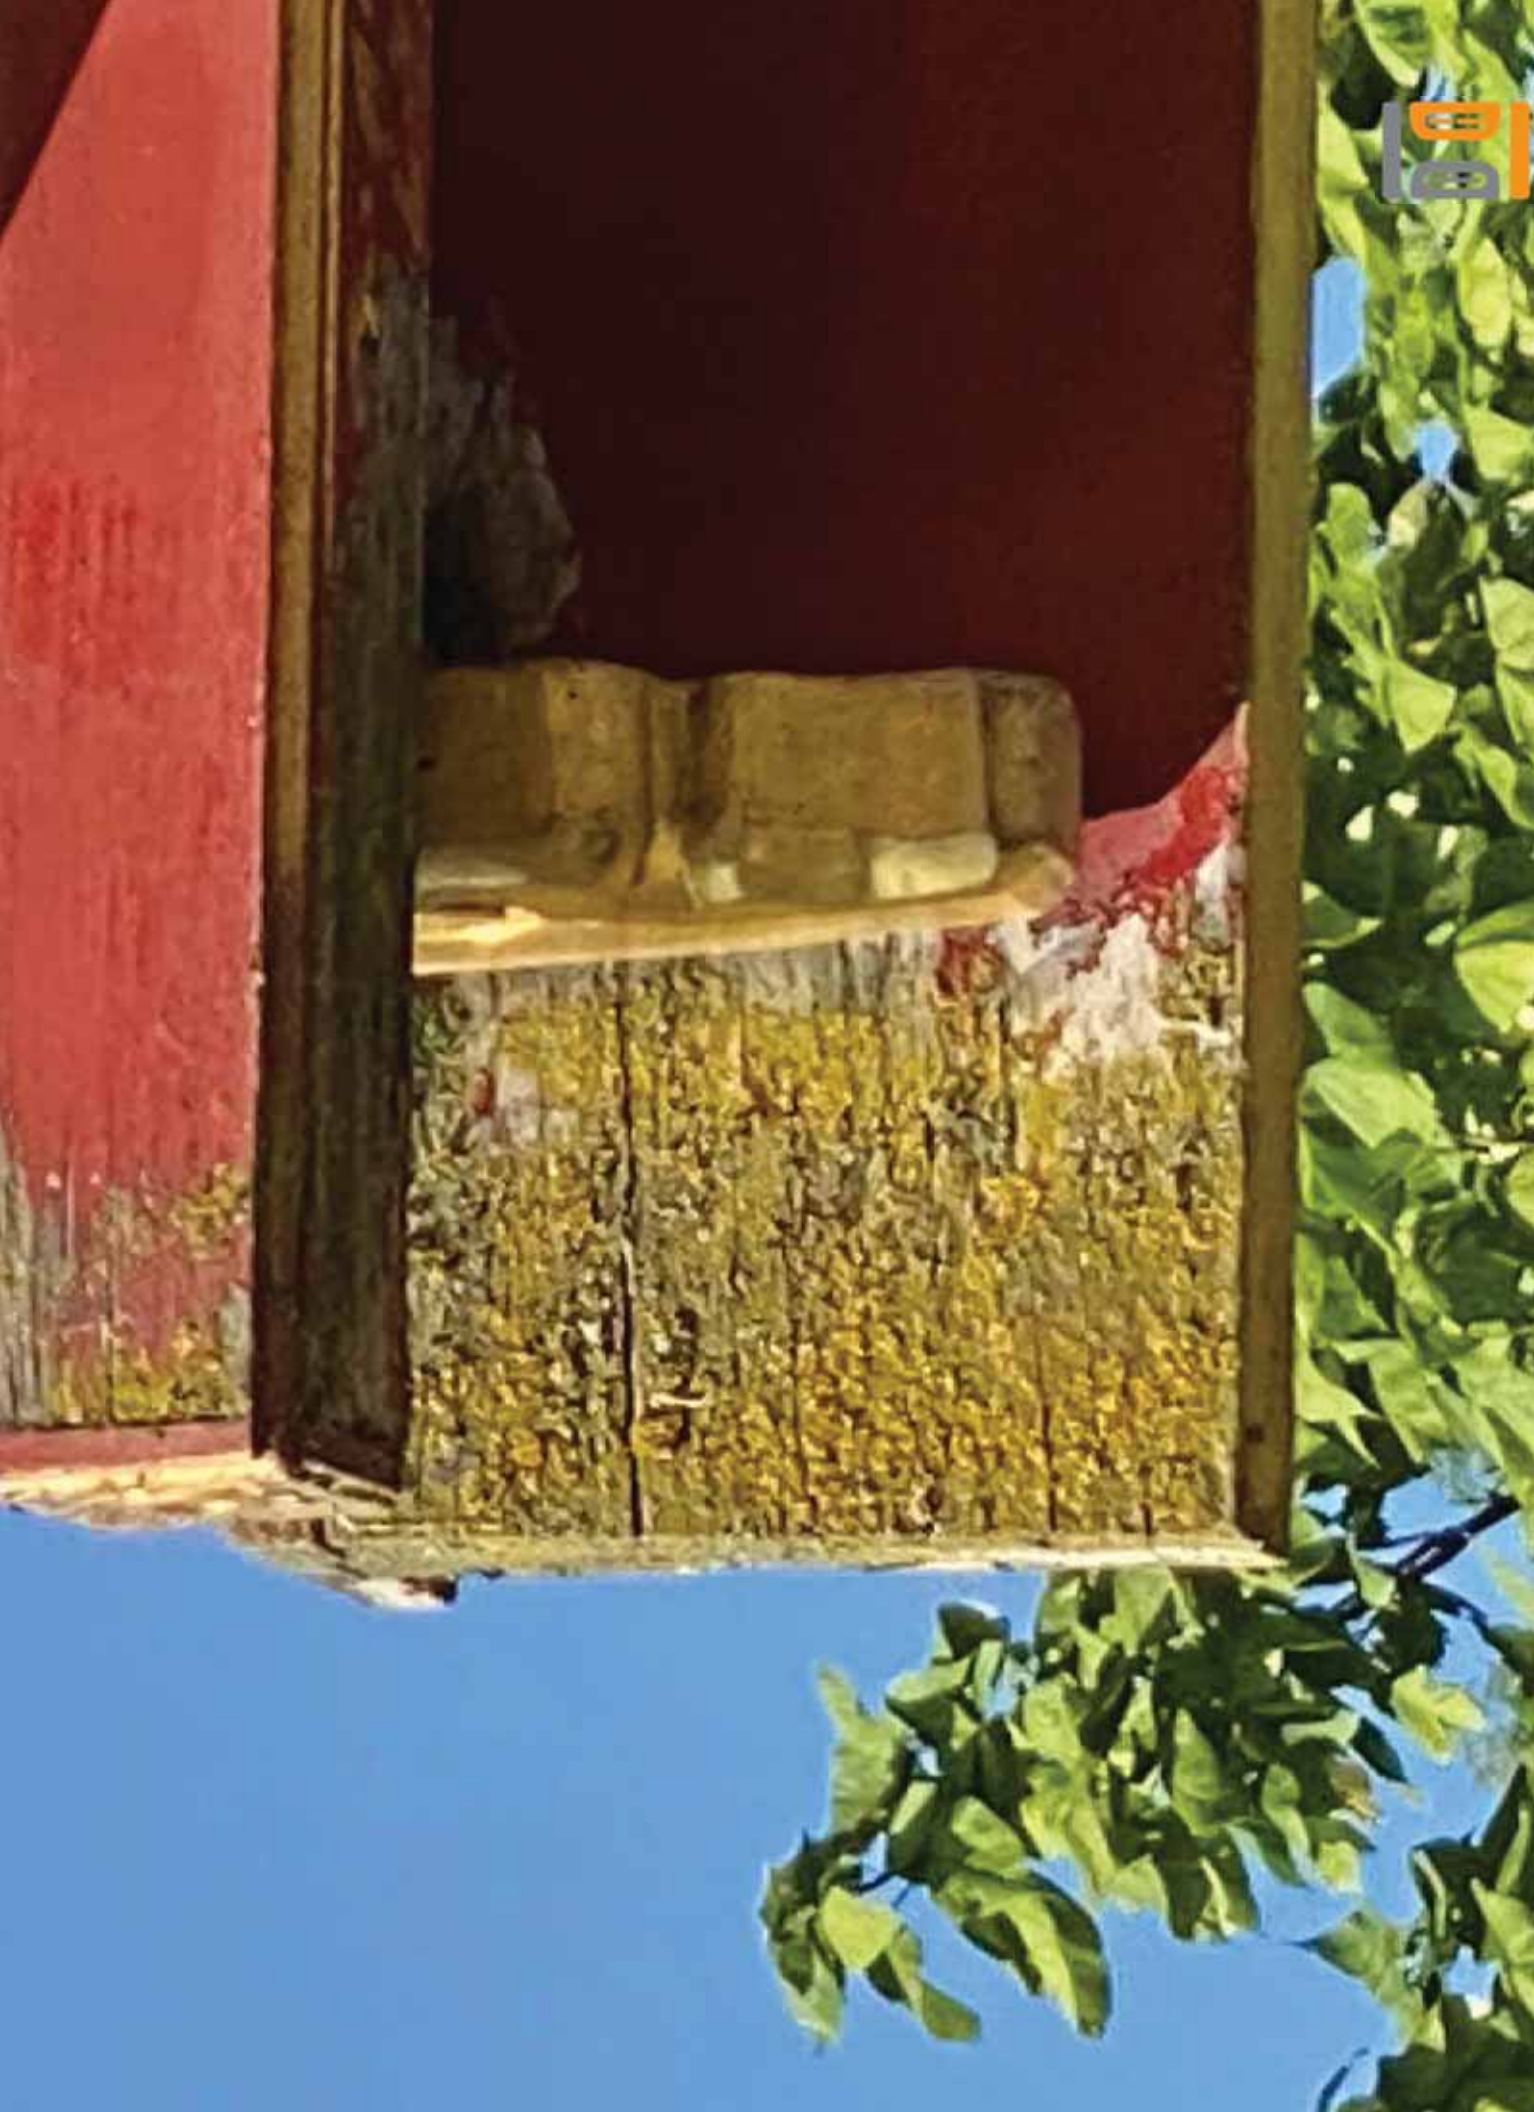
42. Representative image of degradation observed to finishes and wood substrate - Priority 2

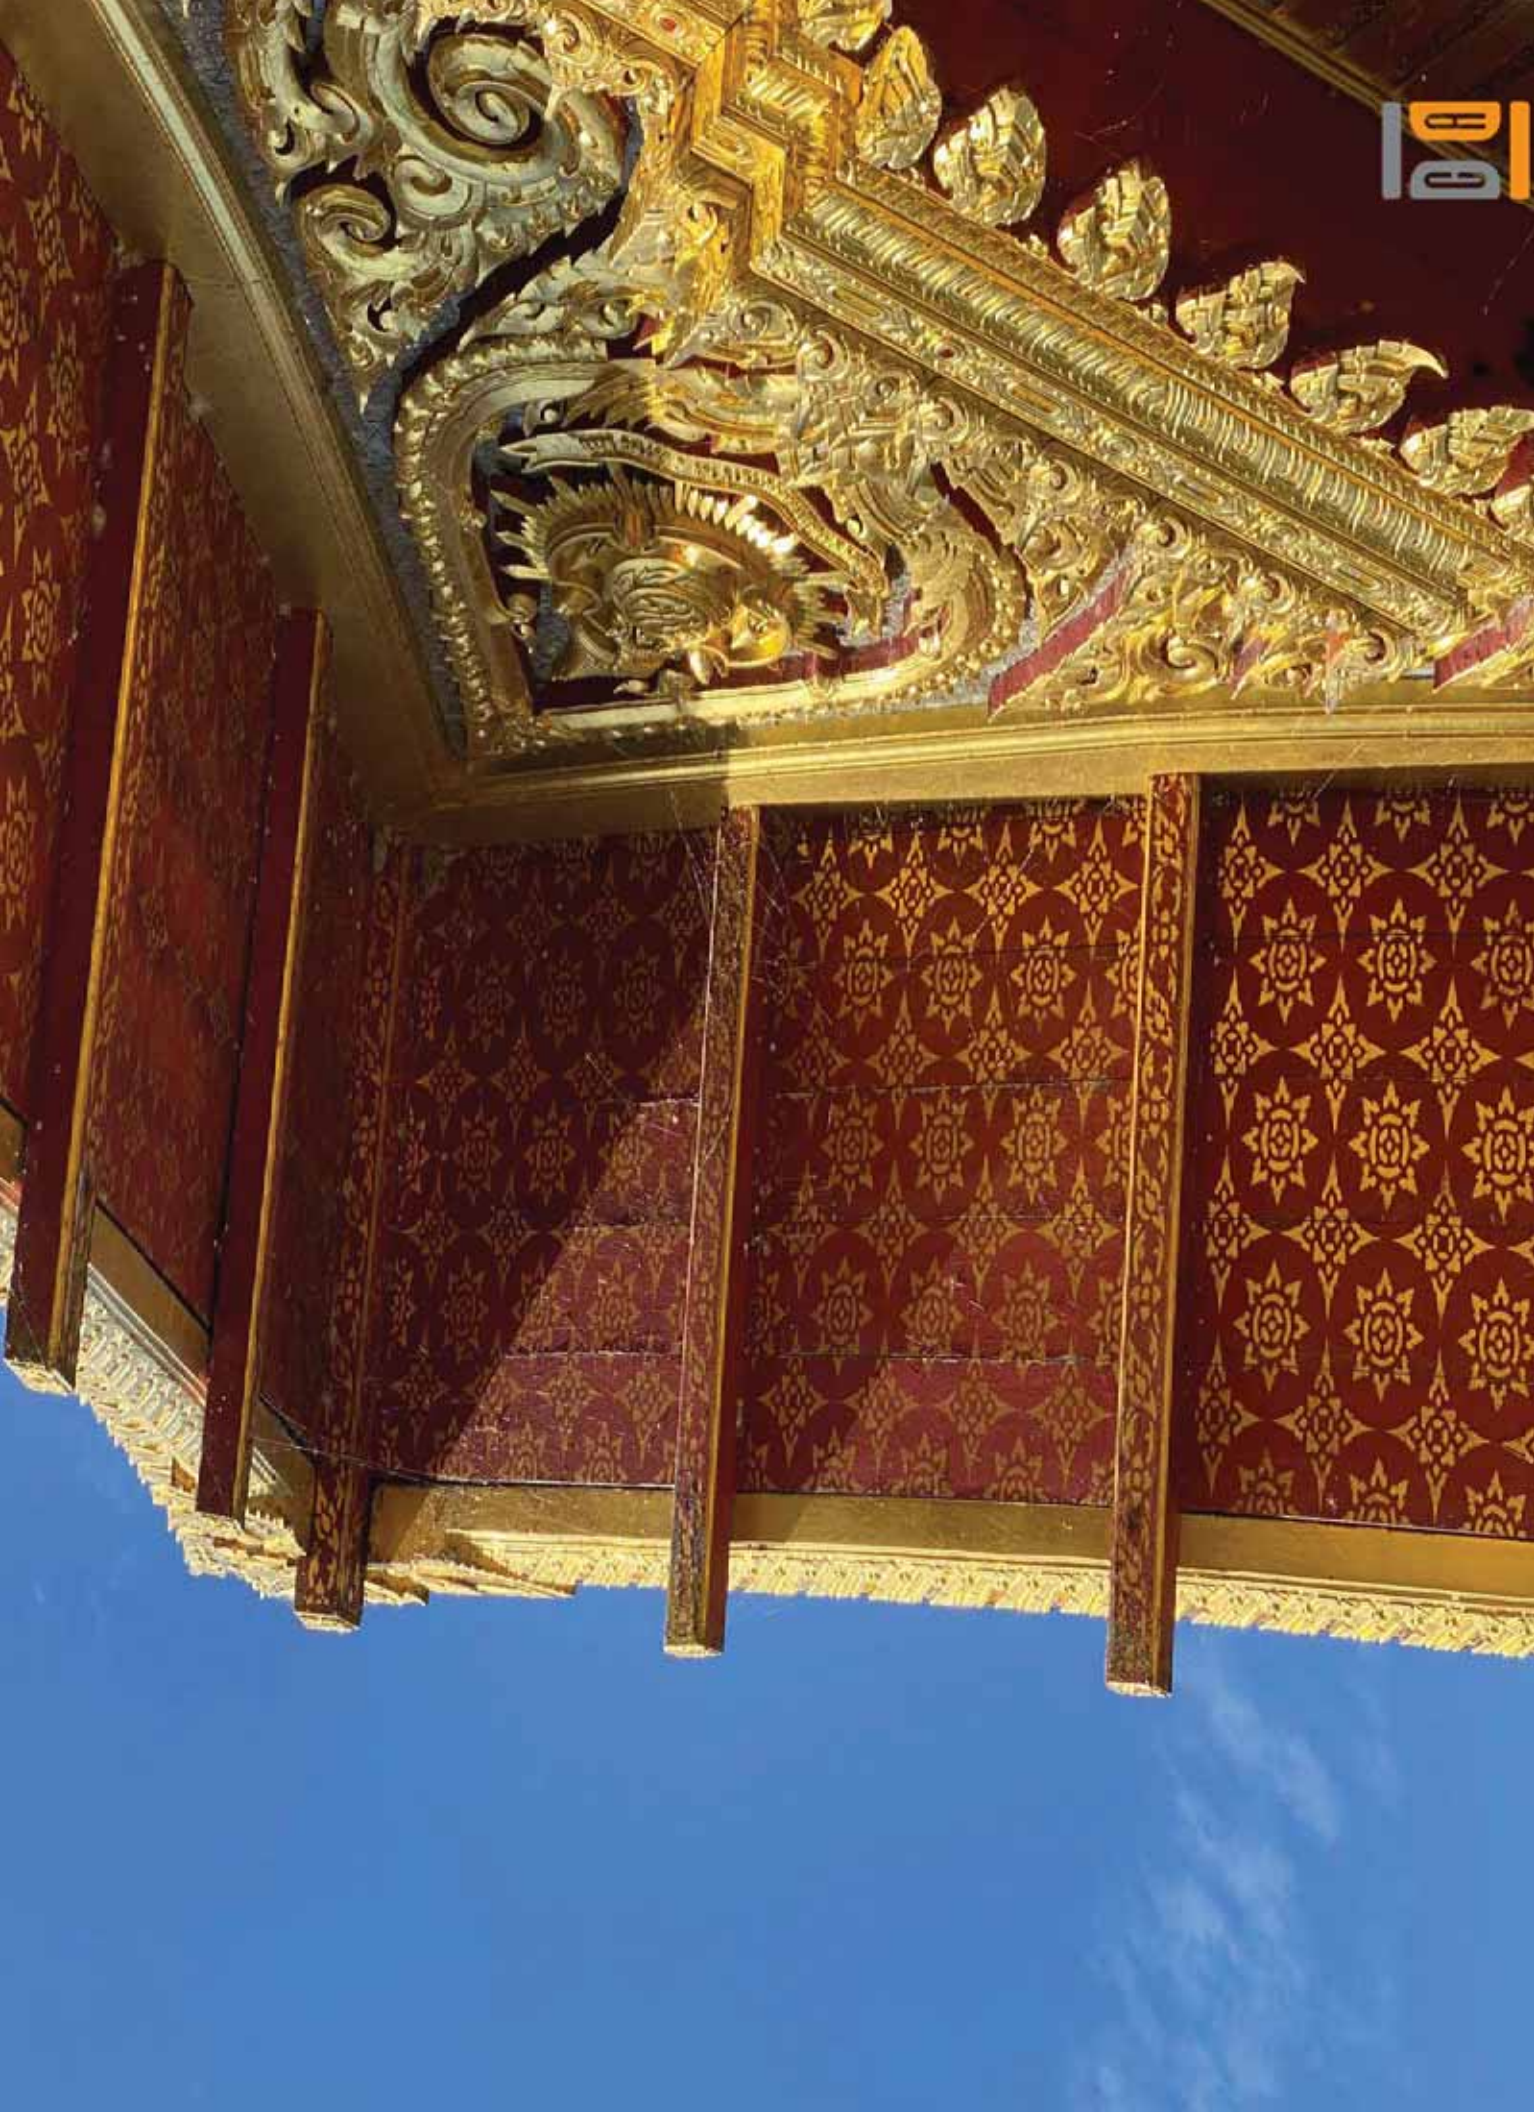
43. Roof Soffit condition with buckling edges and paint failure - Priority 2

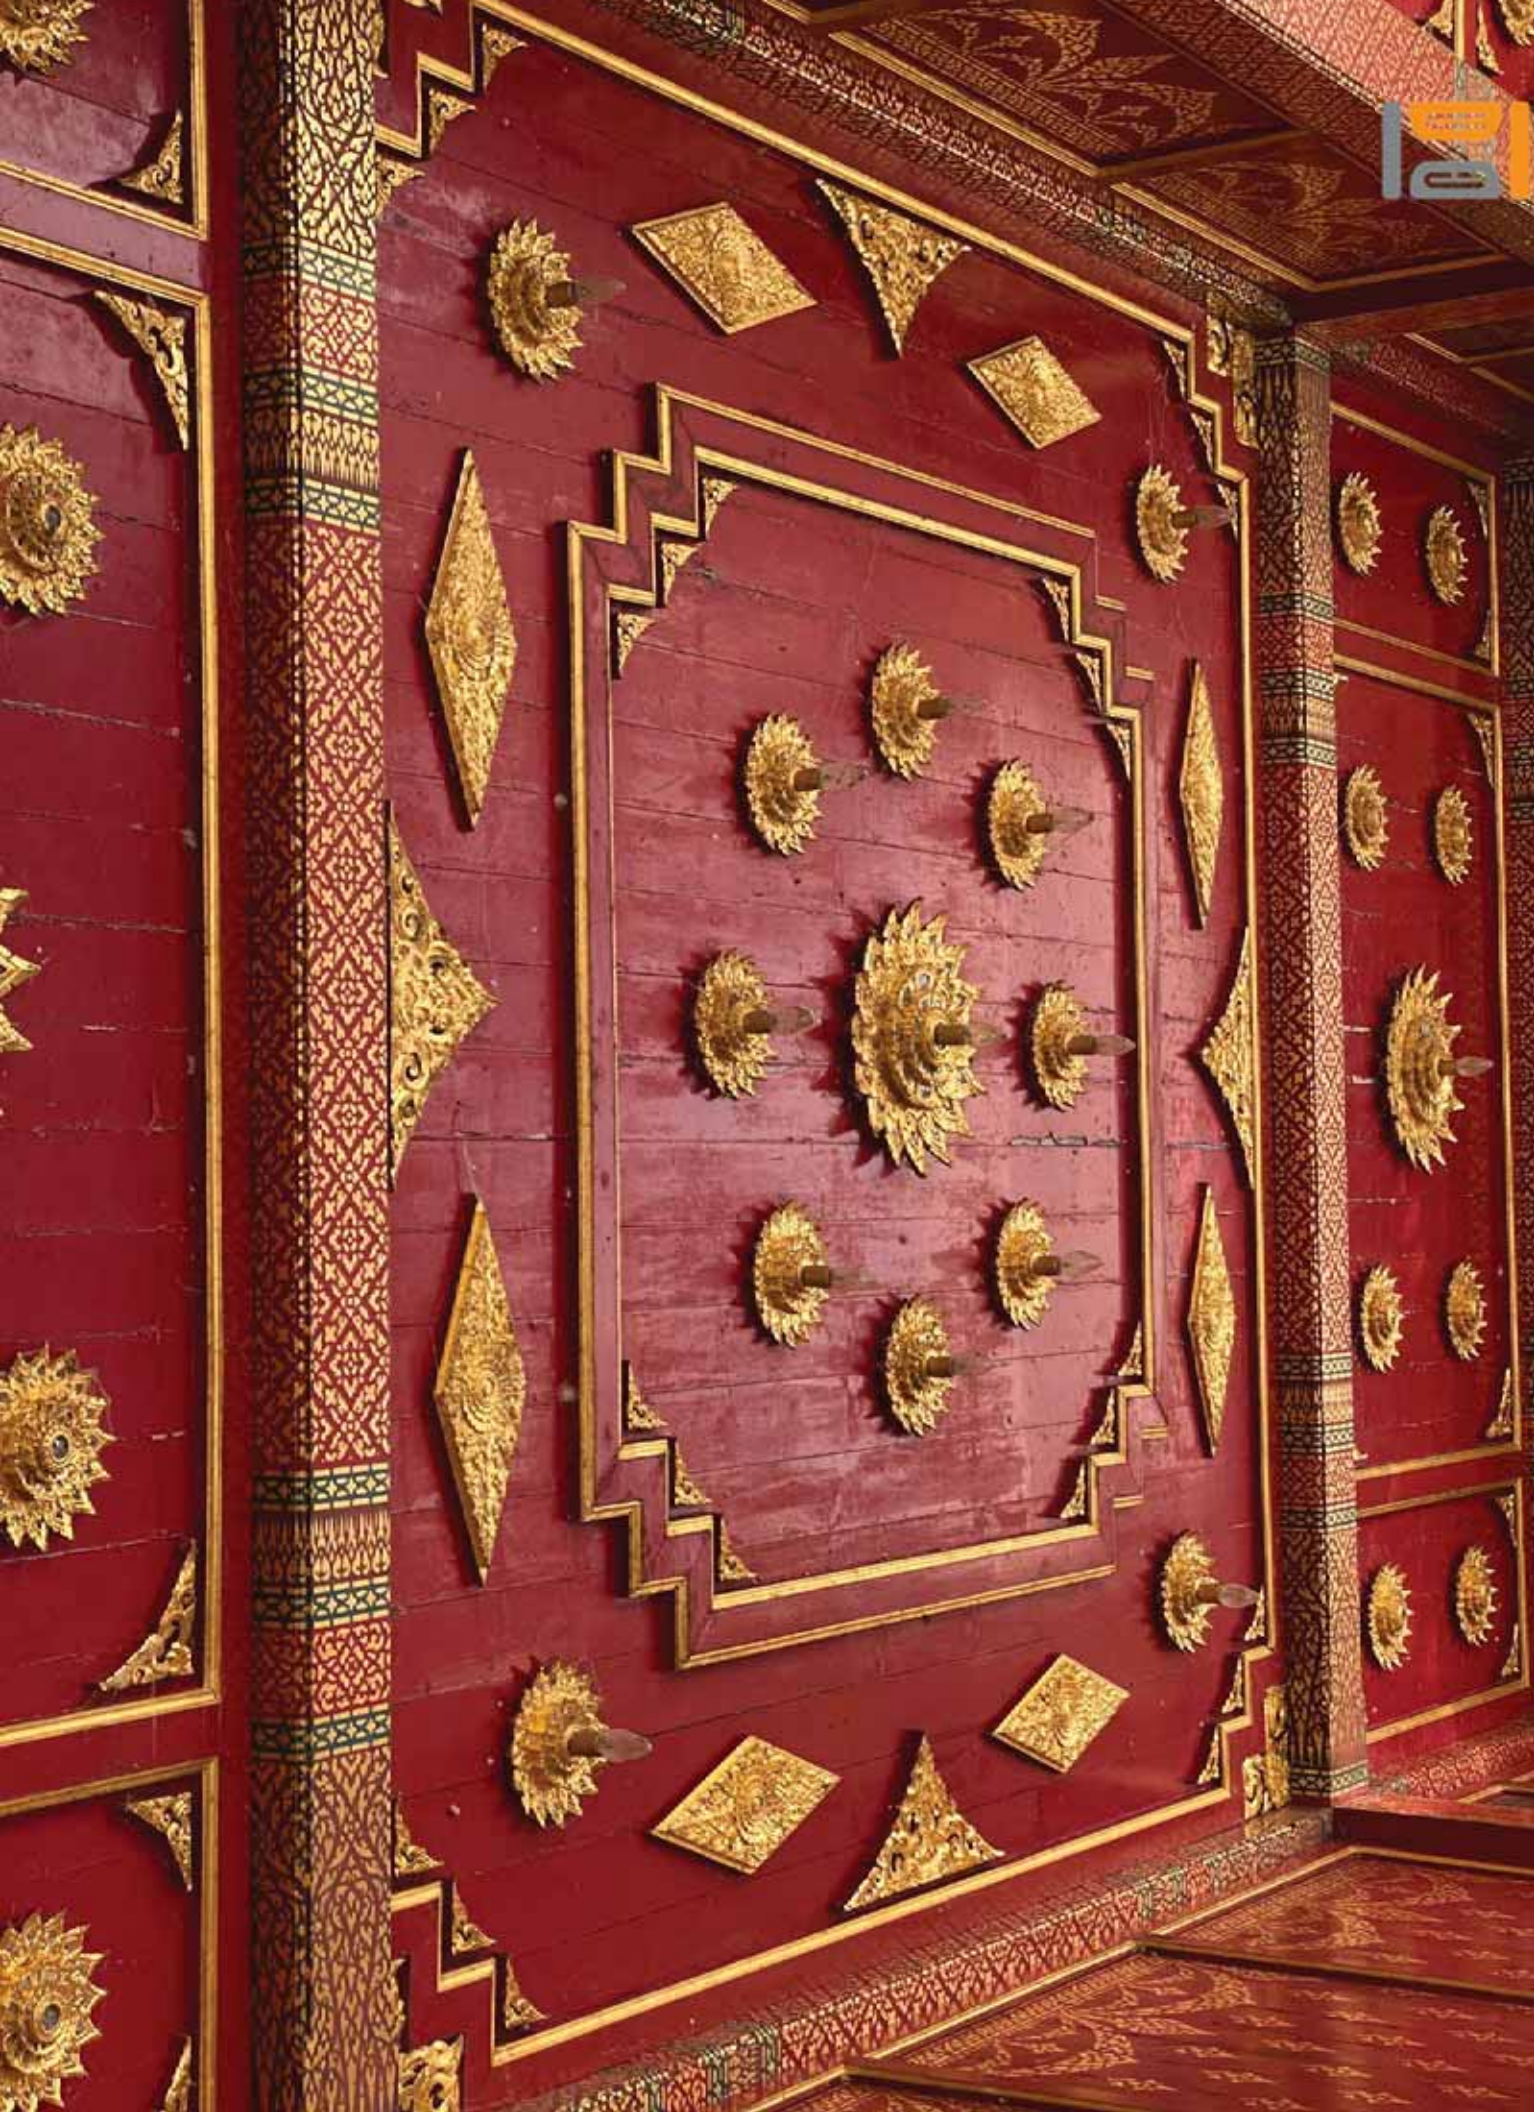
44. Interior Ceiling condition with buckling edges and paint failure - Priority 2

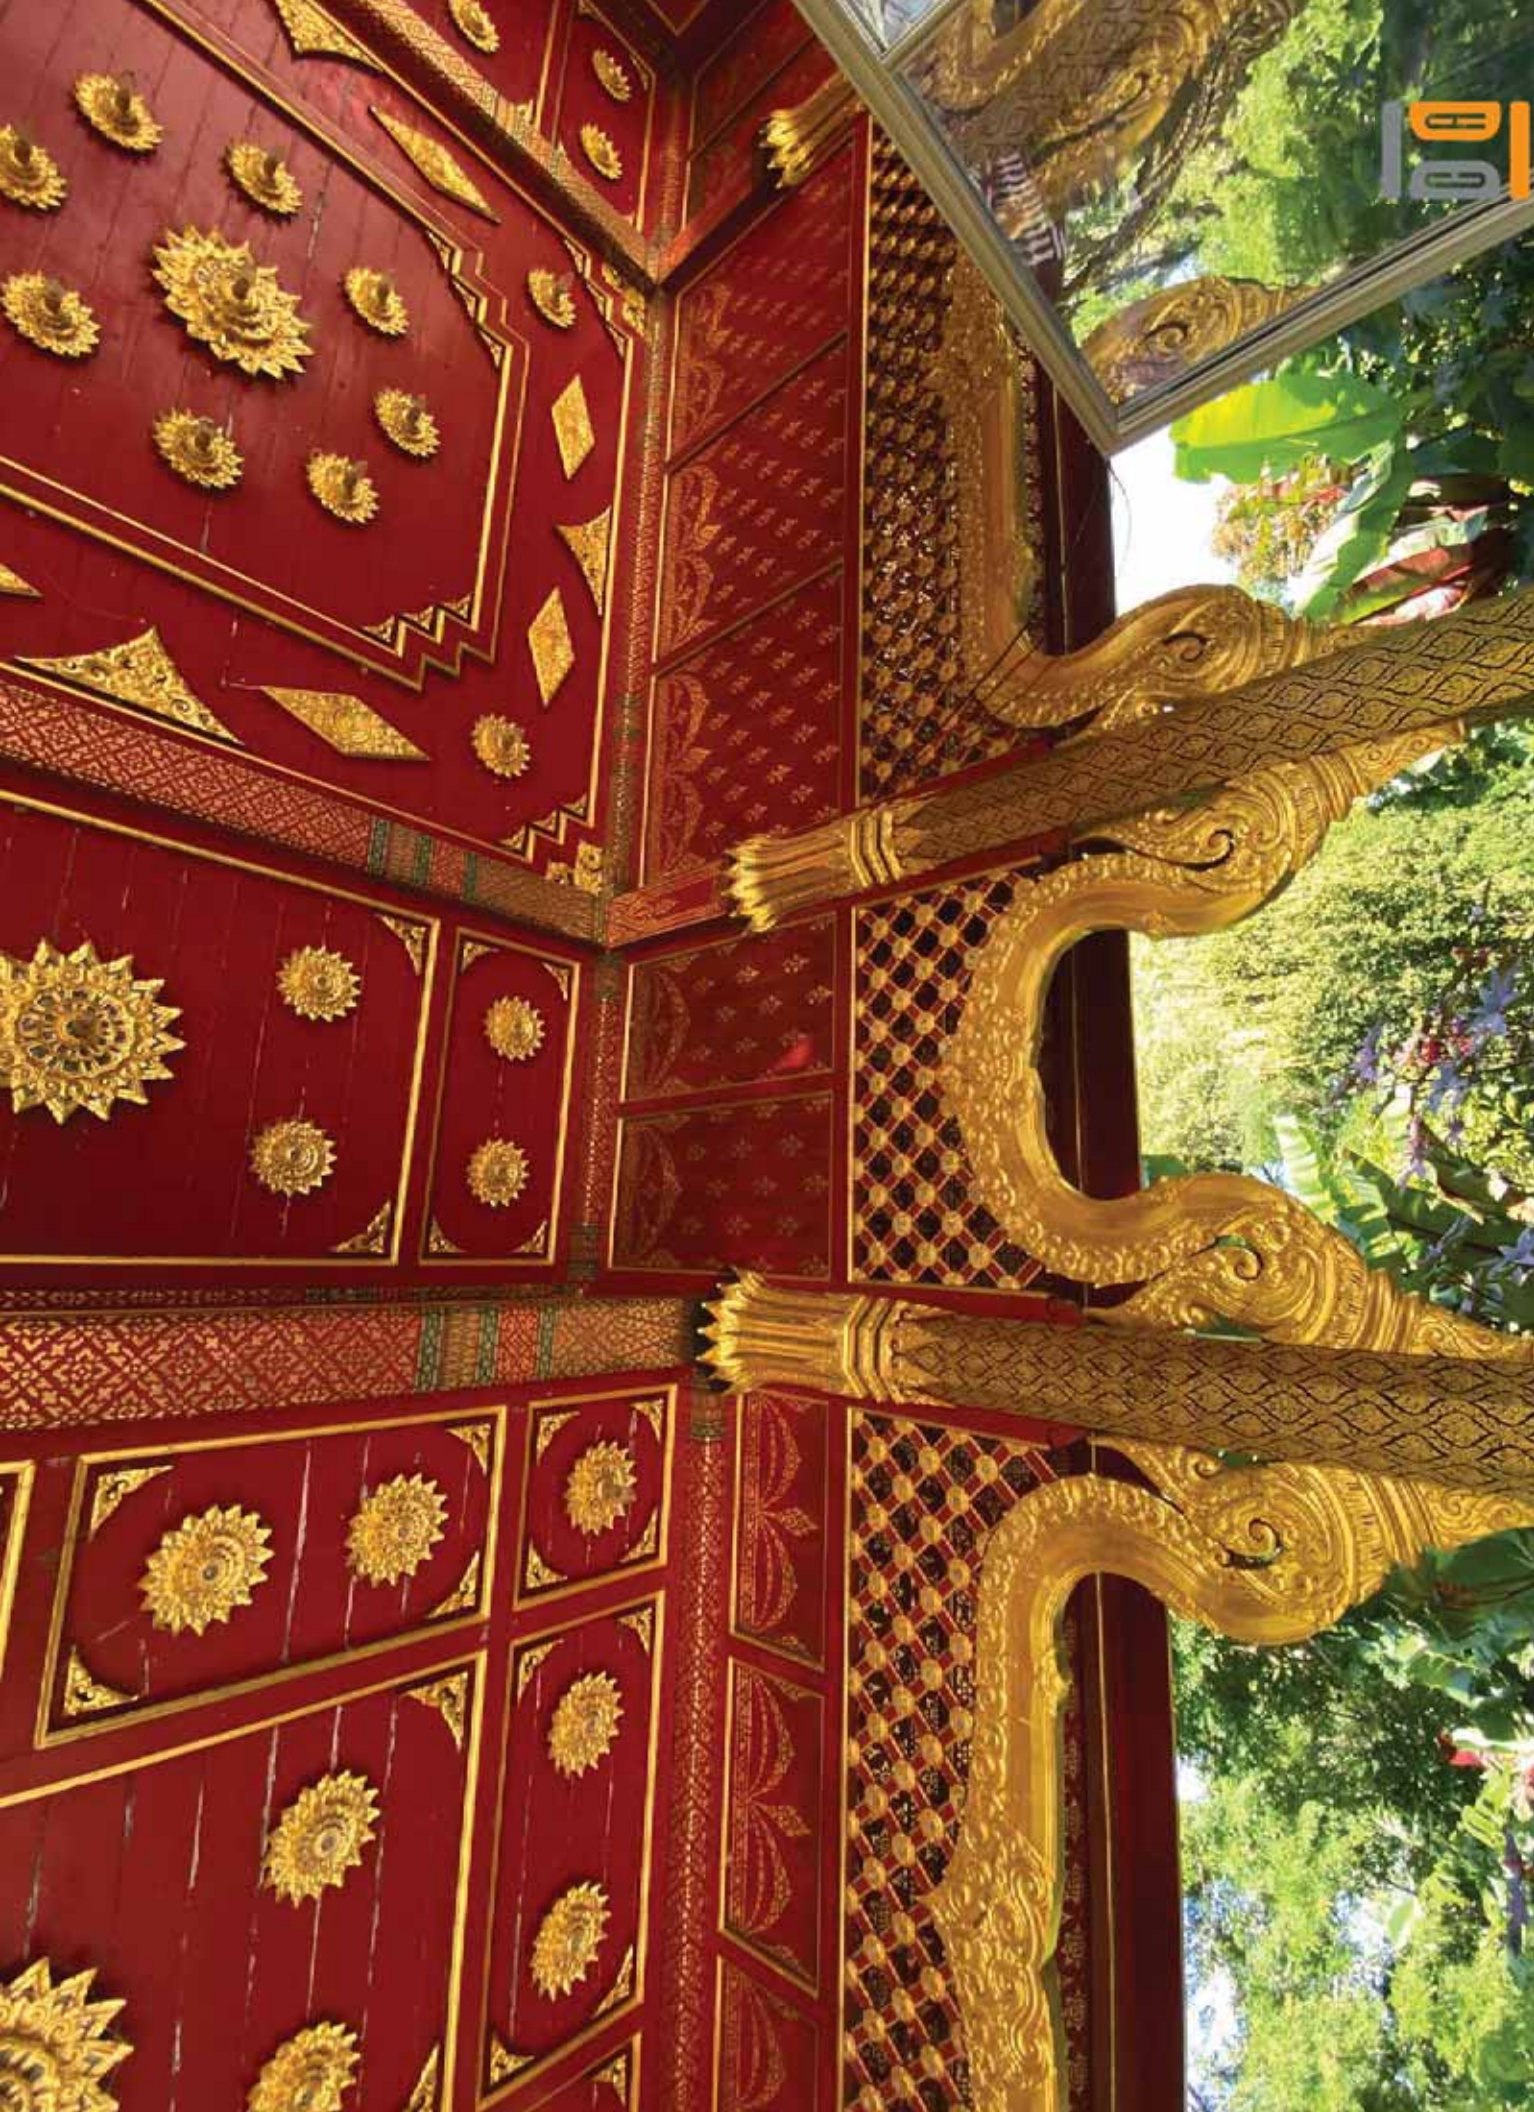
45. Interior Ceiling condition with buckling edges and paint failure - Priority 2

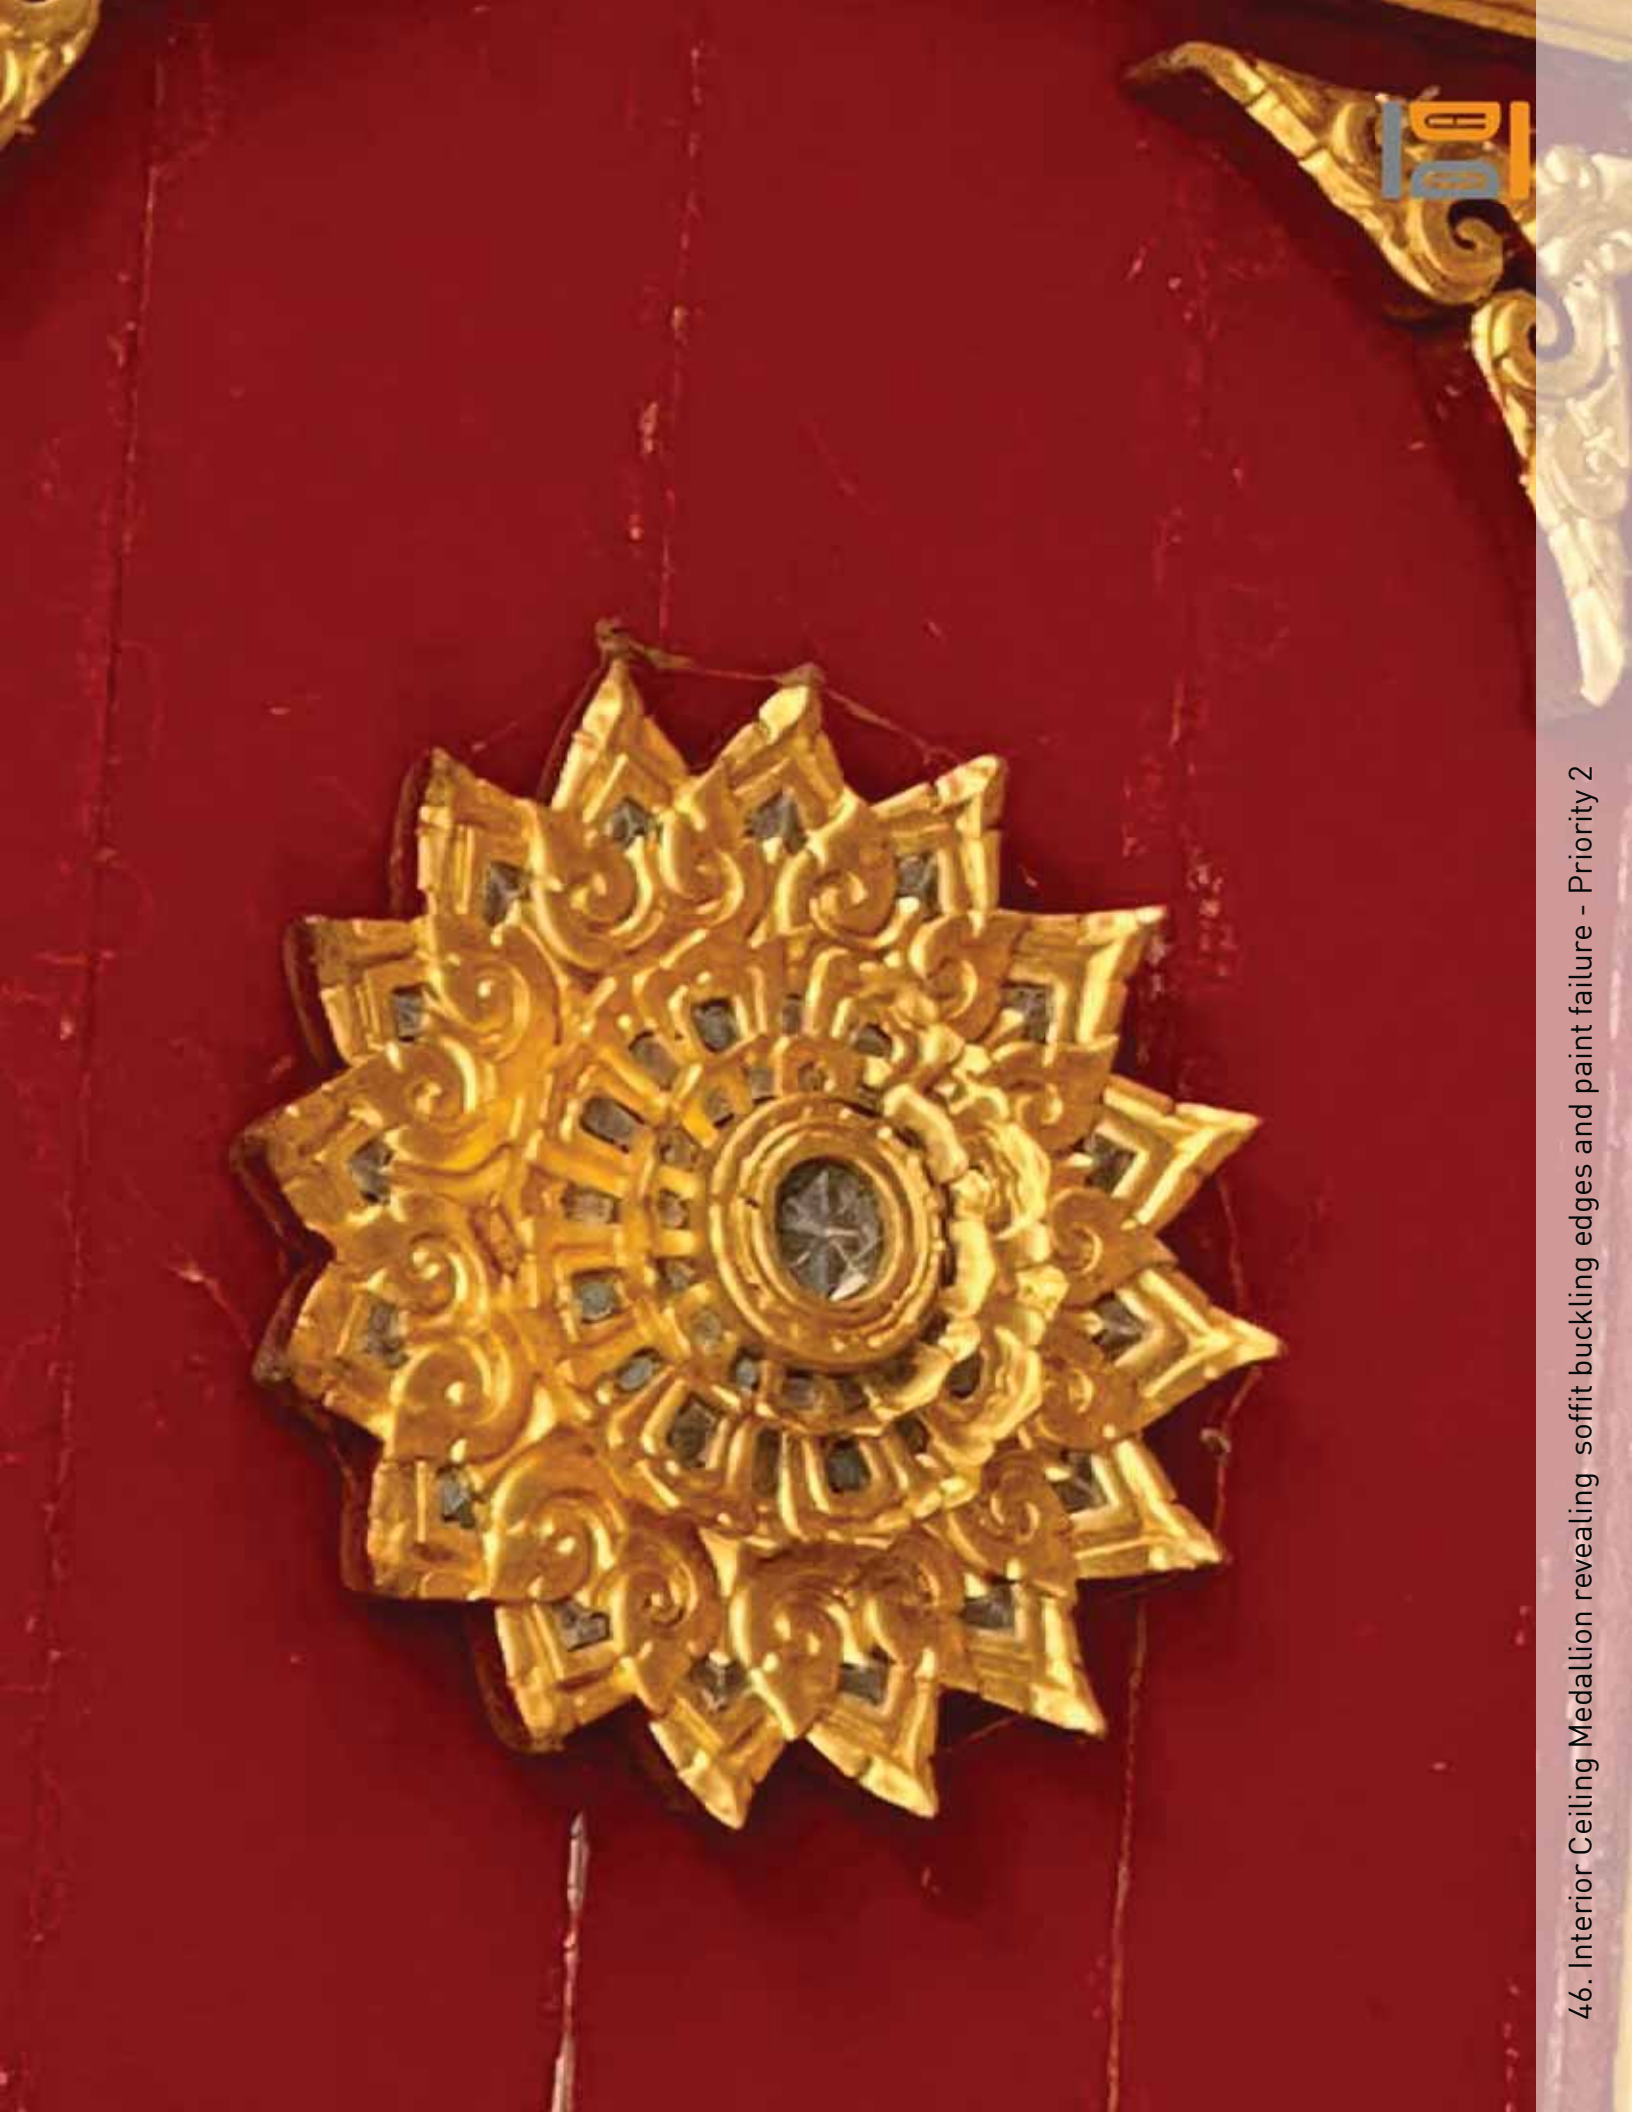
46. Interior Ceiling Medallion revealing soffit buckling edges and paint failure - Priority 2

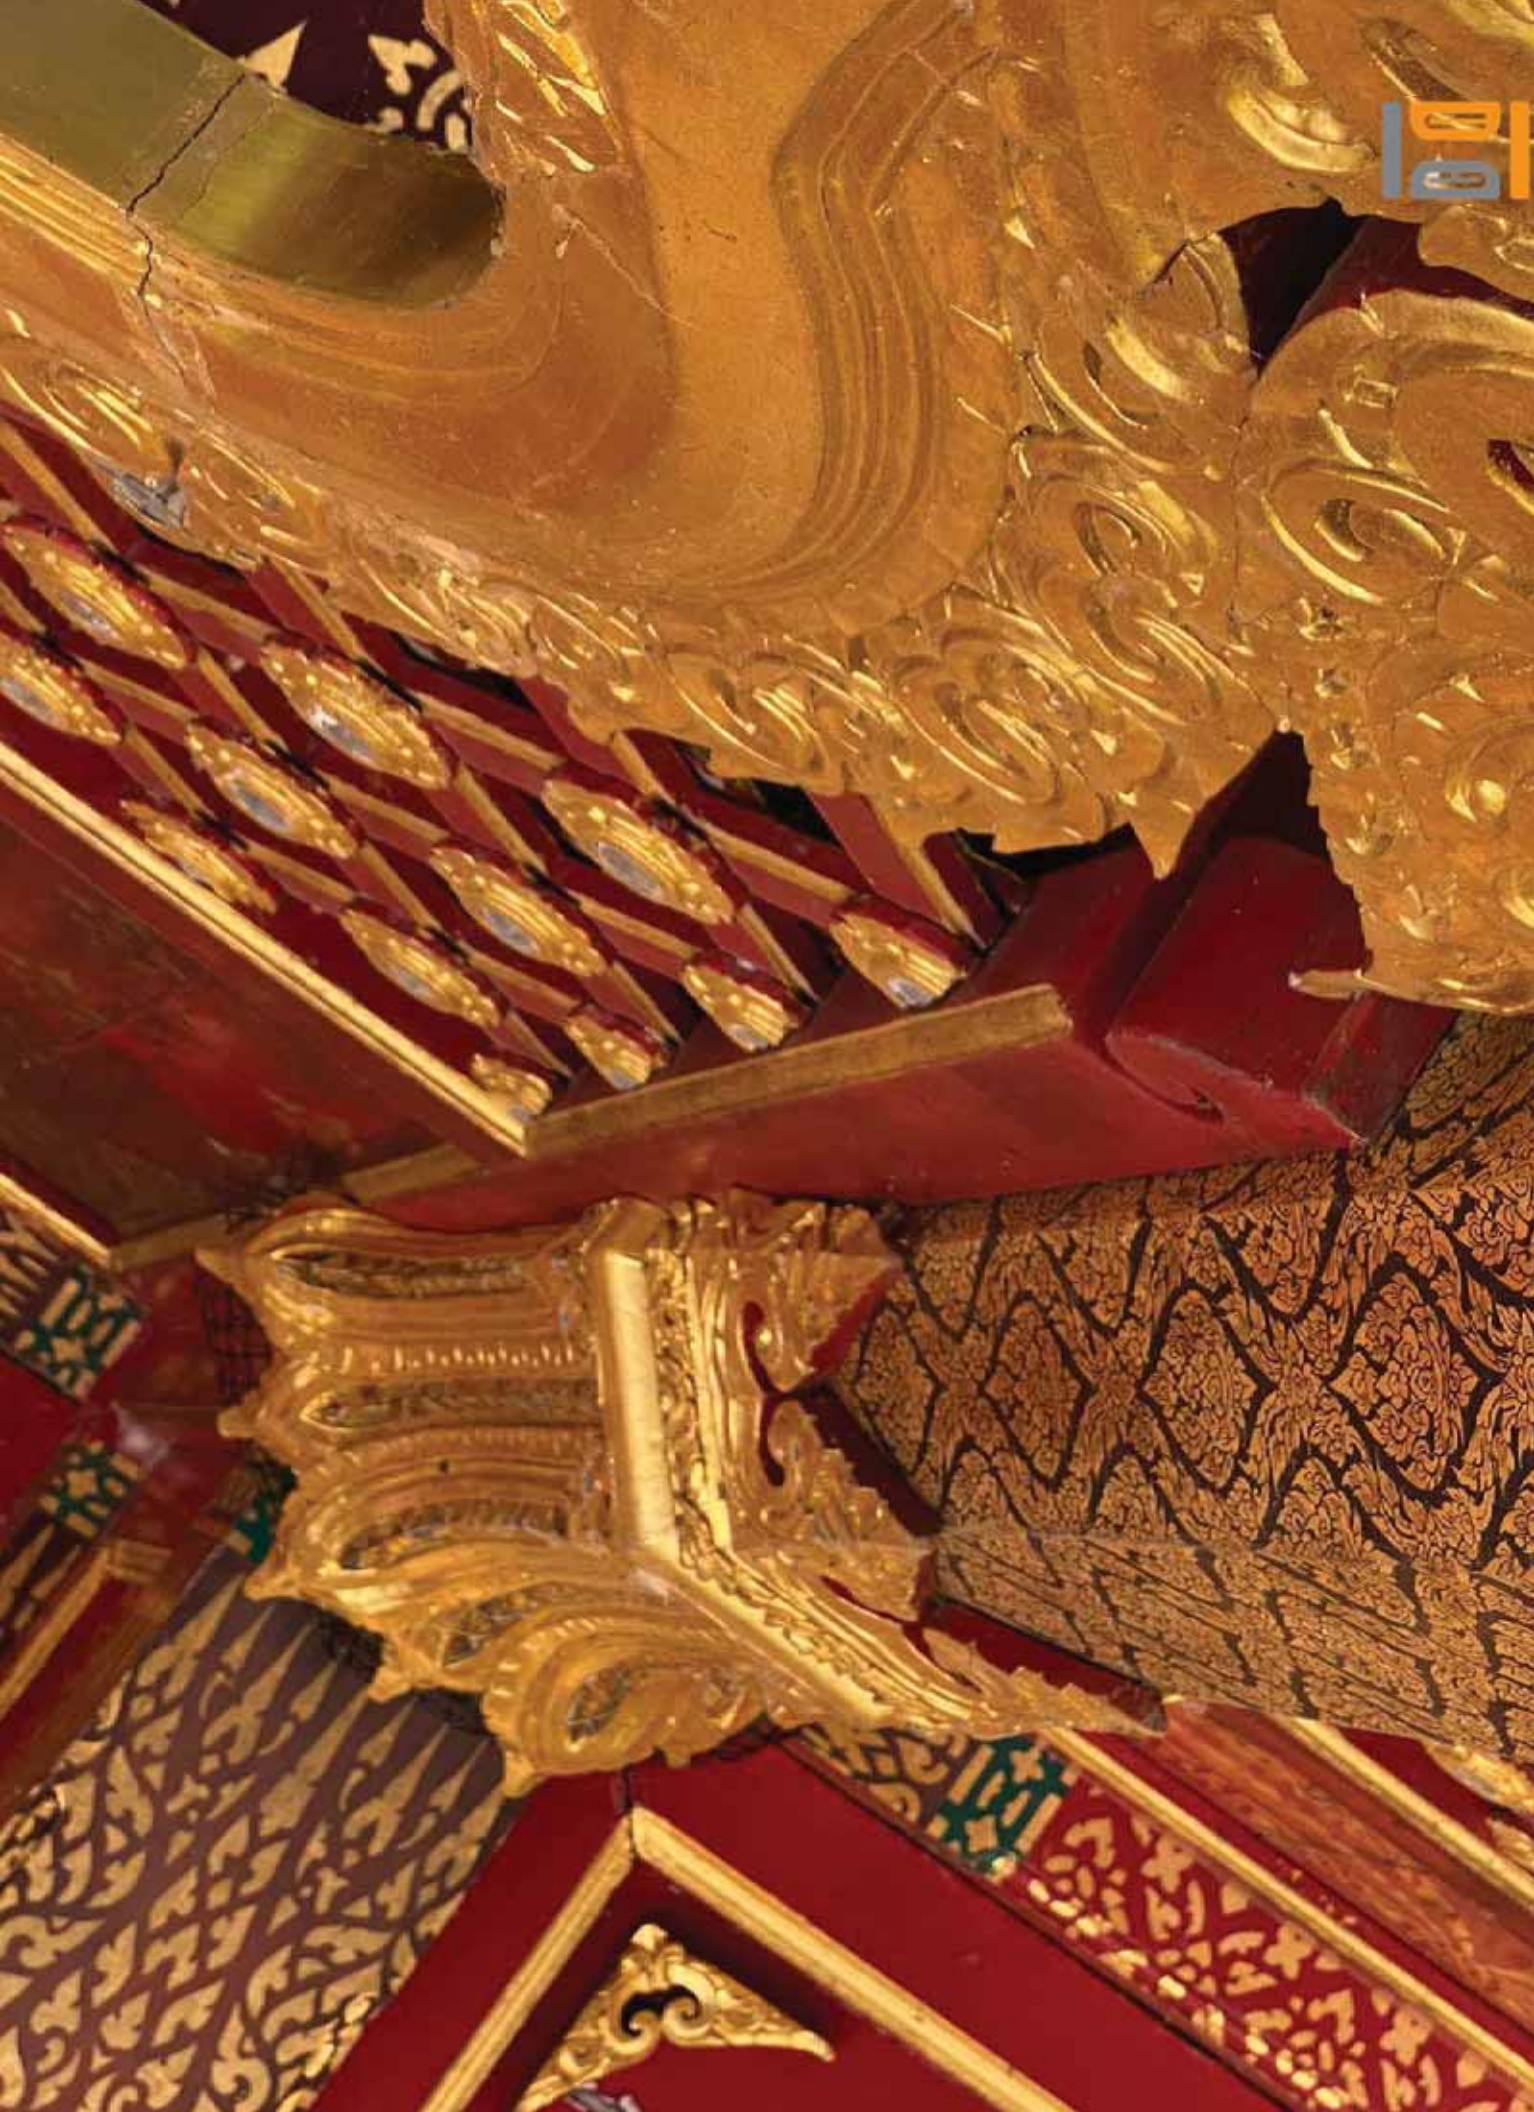
47. Interior Condition of column capital - Priority 2
