OLBRICH BOTOANICAL GARDENS ROYAL THAI PAVILION CONDITION ASSESSMENT REPORT

MAY 20, 2022

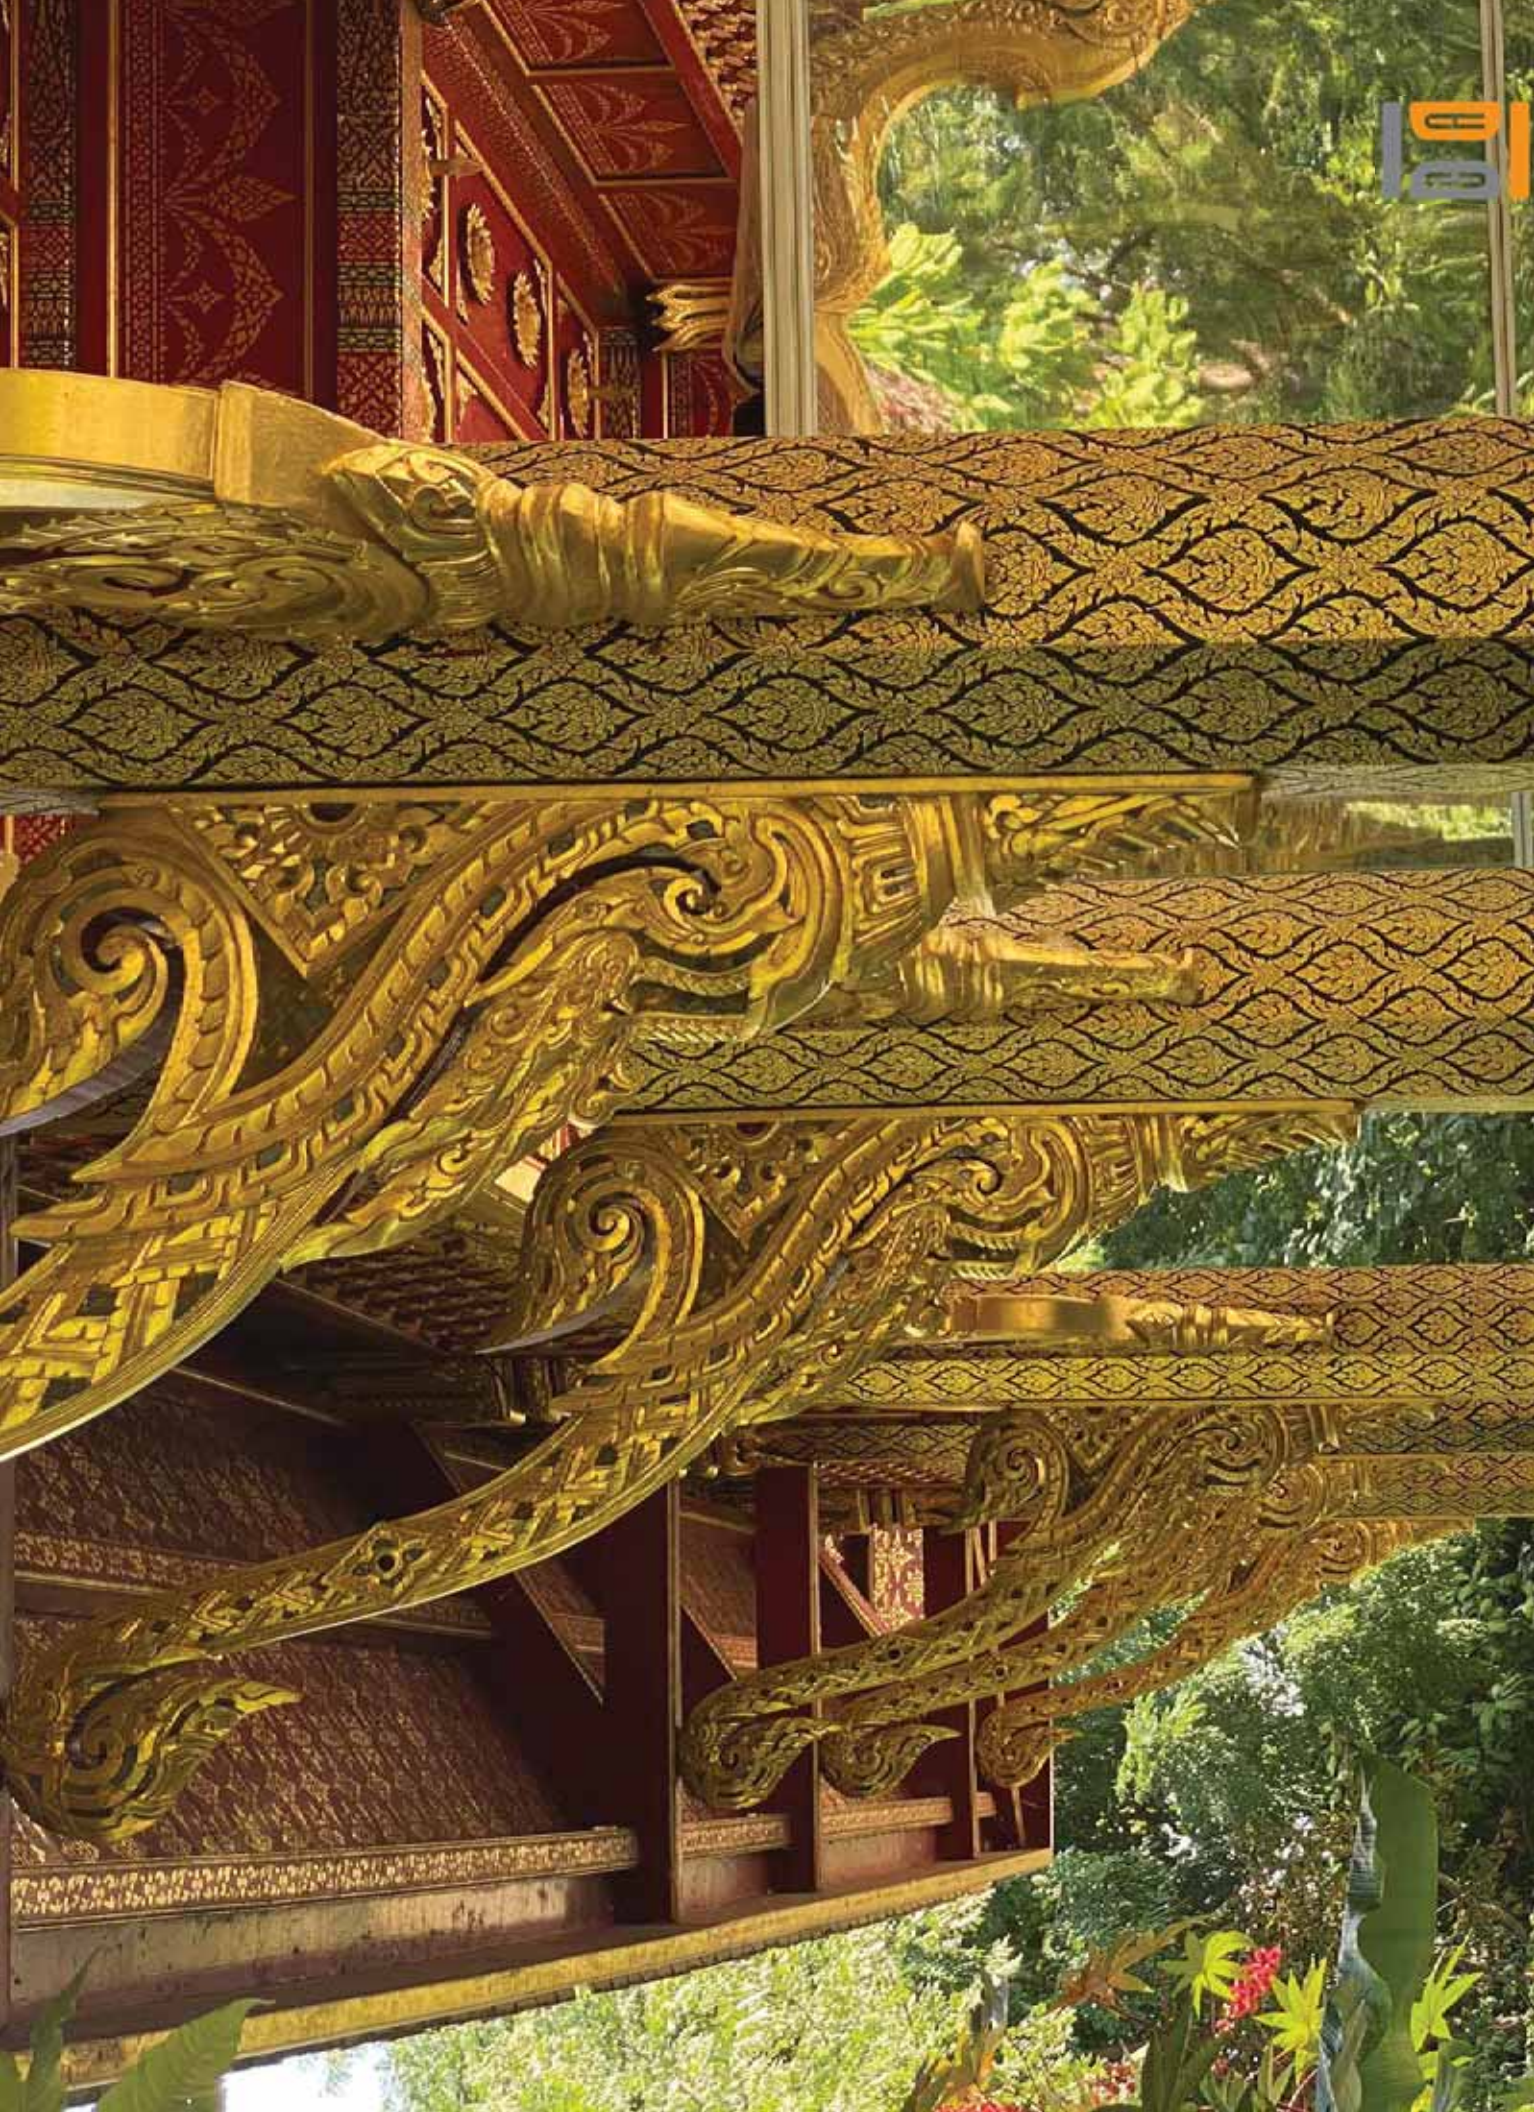
48. Exterior Condition of column capital - Priority 3

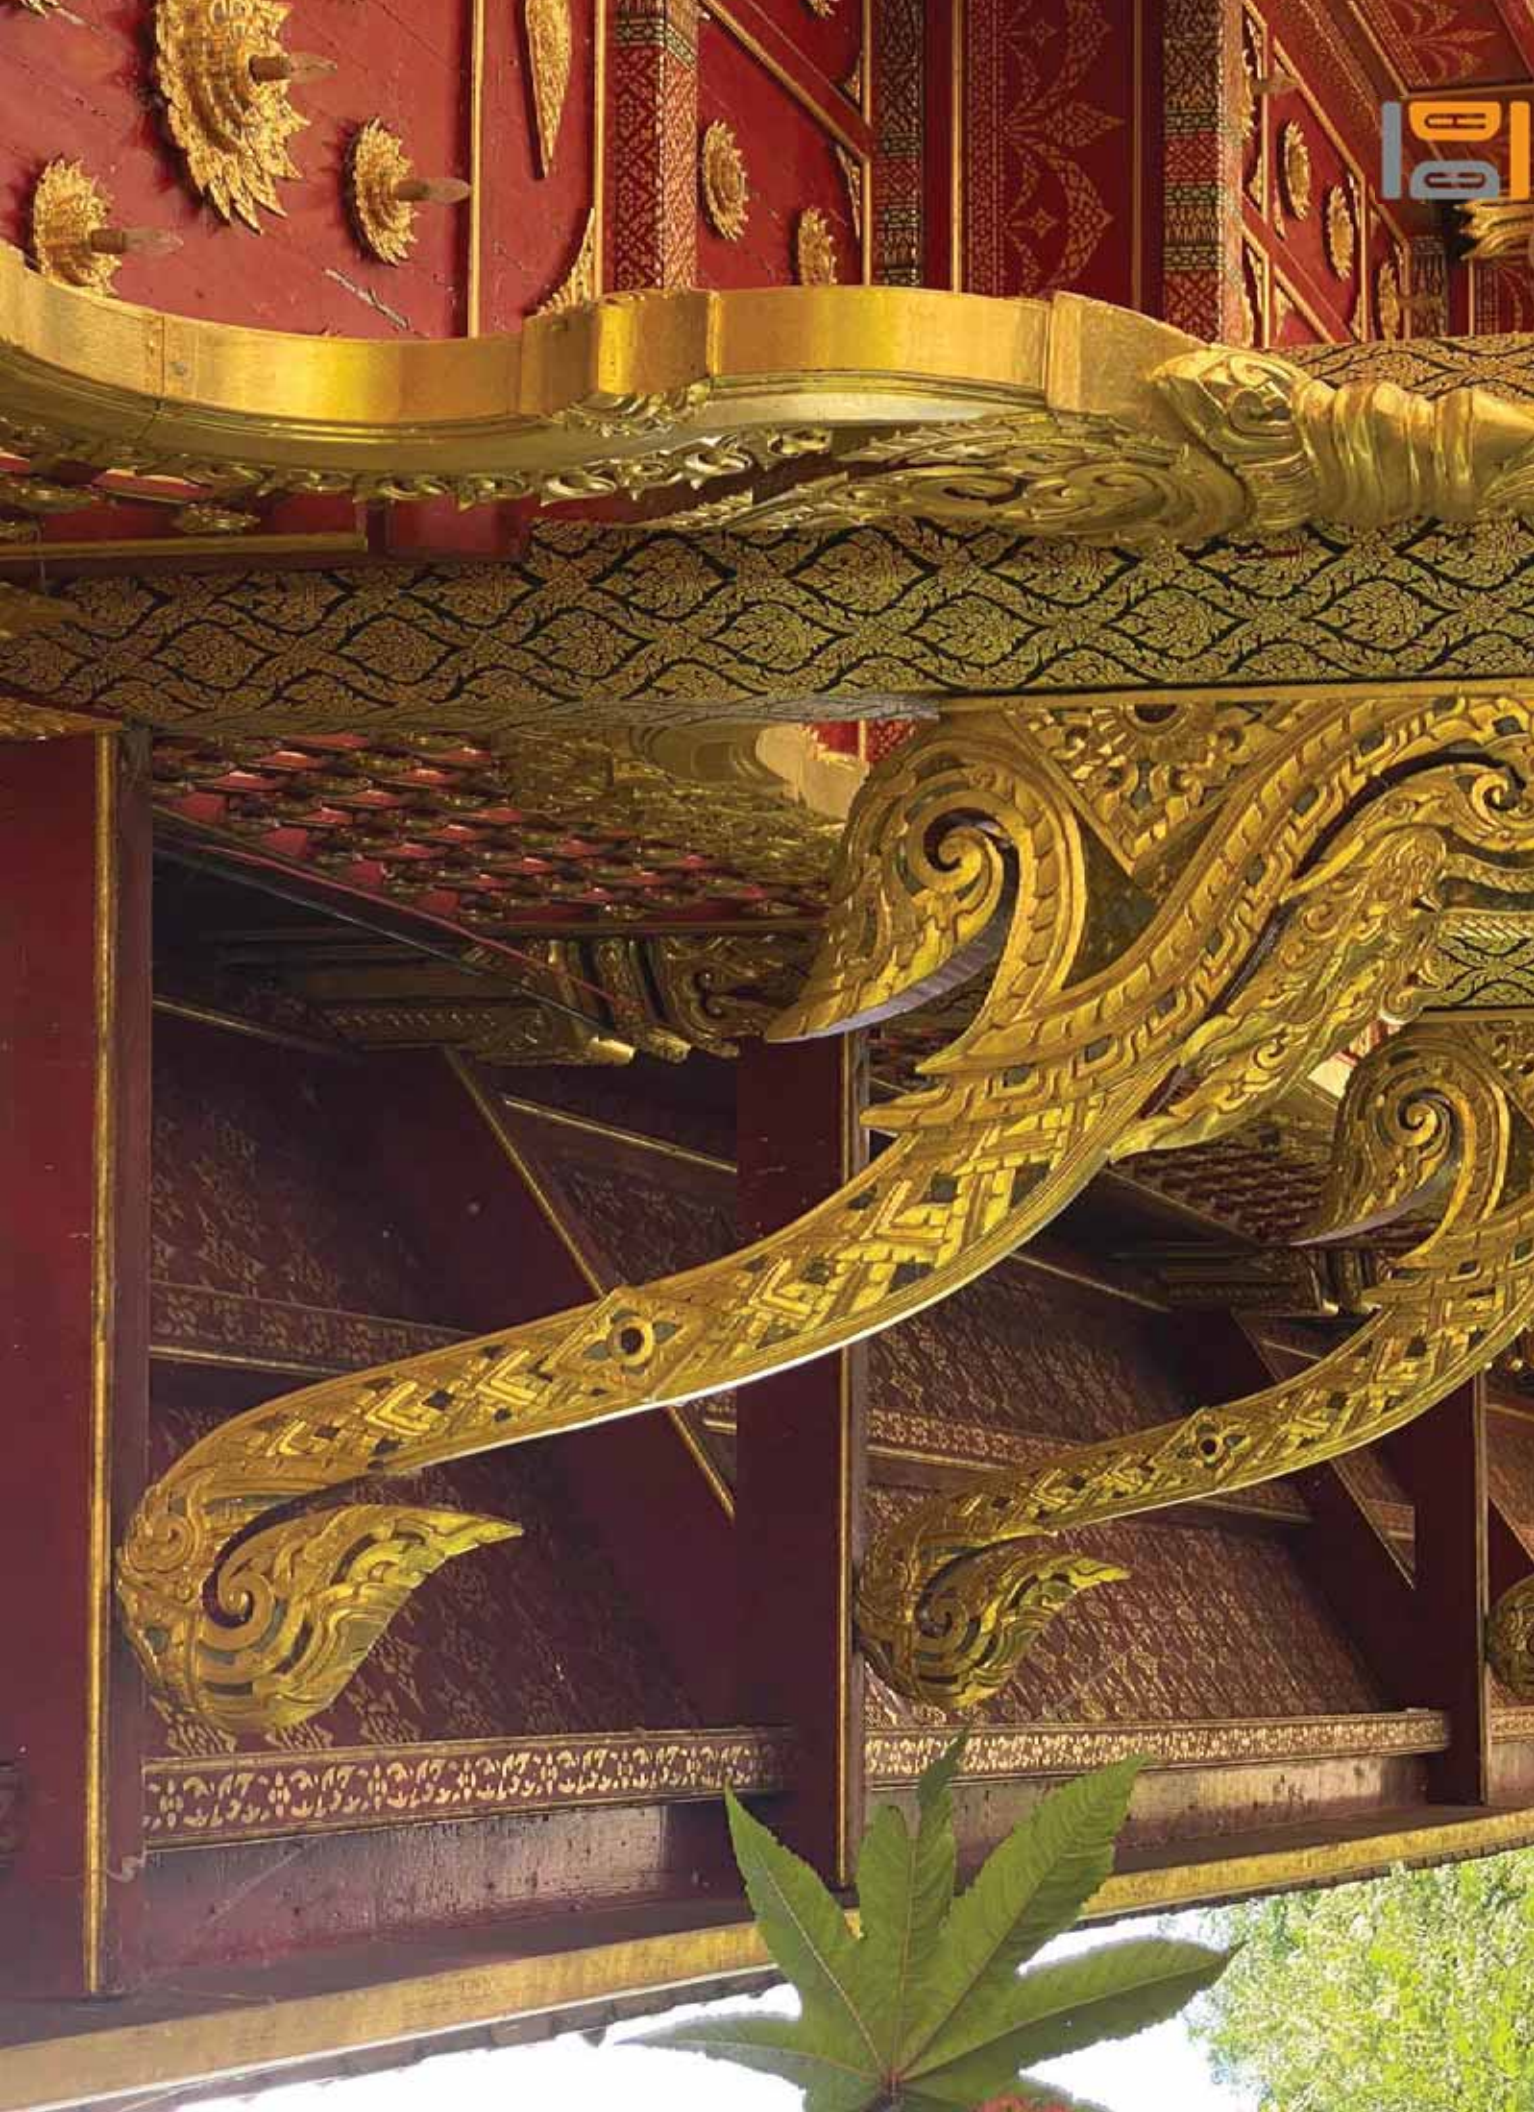
49. Exterior Condition of column capital - Priority 3

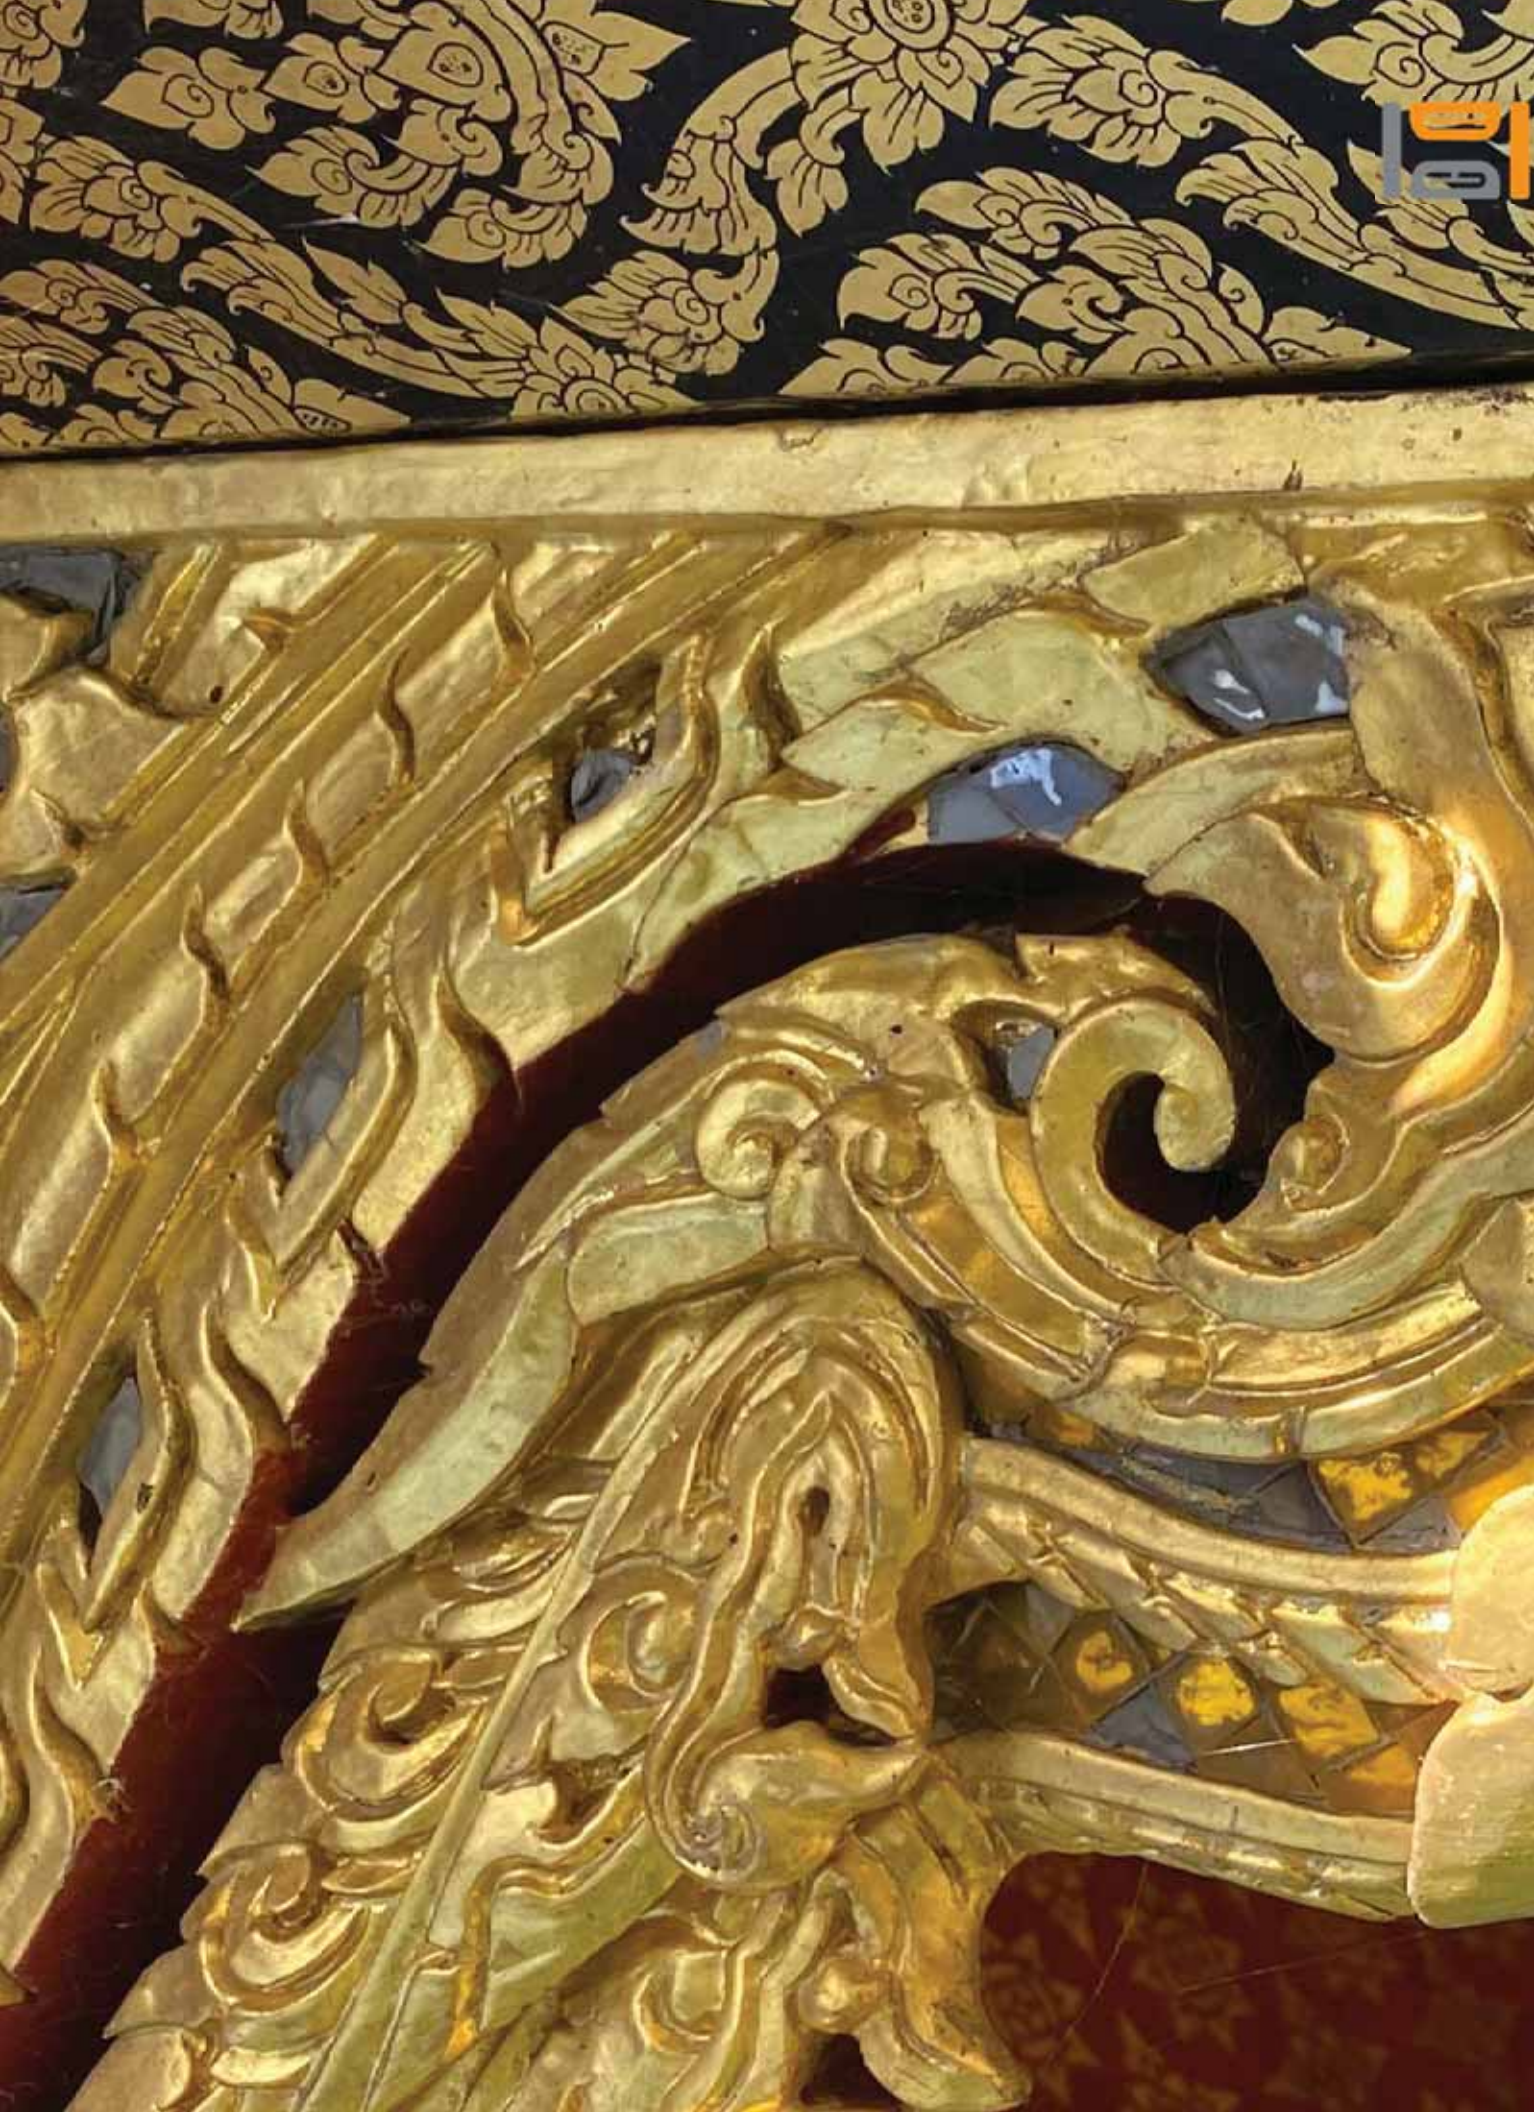
50. Exterior Condition of column capital - Priority 3

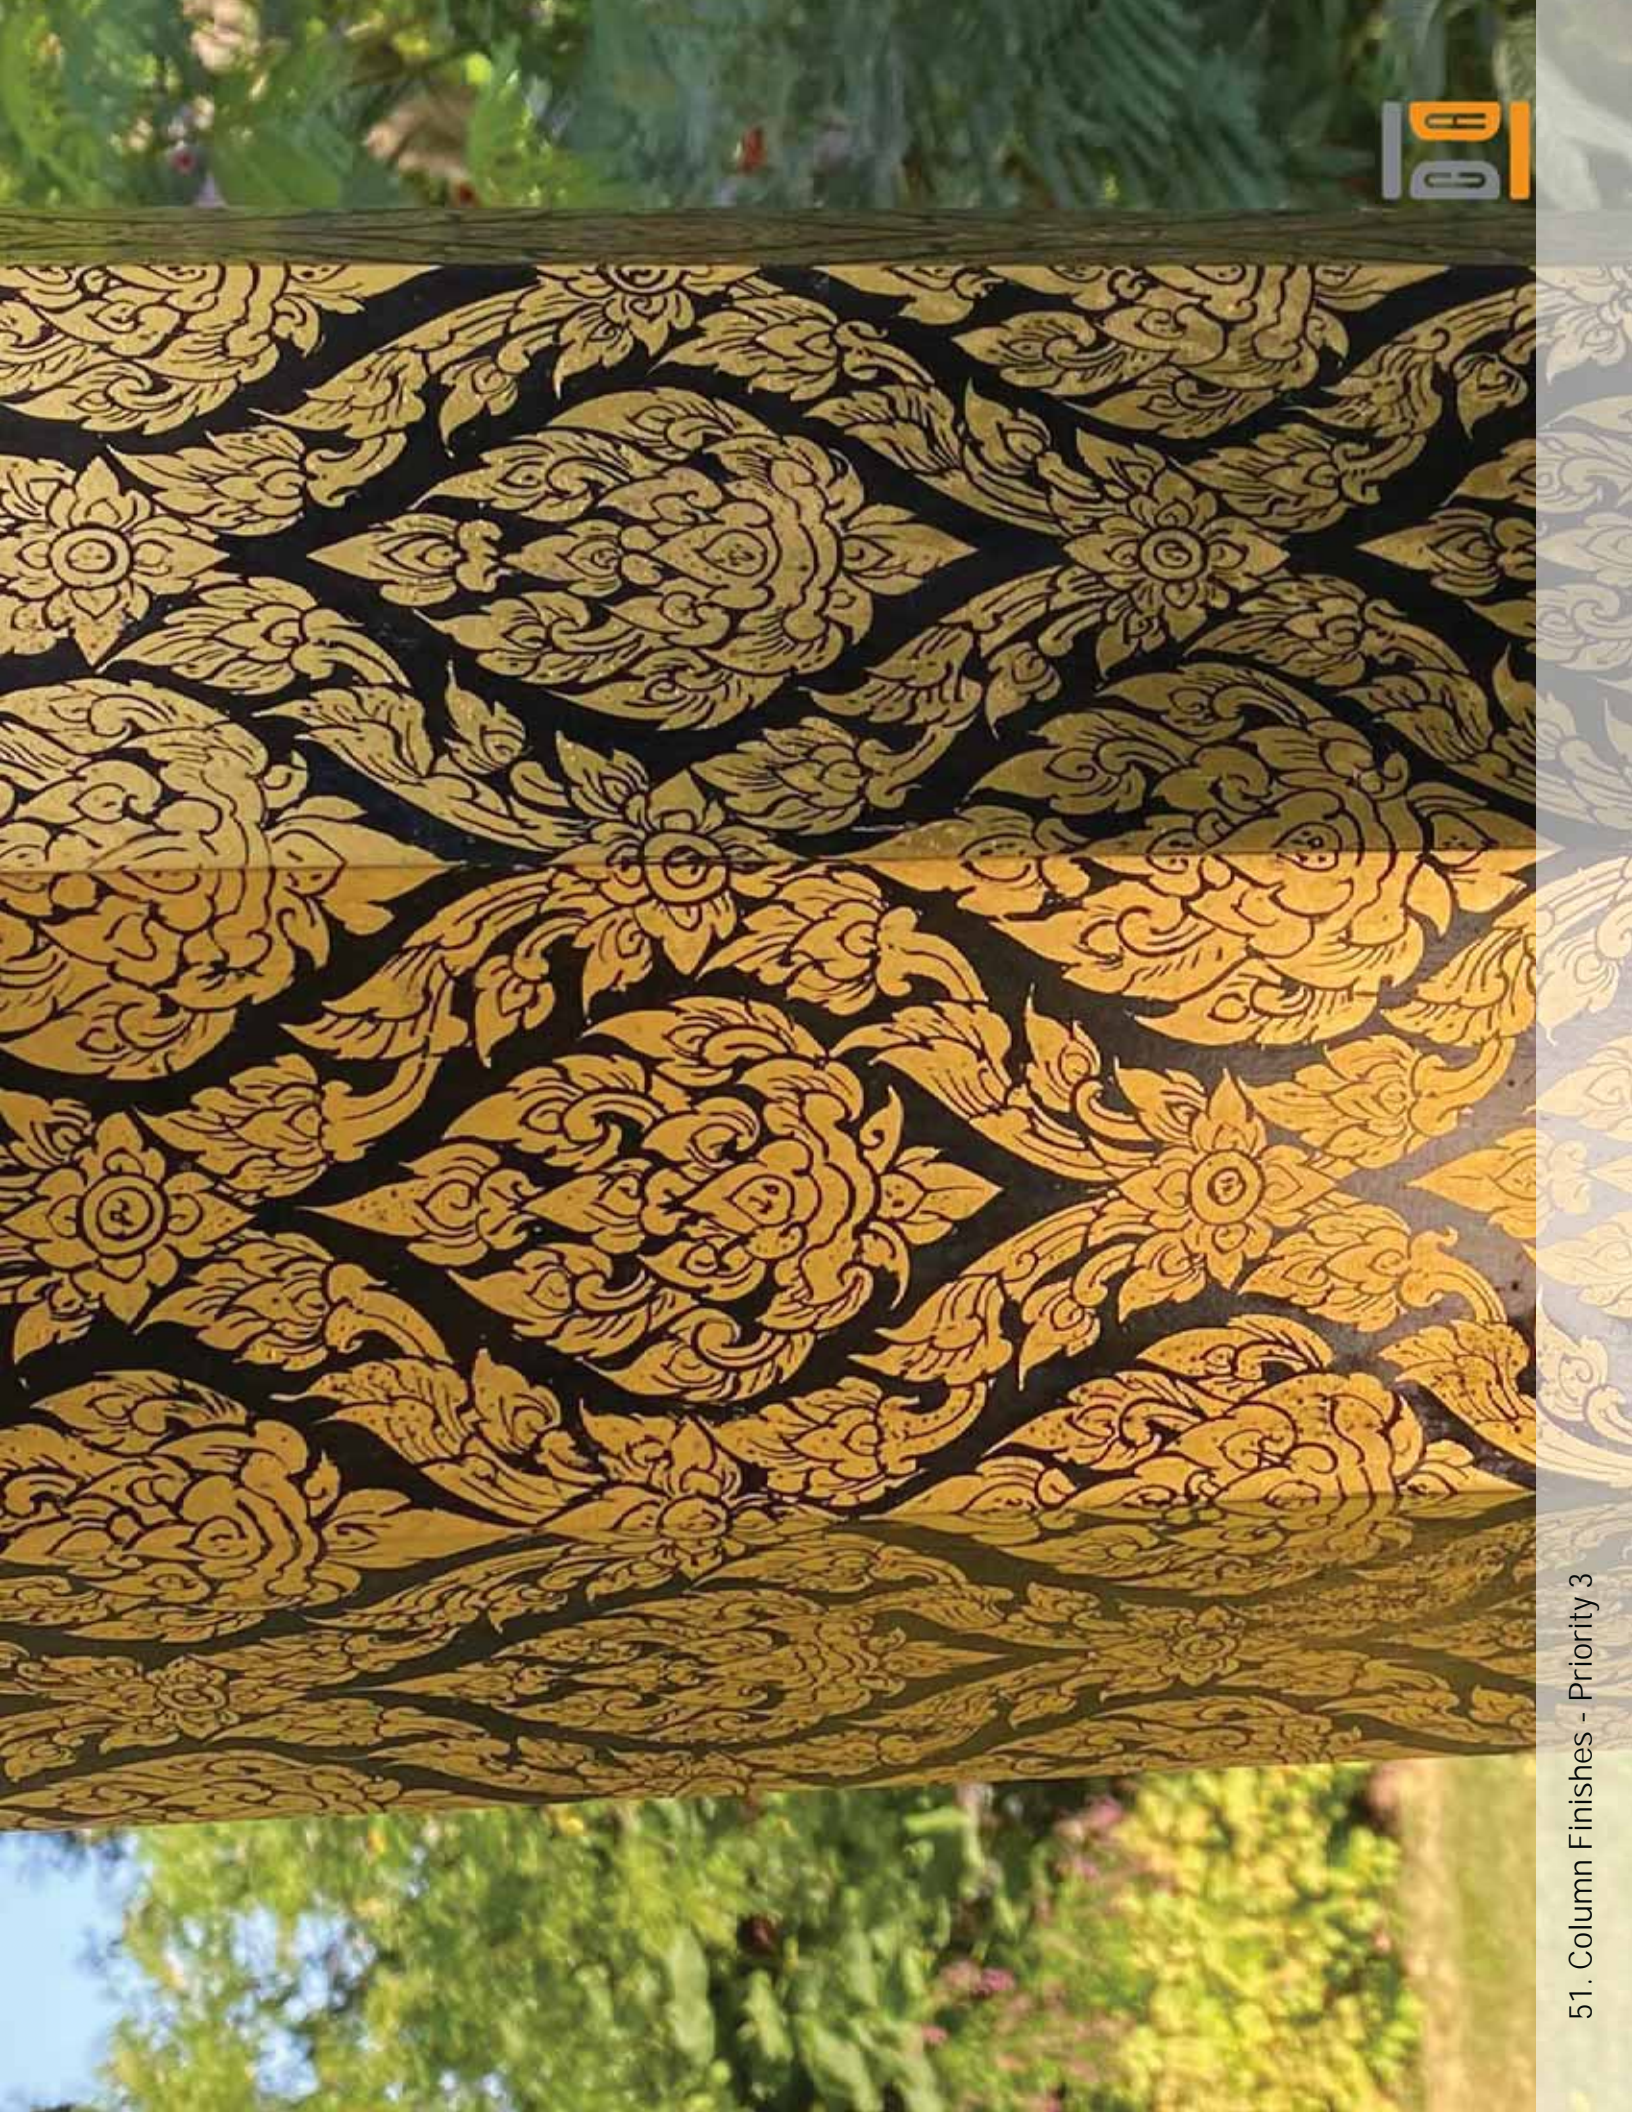
51. Column Finishes - Priority 3

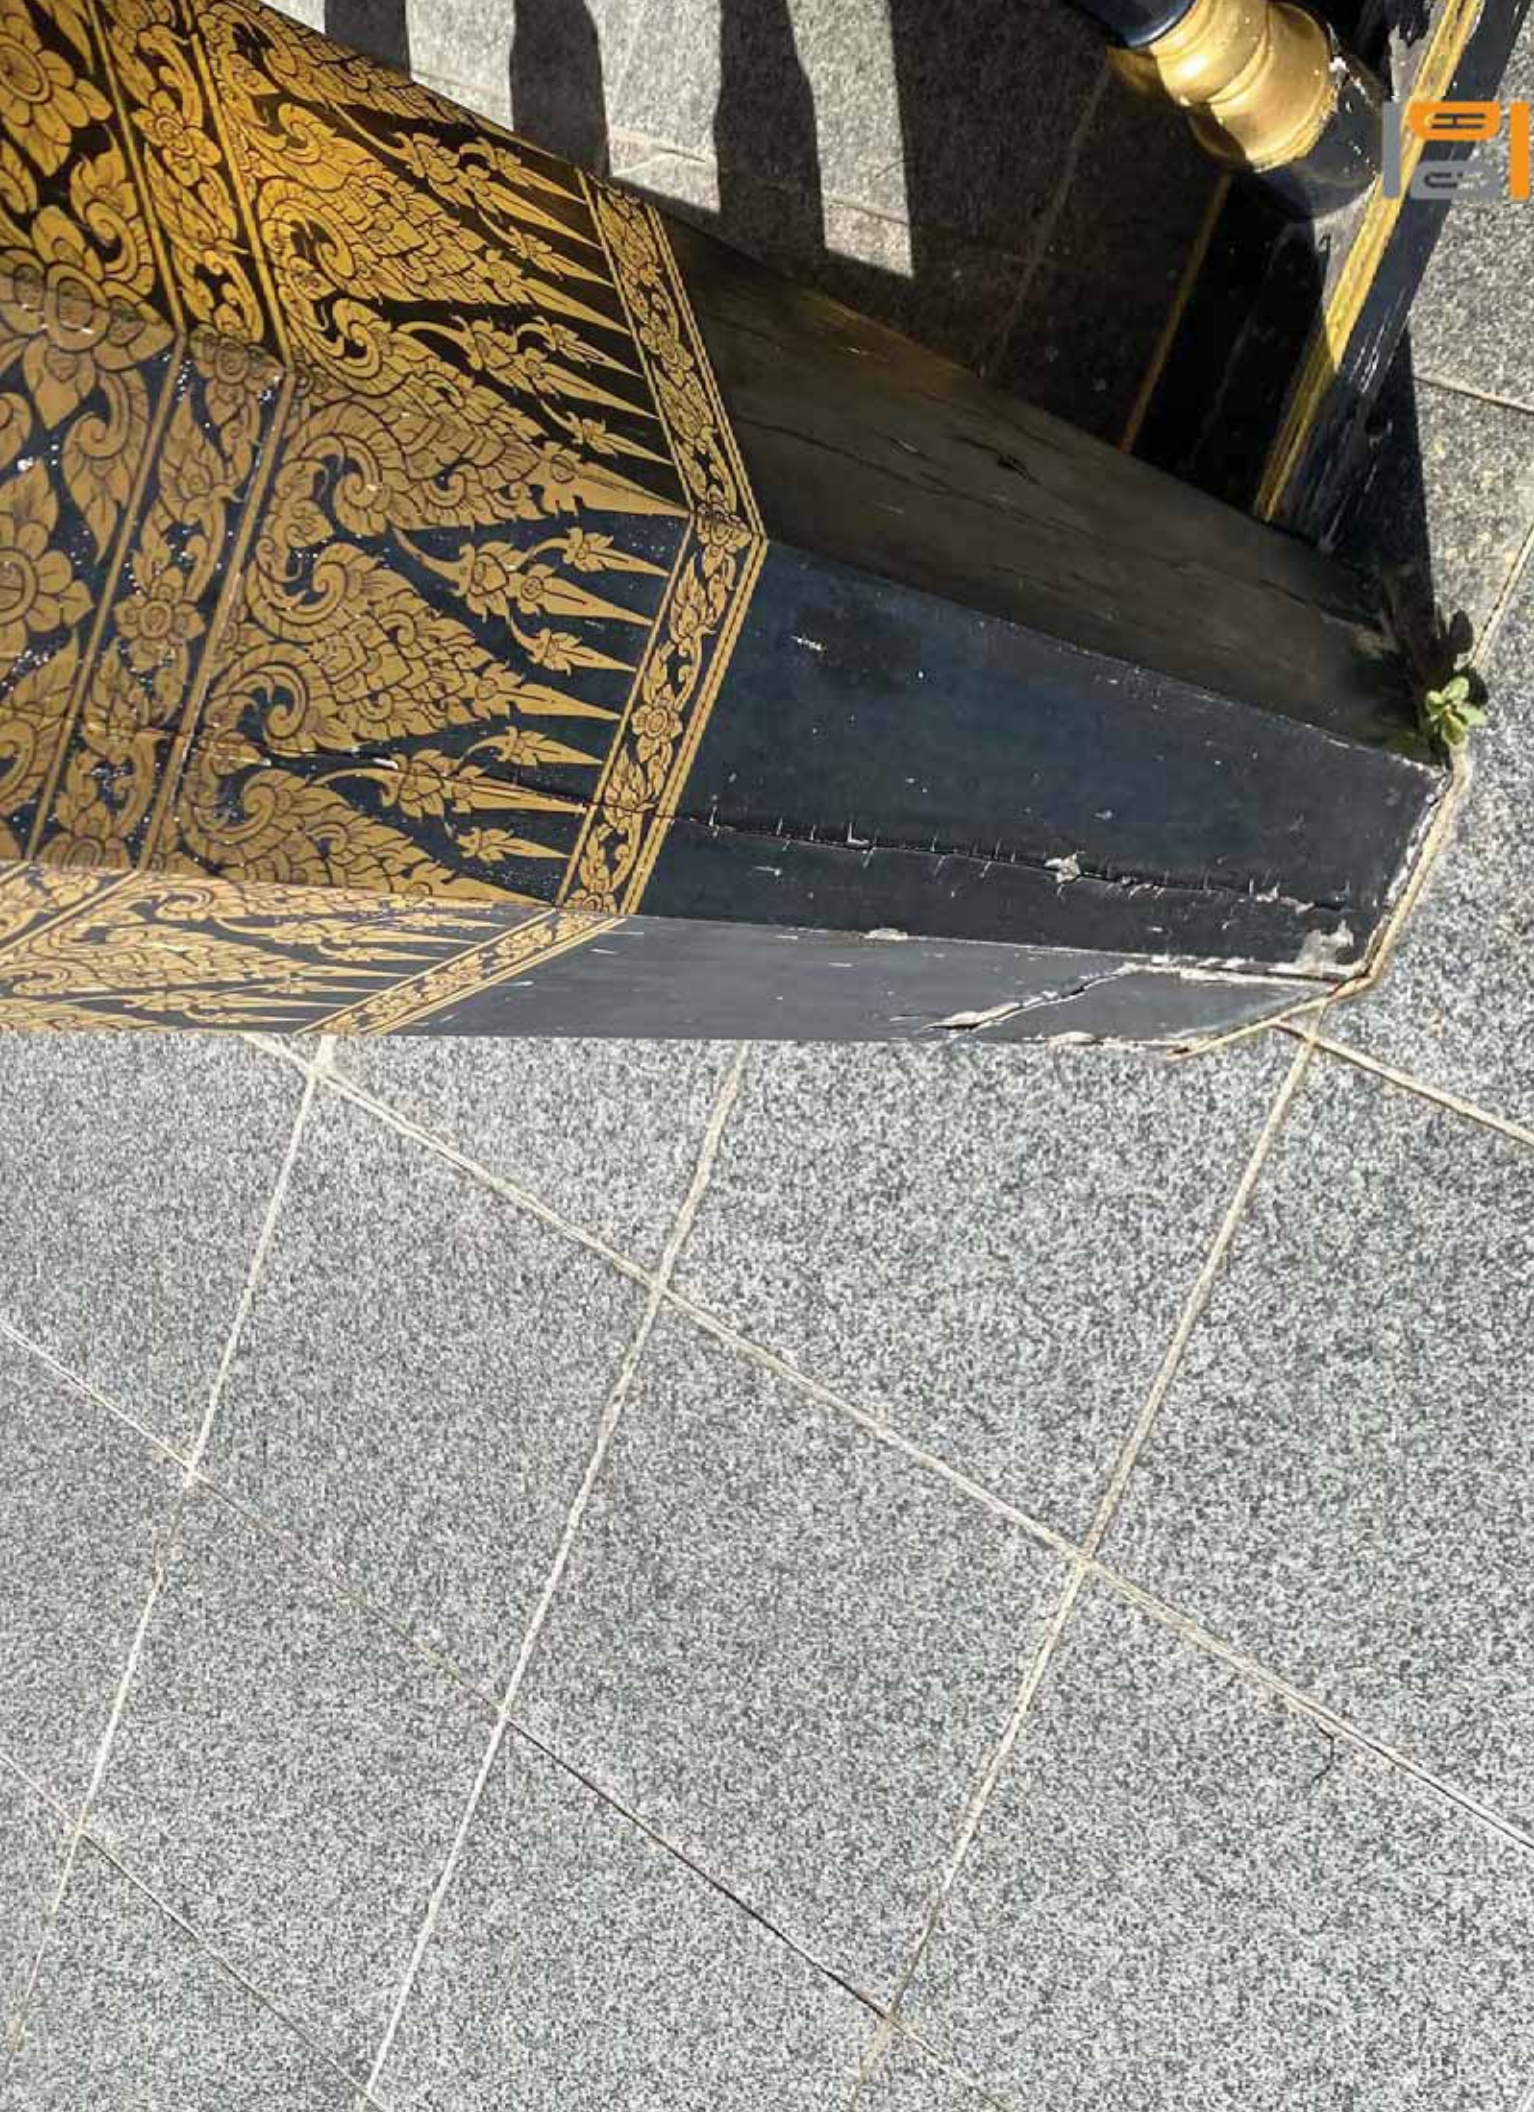
52. Column Base Condition with buckling wood seams and some dry rot - Priority 2
