Ecological Assessment Report

Sauk Creek Greenway

City of Madison, Dane County, Wisconsin

May 16, 2024

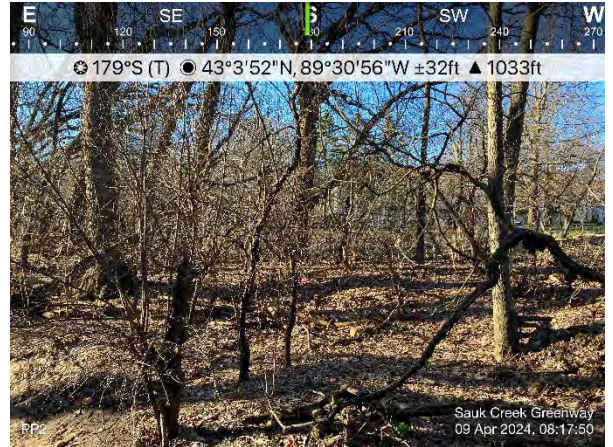
Area 1 has channelized erosion occurring along slopes and Area 15 had areas of soil disturbance from side channel formation. Area 12 has been significantly degraded by flooding of Sauk Creek which has deposited several inches of sediment over the ground surface, resulting in tree health decline and smothering of the herbaceous layer. Areas 9 and 10 were observed to have less soil disturbance and invasive herbs compared to other woodland communities and may fare better with restoration efforts.

Photo #2 Photo point 2, view south in Area 1 with eroded channels and buckthorn-dominated shrub layer

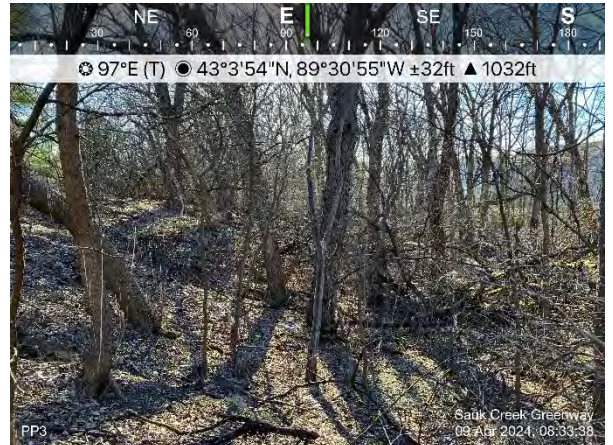
Photo #4 Photo point 3, view east in Area 1 with multiple eroded channels along wooded slope

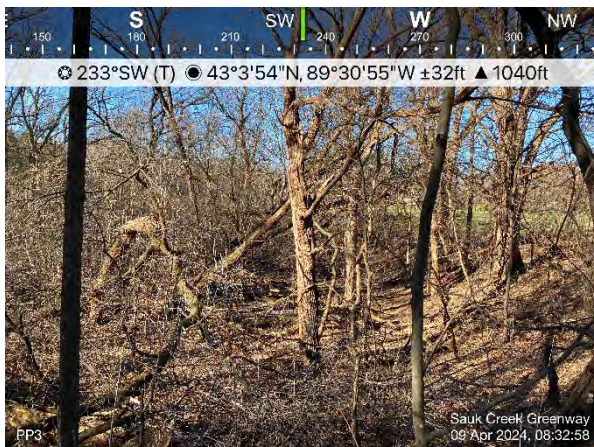
Photo #5 Photo point 3, view southwest in Area 1 of dead and downed trees

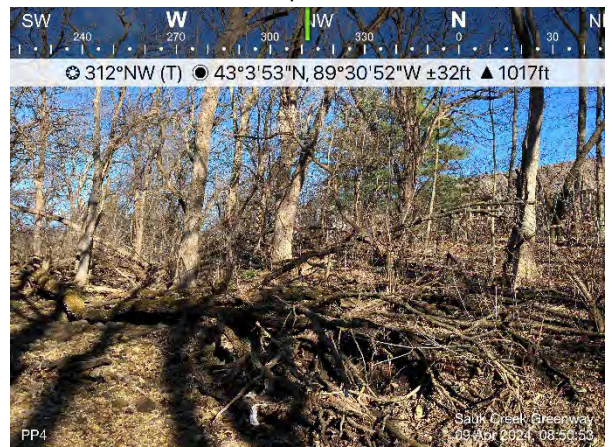
Photo #6 Photo point 4, view northwest from eroded bank of Sauk Creek toward Area 1

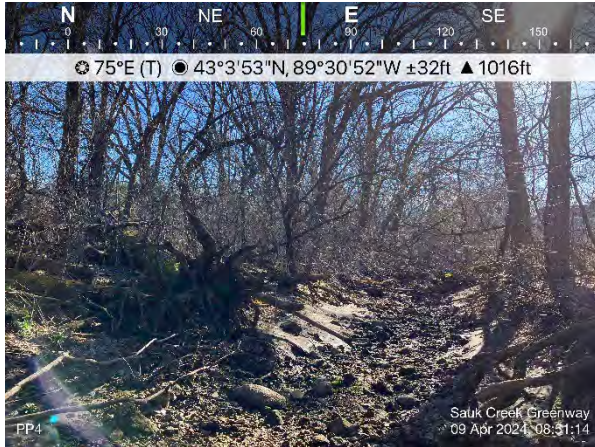
Photo #7 Photo point 4, view east along Sauk Creek with eroded banks and downed woody material

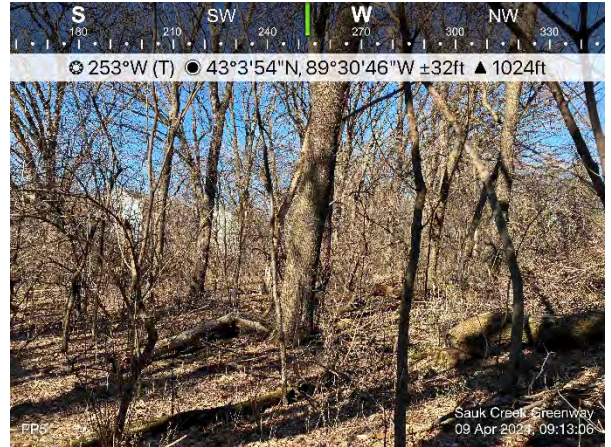
Photo #8 Photo point 5, view west in Area 2 of red oak and black cherry canopy with buckthorn in shrub layer

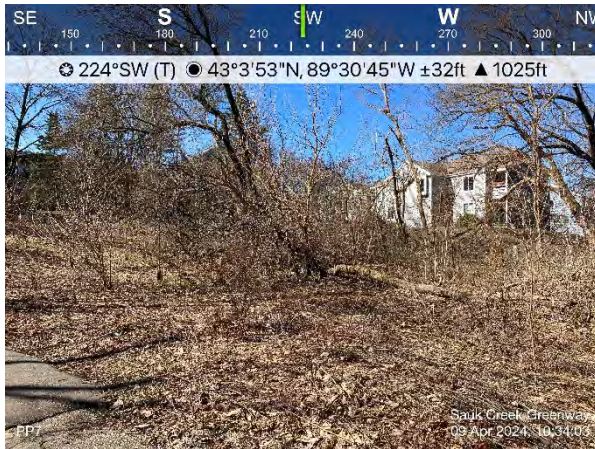
Area 4 is in the southern portion of the Study Area and is impacted by residential uses including stormwater runoff, mowing, and yard waste dumping. There is a random assortment of trees (some of which were likely planted), invading trees saplings and shrubs, and a disturbed herb layer dominated by weedy and invasive species. Area 7 is located south of Walnut Grove Park and has few desirable canopy trees and a degraded understory. Horticultural ground covers have spread into the area and sediment was observed at the soil surface in one location. An adjacent landowner appears to be cutting common buckthorn and it is possible that native herbaceous vegetation is present in this area but was not observed due to the early timing of the field visit.

Photo #13 Photo point 7, view southwest toward Area 4 dominated by disturbance-tolerant species

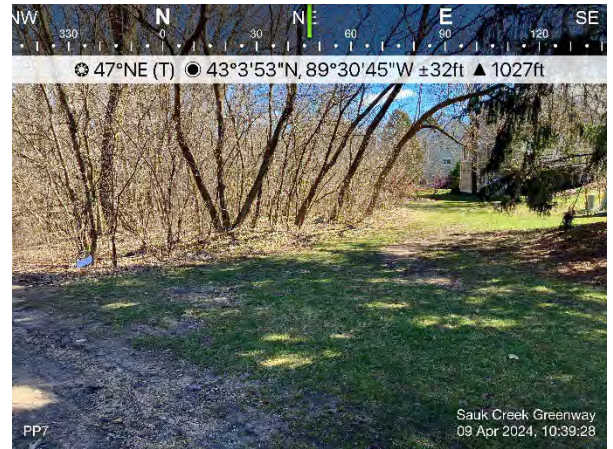
Photo #14 Photo point 7, view northeast of Area 5 dominated by box elder and mowed lawn in greenway

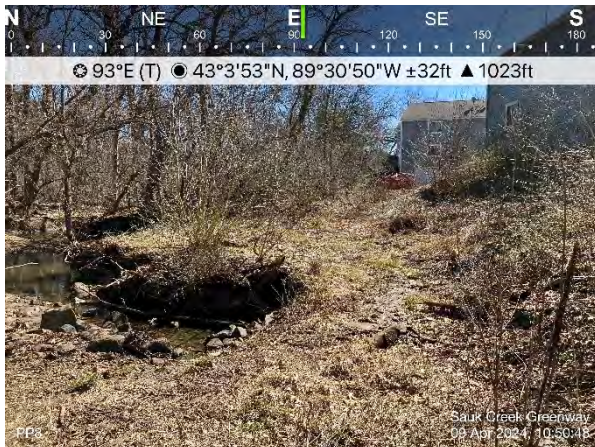
Photo #15 Photo point 8, view east in disturbed Area 4 community and eroded banks of Sauk Creek

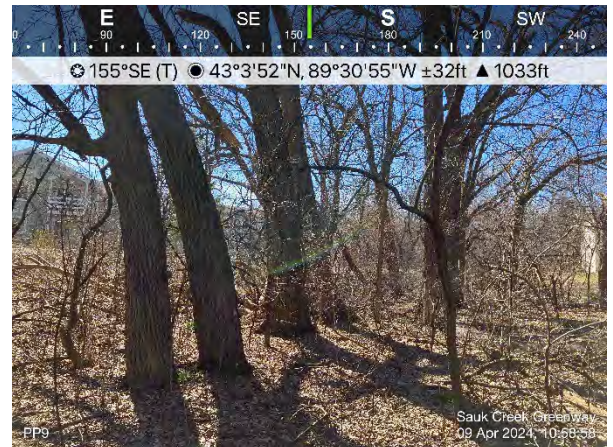
Photo #16 Photo point 9, view south in Area 1 of large bur oak and degraded understory

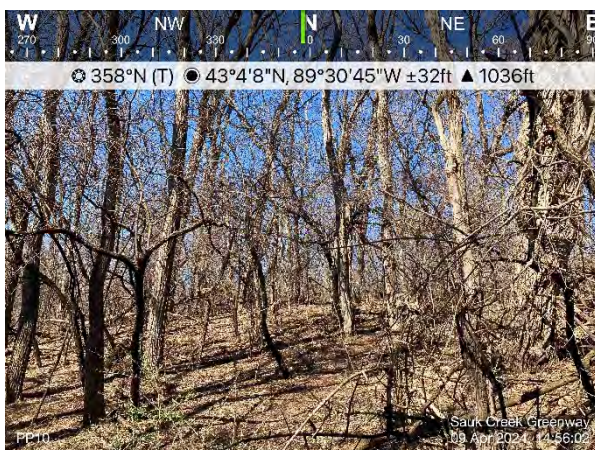
Photo #17 Photo point 10, view north in Area 8 oak-hickory forest dominated by invasive black locust in canopy

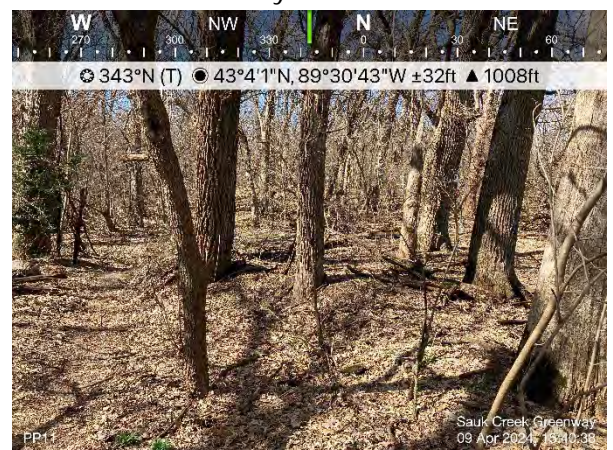
Photo #18 Photo point 11, view north in Area 6 dominated by oaks with degraded understory

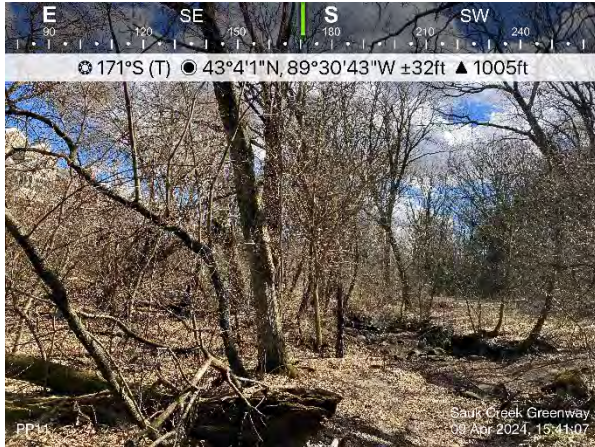
Photo #19 Photo point 11, view south of degraded woodland and Sauk Creek

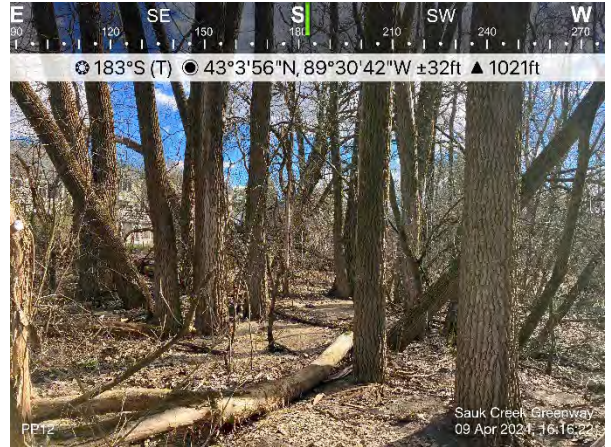
Photo #20 Photo point 12, view south in Area 5 dominated by cottonwood with sediment on ground surface

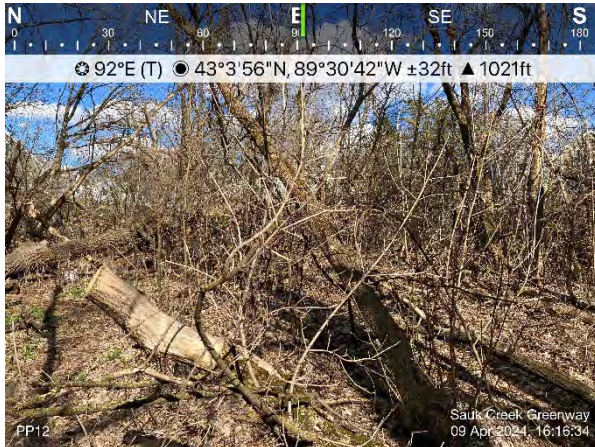
Photo #21 Photo point 12, view east in Area 5 of degraded understory and channel erosion

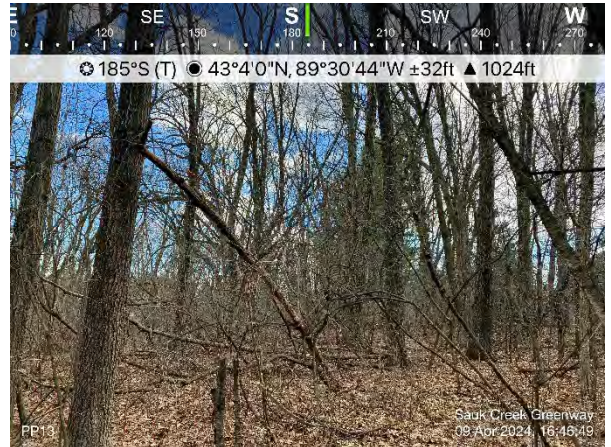
Photo #22 Photo point 13, view south in Area 9 dominated by red oak with buckthorn understory

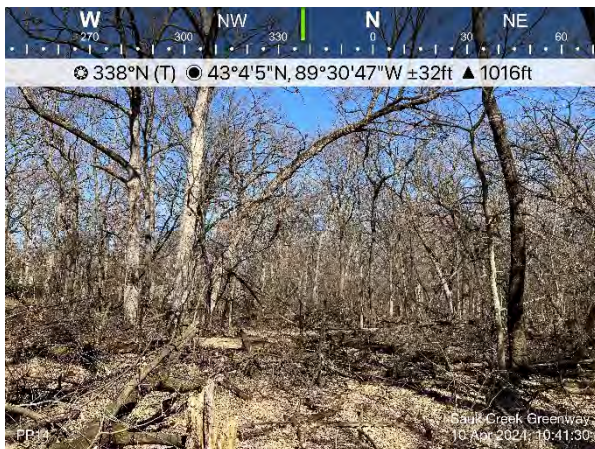
Photo #23 Photo point 14, view northwest in Area 6 with oak canopy and dead/downed woody material

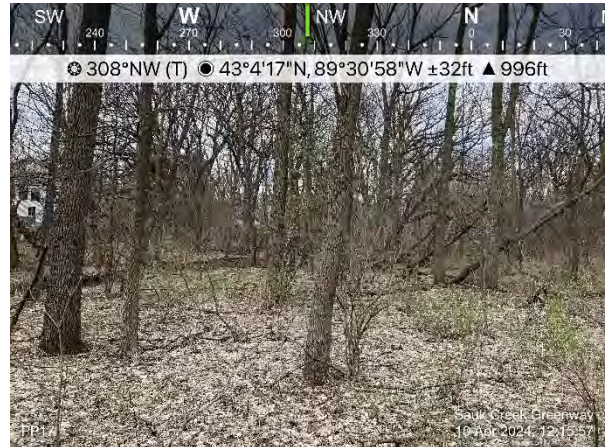
Area 11 is dominated by mesic trees such as black walnut (*Juglans nigra*), hackberry (*Celtis occidentalis*), and elm with limited oaks. Extensive encroachment including flower gardening, yard waste dumping, and spread of horticultural plants threatens the native species that remain in the understory. Area 5 consists of a degraded lowland/floodplain forest that is dominated by large eastern cottonwood (*Populus deltoides*), box elder, and scattered green ash (*Fraxinus pennsylvanica*) that are dead/dying from emerald ash borer. This woodland area has been degraded by lawn encroachment, multiple eroded channels leading to Sauk Creek, as well as flooding from Sauk Creek that has deposited sediment on the ground surface.

Photo #28 Photo point 17, view northwest of Area 11 mesic forest dominated by black walnut, hackberry, and elm

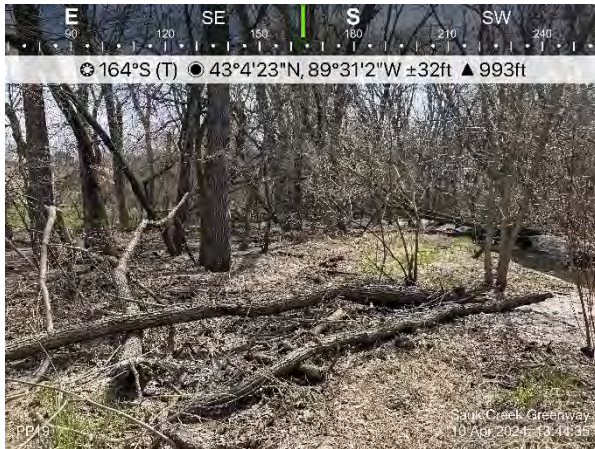
Photo #31 Photo point 19, view south in Area 12 with recent flooding along Sauk Creek and thick sediment on ground

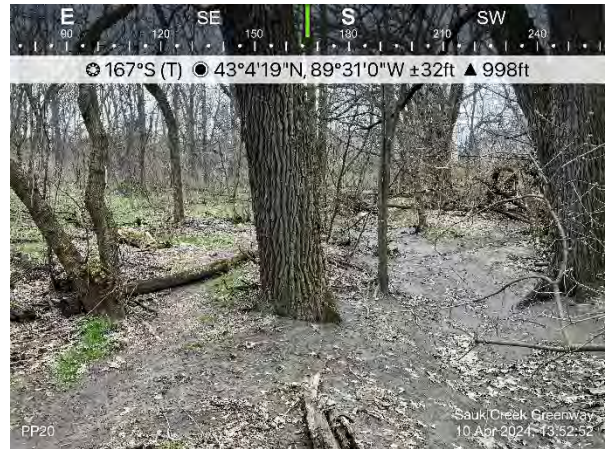
Photo #32 Photo point 20, view south in Area 12 of secondary channel and sediment around oak trees

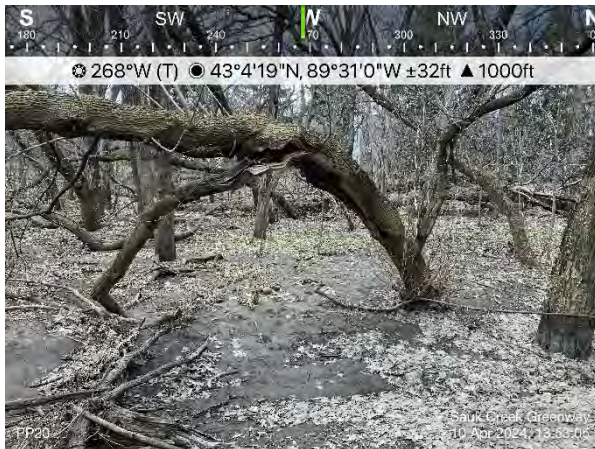
Photo #33 Photo point 20, view west in Area 12 of sediment on ground surface

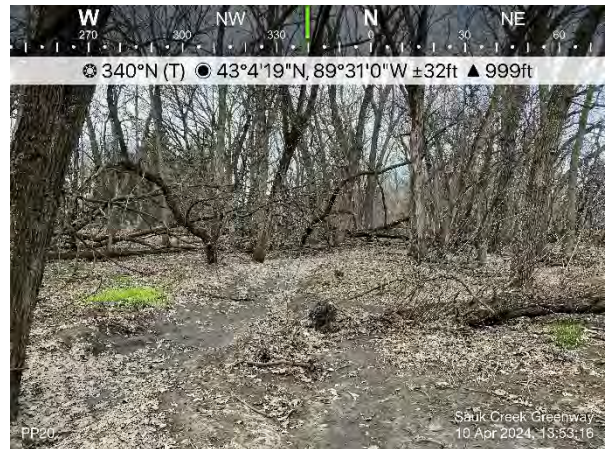
Photo #34 Photo point 20, view north in Area 12 of secondary channel and poor tree health

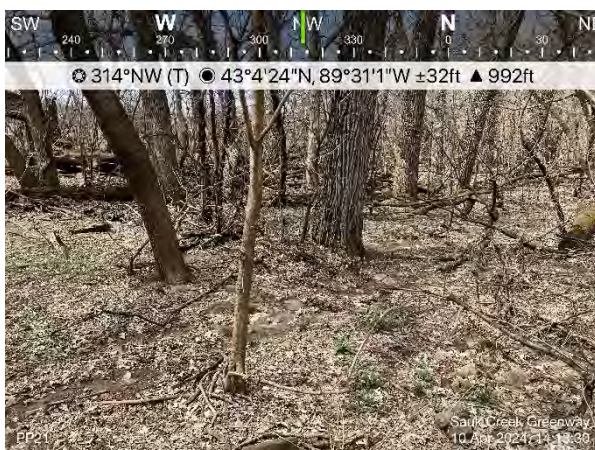
Photo #35 Photo point 21, view northwest in Area 12 with disturbed ground surface

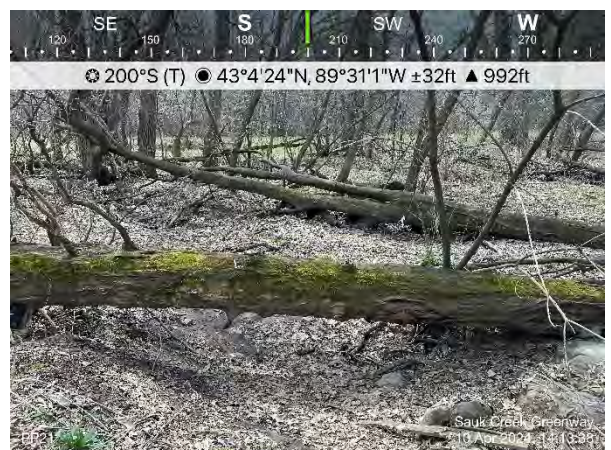
Photo #36 Photo point 21, view south in Area 12 with soil erosion and tree mortality

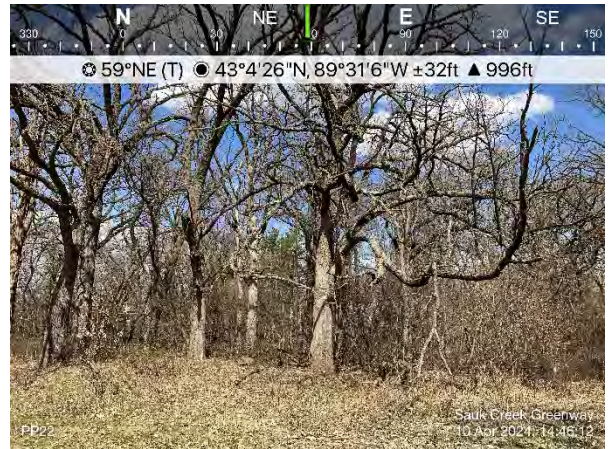
Photo #38 Photo point 22, view northeast of Area 14 with Area 15 degraded oak woodland in background
