Sauk Creek Corridor Plan

*Completed by City Engineering
February 5, 2025*

The Corridor Plan as written includes high level concepts and locations of improvements to achieve the general goal of the plan. It should be considered a water quality plan for upcoming stabilization and pond improvements projects. The Corridor Plan doesn't include all aspects of flood mitigation or the Pheasant Branch Watershed Study. Each design phase will need to be permitted which may involve modifications to the plan.

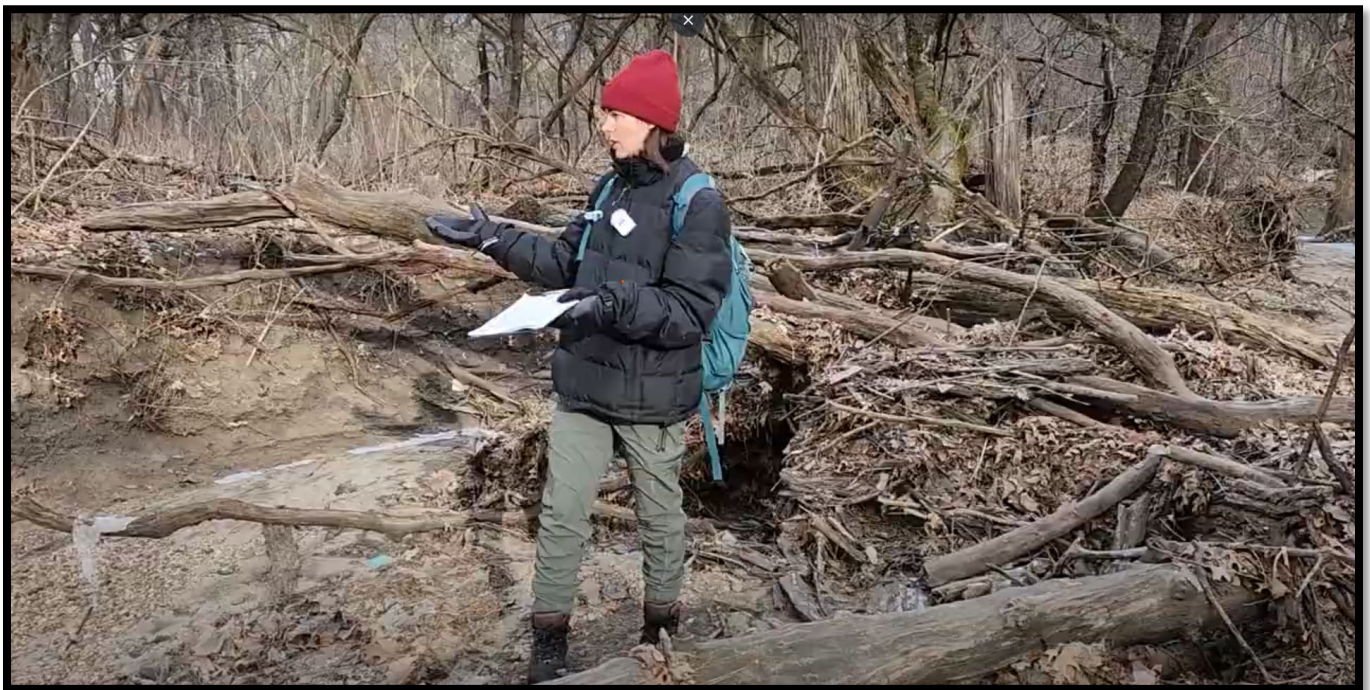
Figure 4 Log dam created a channel blockage and led to erosion on adjacent bank

As a result of the continued erosion, there are many trees adjacent to the channel that have fallen within the channel itself. When these trees pile up, they can create log dams that hold back water within the channel and force the stormwater over at the lowest point (think of a small waterfall), resulting in significant movement of the main channel, widening and eroding of the channel just downstream of the blockage. There are many examples of this occurring and causing further erosion in a self-reinforcing cycle of erosion and subsequent tree loss.

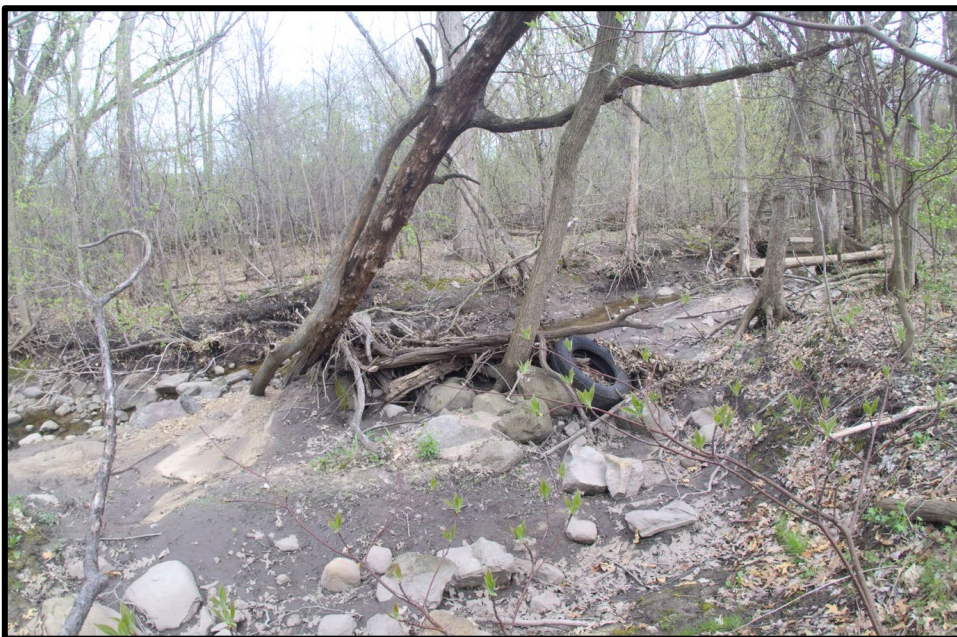
Figure 7 Channel widened due to erosion. Can see widened channel section in foreground near tire.

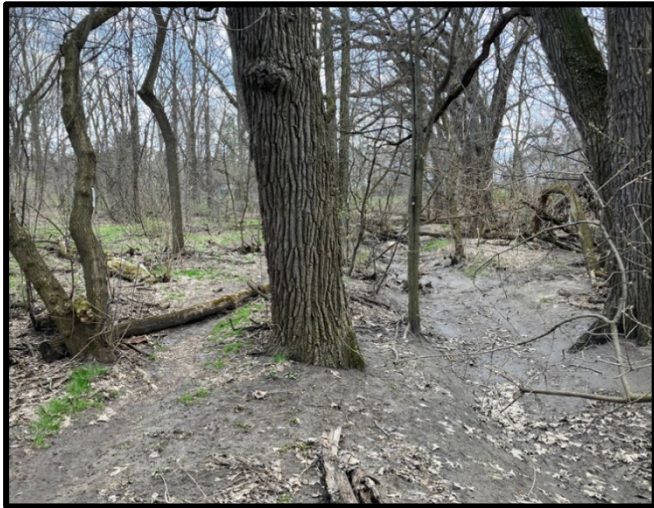
On the north end of the channel in between the St Lawrence Pond and High Point Pond (the existing stormwater treatment ponds between Plover Circle and Canvasback Circle, as shown on Figure 12), the channel flattens out longitudinally which causes the stormwater to slow down and spread out. This is confirmed by neighbors that report that stormwater reaches the edge of their properties along Farmington Way and parts of Sauk Creek Circle. The slowing of the water allows for the sediment to drop out in this location, some of it coming from the upstream actively eroding banks. This is very evident when you walk this area and see tree root flares buried in sediment and very little groundcover.

This sedimentation in the northern end is likely exacerbated by the channel being routed into High Point Pond which can create a backwater or standing water condition in the greenway allowing water to slow more and drop out more sediment.

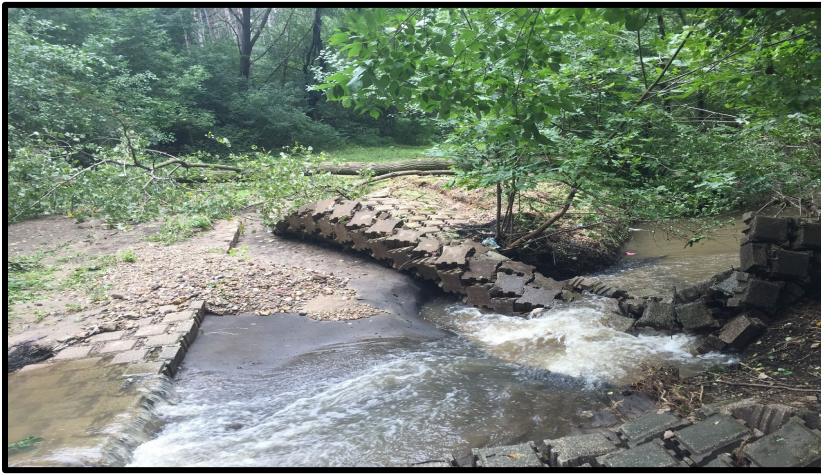
Figure 19 Failed sanitary access path

The City built 2 access paths in the early 2010's within the greenway to allow for access to the structures needed to clean the entire stretch of sanitary sewer. When the southern path was built, an articulated concrete block crossing of the channel was installed at the crossing near Tree Lane and Randolph Dr. (see Figure 19) This crossing did not hold up during large storm events, particularly the 2018 historic rain event, and has since failed. Currently, for the Vactor truck to access the sewer within in the greenway along the rest of the path, a temporary
