Sauk Creek Corridor Plan

*Completed by City Engineering
February 5, 2025*

The Corridor Plan as written includes high level concepts and locations of improvements to achieve the general goal of the plan. It should be considered a water quality plan for upcoming stabilization and pond improvements projects. The Corridor Plan doesn't include all aspects of flood mitigation or the Pheasant Branch Watershed Study. Each design phase will need to be permitted which may involve modifications to the plan.

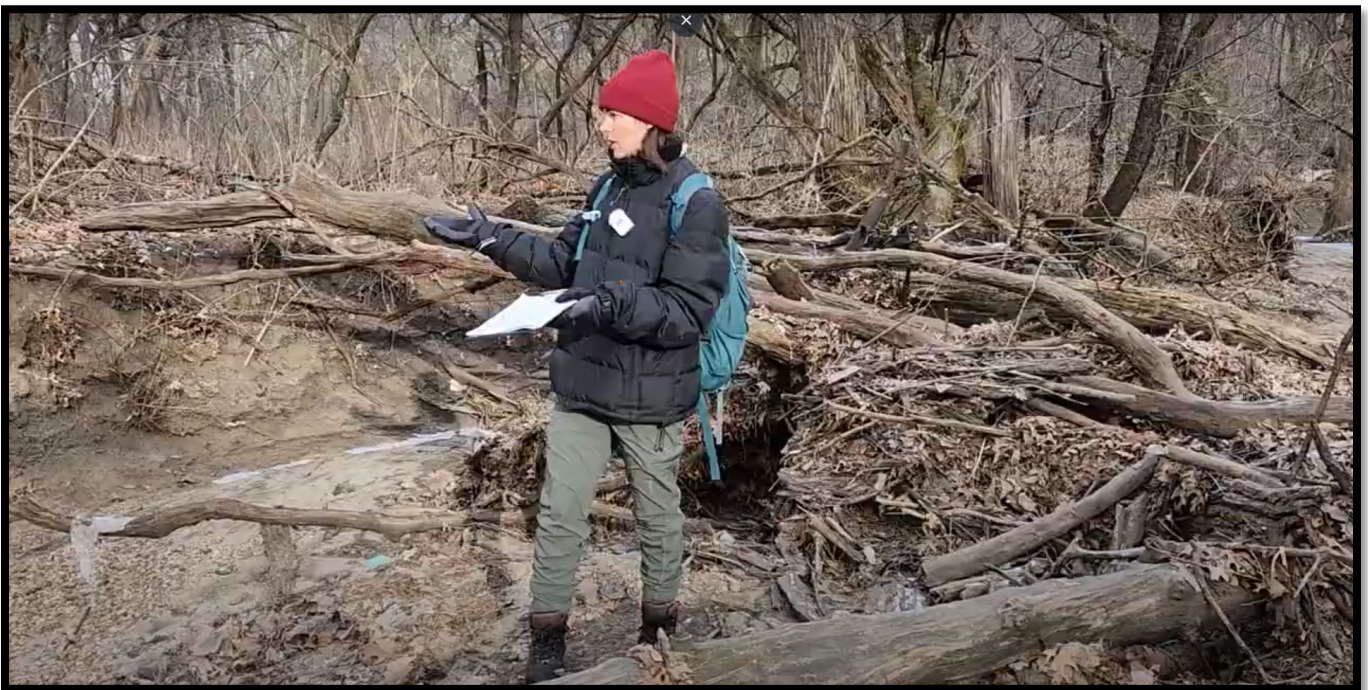
Figure 4 Log dam created a channel blockage and led to erosion on adjacent bank

As a result of the continued erosion, there are many trees adjacent to the channel that have fallen within the channel itself. When these trees pile up, they can create log dams that hold back water within the channel and force the stormwater over at the lowest point (think of a small waterfall), resulting in significant movement of the main channel, widening and eroding of the channel just downstream of the blockage. There are many examples of this occurring and causing further erosion in a self-reinforcing cycle of erosion and subsequent tree loss.

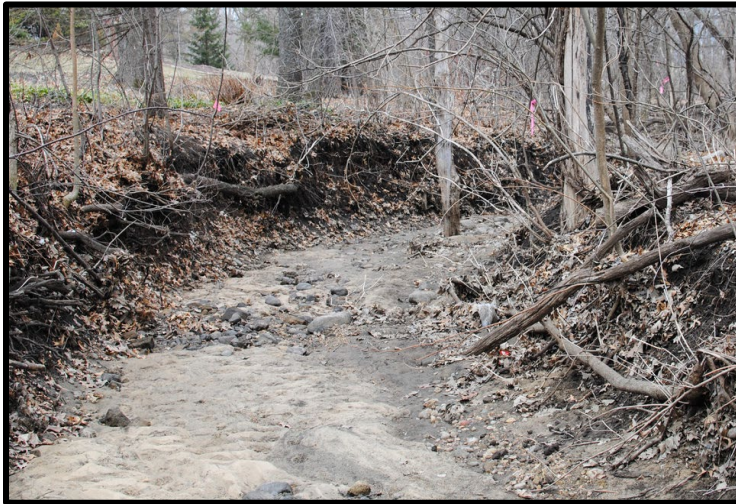
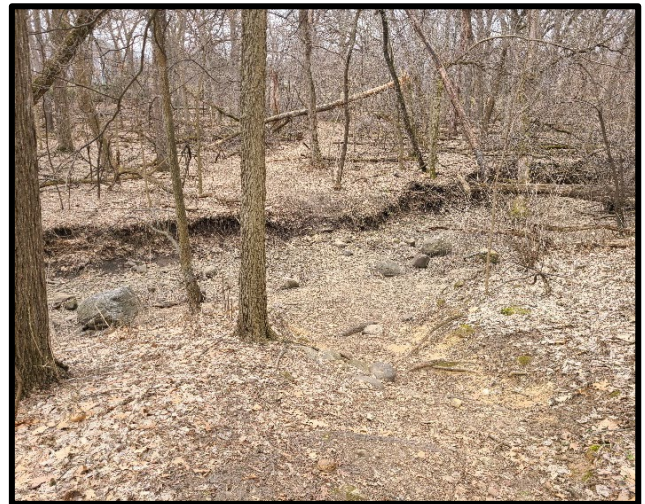
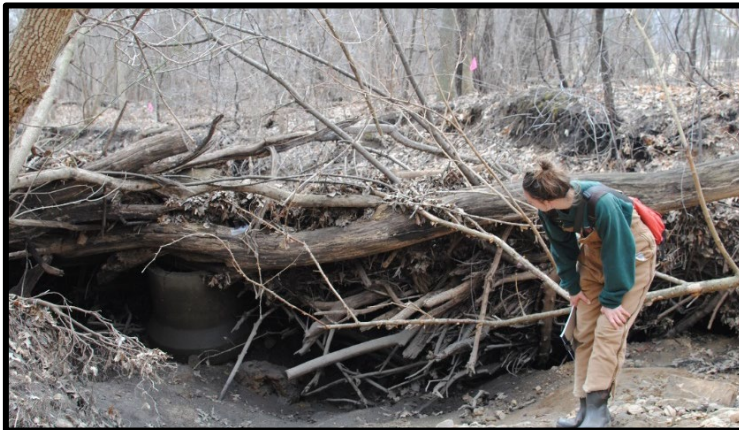
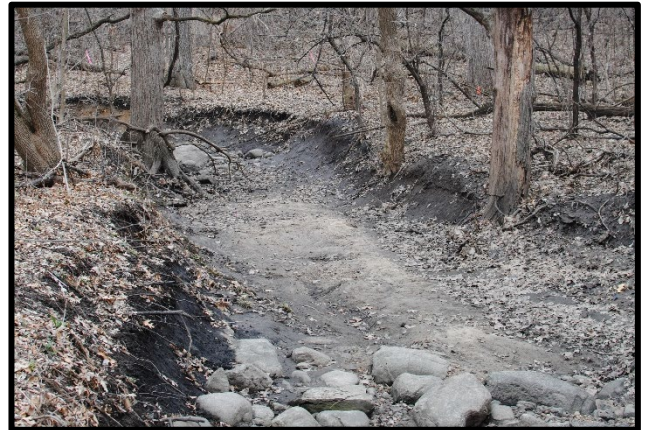
There are several key areas within the channel that are problematic from a bank stabilization perspective:

- Outside banks at large curves in the channel that are being eroded by the more frequent, intense rain events
- Eroding areas adjacent to key infrastructure including the sanitary sewer, sanitary access path, and private property
- Areas that have eroded excessively due to a large channel blockage that resulted in the channel widening for water to move through. You can see many sections of the channel that are 2x the width of the rest of the channel where these blockages resulted in widening of the channel.

- The area near the existing concrete weir that was installed in the late 1980's when the ponds were built. The weir has since failed and is a good example of how the water widens and erodes the channel.

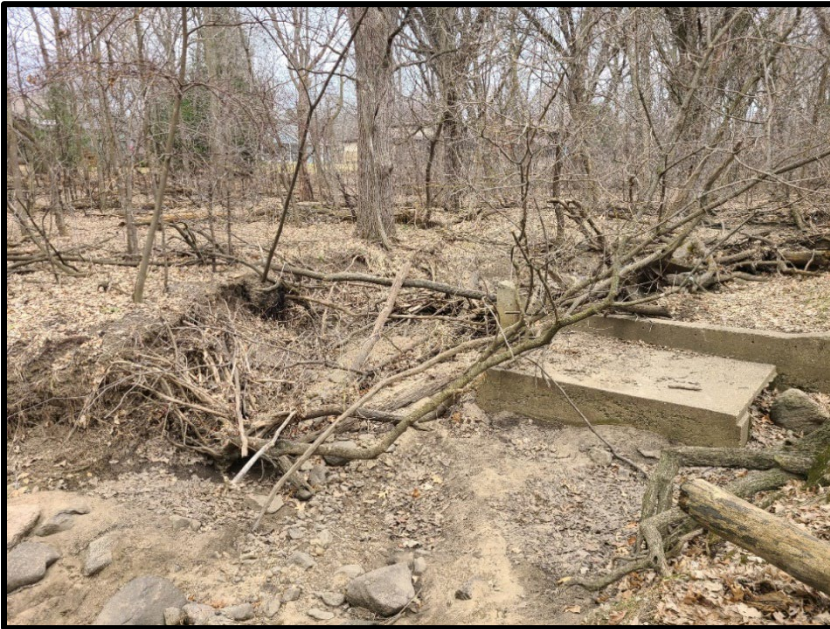
Figure 6 Concrete weir installed when pond was built to hold back water and route it into pond. The length of the concrete weir shows original width of the channel and how much it has widened.

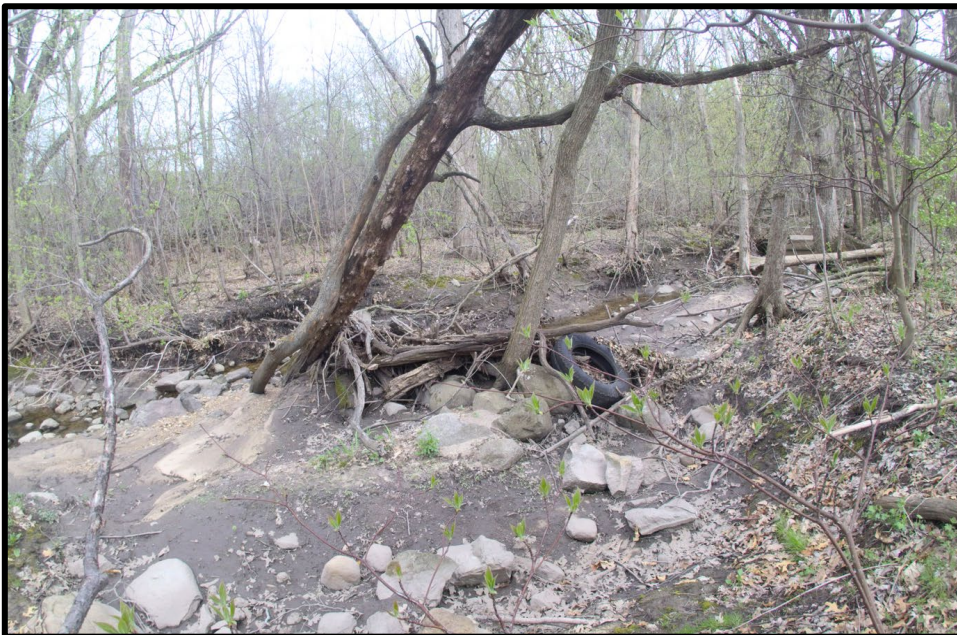
Figure 7 Channel widened due to erosion. Can see widened channel section in foreground near tire.

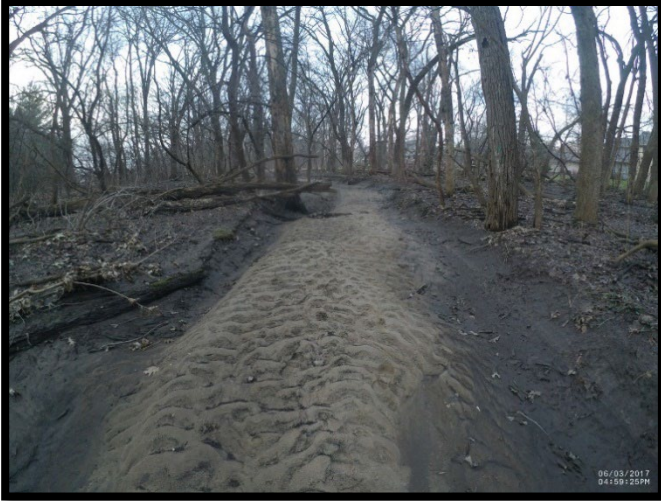
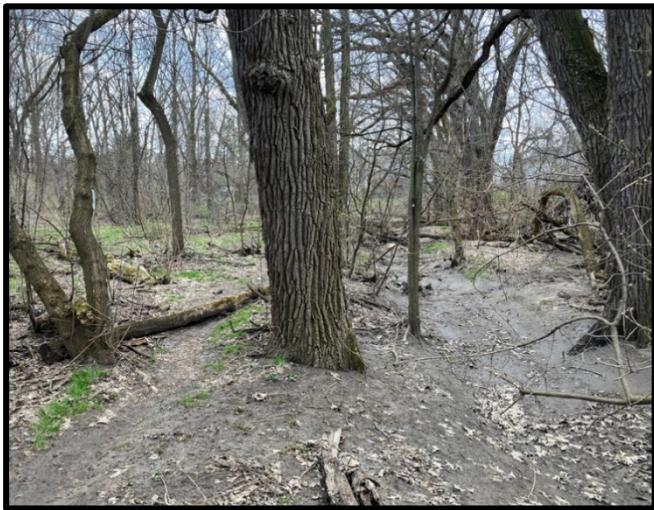
On the north end of the channel in between the St Lawrence Pond and High Point Pond (the existing stormwater treatment ponds between Plover Circle and Canvasback Circle, as shown on Figure 12), the channel flattens out longitudinally which causes the stormwater to slow down and spread out. This is confirmed by neighbors that report that stormwater reaches the edge of their properties along Farmington Way and parts of Sauk Creek Circle. The slowing of the water allows for the sediment to drop out in this location, some of it coming from the upstream actively eroding banks. This is very evident when you walk this area and see tree root flares buried in sediment and very little groundcover.

This sedimentation in the northern end is likely exacerbated by the channel being routed into High Point Pond which can create a backwater or standing water condition in the greenway allowing water to slow more and drop out more sediment.

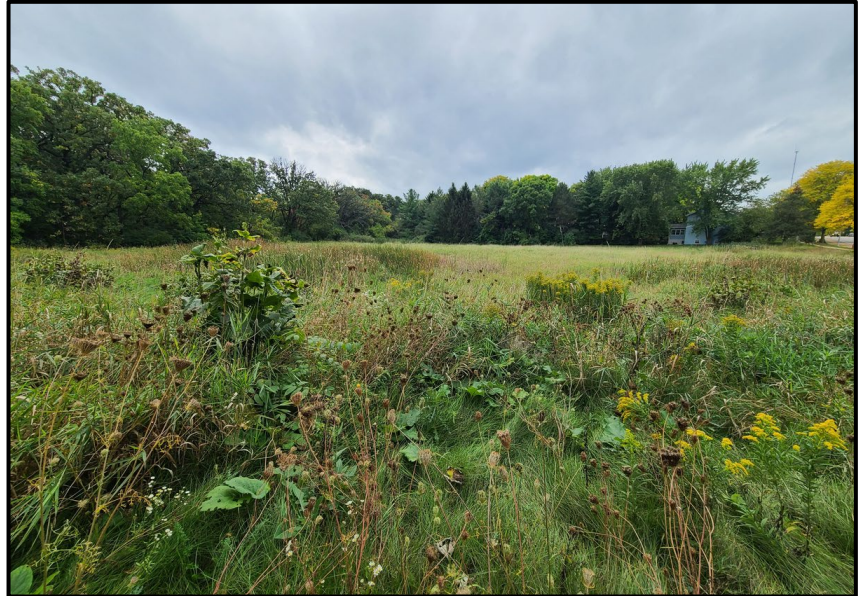
Figure 14 High Point Pond

The High Point Pond was designed to treat flows that come from N High Point Road and Sauk Creek Drive (see purple drainage area in Figure 12). When the pond was built it diverted the low flow channel from the greenway into the pond. The pond is also a “dry pond” or detention basin, meaning that it fills with water during a storm event, and slowly releases the water downstream but isn't intended to hold water permanently. The berm on the north side of the pond is the controlling elevation of how high the pond can fill before it overtops northerly into the channel and down High Point Road. The pond currently captures 7% of the Total Suspended Solids (TSS), or sediment, entering the pond. The 7%

capture assumes regular maintenance. This pond does not have adequate storage for the sediment load, and as it fills with sediment, its treatment potential decreases.

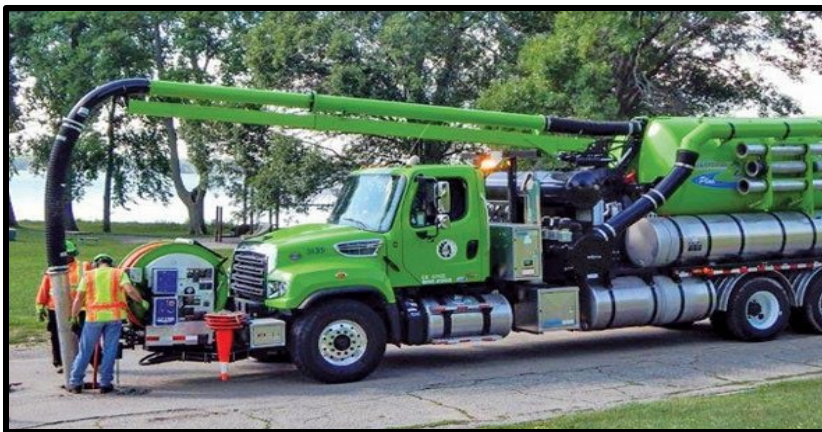
Figure 18

The City has nine 2100 Vector trucks (see Figure 18) that operate 7 days a week, and are designed specifically to accommodate the cleaning and maintenance needs of over 790 miles of sanitary sewer mains citywide. Vectors are very large, heavy, cumbersome trucks, but they are very effective in keeping

our sanitary sewers clear of back-ups and removing back-ups during an emergency. The Vector truck needs to be able to clean the sanitary sewer that runs north-south through the greenway and access the sewer during an emergency. Vectors are the most effective tool for addressing sanitary sewer back-ups, which is essential in large regional sanitary pipes. When there is a back-up that needs to be cleared, Vectors need to be able to access the sanitary access structures adjacent to the back-up.

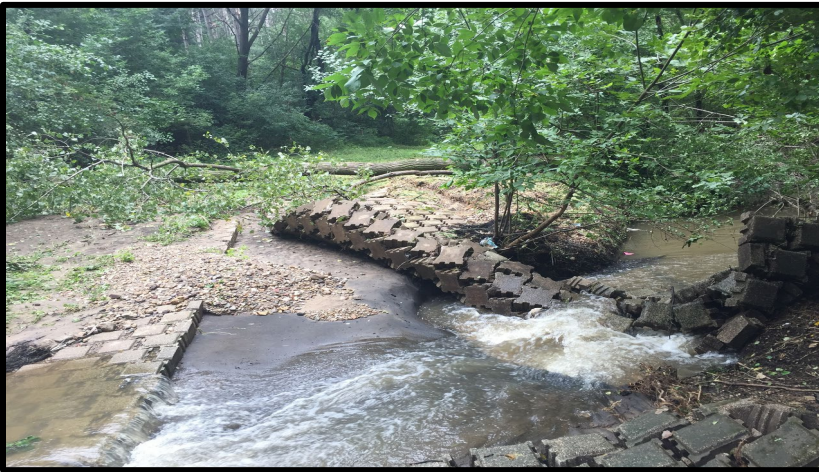
Figure 19 Failed sanitary access path

The City built 2 access paths in the early 2010's within the greenway to allow for access to the structures needed to clean the entire stretch of sanitary sewer. When the southern path was built, an articulated concrete block crossing of the channel was installed at the crossing near Tree Lane and Randolph Dr. (see Figure 19) This crossing did not hold up during large storm events, particularly the 2018 historic rain event, and has since failed. Currently, for the Vactor truck to access the sewer within in the greenway along the rest of the path, a temporary crossing is installed with swamp mats, which are typically large wooden planks, and are used to create a temporary road when the ground is wet or unstable. This takes 1-2 days of work for a City Engineering Operations crew to load, haul, and assemble swamp mats to create safe access for the Vactor truck and televising equipment, and it can only be completed when there isn't rain in the forecast for a series of days. If a sanitary sewer backup, or another sanitary sewer emergency is reported, the process to install swamp mats creates an unreasonable response time to address an emergency. Additionally, during typical maintenance, the amount of time crews need to spend installing a temporary road prevents them from completing other maintenance activities during those days anywhere else along the almost 800 miles of sewer mains in the city.

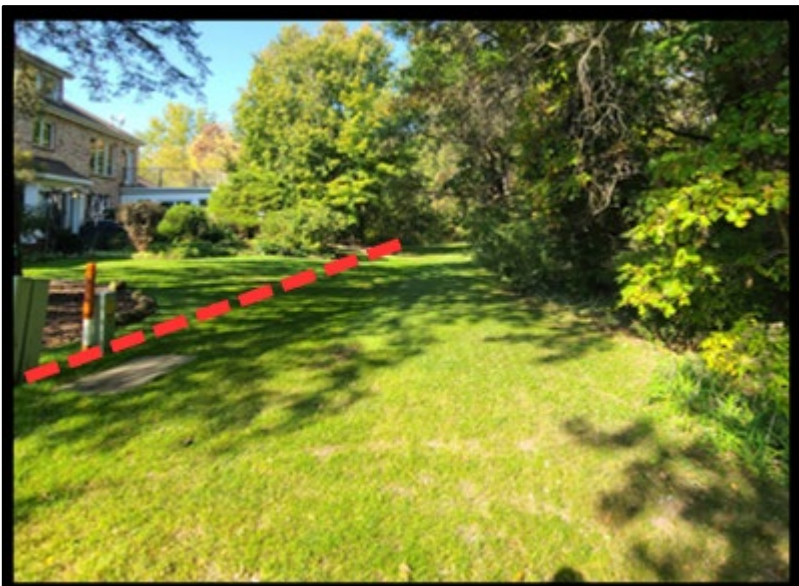
Figure 20 Existing sanitary access path along back of lots (red dashed line shows approximate property line)

The City built 2 access paths in the early 2010's within the greenway to allow for access to the structures needed to clean the entire stretch of sanitary sewer. When the southern path was built, an articulated concrete block crossing of the channel was installed at the crossing near Tree Lane and Randolph Dr. (see Figure 19) This crossing did not hold up during large storm events, particularly the 2018 historic rain event, and has since failed. Currently, for the Vactor truck to access the sewer within in the greenway along the rest of the path, a temporary

access is insufficient for Vactor trucks (Vactor trucks weigh >70,000 lb). Vactor trucks tend to sink into the topsoil, and the grass is very slippery in wet, or even dewy conditions. Vactors are full of liquid, making them challenging to drive due to the shifting weight, and their large, wide attachments make maneuvering

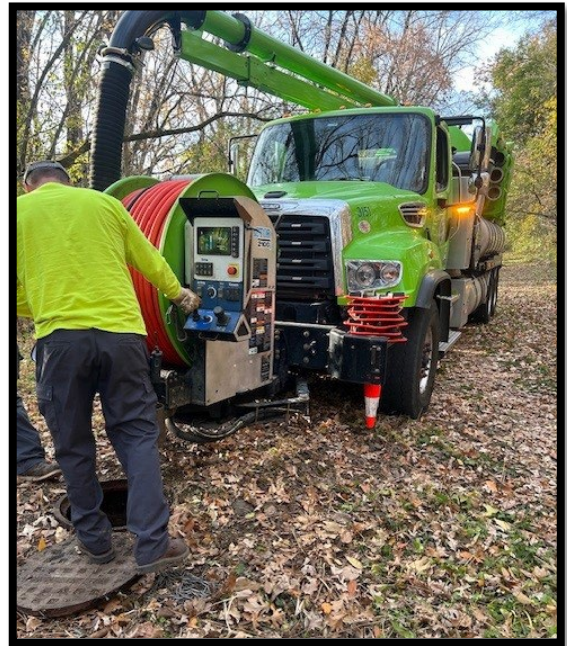
Figure 21 Vactor and crew cleaning sanitary mains via access structure in Sauk Creek greenway

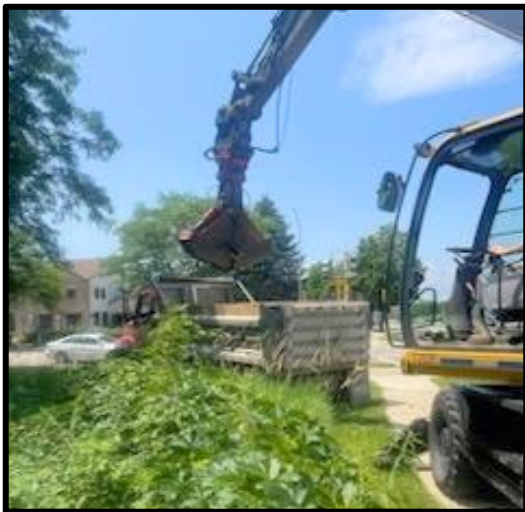
Figure 26

For tree removal requests, there is a variety of equipment used, depending on if the tree is standing or down. The largest pieces of equipment are excavators with grapple hook (shown in Figures 25 and 26), and a tandem axel dump trunk. Sometimes smaller scale tree removal requests can be managed with equipment such as a mini excavator, bandit chipper, track bobcat or a 1-ton truck (shown below). Tree removals that require specialized equipment or technical felling techniques often are performed by a City approved contractor. Contractors who are hired by the City possess the equipment and skills to perform specialized tree removals. However, scheduling the contractor and the higher associated costs for these services delay response time and reduce funds for other maintenance activities.

When the channel gets blocked, it tends to dam up with additional debris, sometimes causing huge tangles of fallen trees, large limbs, leaves and other debris. Removing large blockages requires the correct equipment. The type of equipment needed to safely and efficiently remove a large channel blockage is an excavator with a grapple bucket. Generally, the large blockages that are likely to lead to significant erosion have a variety of stacked heavy limbs and trunks that have a loaded force on them (keep in mind the weight of a large down tree trunk is thousands of pounds). When crews must manually cut or pull apart log jams, there is a hazard of loaded limbs, unloading their stored force and snapping back, which could cause equipment damage, and more importantly it can endanger the cutting crew. However, an excavator with a grapple bucket can allow the operator to grab and lift logs, increasing the distance from equipment and reducing the need of ground crews manually cutting the jam apart. Using the appropriate size equipment can mean a log jam can be safely managed in hours vs days.

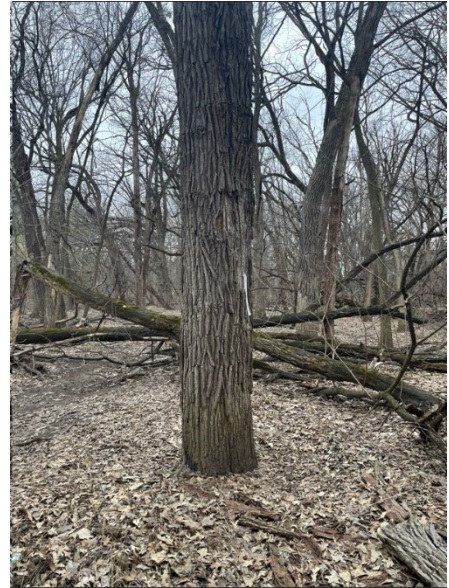
Figure 34 Root flare on mature oak tree is buried under sediment.

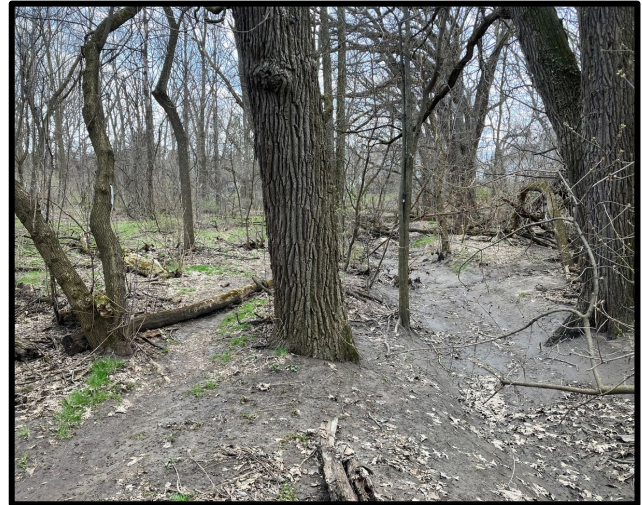
Figure 38

Sedimentation from channel flooding leads to loss of herbaceous layer plants. Tree health is impacted when the bases of trees are smothered by sediment. For example, sections of the channel along the northern part of the greenway exhibit such dense sediment deposition that tree root flares appear to be buried, arresting the ability of the tree to exchange gases and nutrients and leading to potential root rot, decay or death⁴. Continued sedimentation leads to concerns with tree mortality, blockages of the drainage way from downed trees and overall tree regeneration when continued sedimentation occurs.

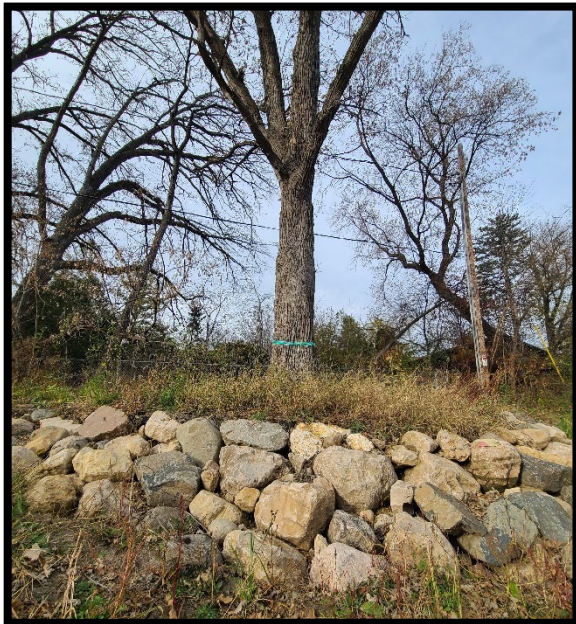
Figure 59

Locations of access paths shown on corridor plan are approximate. The design will determine the final location and will navigate around trees, as prioritized based on the Community input, and minimize impacts to adjacent properties. The design will assess the shear forces of the stormwater that may flow over the path during different events based on stormwater modeling and propose additional enforcements where necessary to avoid washout. The path will be built on grade throughout most of the corridor to avoid water backing up on either side of the path, and to minimize grading. In areas where grading may be needed along steeper slopes, such as in the east-west section, the City will consider using glacial field stone walls to minimize grading and protect adjacent trees. You can see an application of this in Figure 59.

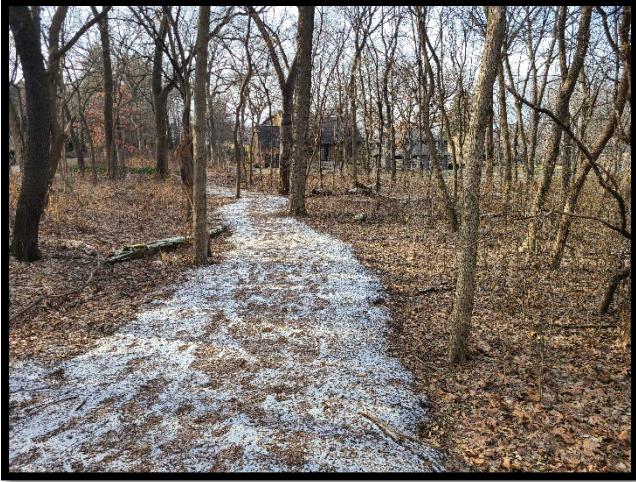
Figure 60

The maintenance access paths will be different from the existing sanitary access path. They will wind through wooded areas to avoid trees. A good, nearby example for the Community to see similar width paths, and the impact to the space, would be the un-paved paths in Wexford Park (see Figure 60). These paths offer walking routes for neighbors, can be used as maintenance access paths for Parks, and an abundance of wildlife can be viewed throughout the park. A major difference between the paths that are

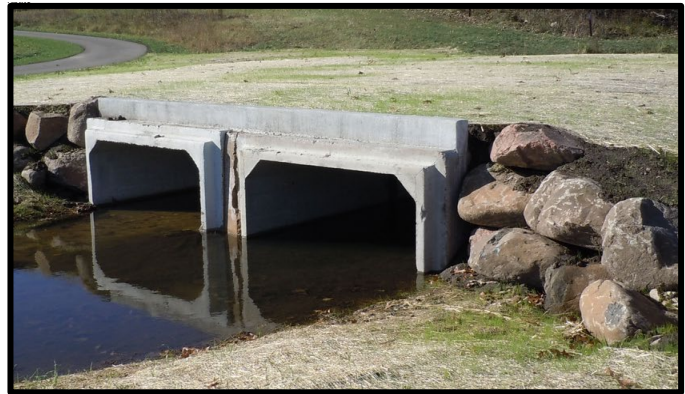
Figure 62 – Example of a box culvert

Box culverts are concrete square shaped storm sewers that will be 14-20' long (meaning the crossing will be 14-20' wide). A culvert allows the low flows of water to pass through the channel as normal while creating a safe, stable crossing overtop of the culverts. The culvert will be designed to match the approximate size of the existing channel to not create a bottleneck, and safely have water also flow over the top when it leaves the channel bank during large rain events.

An example of a box culvert can be seen in Figure 62, however it is not representative of how the culverts will look in scale, cover, or surrounding vegetation (including trees).

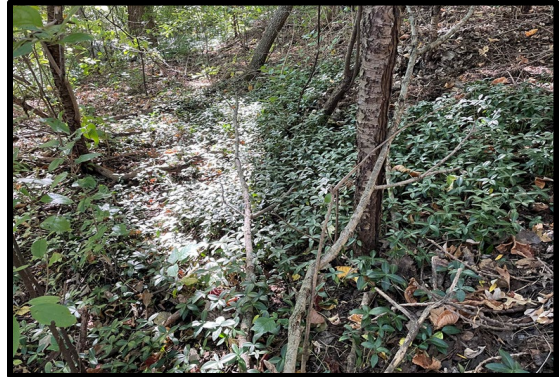
Figure 65 Periwinkle invading a greenway understory

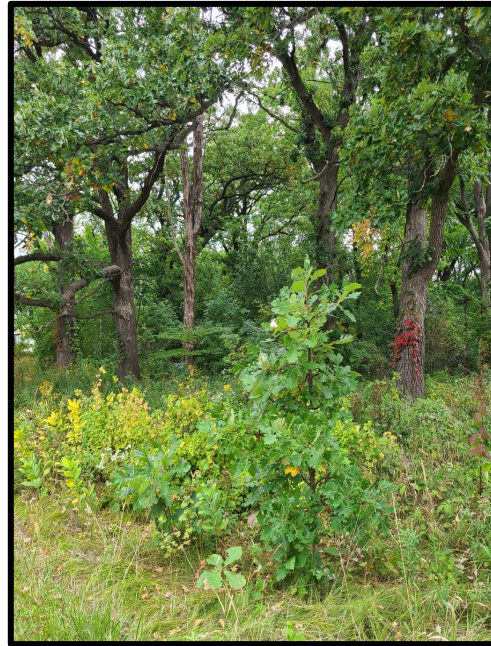
Figure 68 Canopy oaks are not being replaced in areas where shrub layer is too dense as seen in background. Young oak will be planted along edges of restoration areas where pockets of light will be created.

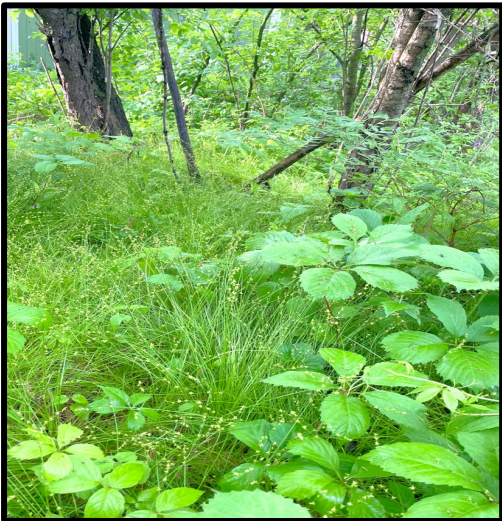
Figure 66 Native rosy sedge and Virginia creeper dominate the groundlayer in this wooded portion of Bram St pond
