Madison Metro Transit 1101 E. Washington Building Summary

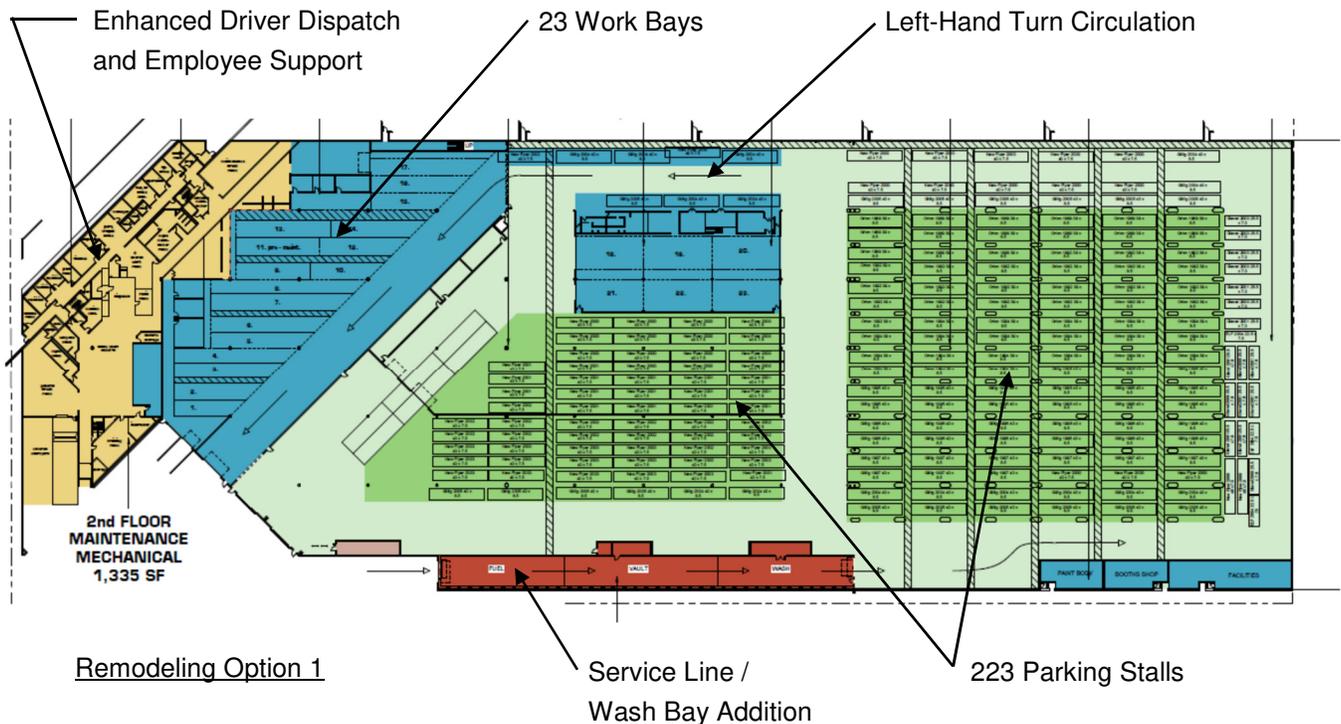
- **Staff safety and retention** are key priorities.
- Reorganize bus traffic flow for **Left-Hand turns** in lieu of current Right-Hand Turns for increased safety.
- **Sustainable Methods and Decreased Maintenance** are values for the City.
- Through the charrette process, with staff interviews, surveys, and department head meetings, three key priorities called for improvements of **Ventilation, Safety, and Toilet Rooms**.
- **REMODELING OPTION 1** resolves many of Metro’s challenges:

- The development of the program and renovation strategies started with early guidance provided by the City of Madison Engineering group and Madison Metro. At the forefront were the following goals and objectives:
 - Maintain functions generally **within the existing footprint**.
 - Provide a **20-year solution** for the site.
 - **Improve workflows** by reorganizing functional adjacencies.
 - **Identify upgrade requirements** for utilities and life safety.
