OLBRICH BOTANICAL GARDENS ROYAL THAI PAVILION CONDITION ASSESSMENT REPORT

AUGUST 30, 2022

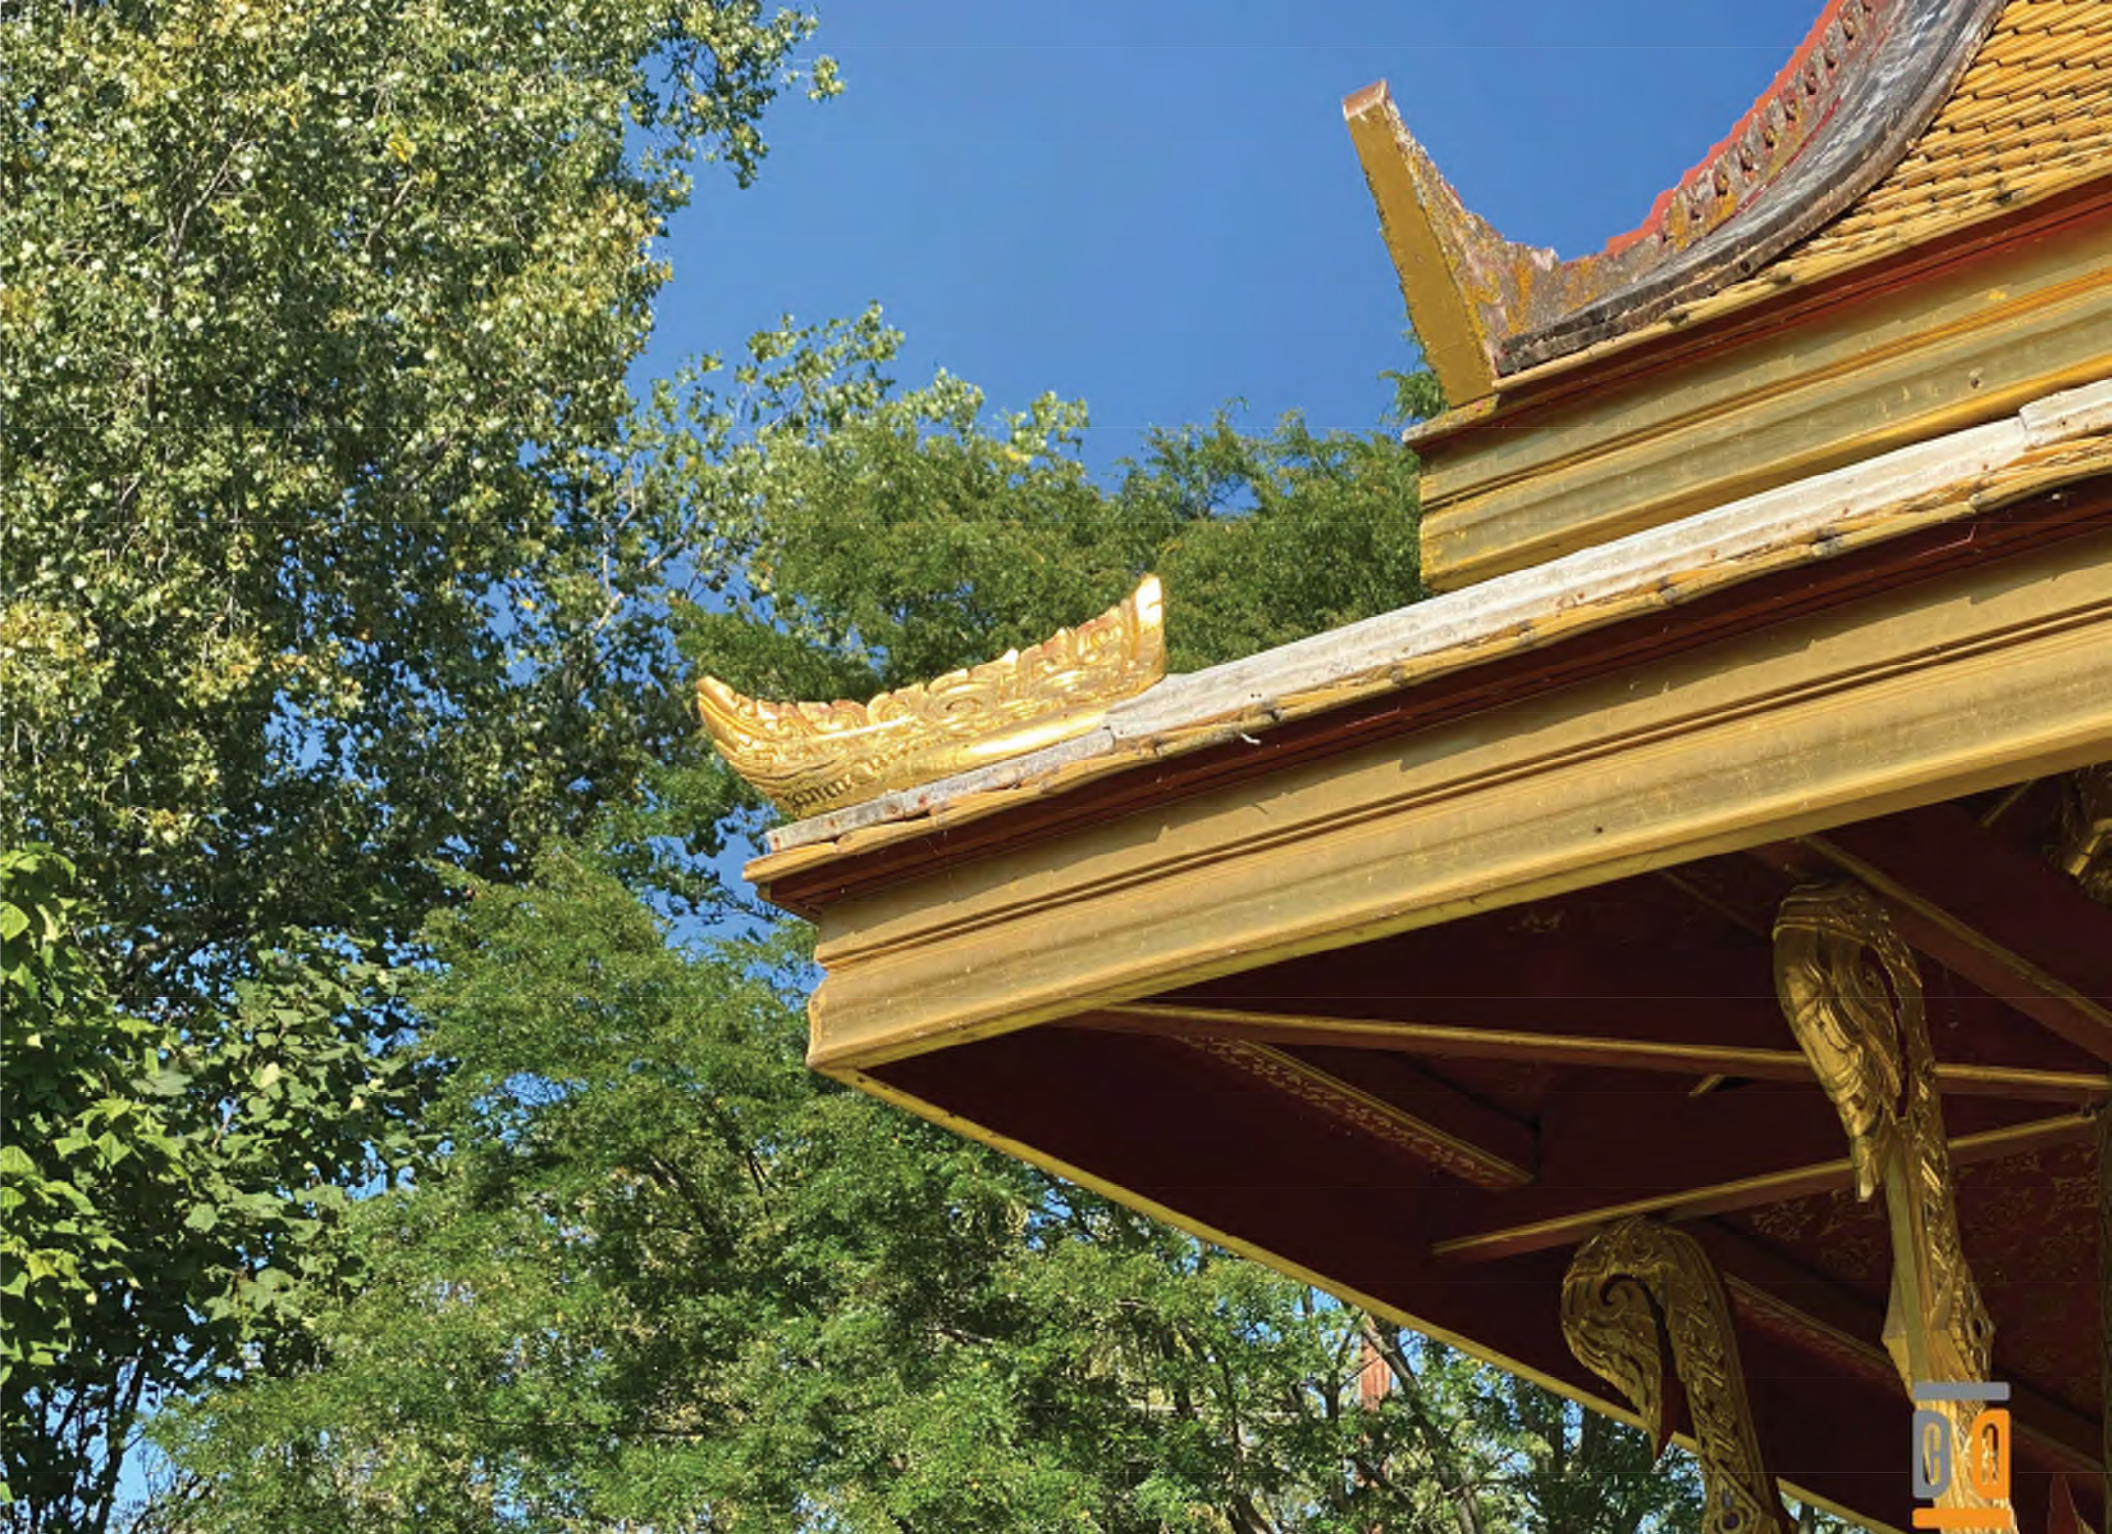
37. Corner view of North Gable end - Priority 2
