OLBRICH BOTOANICAL GARDENS ROYAL THAI PAVILION CONDITION ASSESSMENT REPORT

MAY 20, 2022

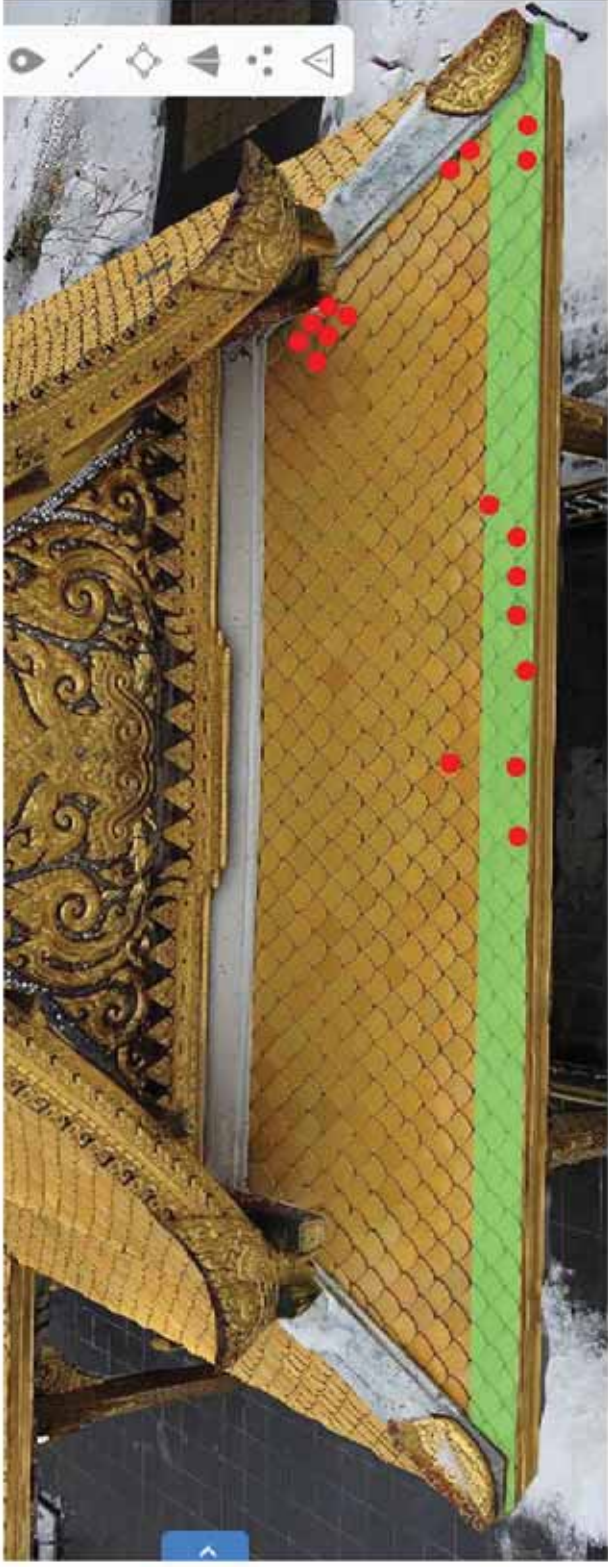
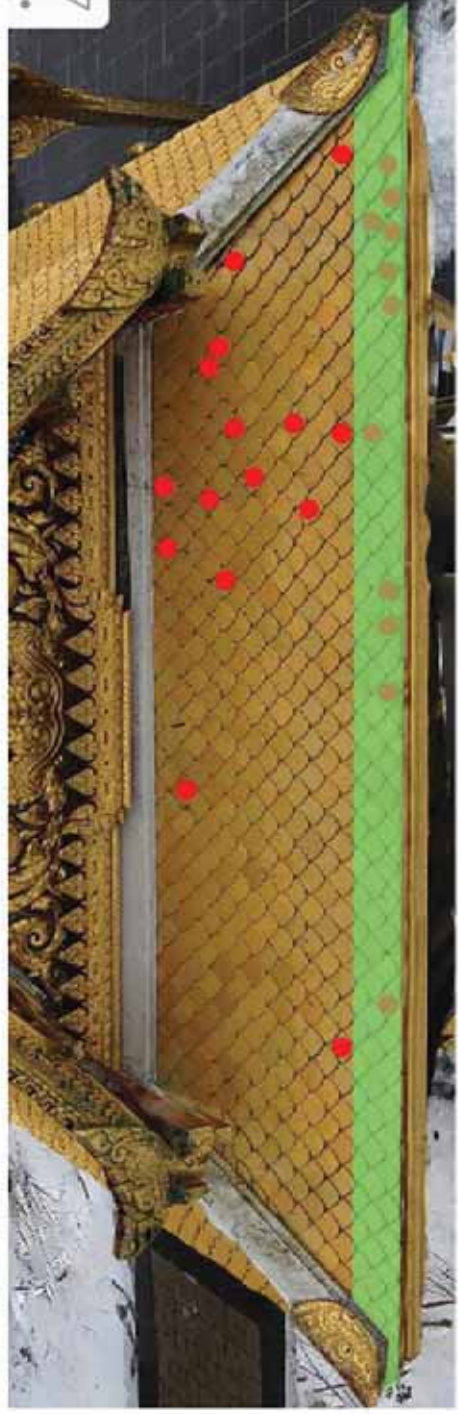
The condition of the roofing tiles is **CRITICAL**. The tiles are failing through splitting or shaling due to continued water exposure, and further deteriorating

through our Wisconsin climate's freeze-thaw cycle. It is assumed that more than 40% of the tiles are currently damaged. While testing has not been conducted on the existing tile nor the attic stock on hand, it is generally assumed that it is the Thai buff clay substrate that is not well-acclimated to withstand the typical weather patterns of our northern climate, regardless of enhanced treatments.

3. North & South Roofs of West Gable - Initial observed damaged tiles (not accounting for shear cracking) - Priority 1

A full replacement of the roofing tiles is recommended. The replacement tiles themselves should be recreated in shape, size, and glazed color, yet be made of an alternate clay material that is compatible with the Wisconsin climate. The tile should be convex to match the existing tiles for aesthetic and technical reasons. The overall surface of the tile will look much more uniform if the tiles are manufactured in this way. The tile should be laid in the same pattern and method, utilizing the tabs as originally designed. Modern substrate materials and roofing methods should be incorporated to prevent further water infiltration to the remaining structure. These will include contemporary synthetic underlayments, sub-tile membrane, and flashing systems. These systems must be carefully engineered to allow for the freest possible flow of water vapor and resist bulk water from above being introduced to the interior portions of the pavilion.

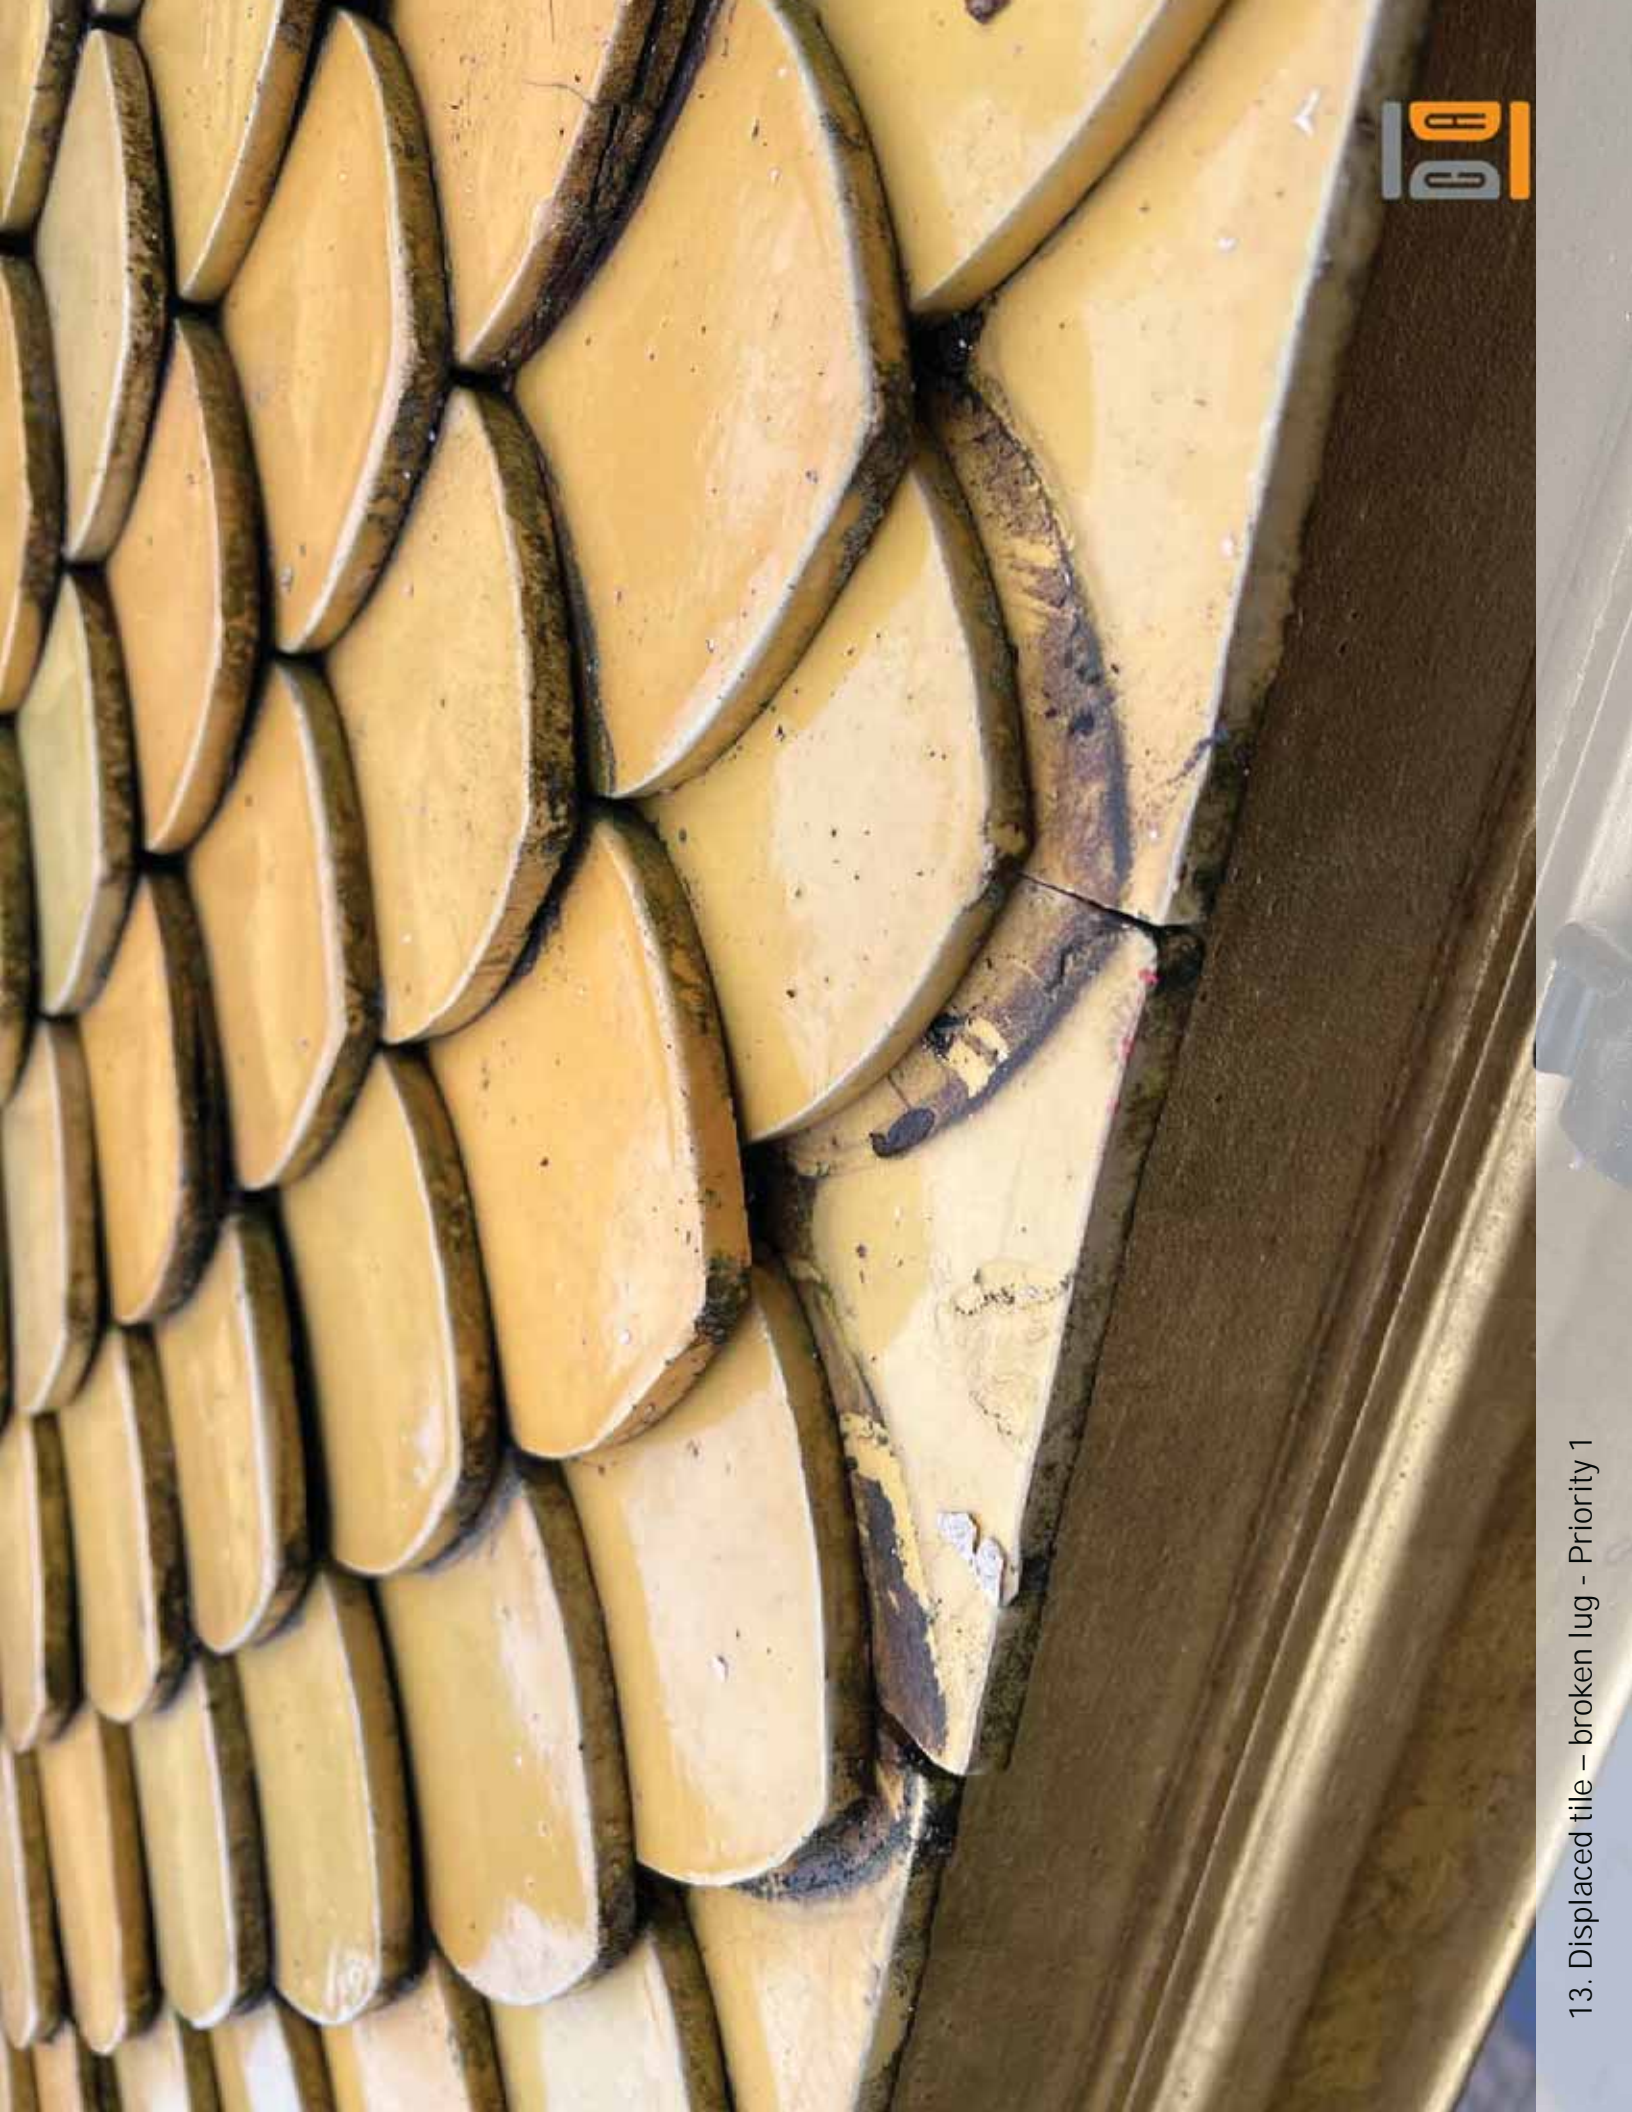
12. Grouping of three tiles removed for further study - Priority 1
