OLBRICH BOTANICAL GARDENS ROYAL THAI PAVILION CONDITION ASSESSMENT REPORT

AUGUST 30, 2022

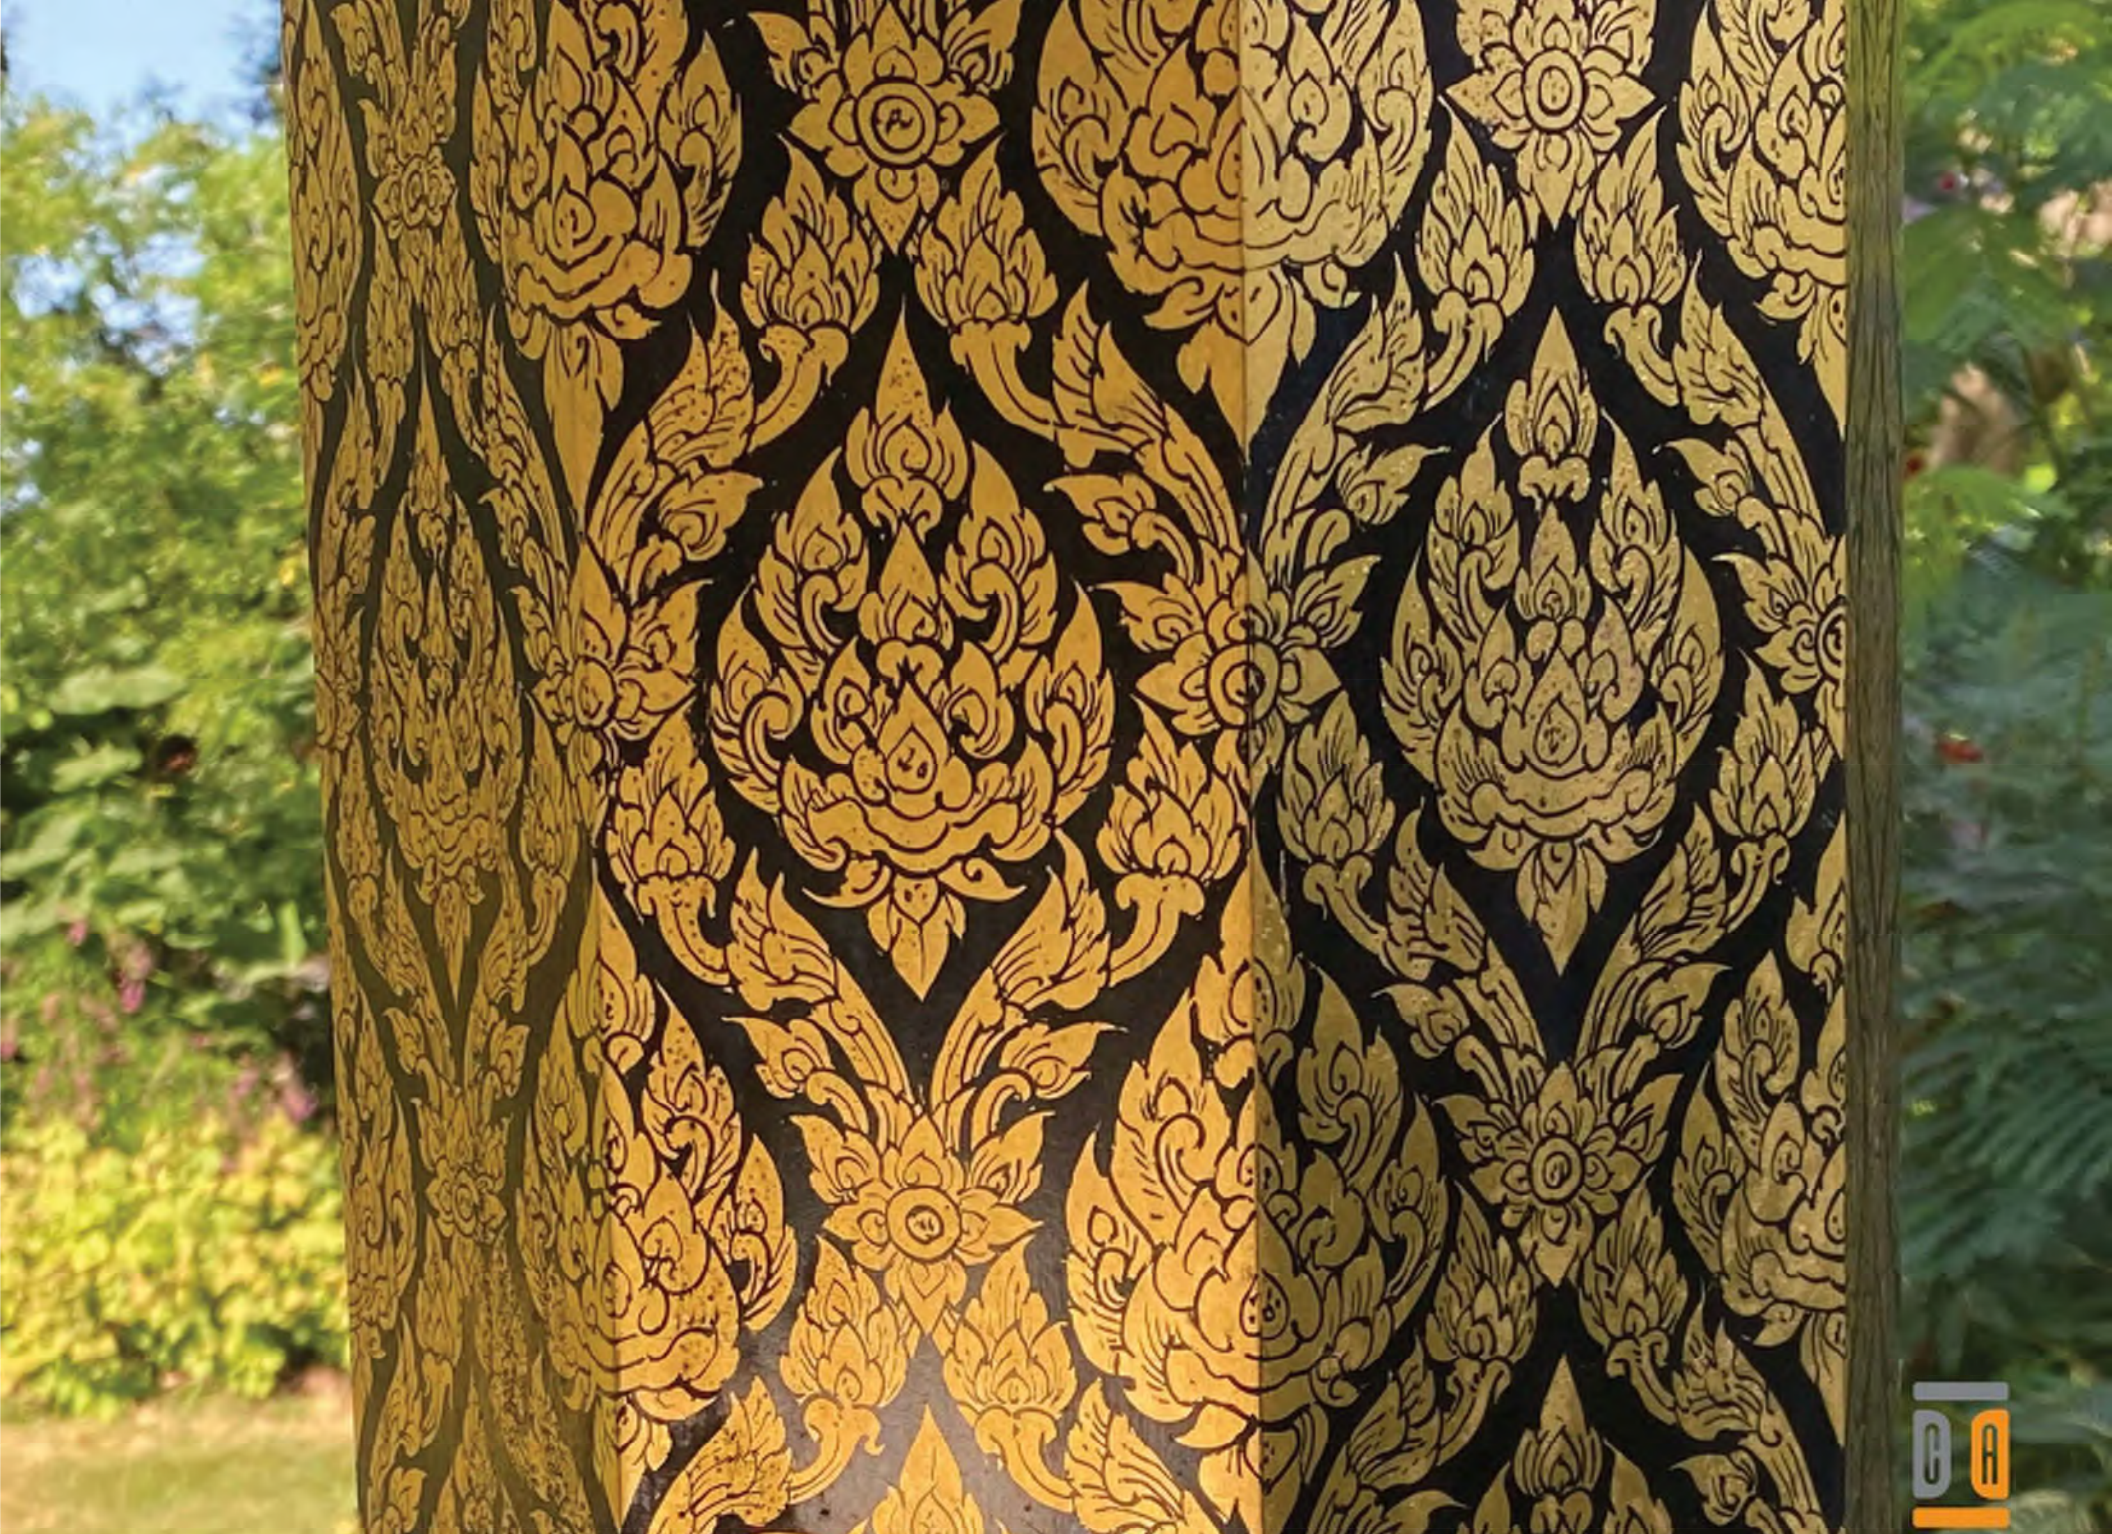
50. Exterior Condition of column capital - Priority 3
